WELL NAME: HILL RANCH 10-14V, API #: 071-07298, INSP. # 695109498

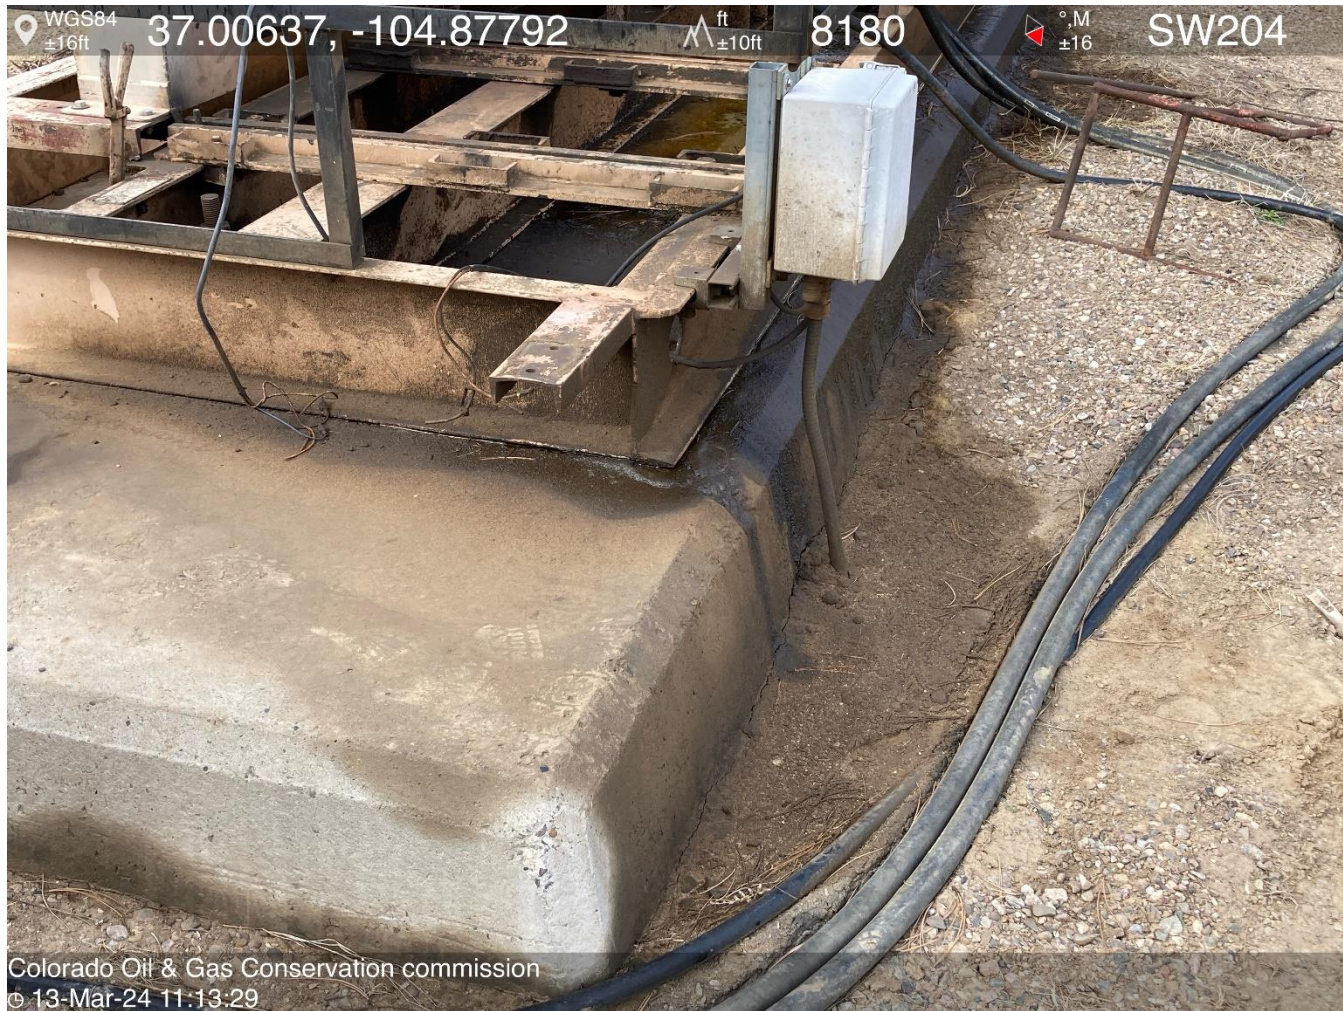
PHOTO 4: Impacted soil identified at various locations through out location. Conduct maintenance on equipment, cleanup stained material and review self inspection processes. COMPLY WITH RULE 1002,(2).D. CA DATE 5-22-24.

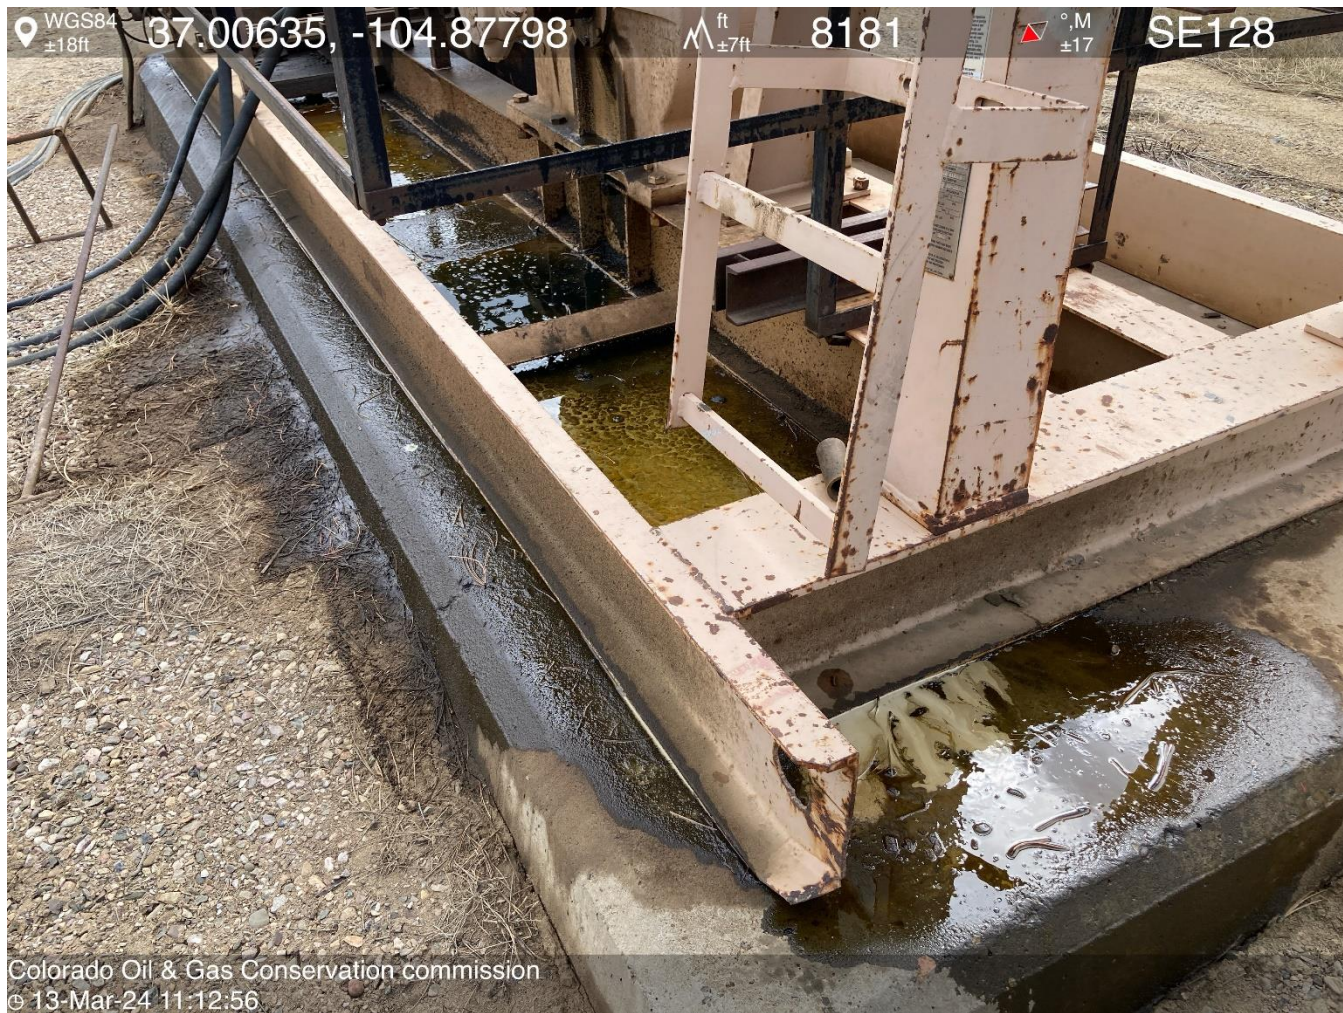
PHOTO 5: ANOTHER IMAGE OF IMPACTED SOIL. SEE PHOTO 4 FOR CORRECTIVE ACTION.

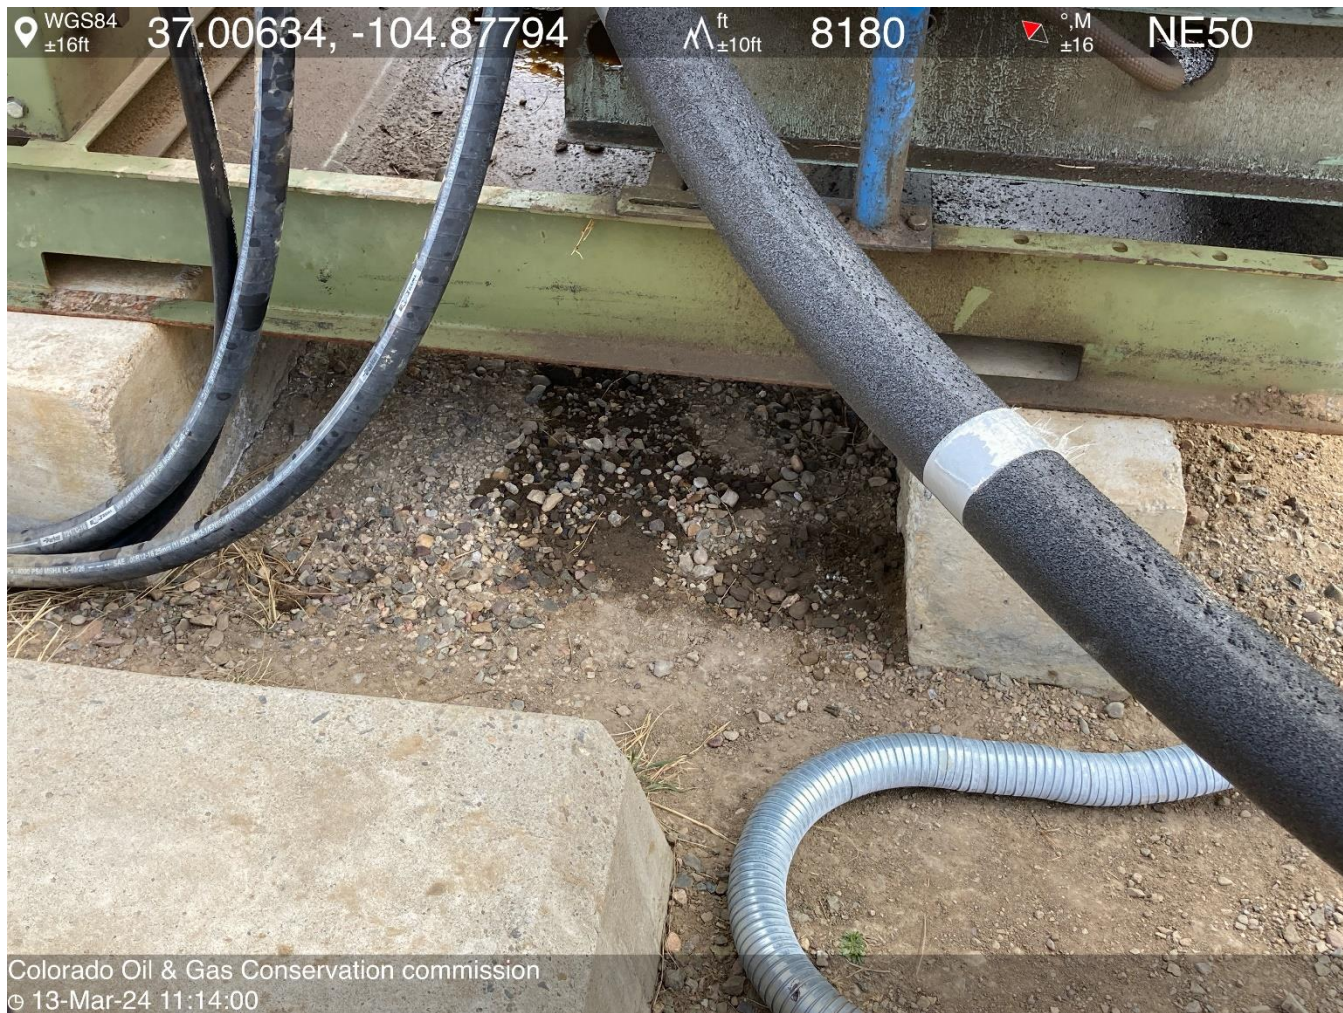
PHOTO 6: ANOTHER IMAGE OF IMPACTED SOIL. SEE PHOTO 4 FOR CORRECTIVE ACTION.

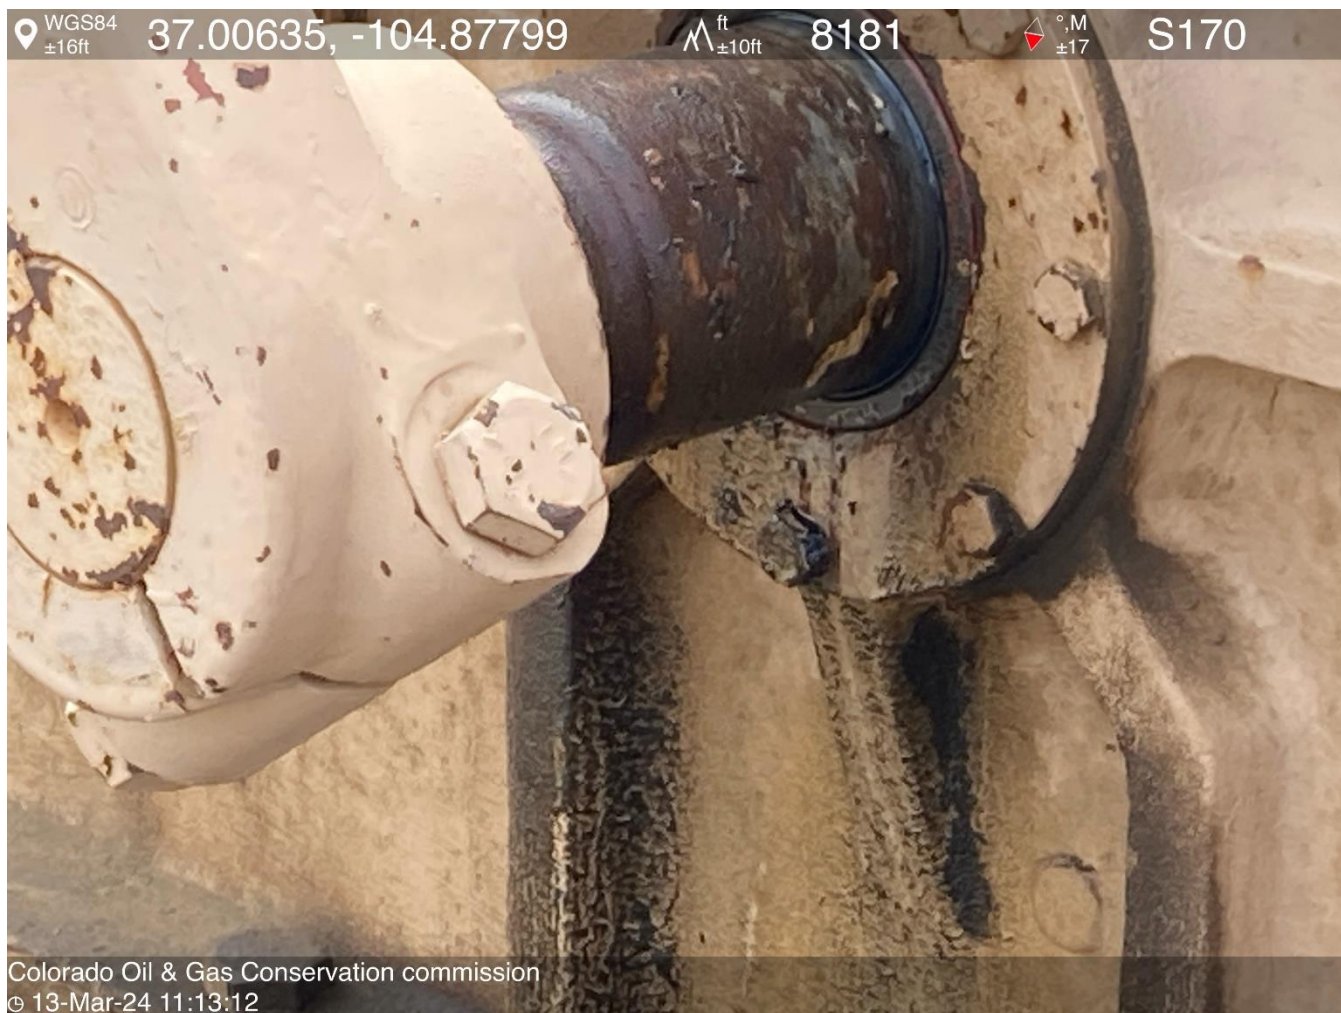
PHOTO 7: LEAK ON PUMPJACK GEAR BOX APPEARS TO BE THE SOURCE OF OILY WASTE IMPACTING SOILS AROUND PUMPMACK.
Securely fasten all valves, pipes, fittings, and Production Facilities to ensure good mechanical condition, inspect at regular intervals and maintain in good mechanical condition per Rule 608.e. CA DATE 5-22-2024.

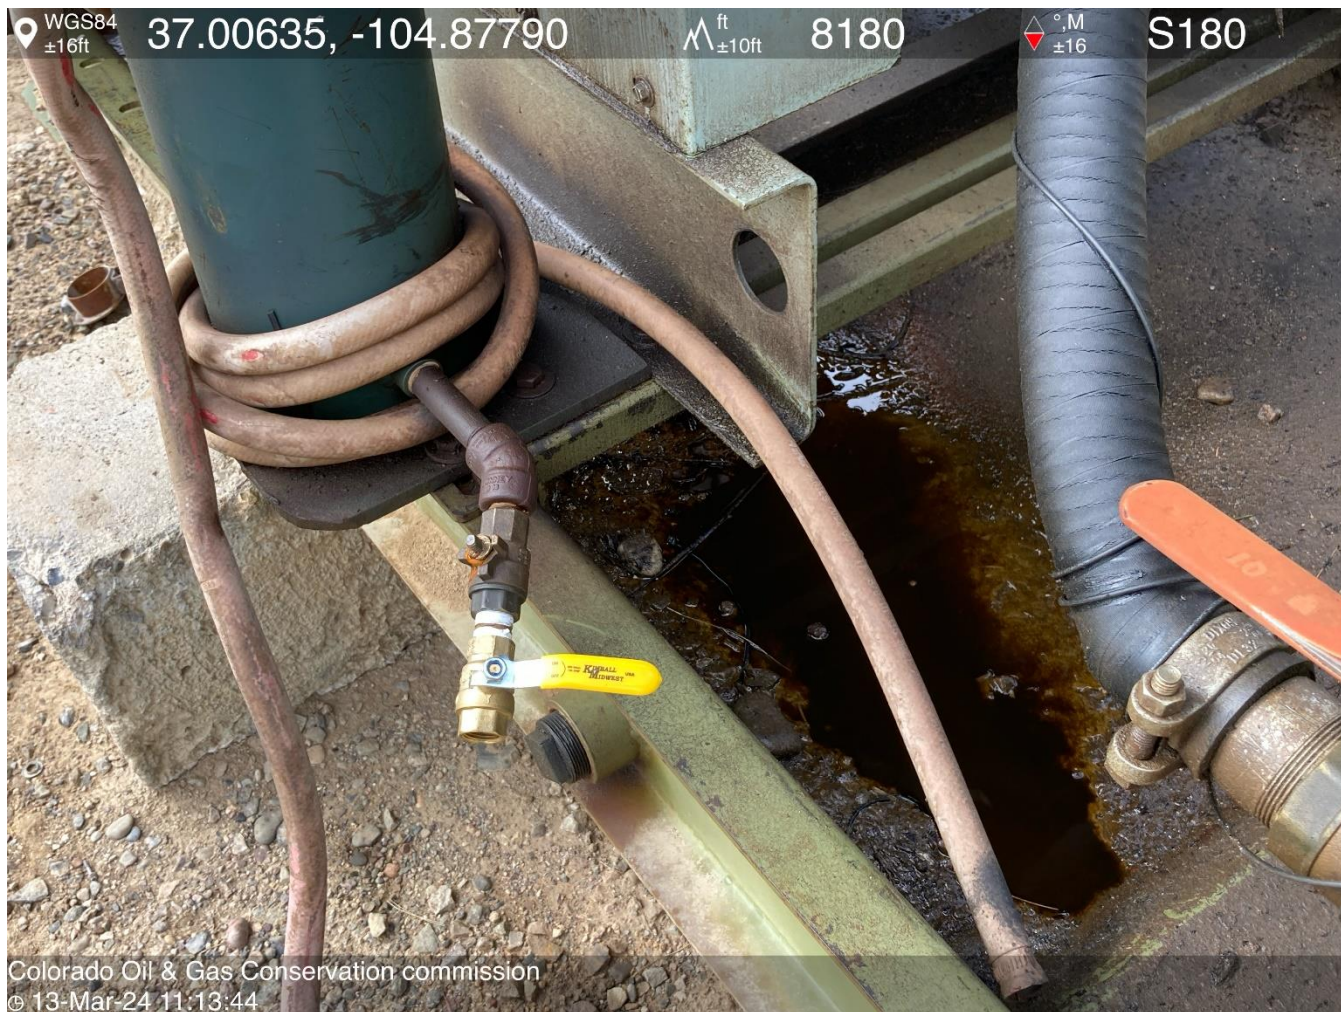
PHOTO 8: OILY WASTE INSIDE PRIME MOVER SECONDARY CONTAINMENT (ENGINE SKID). COMPLY WITH RULE 1002.f.(2)B, Comply with general provisions of the oil and gas act for wildlife protection AND SB-181. CA DATE 4-23-2024.
