Inspection Photos

Loc: 484357

Operator: DESERT EAGLE OPERATING LLC

Inspection Date: 4/22/2024

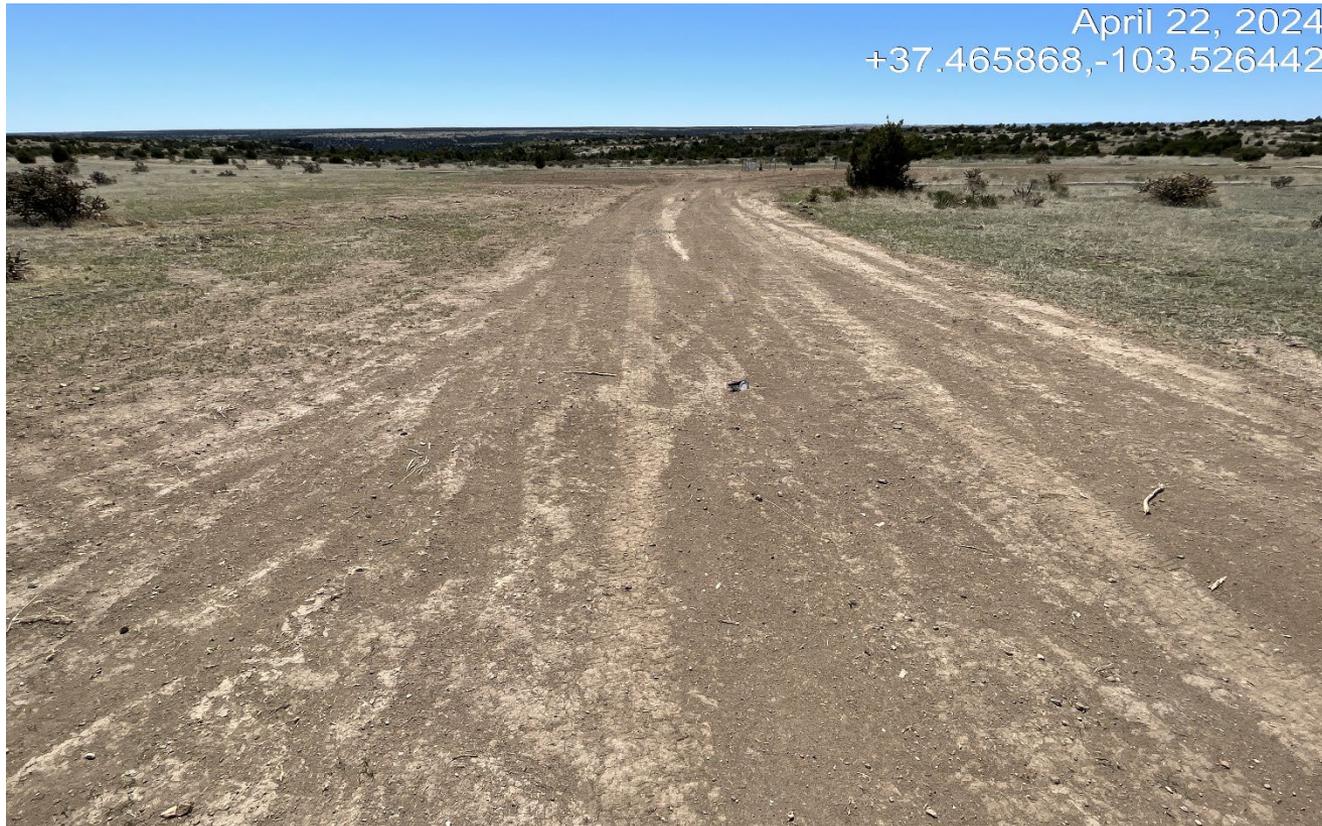
Photo 1. Facing south along the access road. Topsoil was not salvaged along the road and soils are very compacted.

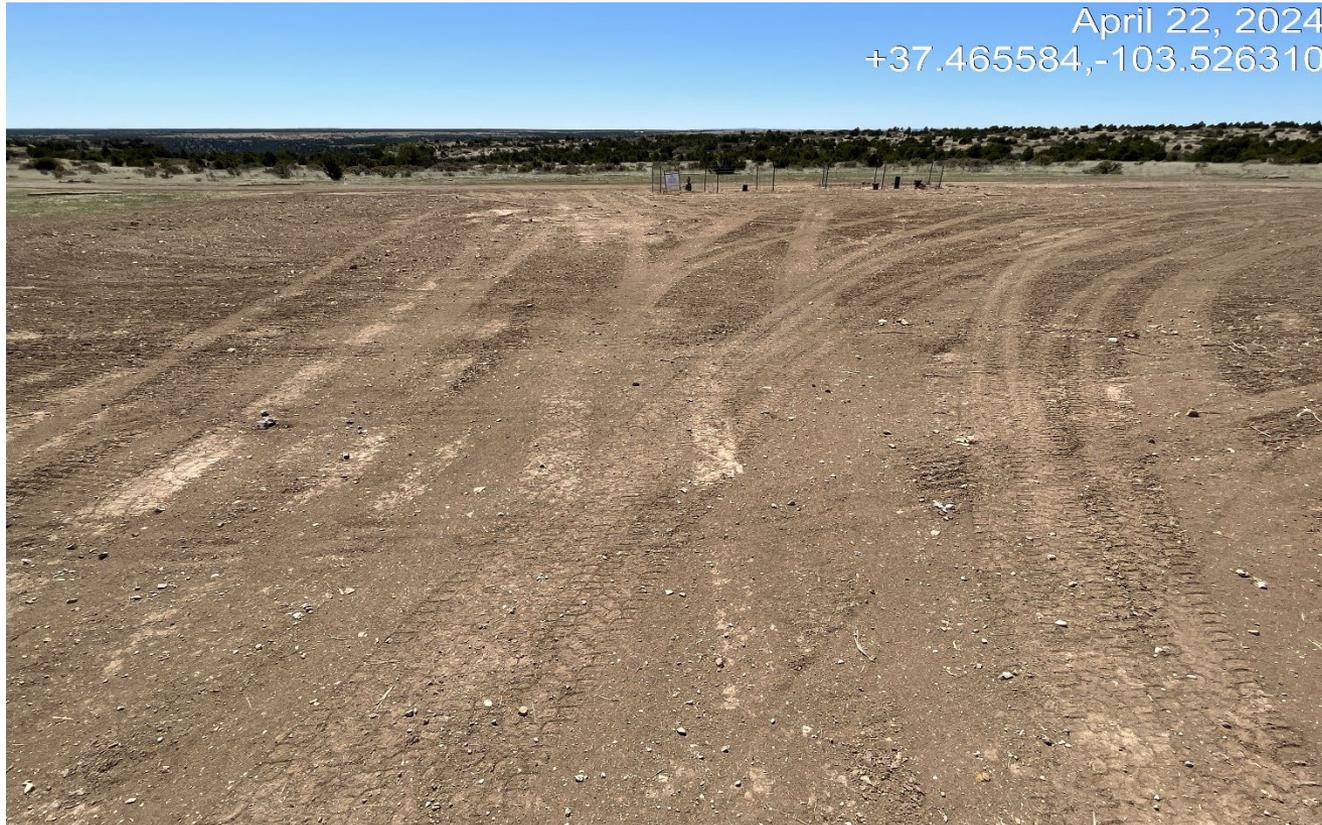
Photo 2. Facing south toward the location.

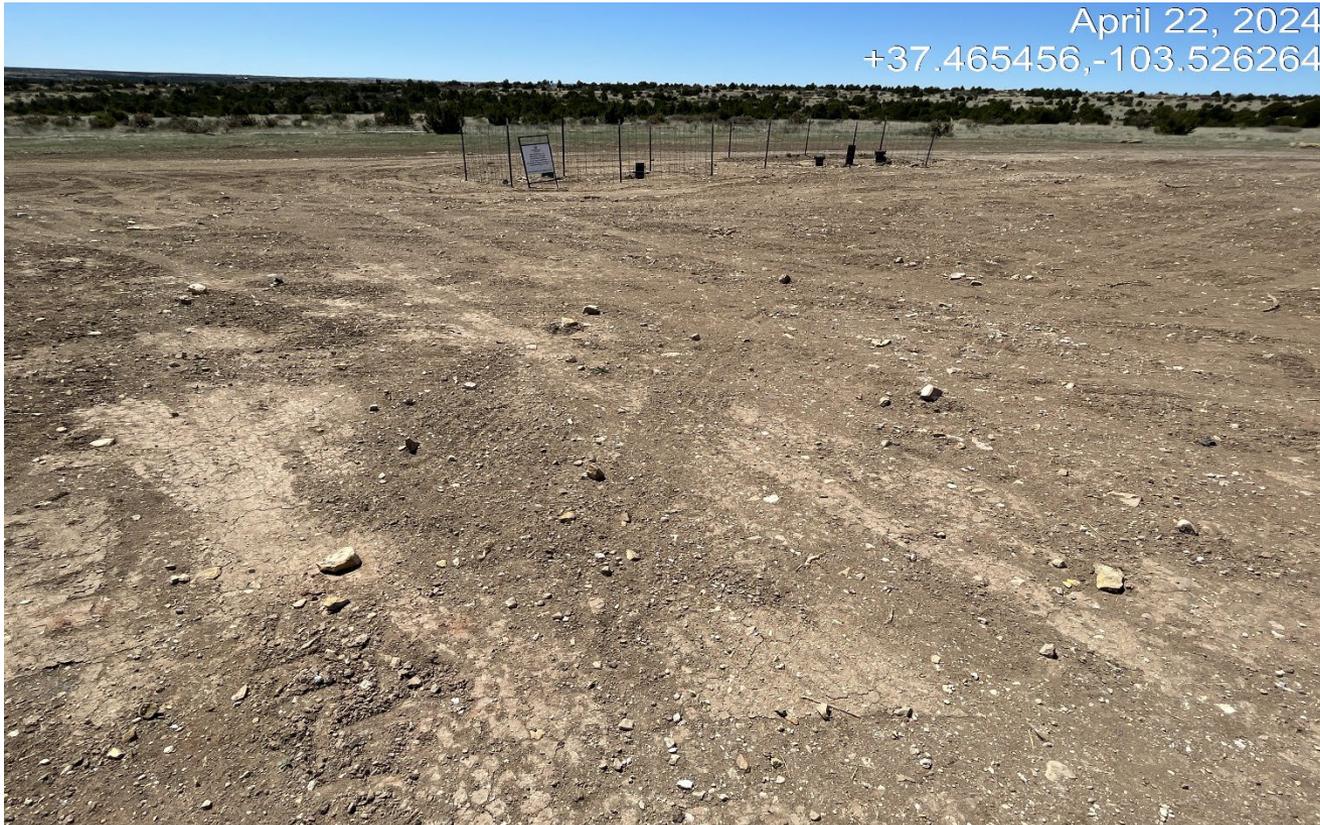
Photo 3. Facing east toward along the access road near the location. There are area where soils are very compacted. Seeding was performed in this area however vegetation will not grow well in compacted soils.

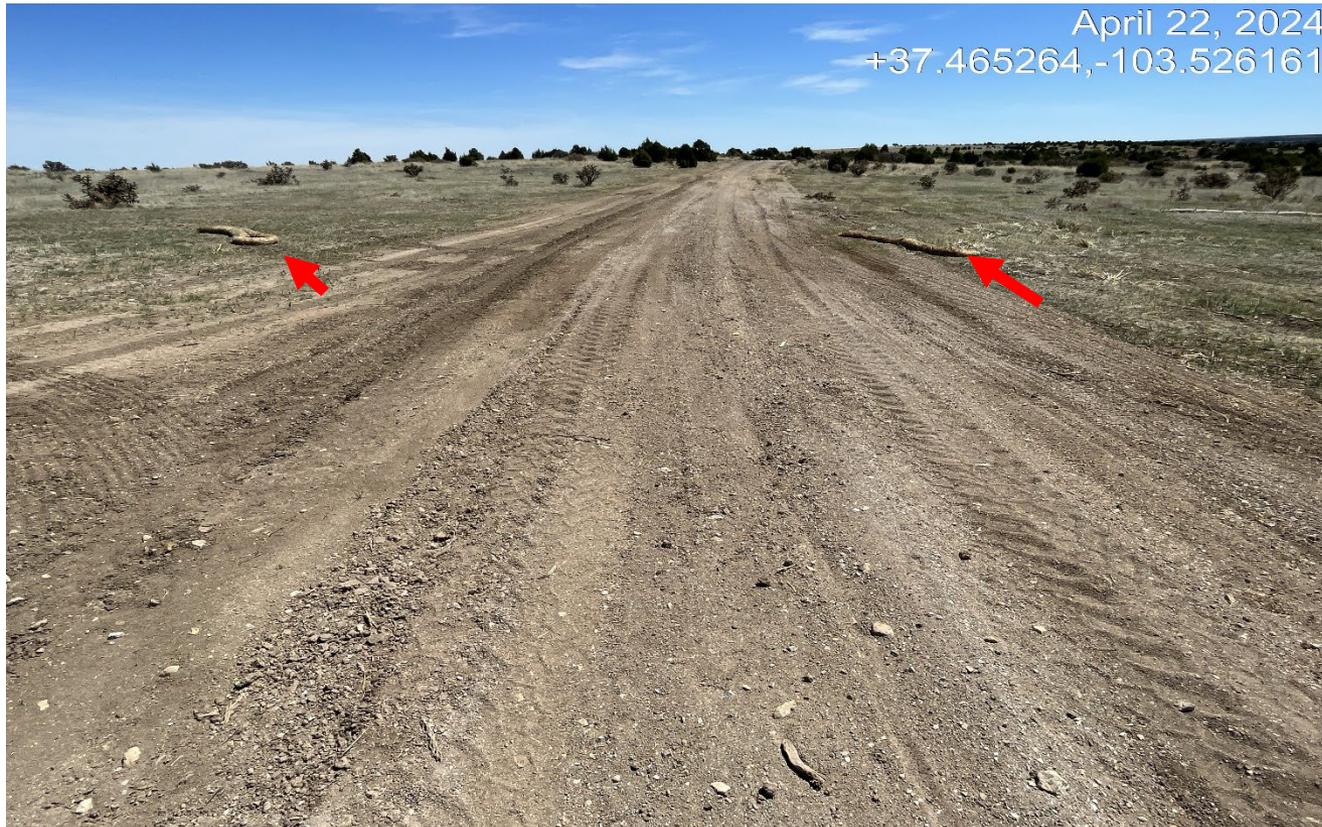
Photo 4. Facing east toward the flowline disturbance. The soils are not stabilized and are susceptible too erosion. There are displaced wattles shown at red arrows.

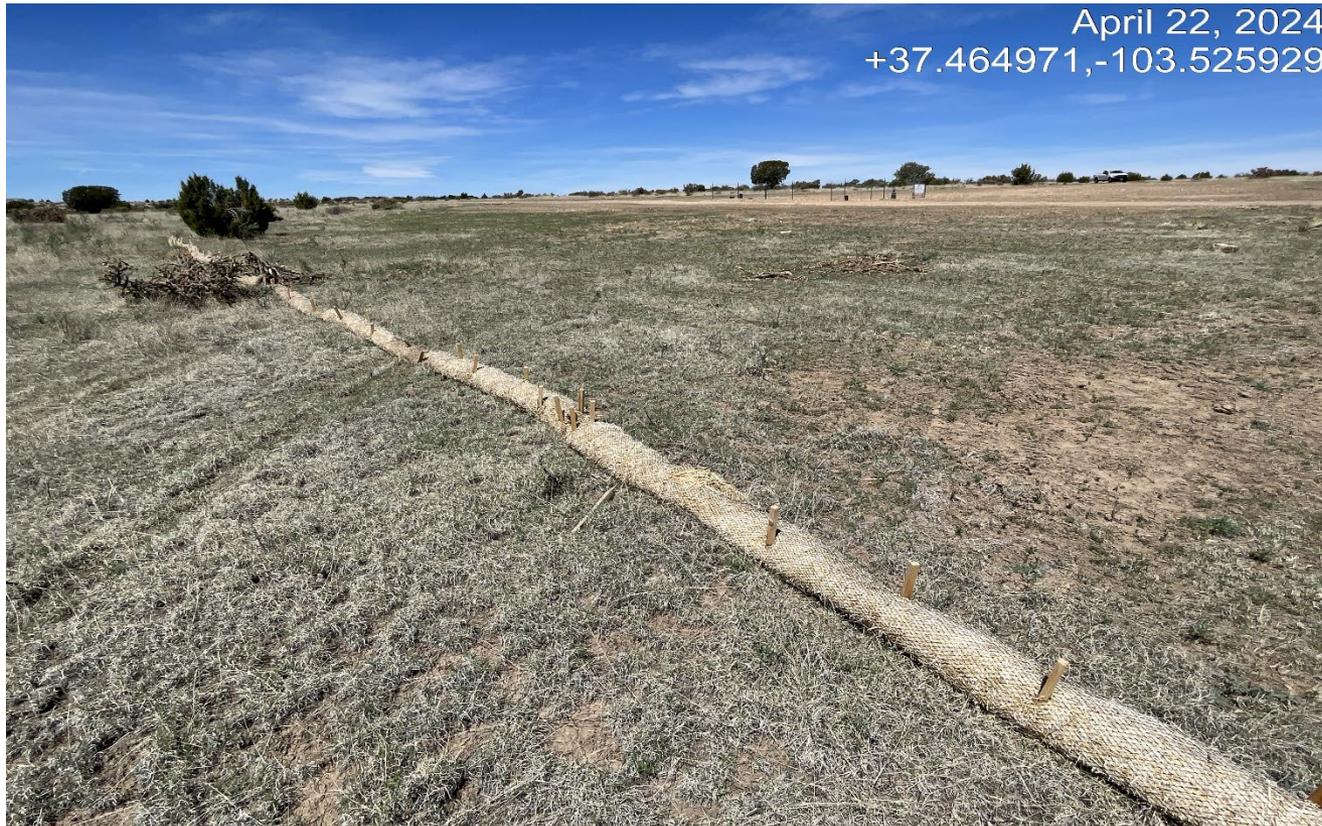
Photo 5. Facing northwest at the location. These perimeter wattles are installed far away from the disturbance area and should be reinstalled for better erosion control.

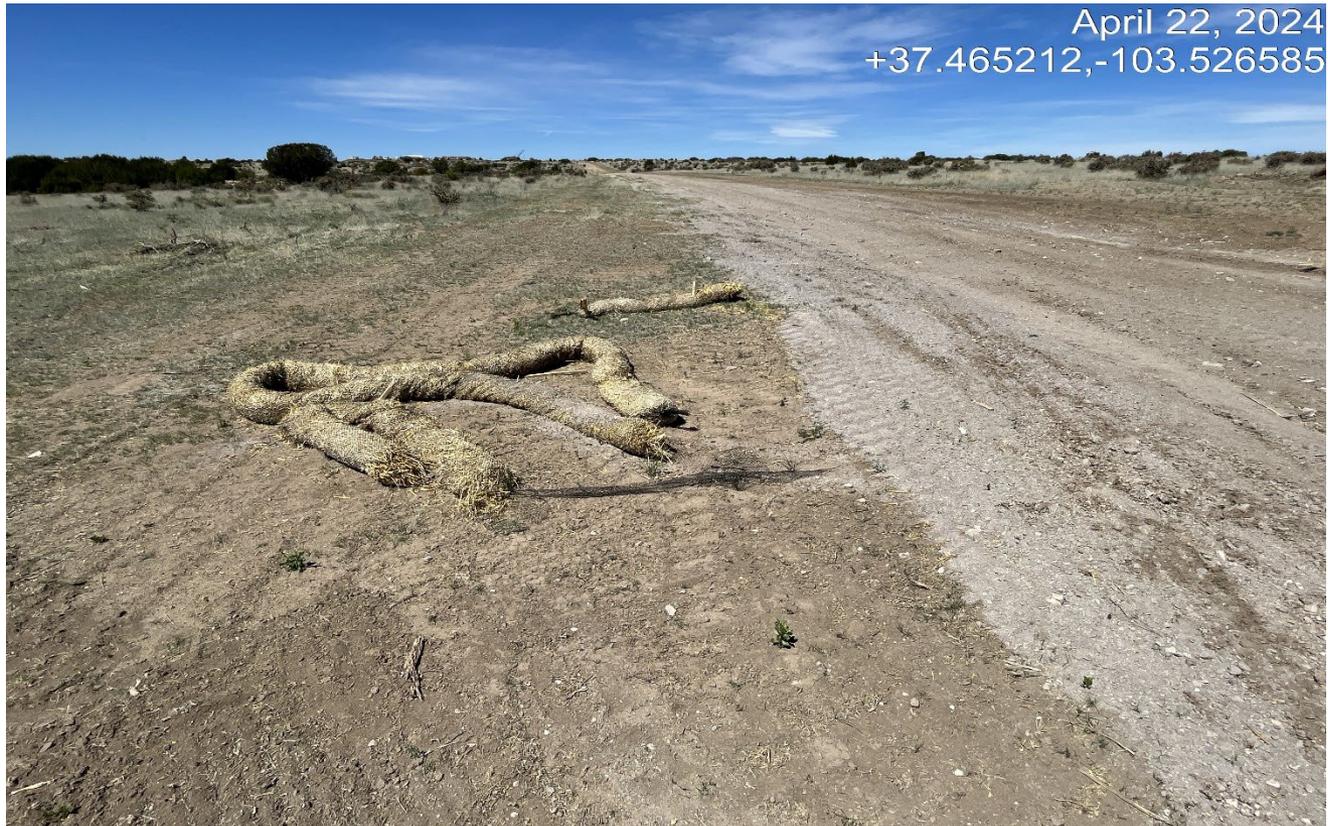
Photo 6. West side of the location. The are broken up straw wattles that need to be removed.

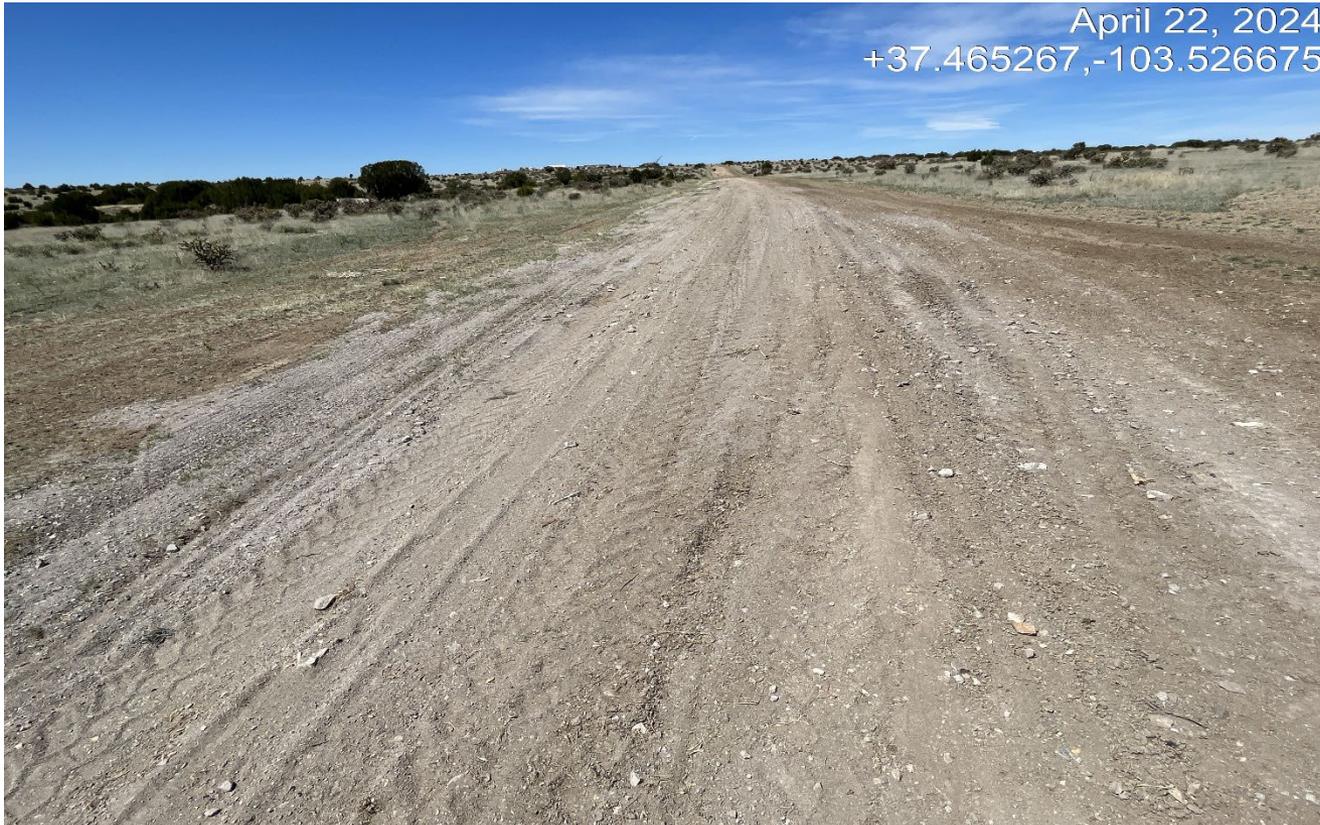
Photo 7. Facing west toward the flowline disturbance. The topsoil was not salvaged along the flowline and grey material was brought to the surface. It is likely soil amendments or topsoil will be needed for reclamation.

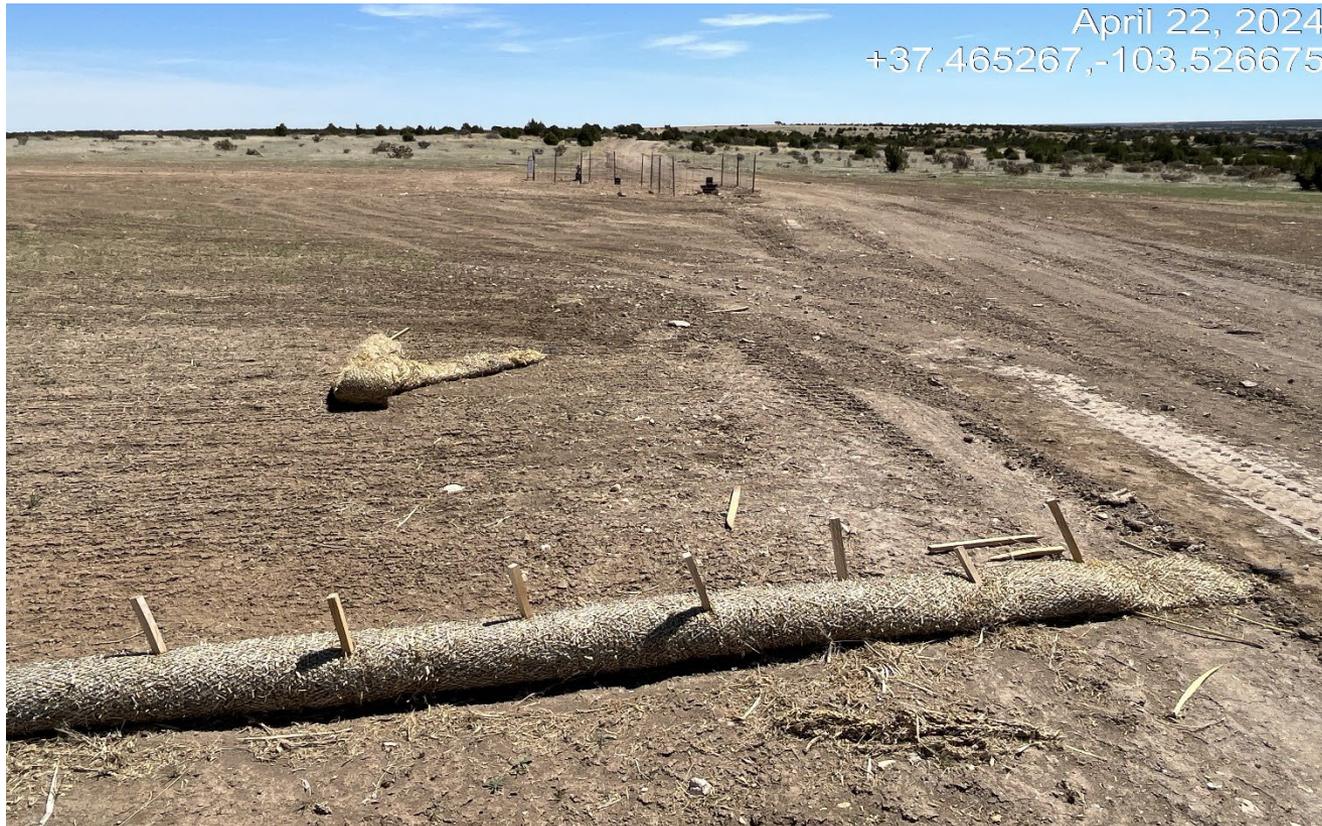
Photo 8. Facing east at the location. The stormwater wattles are displaced and have been run over by vehicles .
