**KT Resources LLC
Ant Hill Unit 7-43
Location ID: 316628**

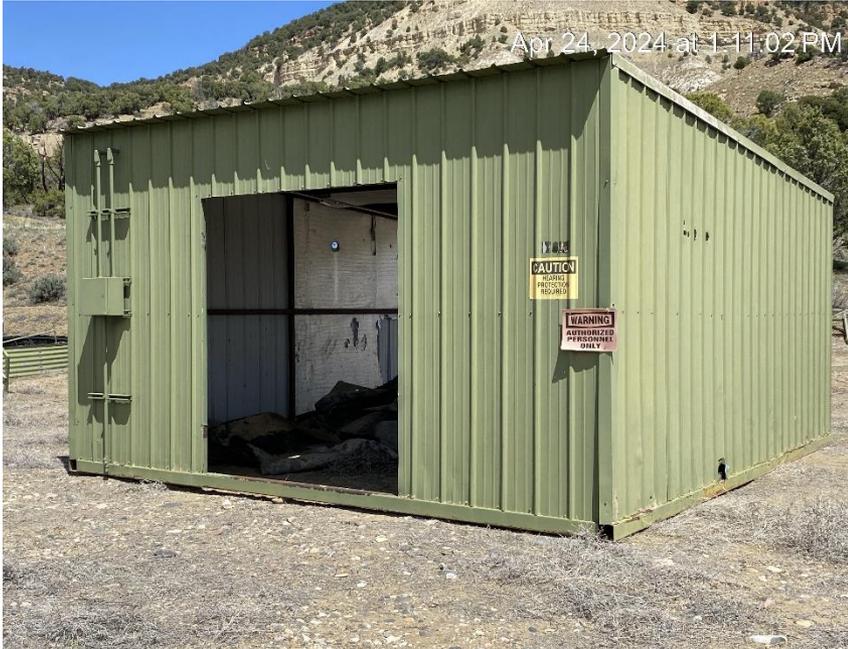
Debris and unused equipment

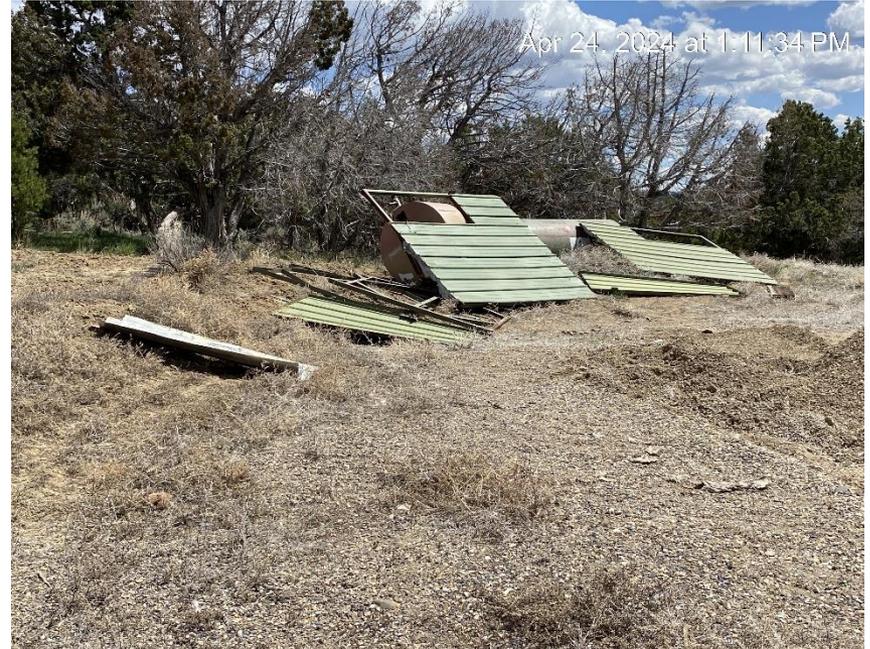
Debris. Unused equipment.

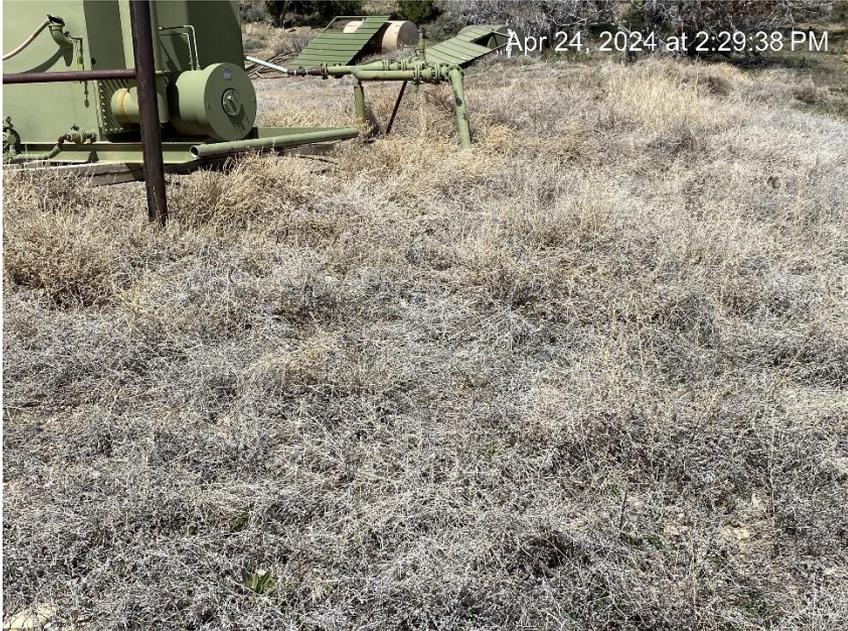
Debris from previous lack of weed maintenance.

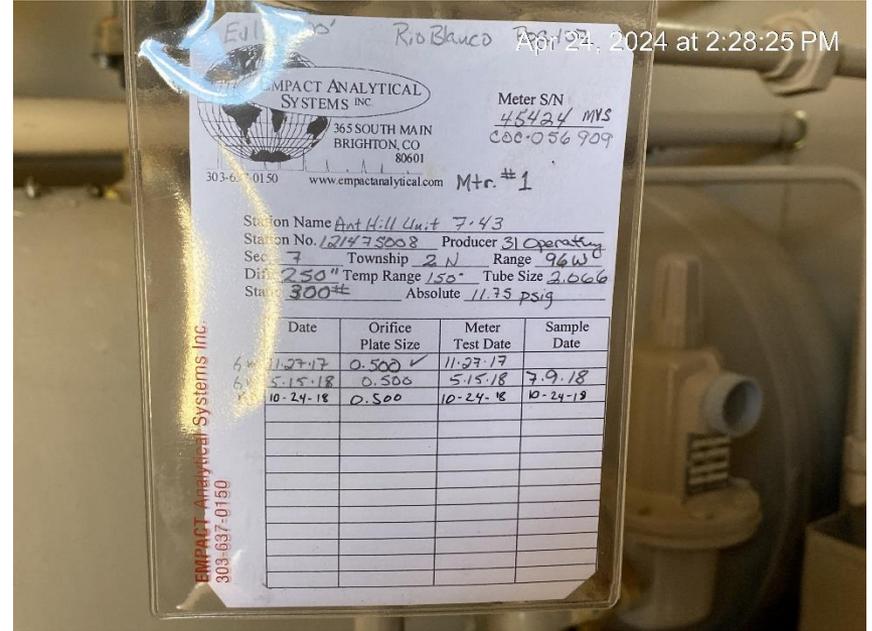
Gas calibration out of compliance.

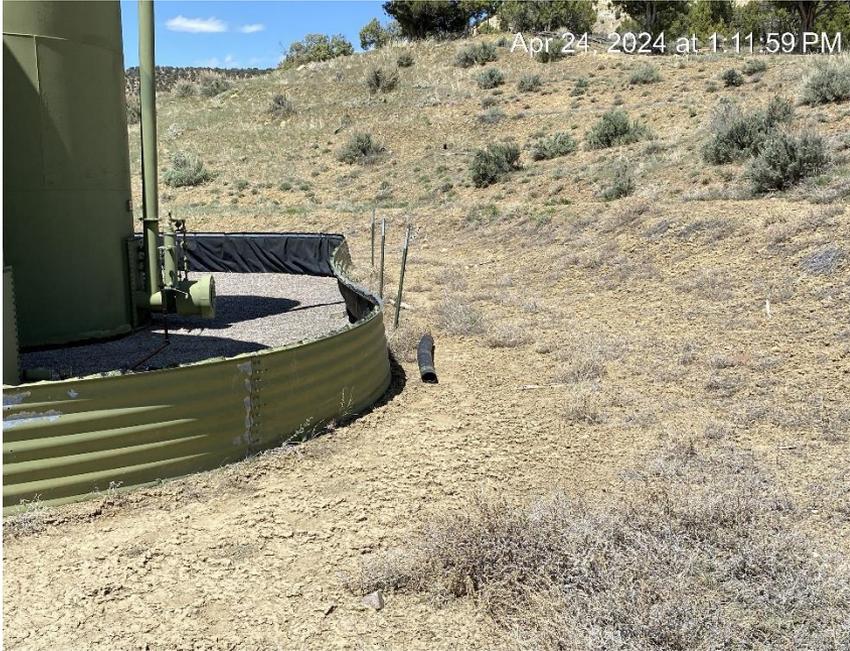
Debris

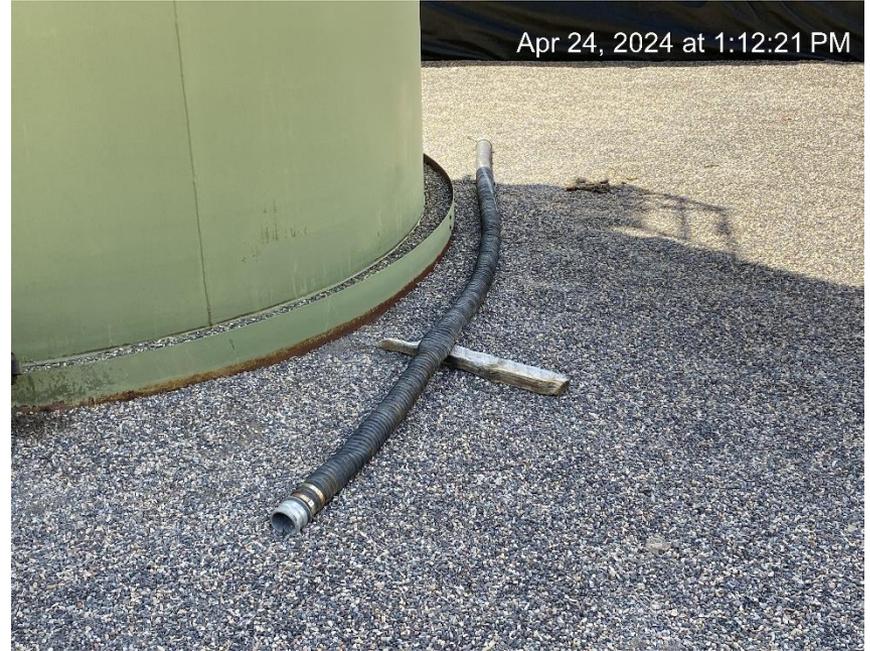
Debris

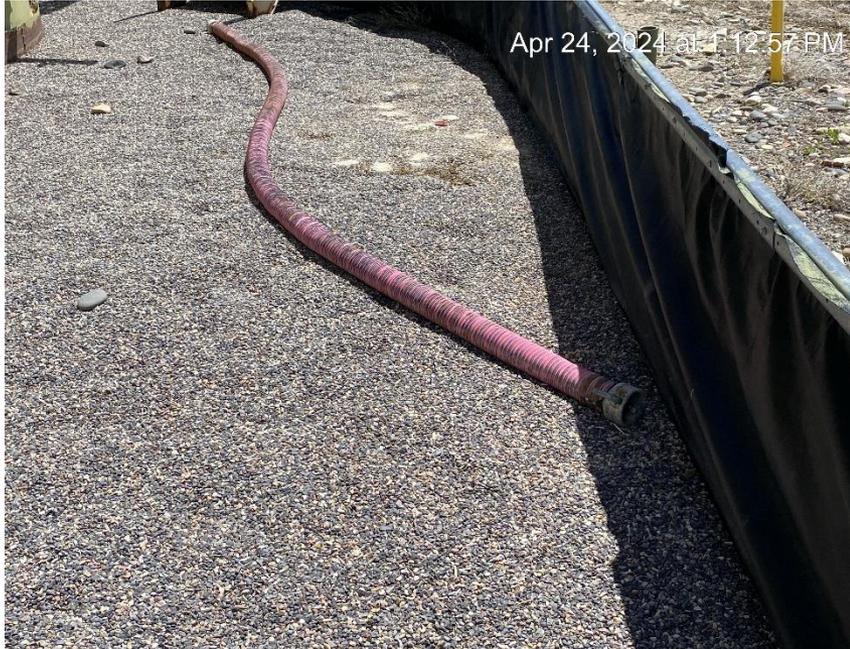
Debris

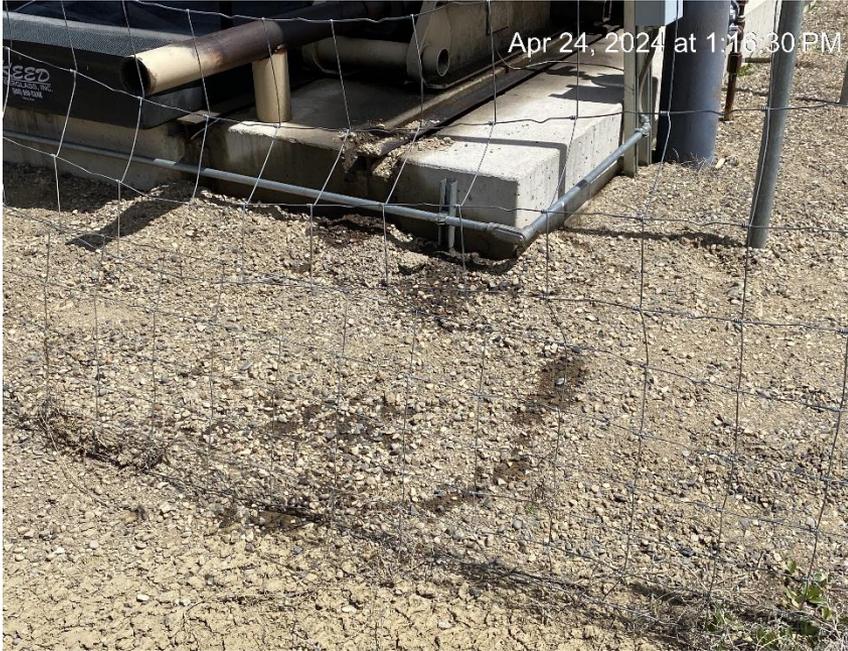
Stained soil covered with gravel

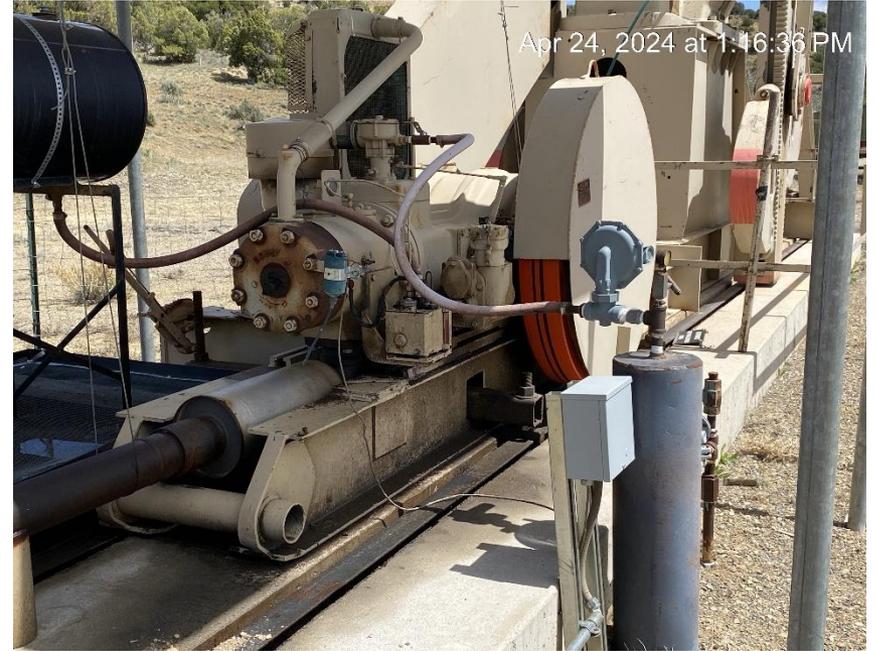
Oil leaks on engine

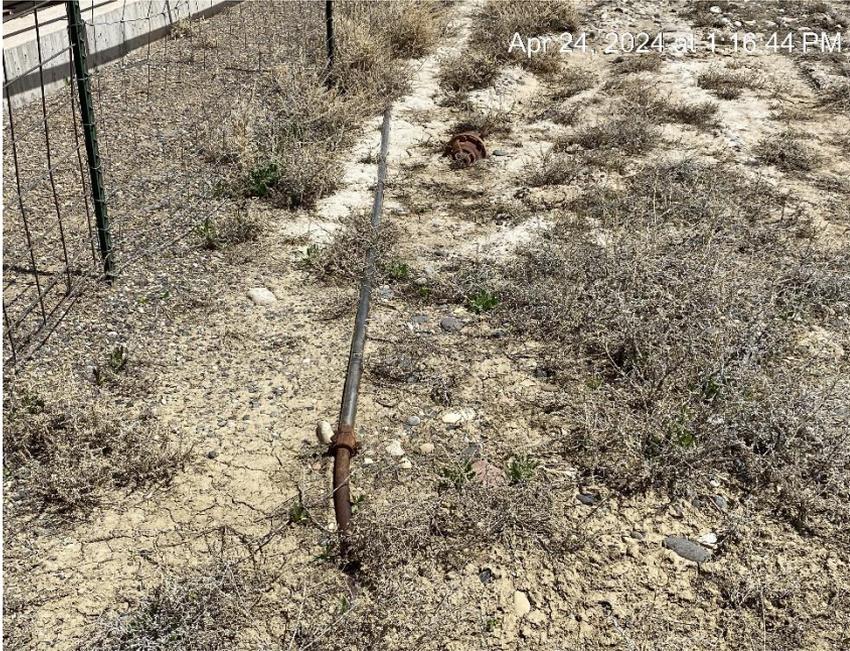
Debris

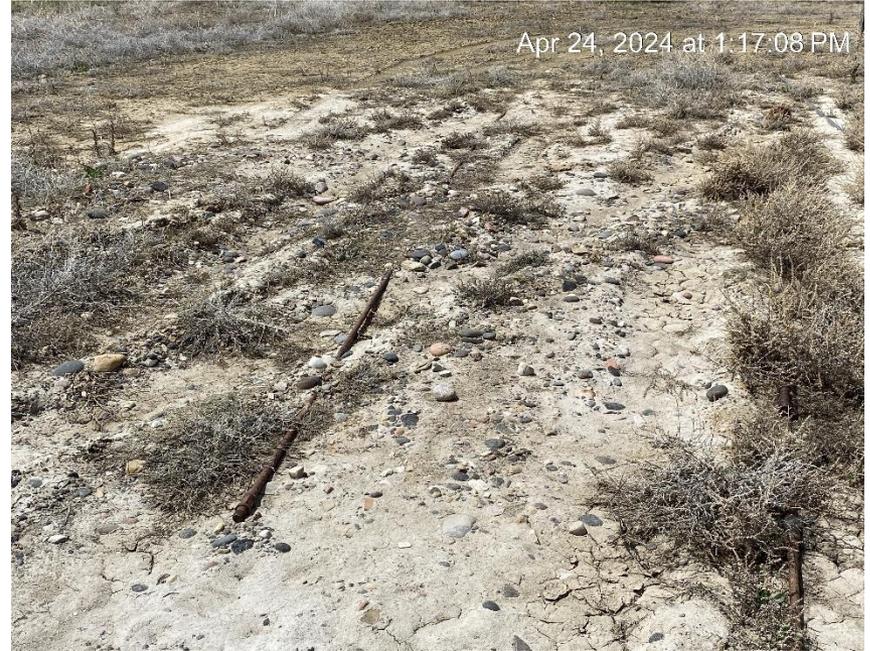
Debris
