Inspection Photos

April 23rd, 2024

Operator: Simcoe LLC - 10749

Inspection Photos
Location Name: Carmelita Gallegos A 3
Location ID: 320858

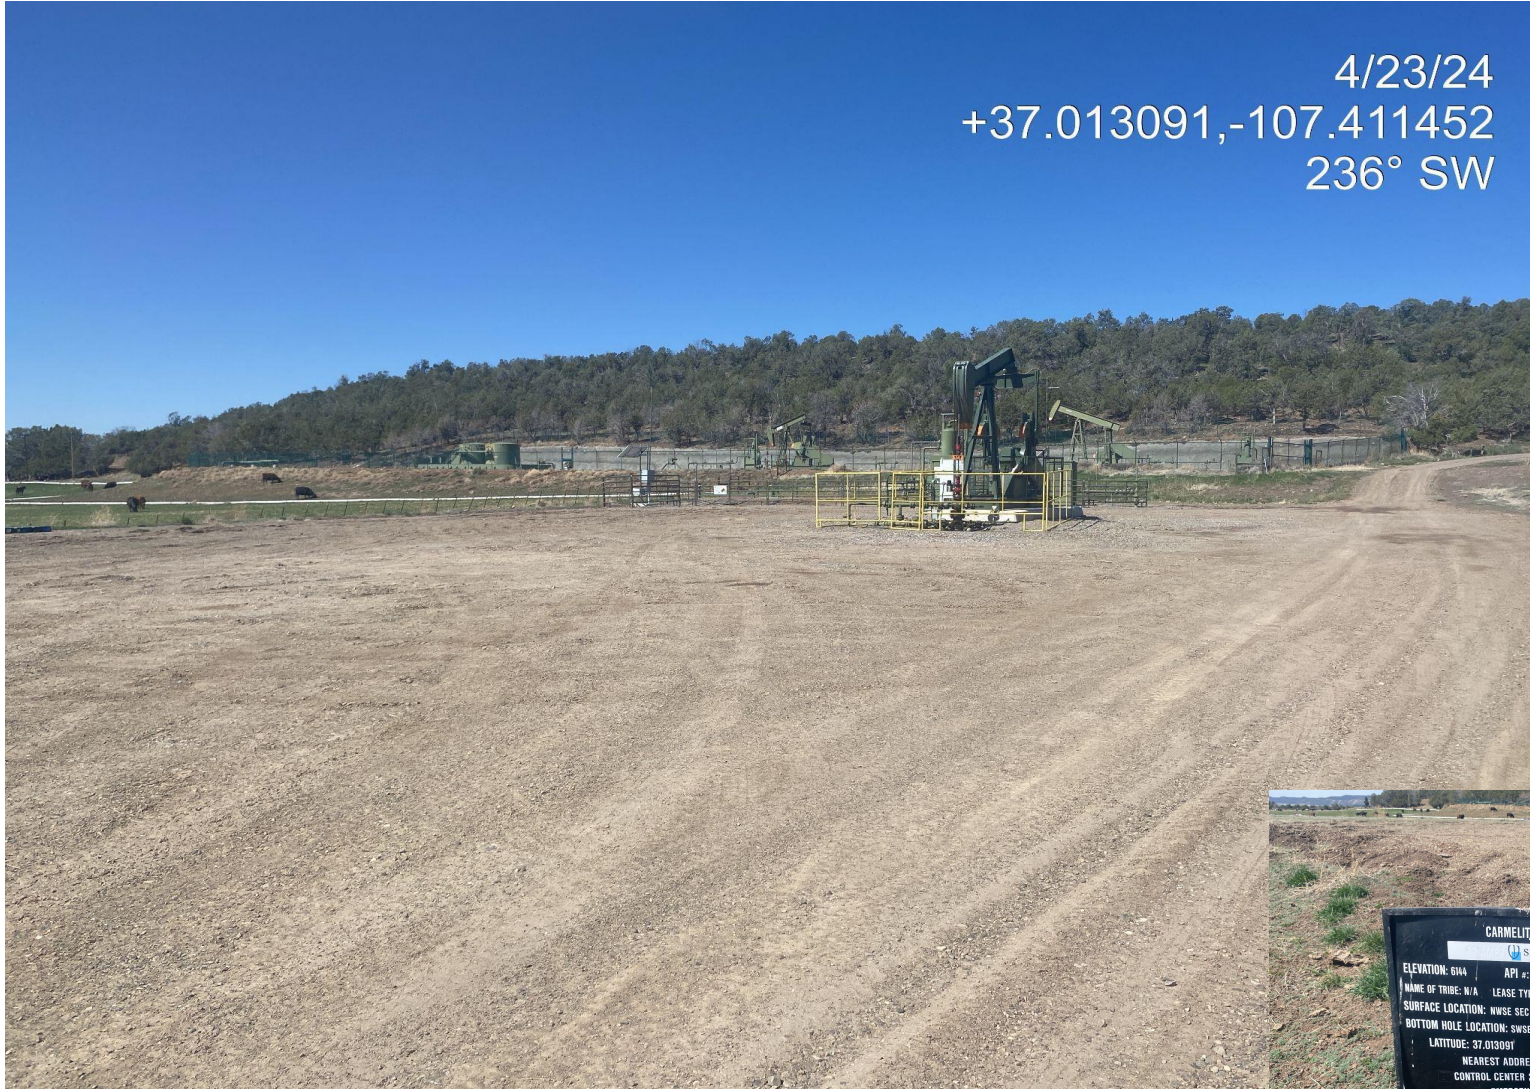
Photo 1. View of the disturbance taken from the access point facing center.

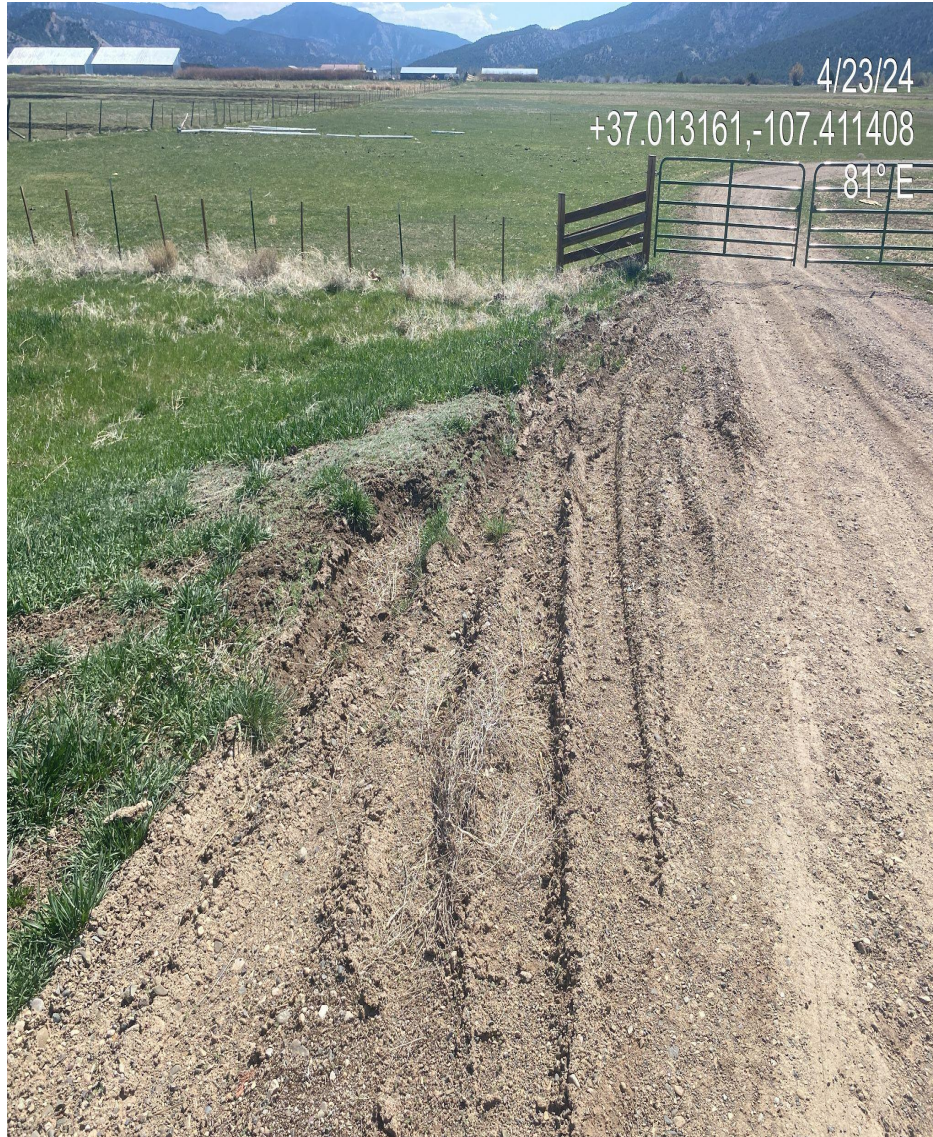
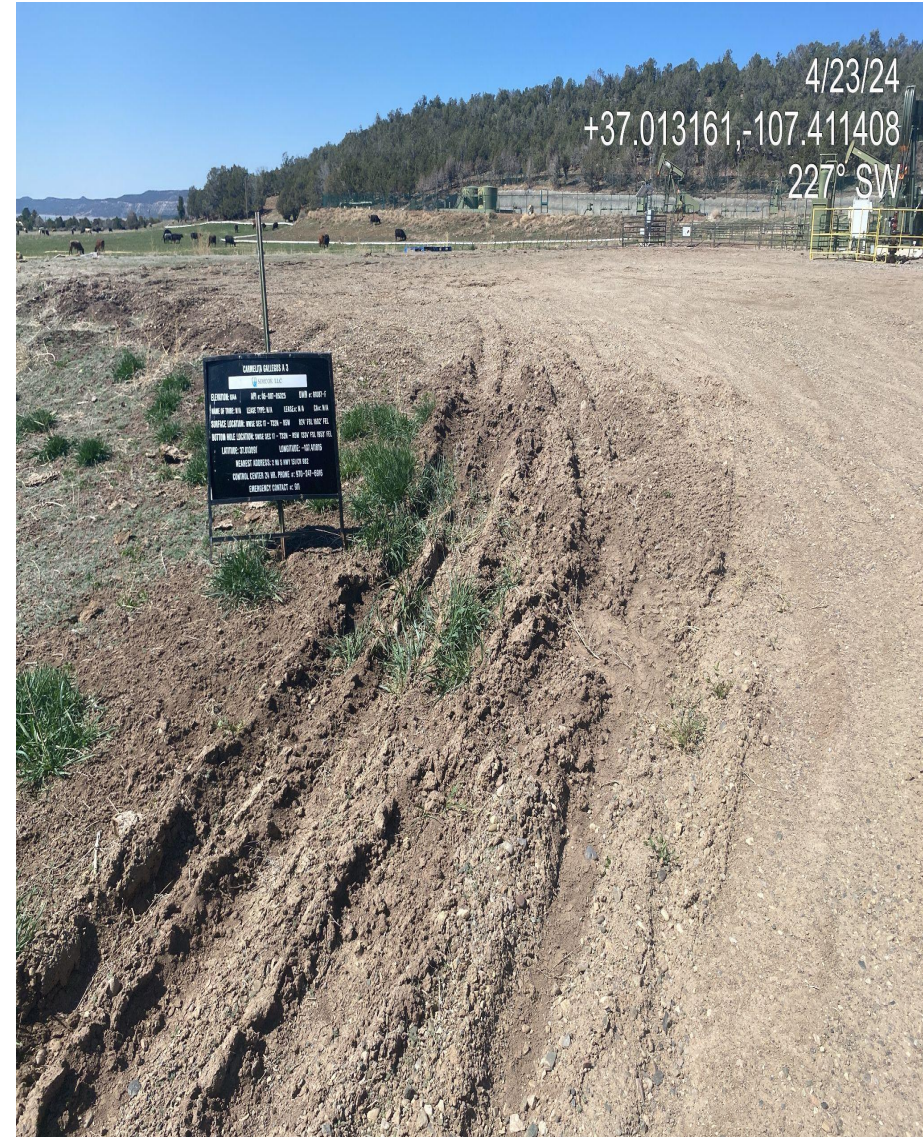
Photo 2. View of rutting observed on either edge of the access point.
Additional stabilization is needed to minimize site degradation.

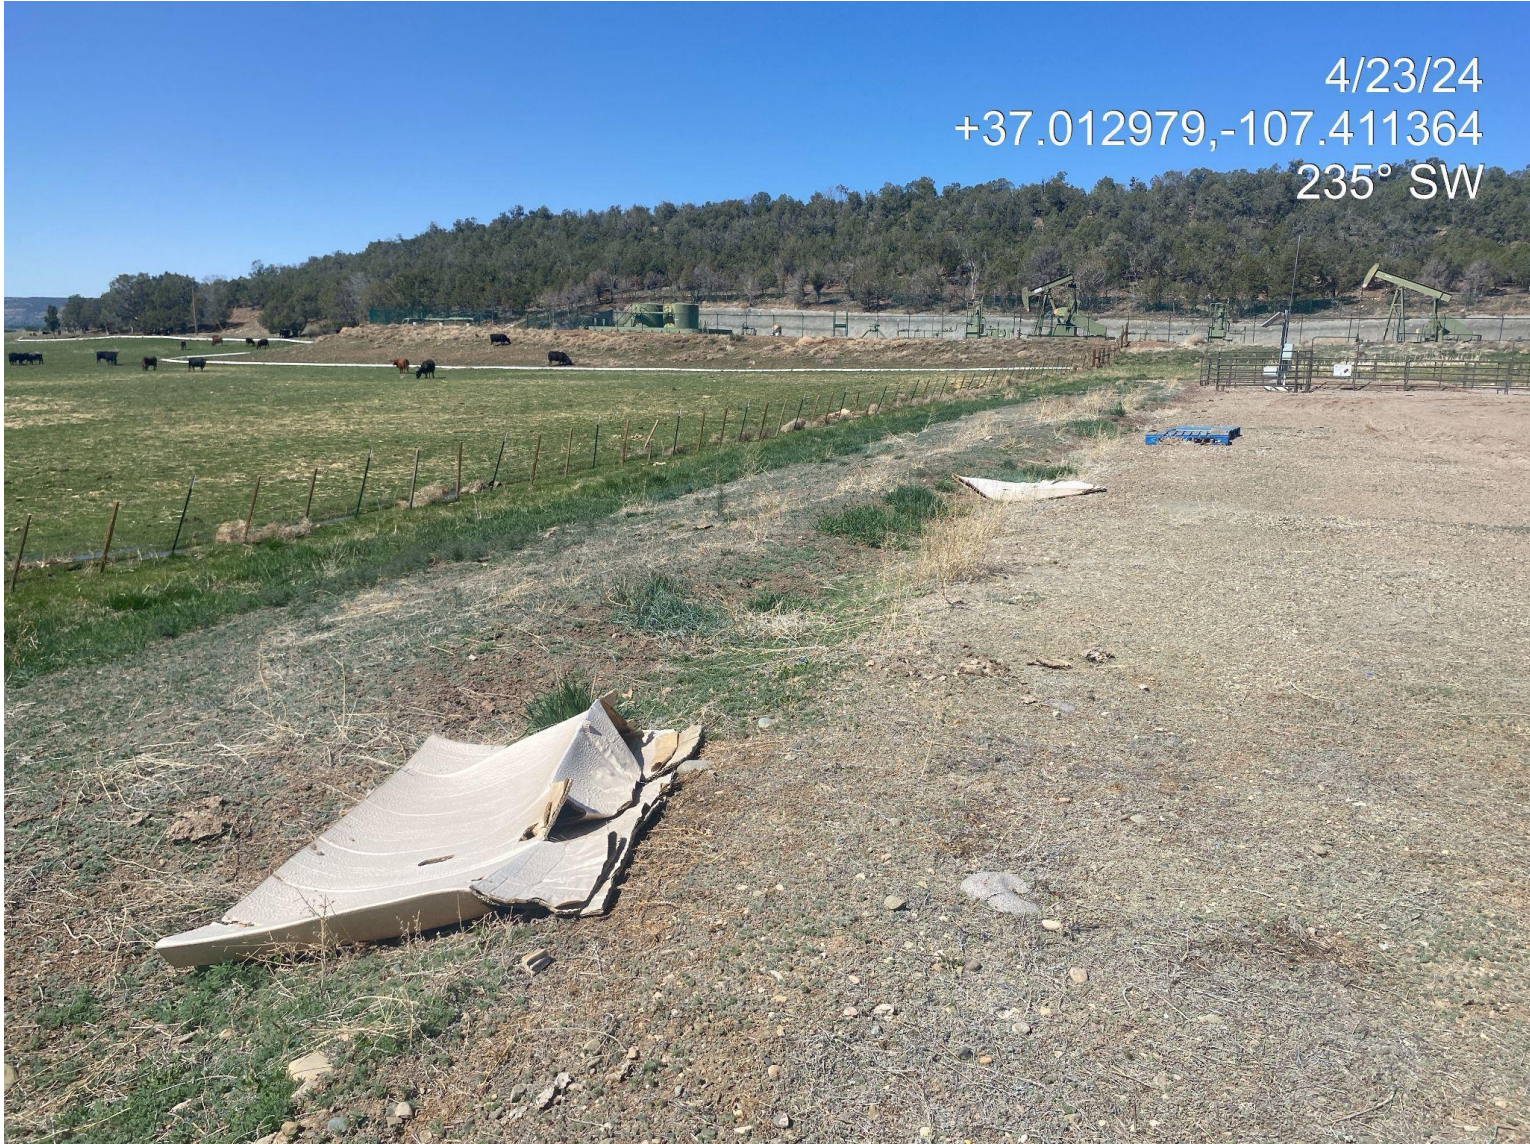
Photo 3. View of cardboard and wood pallet debris observed along the southern edge of the disturbance.

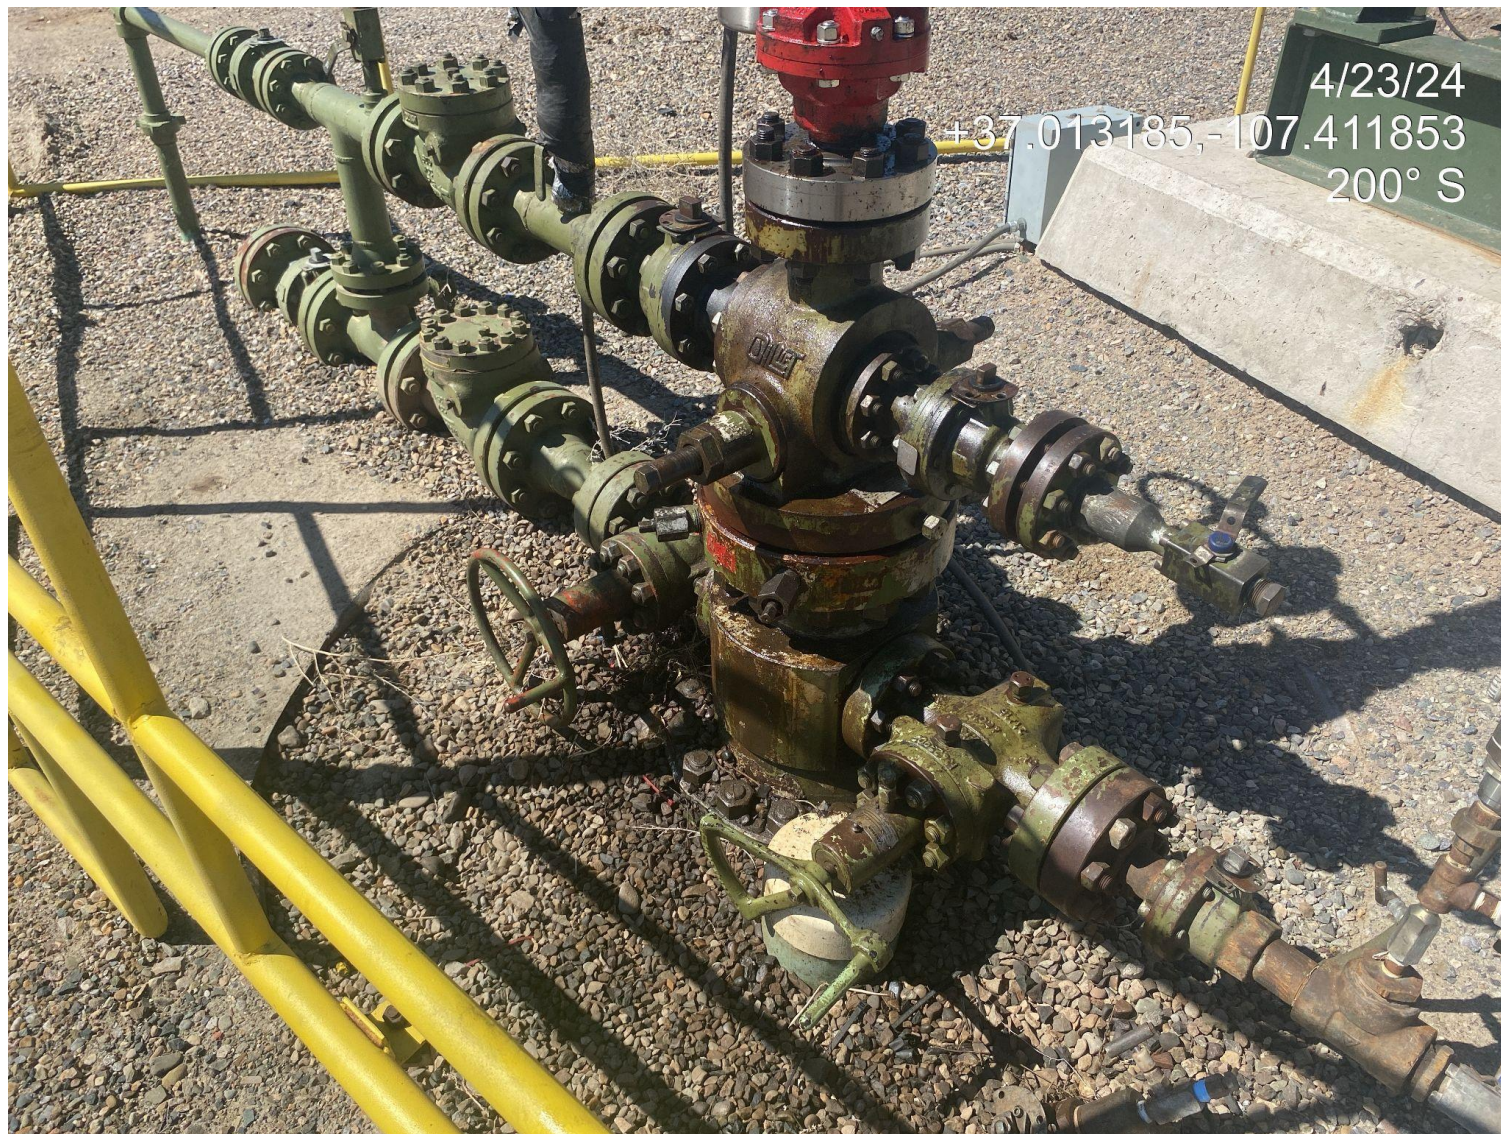
Photo 4. View of surface material observed at the well head.

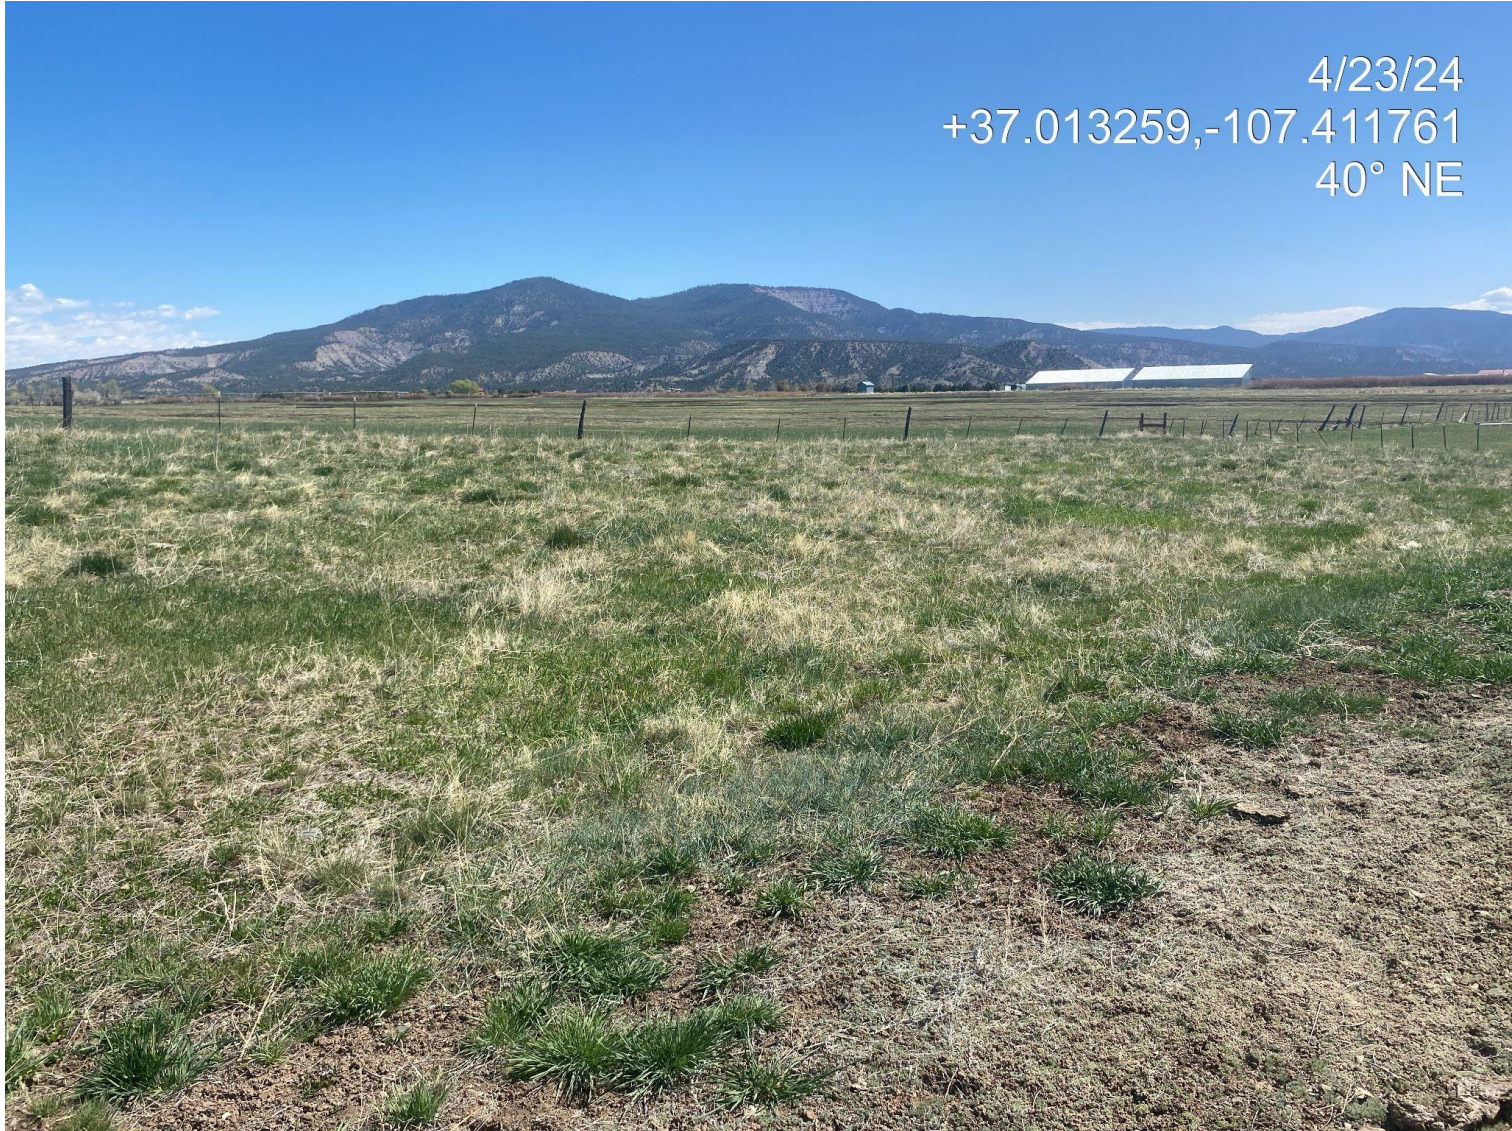
Photo 5. View of the eastern interim reclamation area facing north east.
Vegetation comprised of smooth brome.

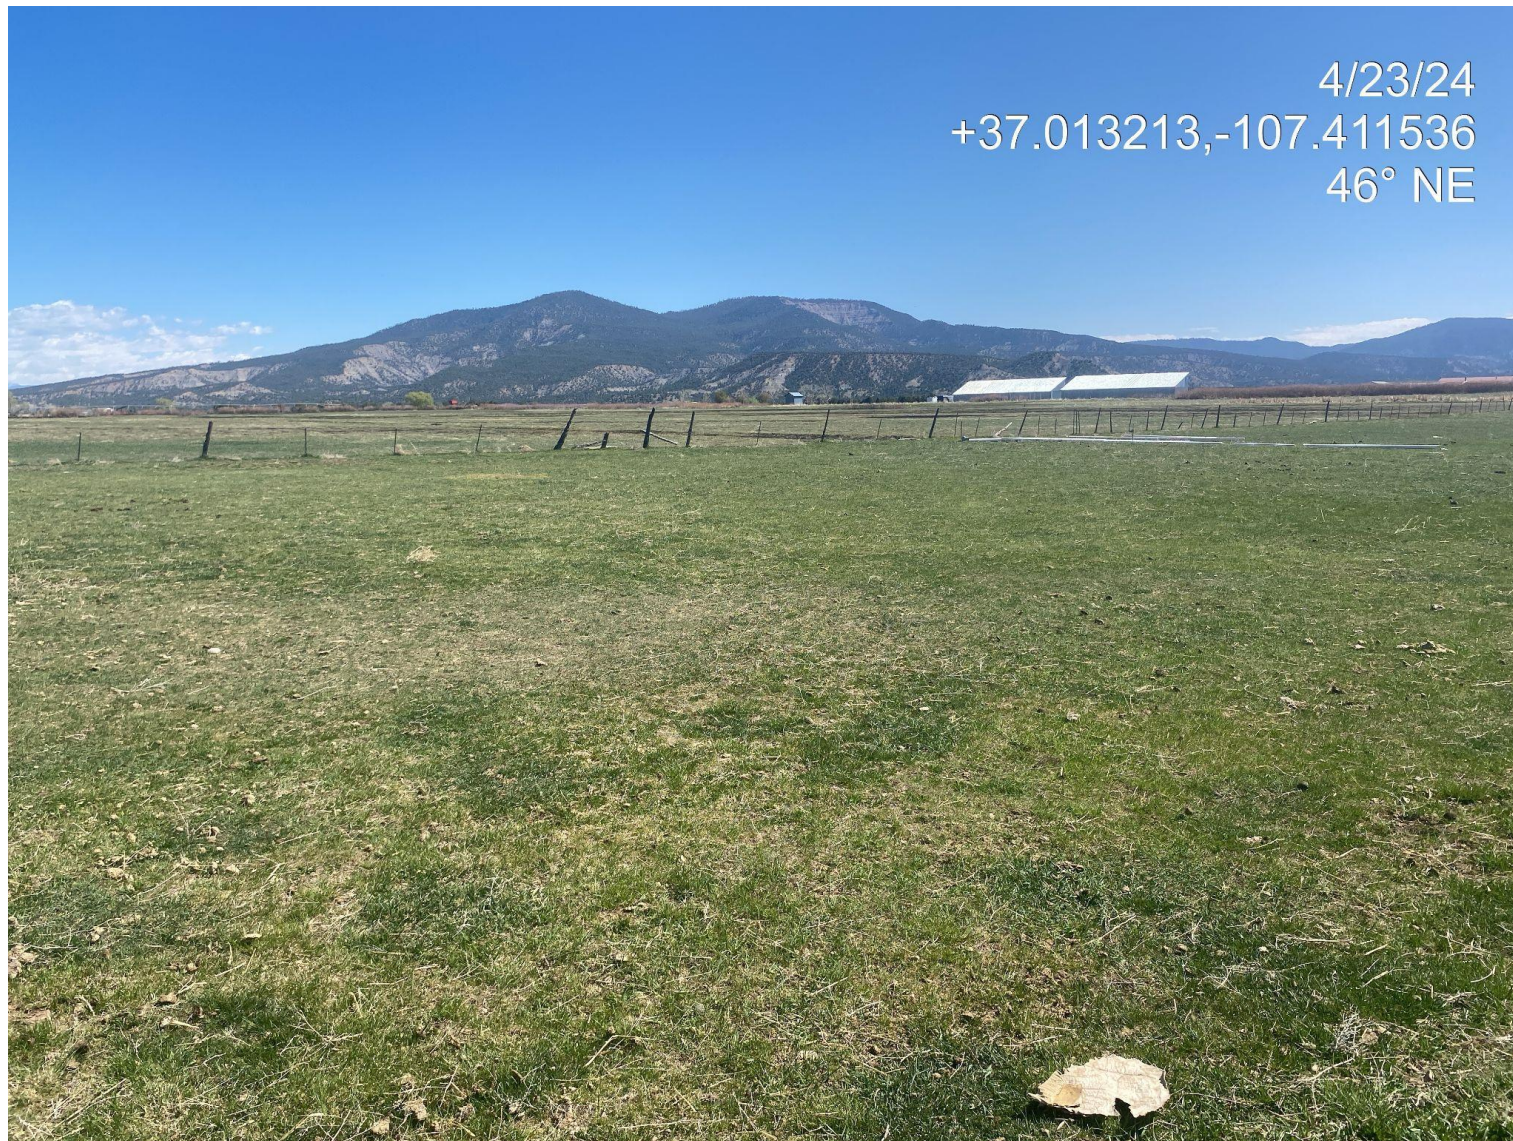
Photo 6. Reference area comprised of a grazed grass field/pasture.
