Inspection Photos

Location Name: CAERUS PICEANCE LLC FEDERAL 21-9C (PJ21) Pad

Location #: 427395

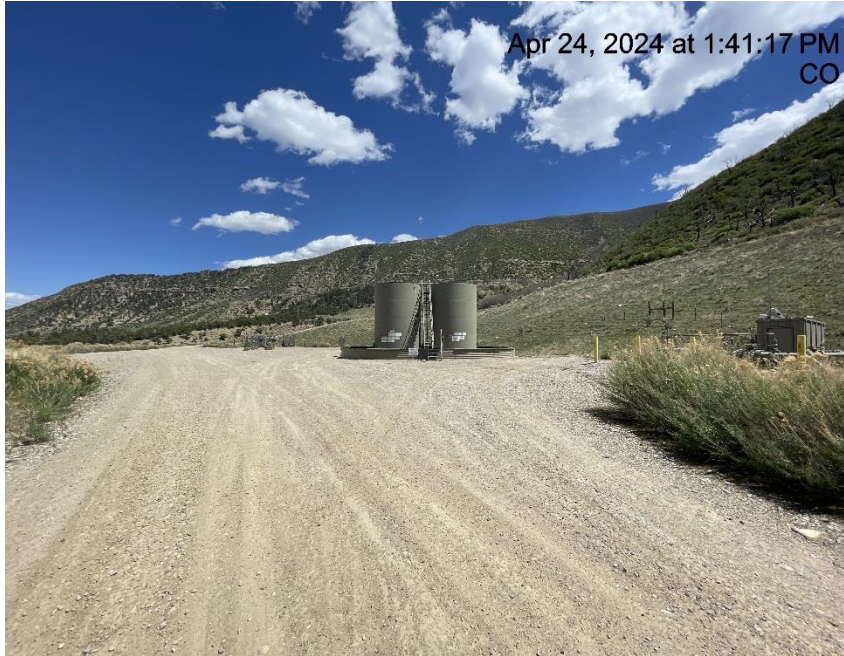
Photo # 4869 From entrance to location

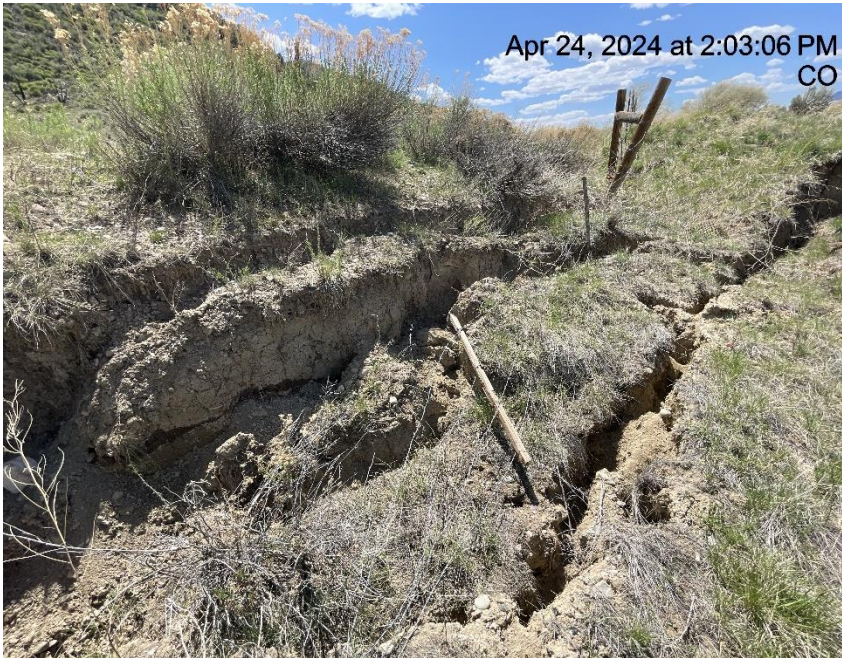
Photo # 4877 Barbed wire fence needs maintenance, barbed wire laying on ground/wildlife hazard

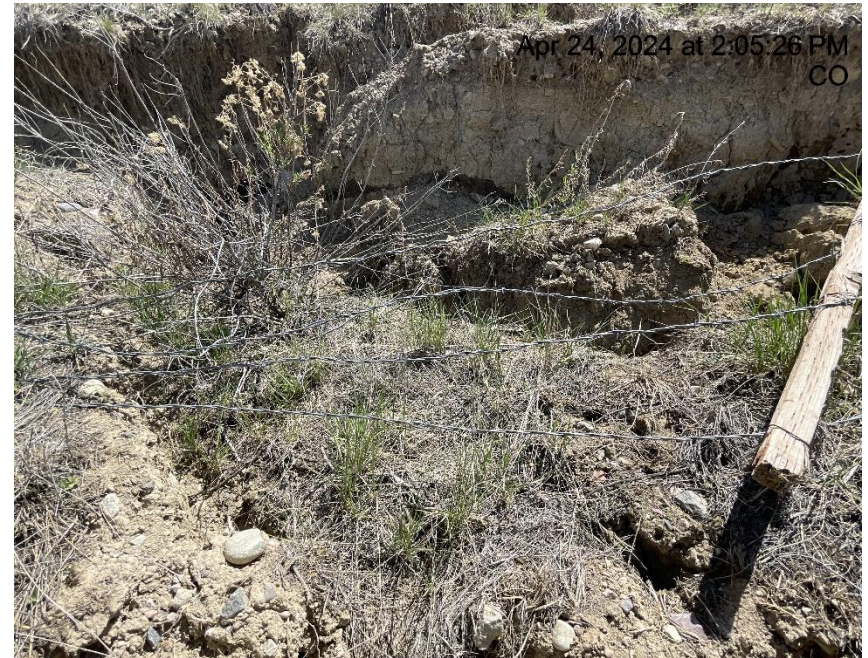
Photo # 4878 Barbed wire fence needs maintenance, barbed wire laying on ground/wildlife hazard

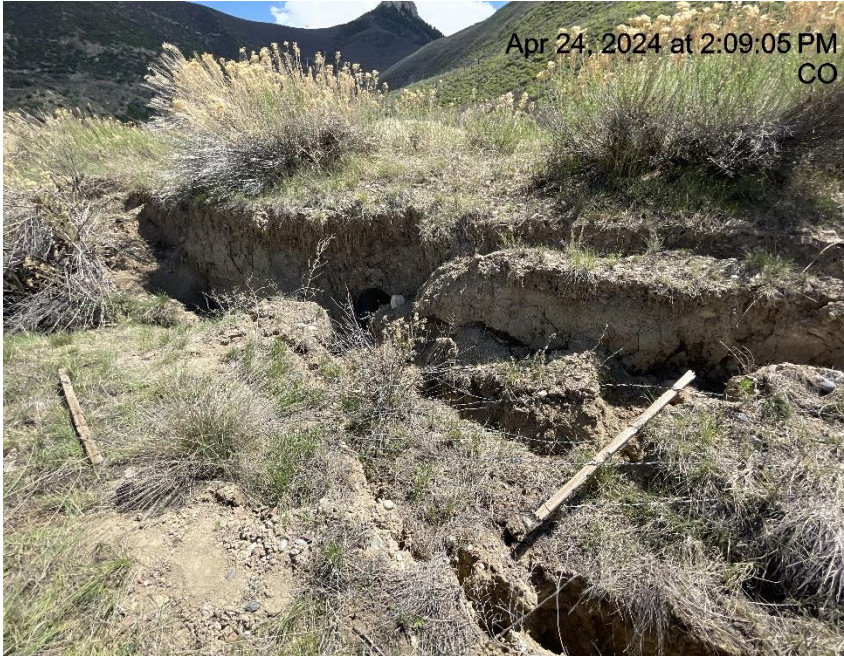
Photo # 4879 Barbed wire fence needs maintenance, barbed wire laying on ground/wildlife hazard

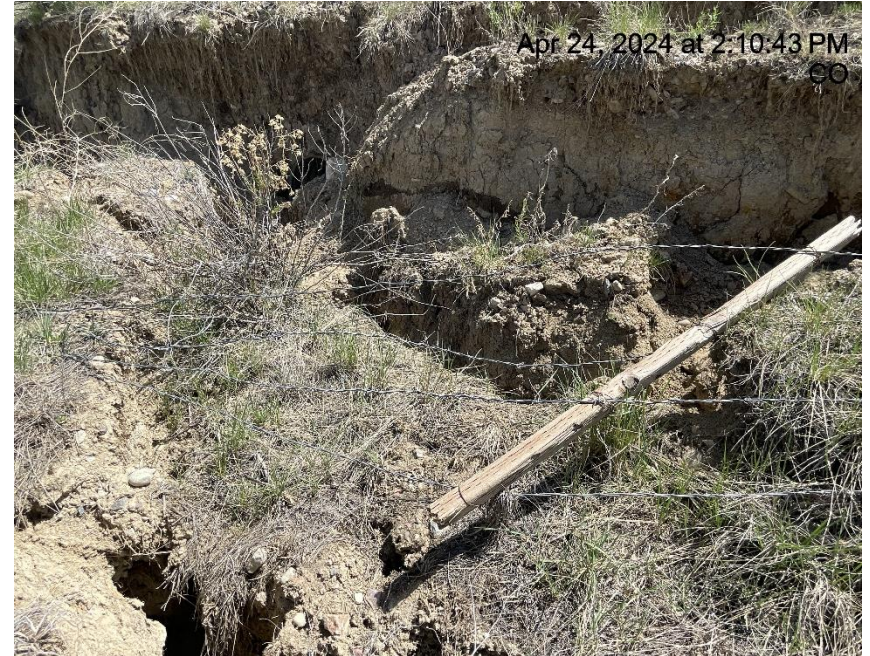
Photo # 4880 Barbed wire fence needs maintenance, barbed wire laying on ground/wildlife hazard

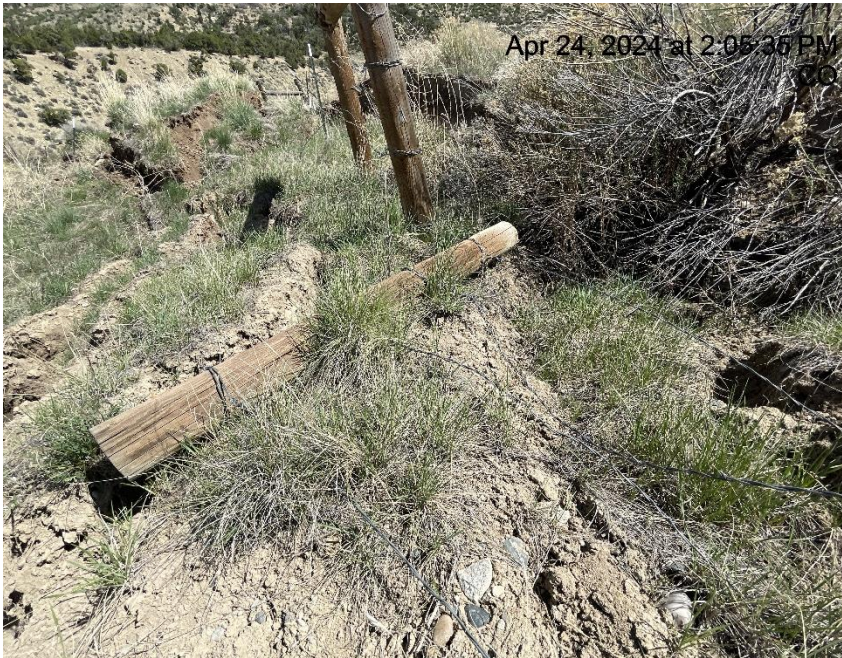
Photo # 4881 Barbed wire fence needs maintenance, barbed wire laying on ground/wildlife hazard

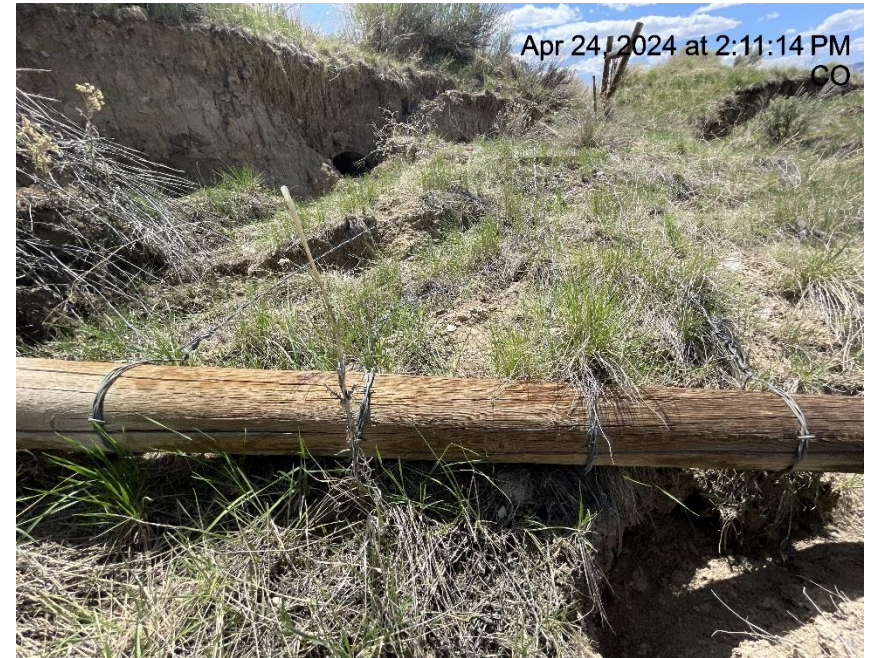
Photo # 4882 Barbed wire fence needs maintenance, barbed wire laying on ground/wildlife hazard

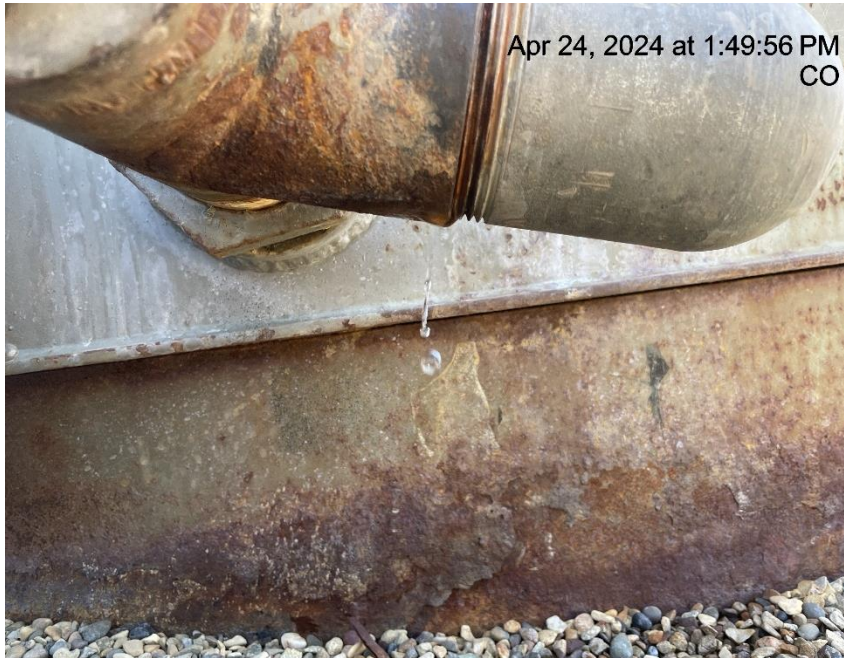
Photo # 4883 Mechanical condition - fluid leaking from tank valve

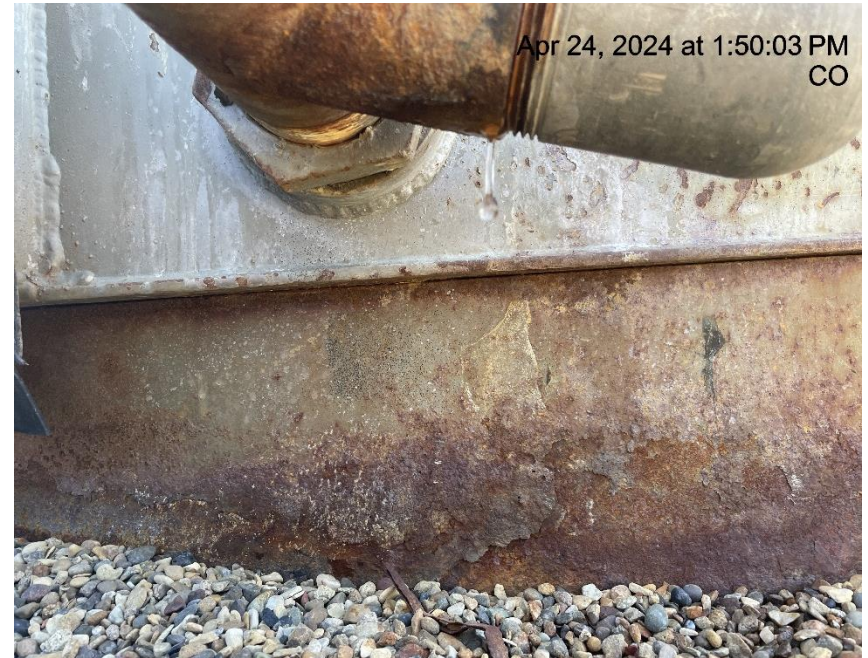
Photo # 4884 Mechanical condition - fluid leaking from tank valve

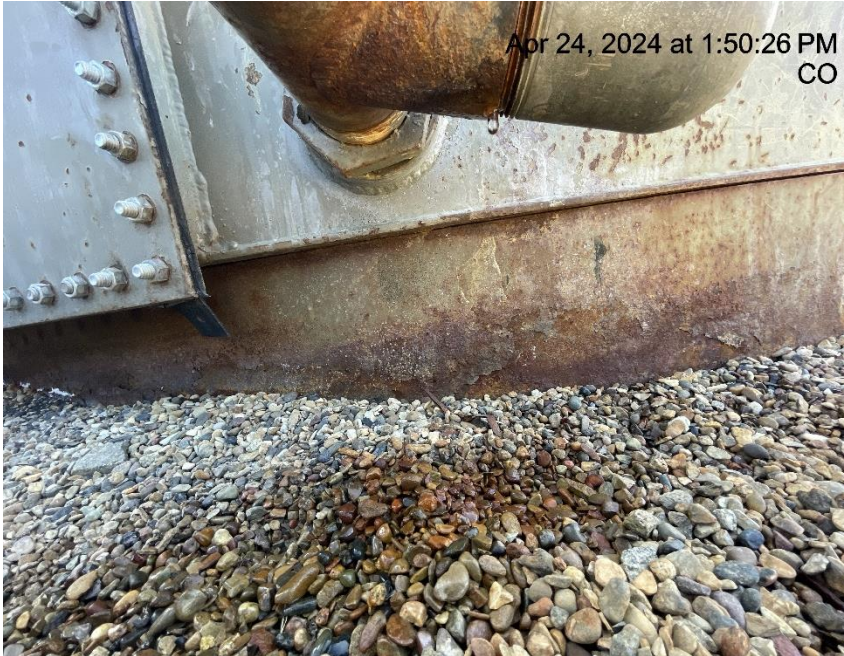
Photo # 4885 Mechanical condition - fluid leaking from tank valve

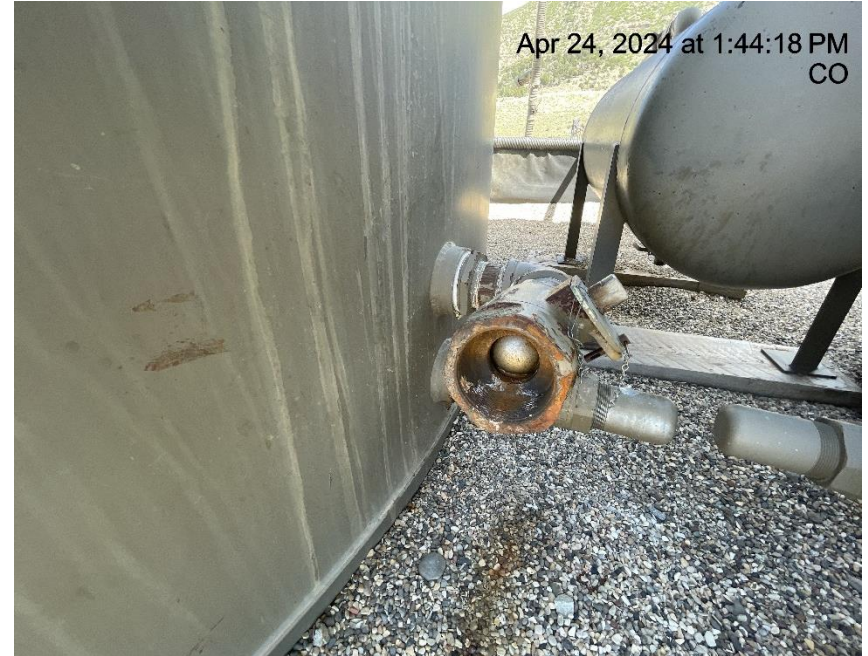
Photo # 4886 Open ended load line
