Storm Water Management and Erosion control
Location Name: CAERUS PICEANCE LLC FEDERAL 21-9C (PJ21) Pad
Location #: 427395

**Location Overview: Location is within High
Priority/Density/Black Bear Habitat areas. Location is in close
proximity to Rule 411a Surface Water External Buffer.
Section/Township/Range: 21 7S95W**

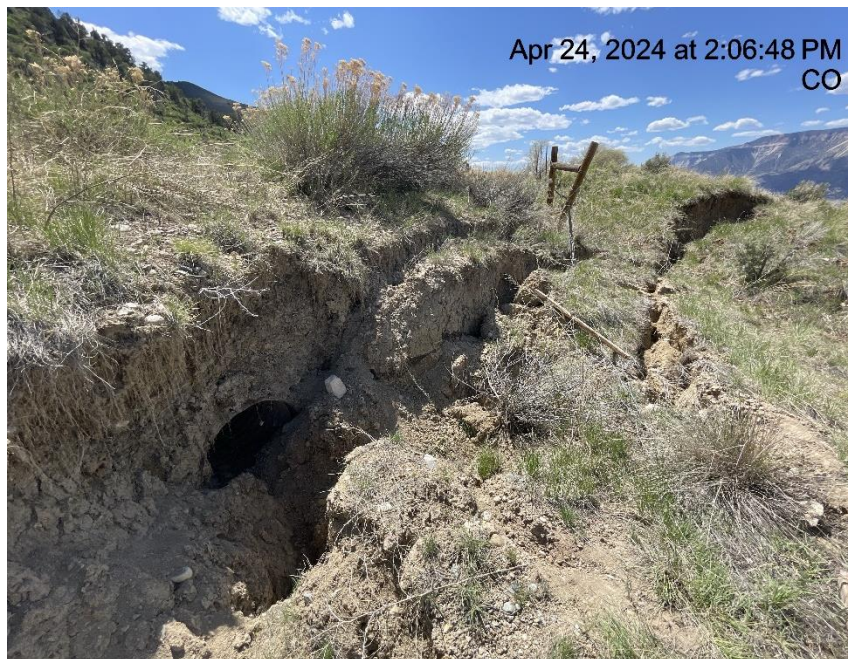
Photo # 4887 Culvert damaged/BMP needs maintenance

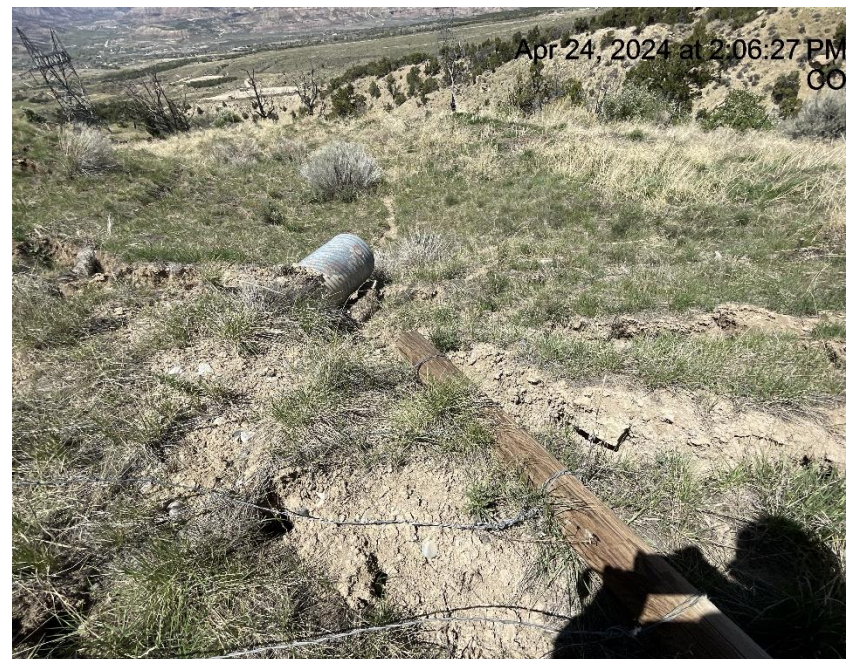
Photo # 4888 Culvert damaged/BMP needs maintenance

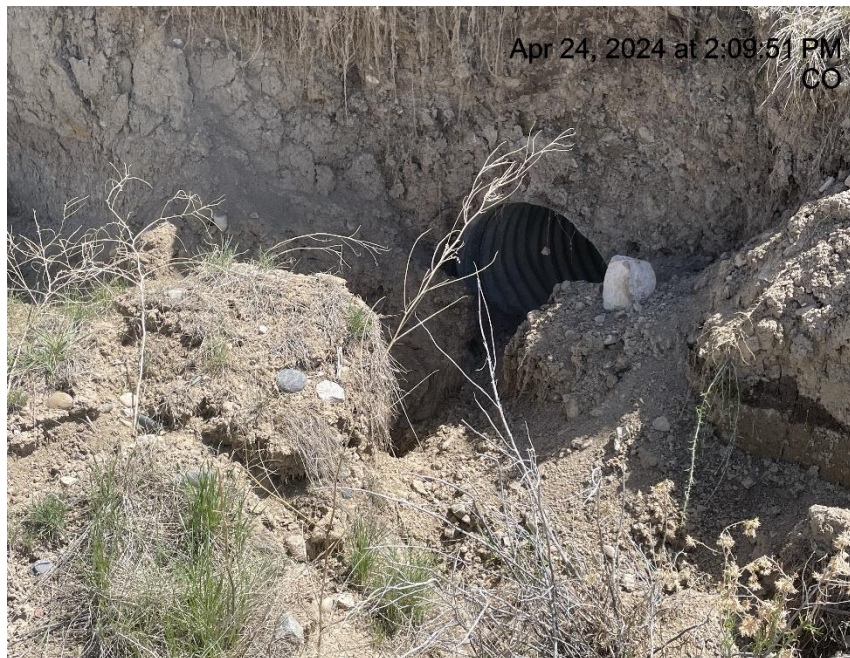
Photo # 4889 Culvert damaged/BMP needs maintenance

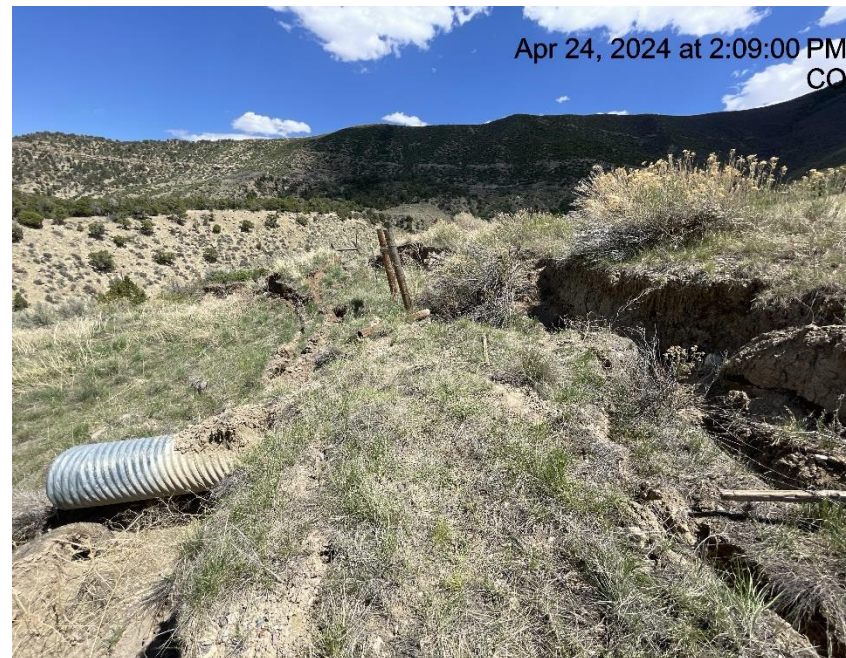
Photo # 4890 Culvert damaged/BMP needs maintenance & slope destabilized & sloughing

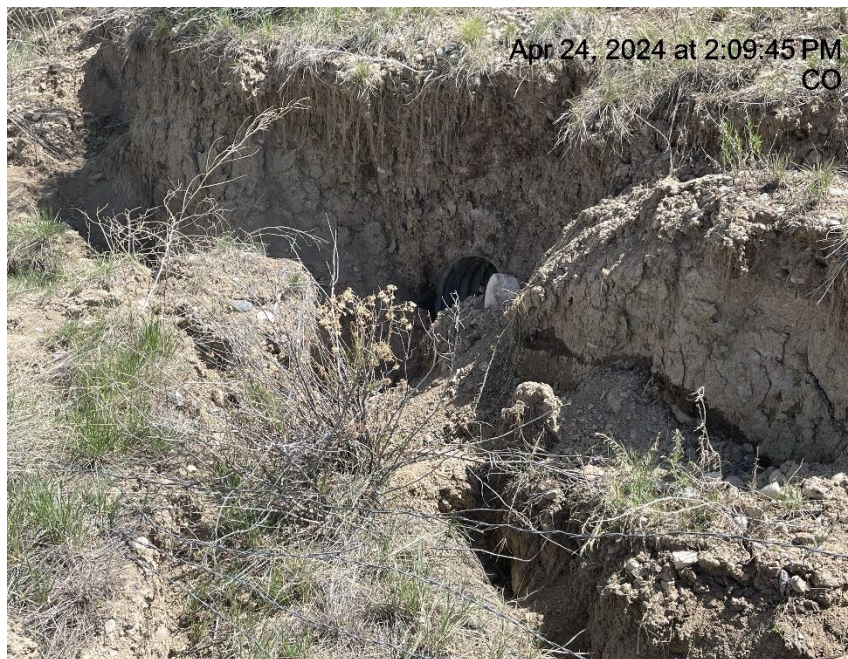
Photo # 4891 Culvert damaged/BMP needs maintenance & slope destabilized & sloughing

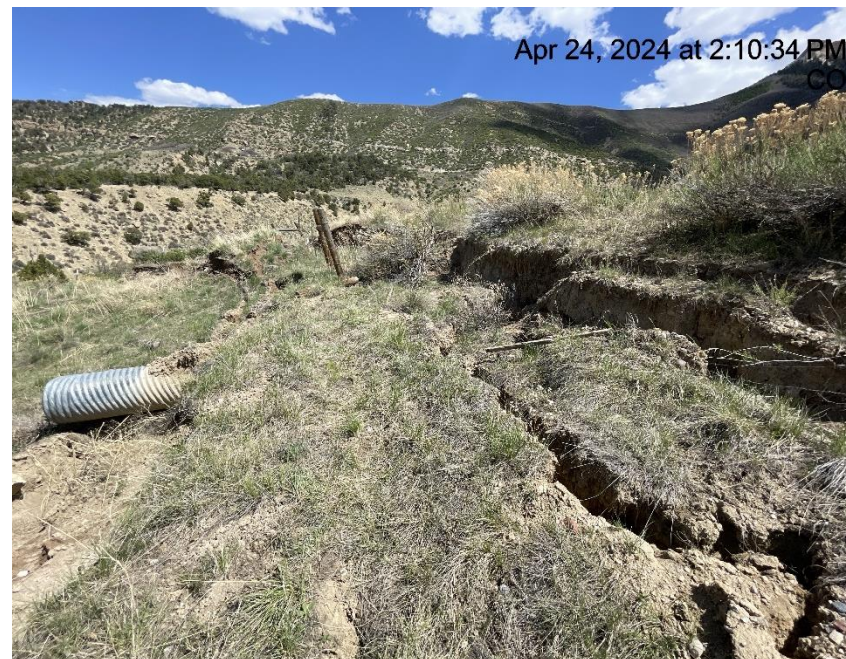
Photo # 4892 Culvert damaged/BMP needs maintenance & slope destabilized & sloughing

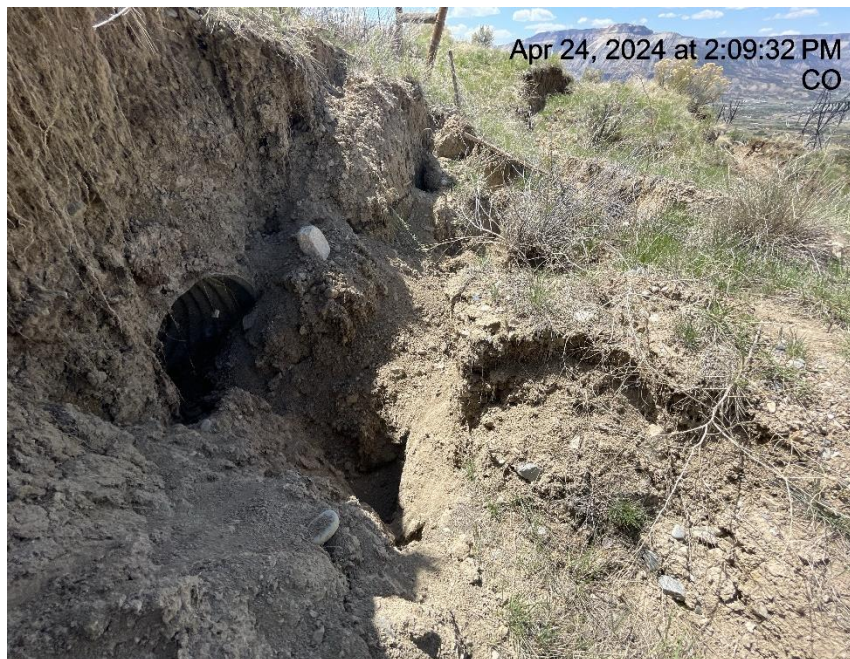
Photo # 4893 Culvert damaged/BMP needs maintenance & slope destabilized & sloughing

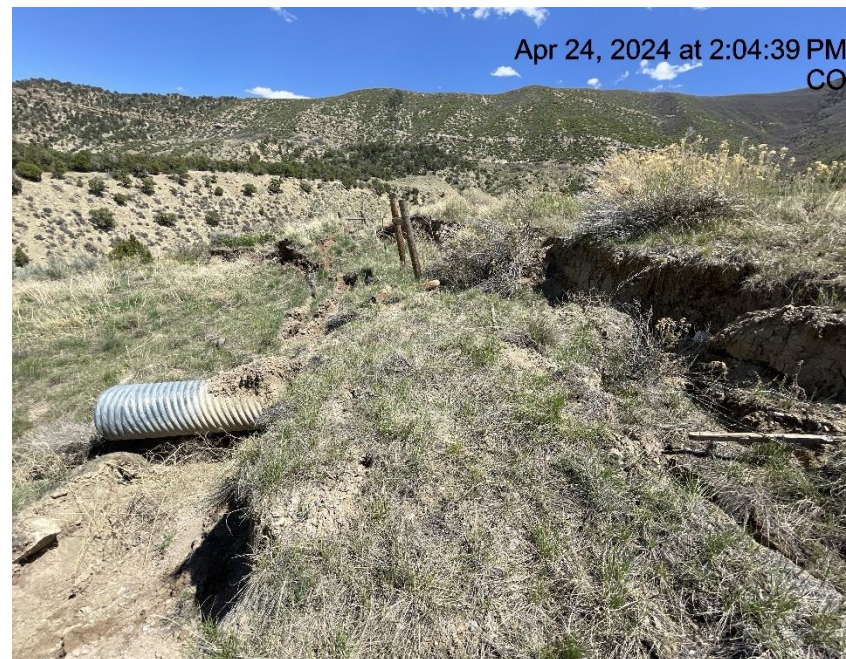
Photo # 4894 Culvert damaged/BMP needs maintenance & slope destabilized & sloughing

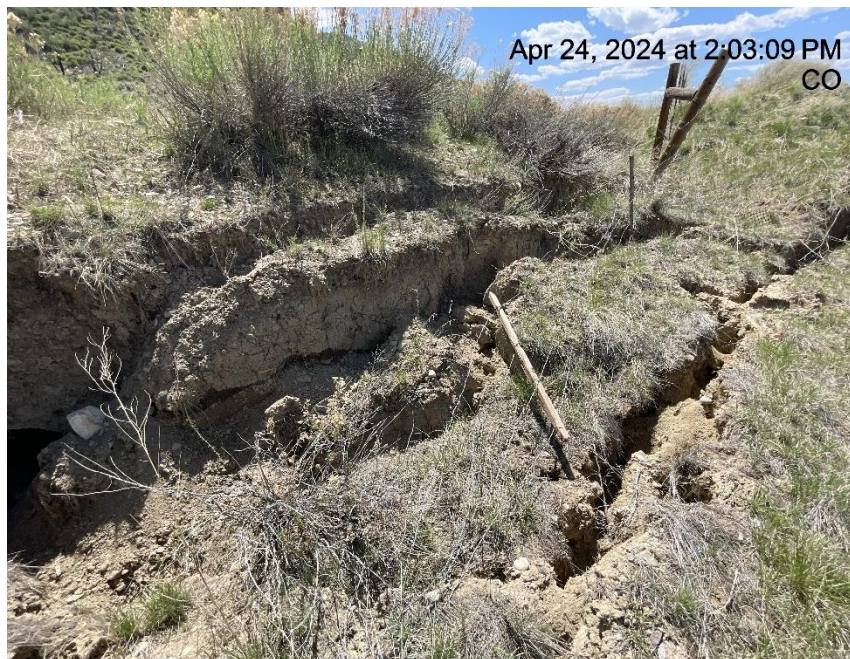
Photo # 4895 Slope destabilized & sloughing

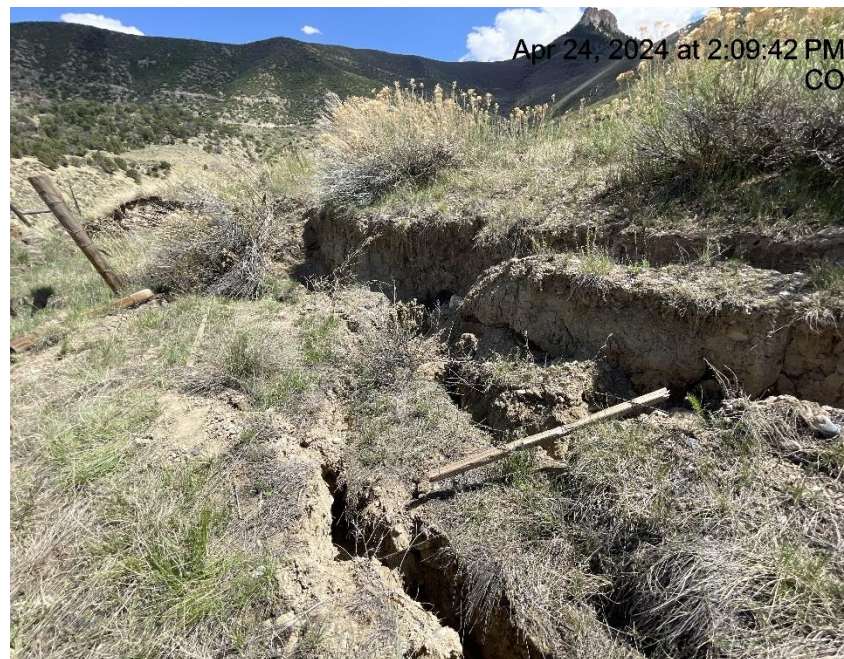
Photo # 4896 Slope destabilized & sloughing

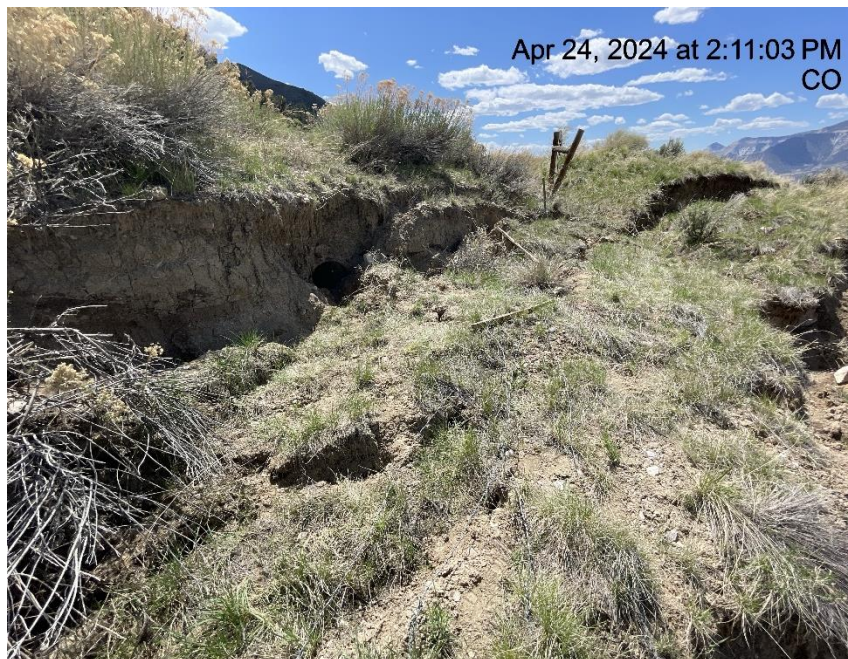
Photo # 4897 Culvert damaged/BMP needs maintenance & slope destabilized & sloughing

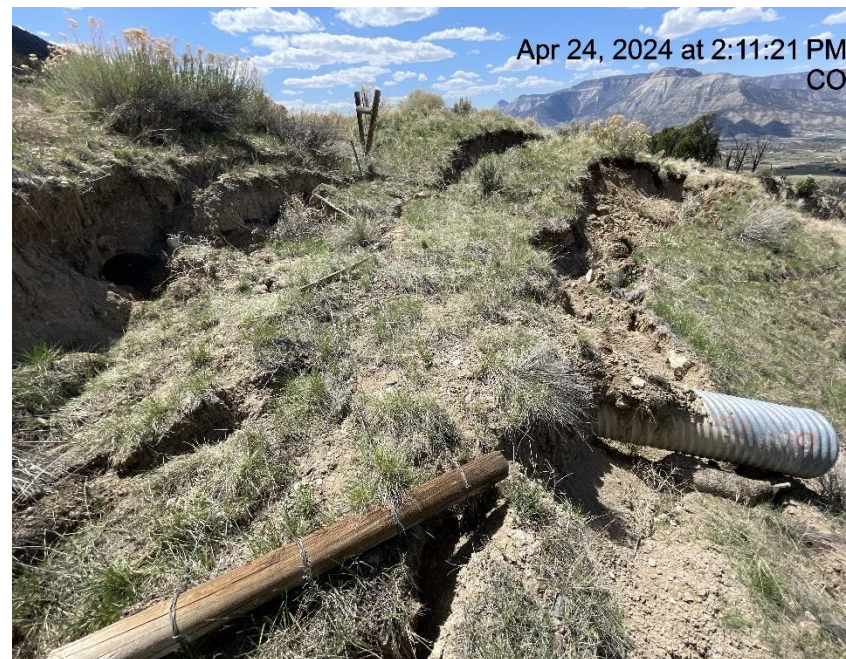
Photo # 4898 Culvert damaged/BMP needs maintenance & slope destabilized & sloughing

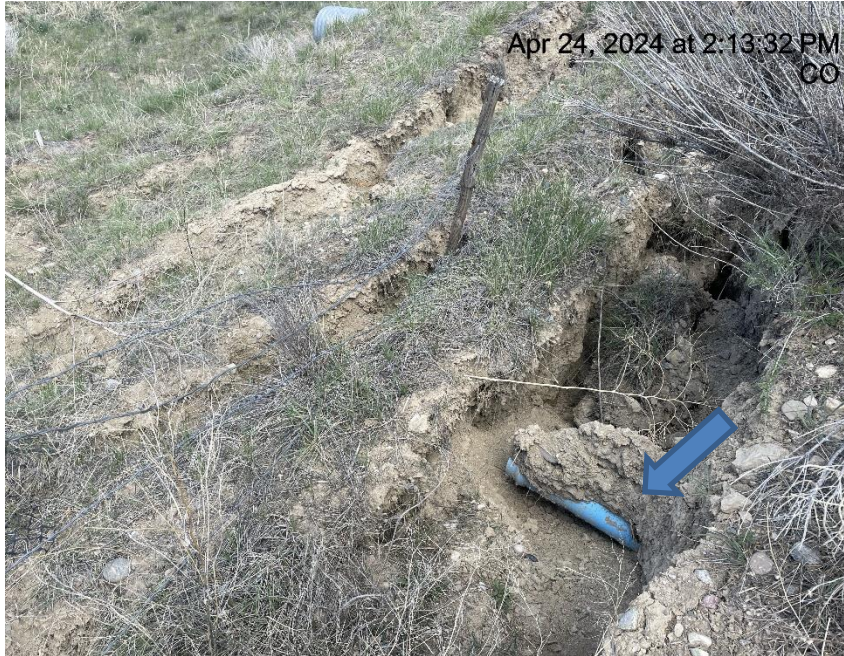
Photo # 4899 Exposed pipe in one of the areas where slope is destabilized & sloughing
