Inspection Photos

April 23rd, 2024

Operator: MorningStar Operating LLC - 10755

Inspection Photos
Location Name: Dungan 32-5 5-5
Location ID: 333346

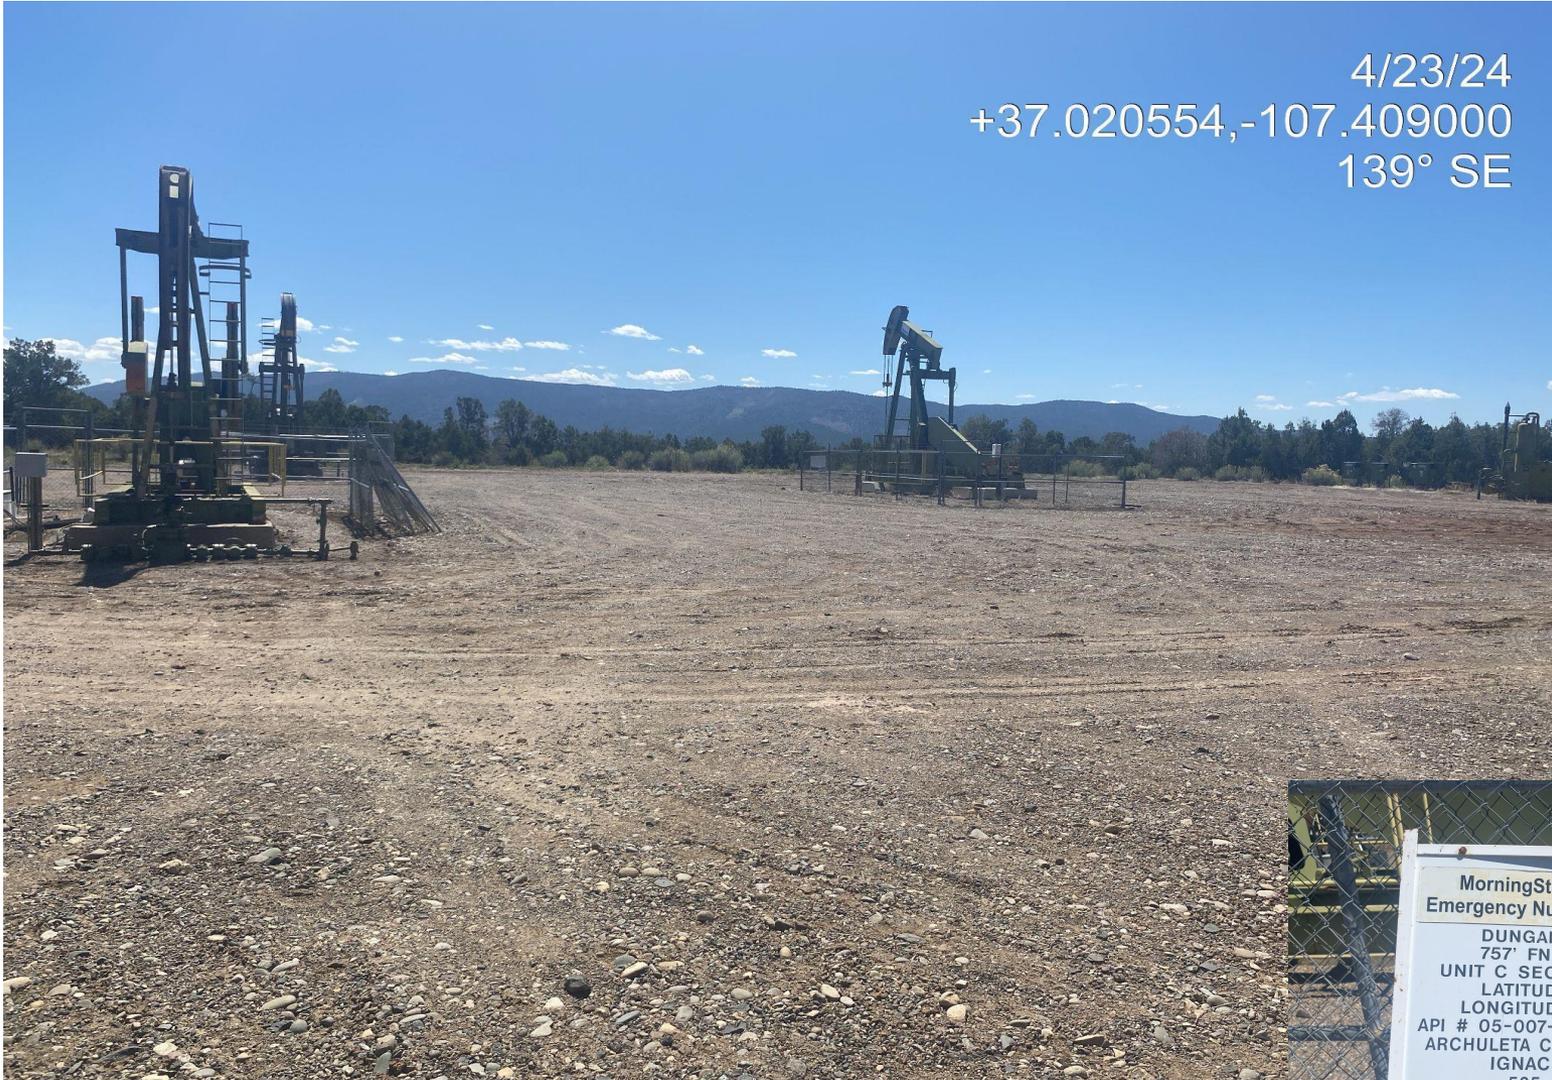
Photo 1. View of the disturbance taken from the access point facing center.

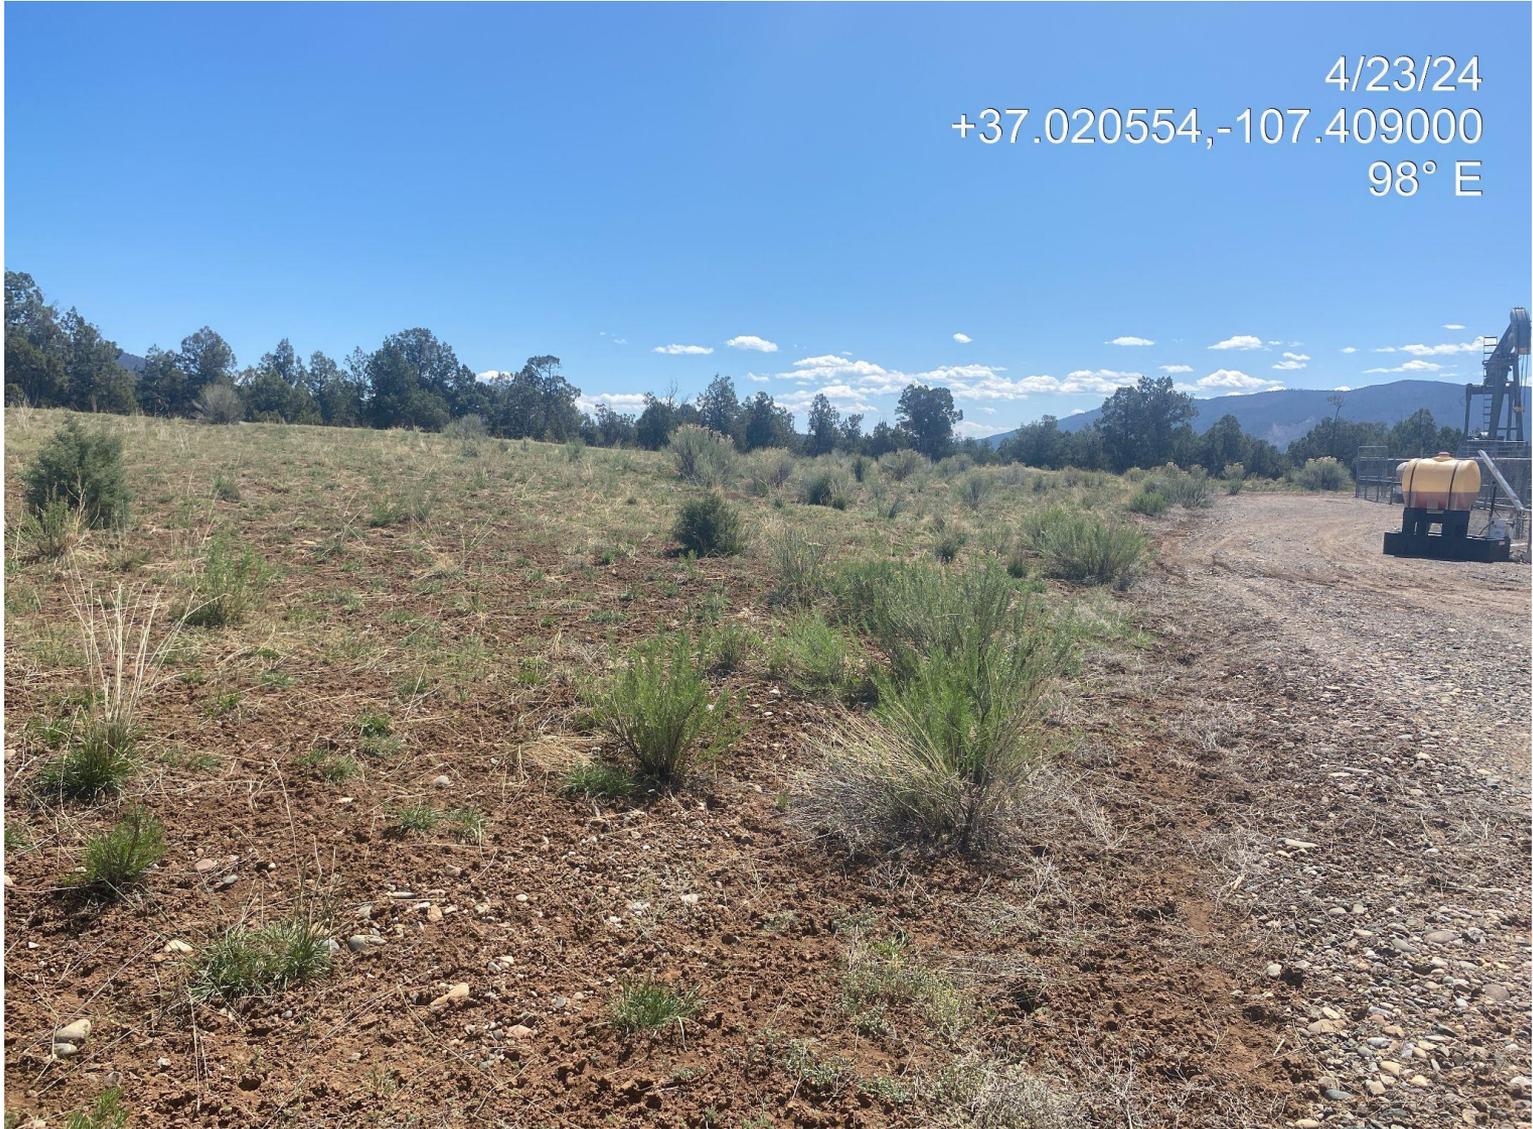
Photo 2. View of the northern interim reclamation area facing east, vegetation comprised of smooth brome and rabbit brush.

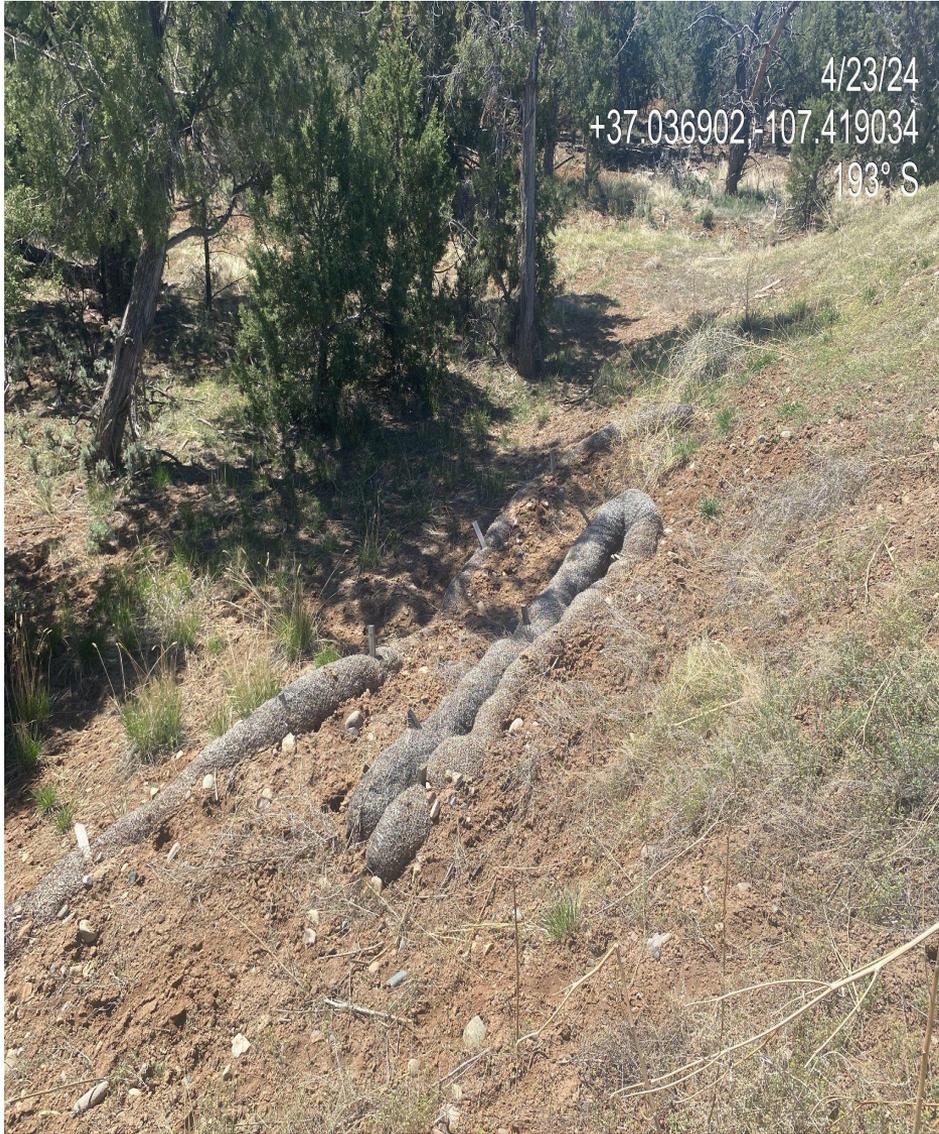
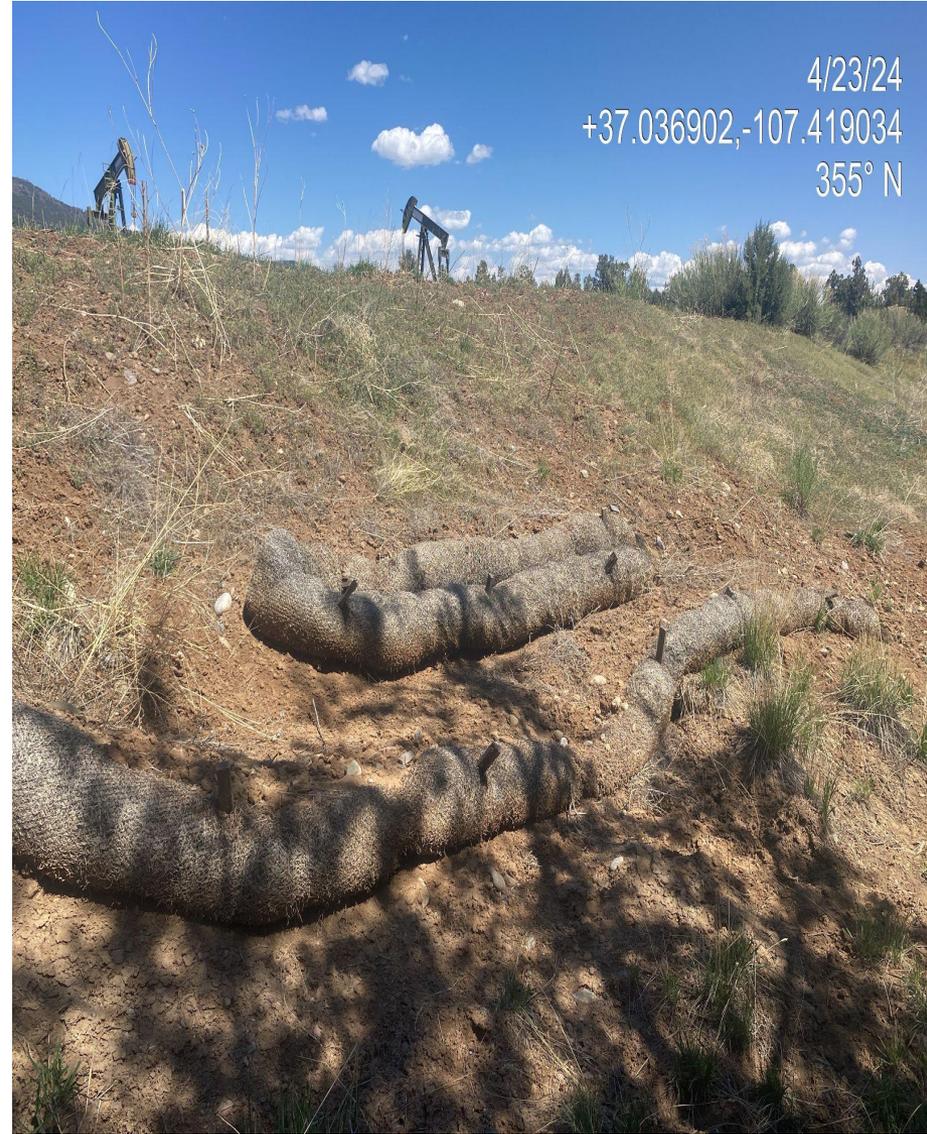
Photo 3. View of wattle BMPs that are no longer functioning and over filled with sediment.

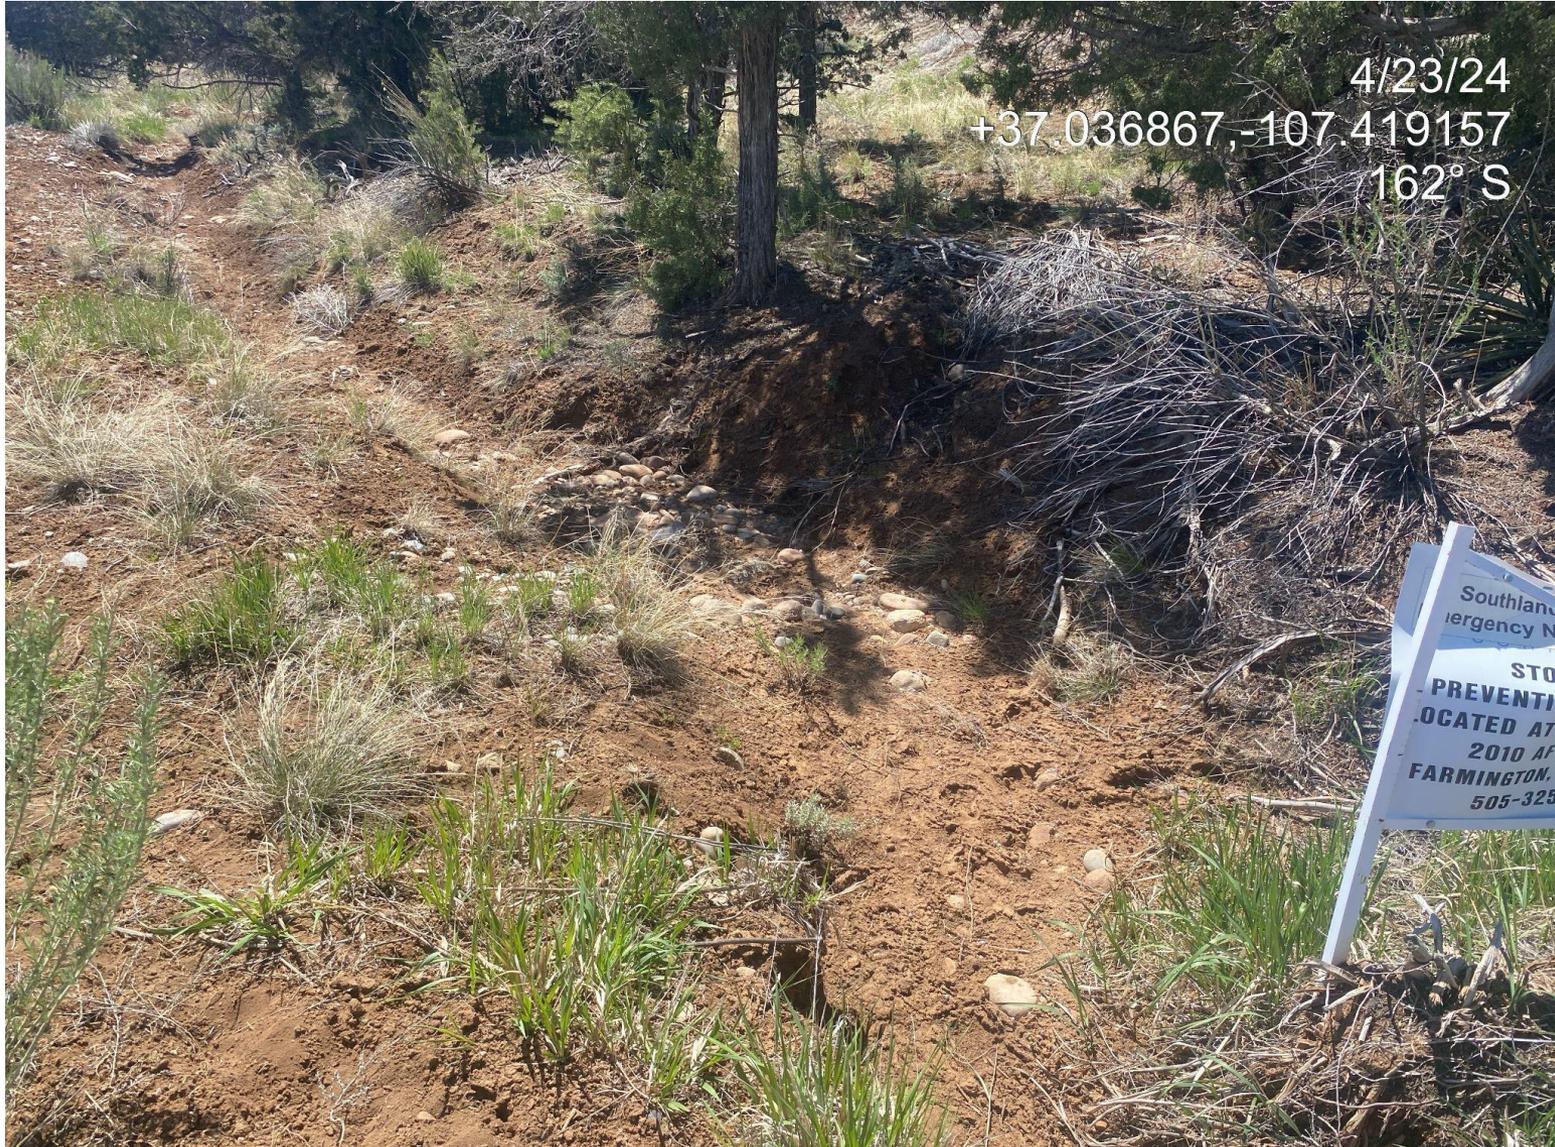
Photo 4. Inadequate/non functional storm water BMPs observed at location access point.

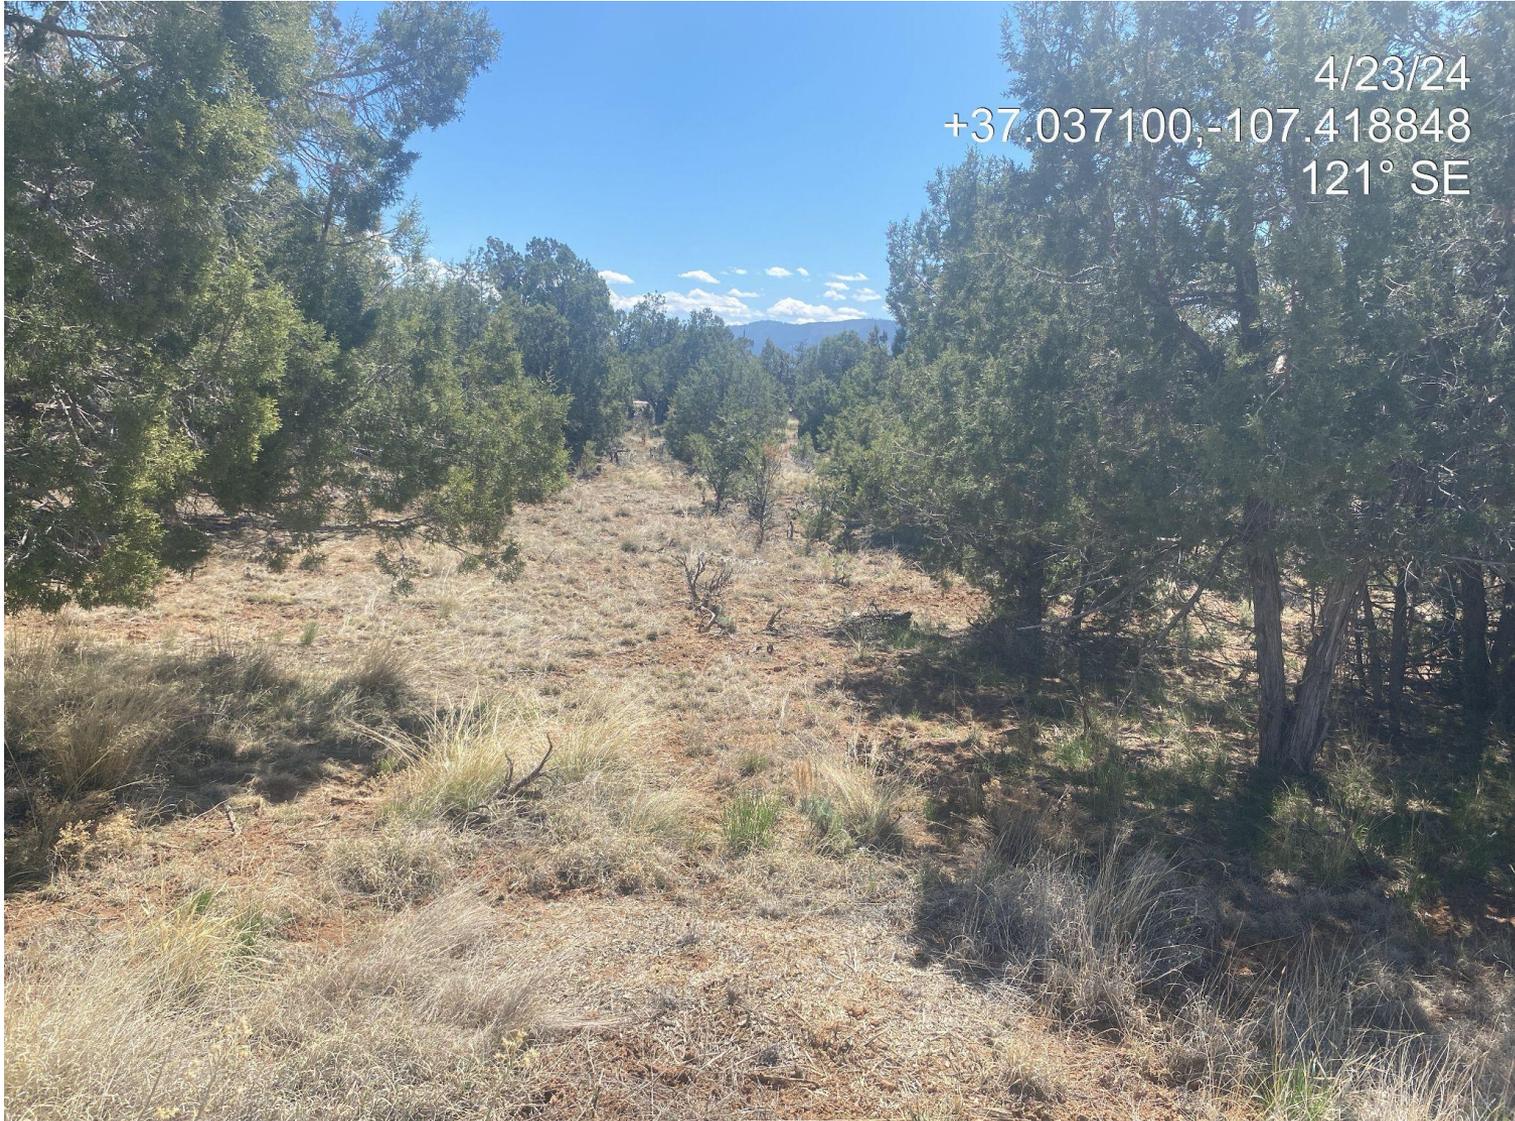
Photo 5. Reference area comprised of indian rice grass and juniper.
