Inspection Photos

Location Name: CAERUS PICEANCE LLC Federal 22-14 (PH-21) Pad

Location ID: 427746

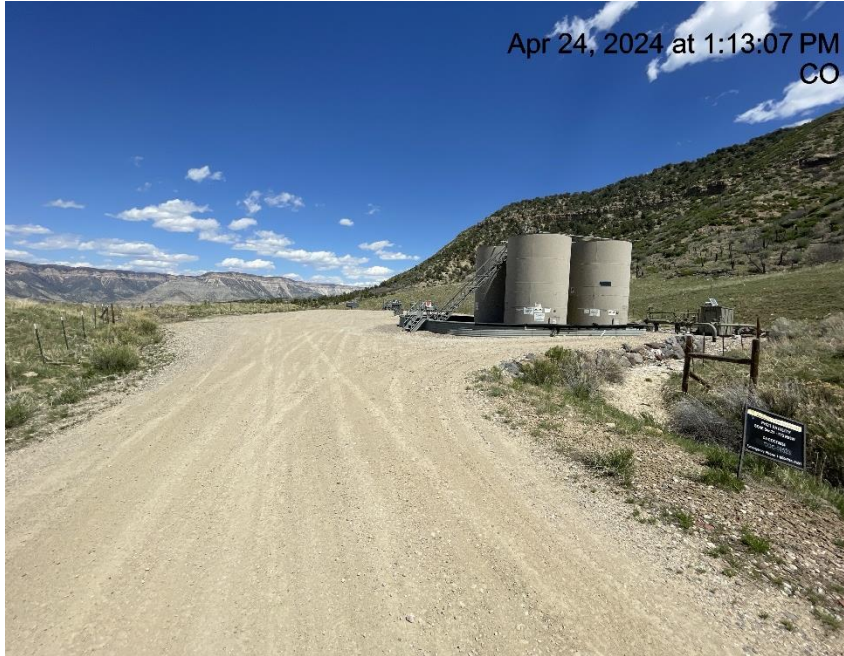
Photo # 4826 From entrance to location

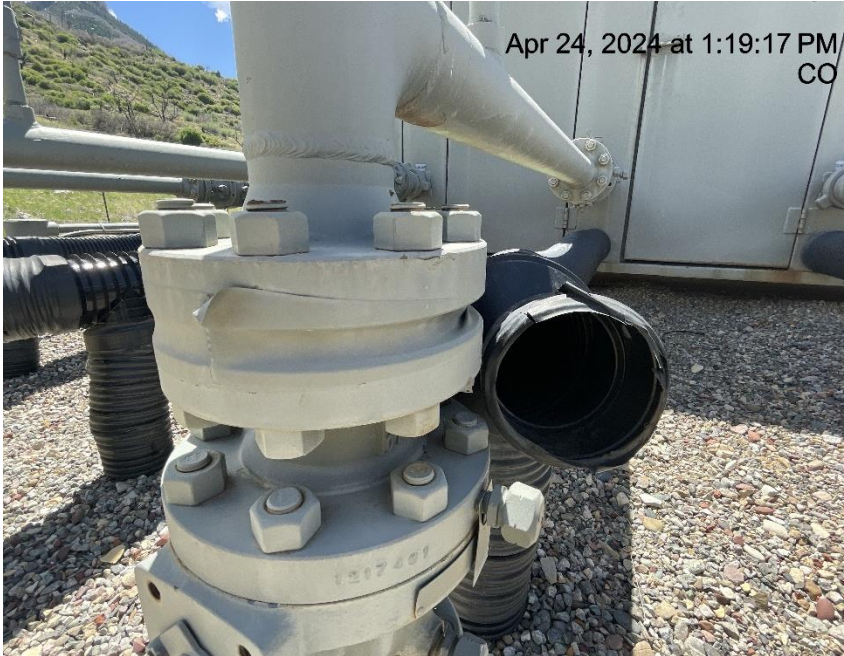
**Photo # 4834 Flowline heating insulation open ended
/wildlife hazard/available for entry by wildlife**

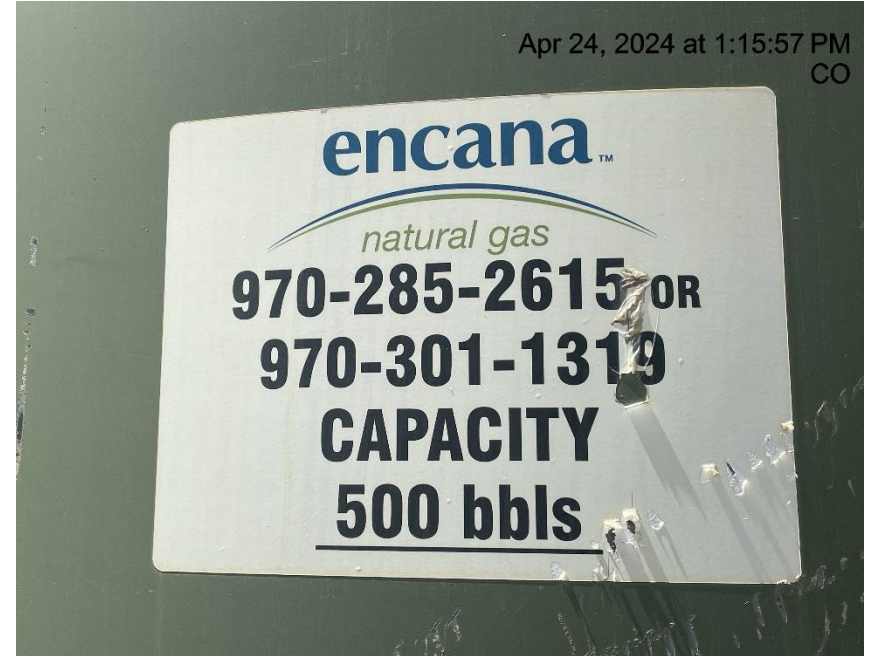
Photo # 4835 Tank label contains inaccurate information

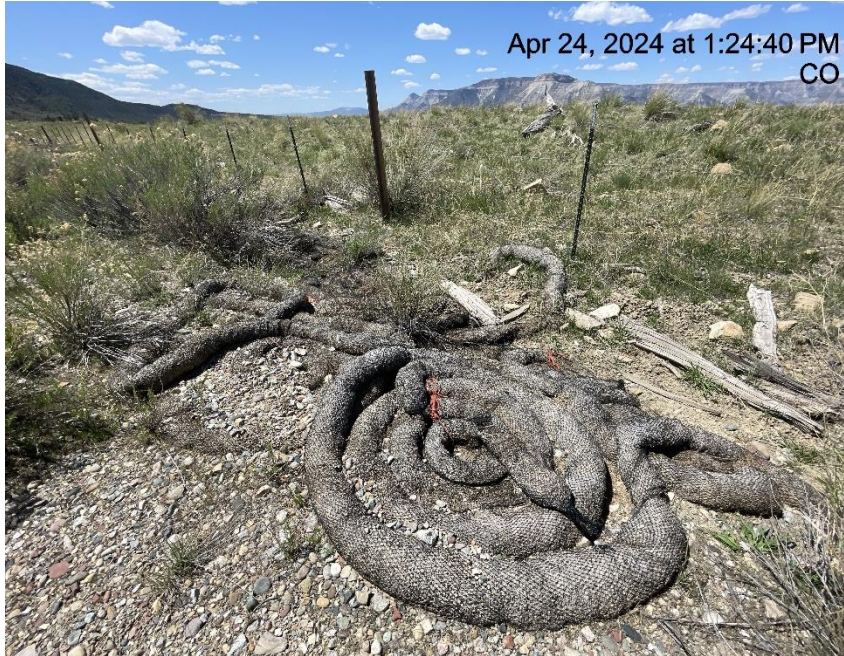
Photo # 4836 Debris

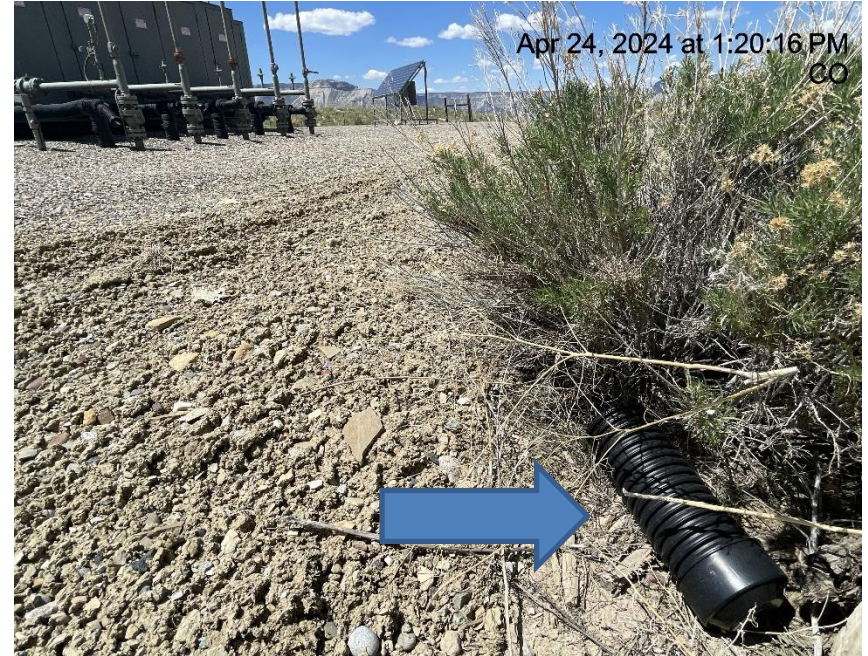
Photo # 4837 Debris

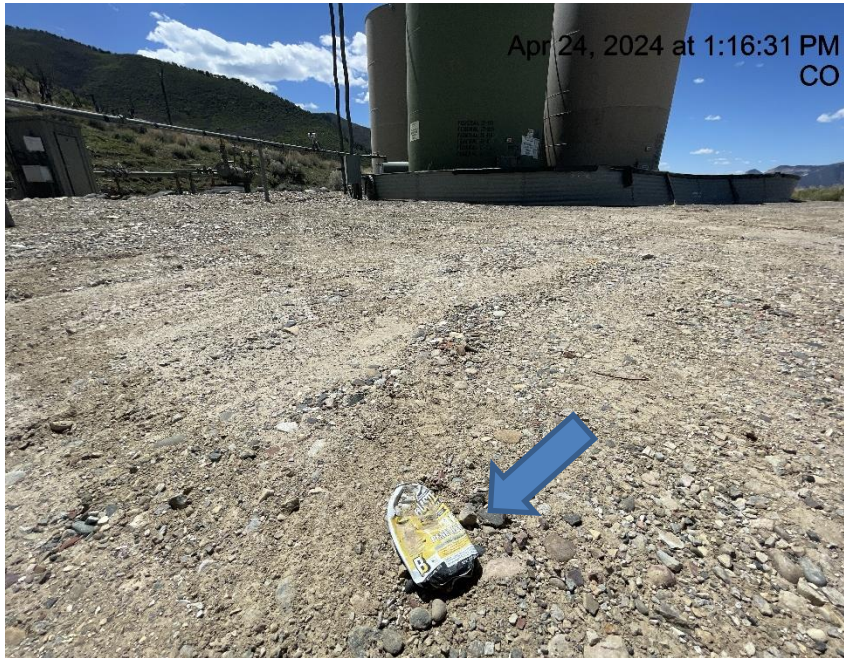
Photo # 4838 Debris

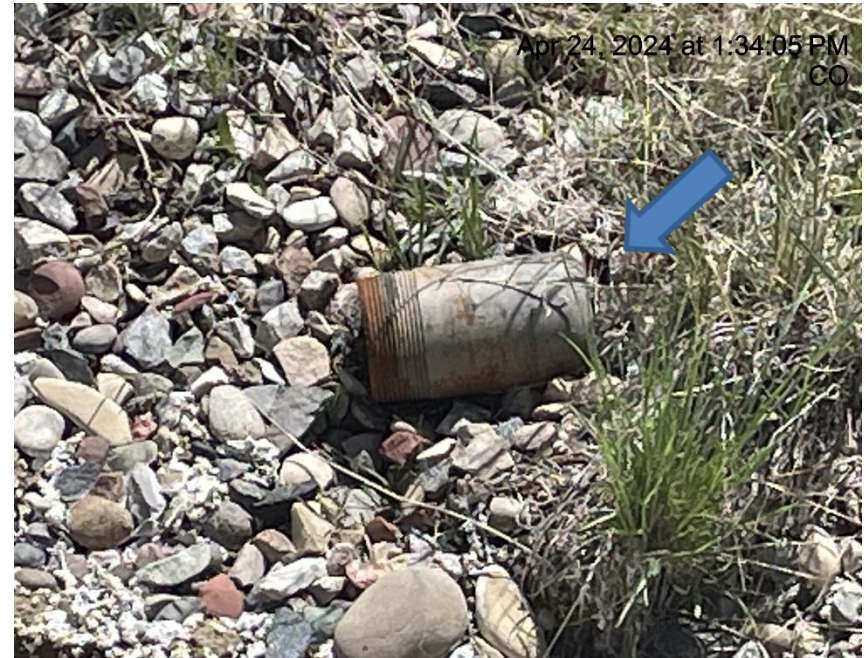
Photo # 4839 Debris

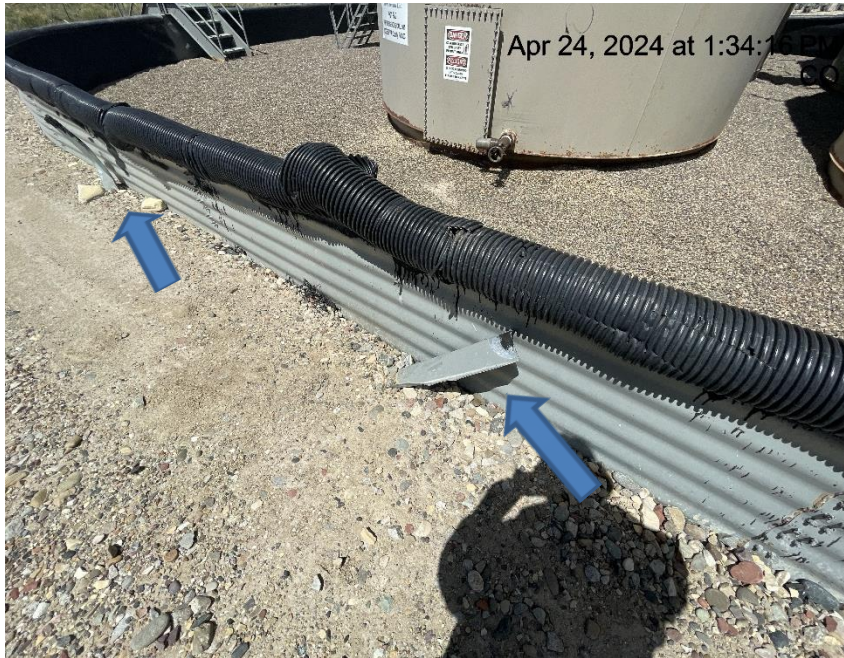
Photo # 4840 Tank containment damaged/buckling

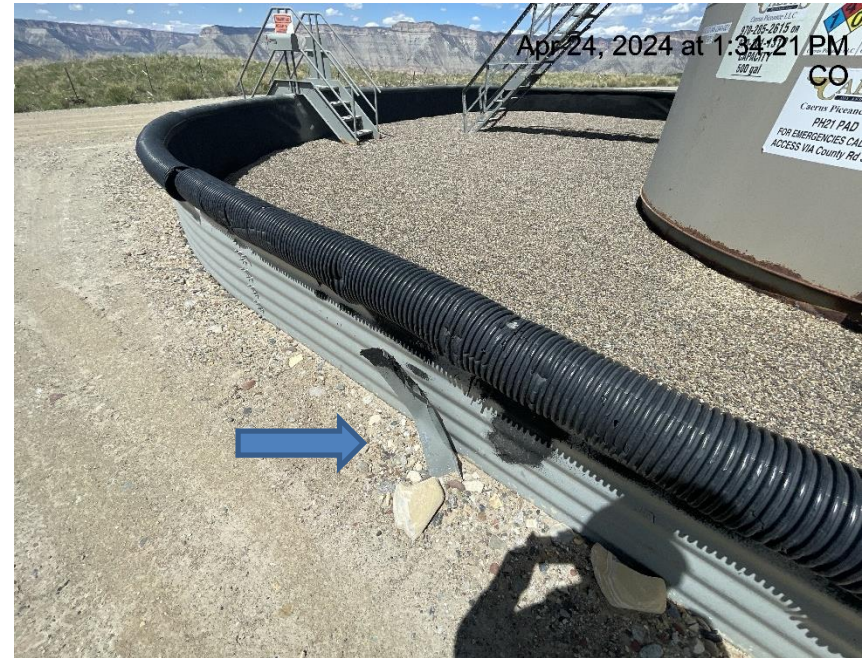
Photo # 4841 Tank containment damaged/buckling

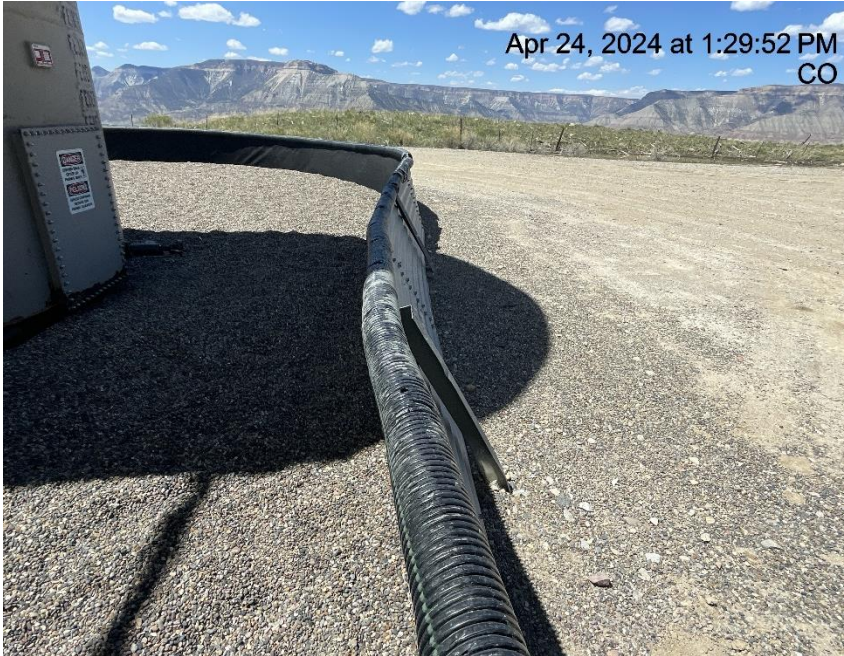
Photo # 4842 Tank containment damaged/buckling

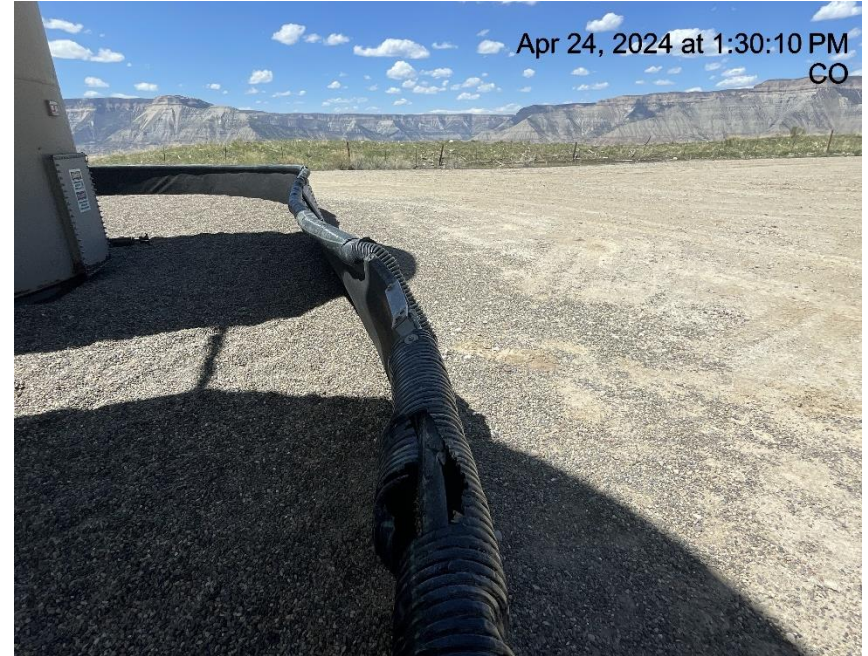
Photo # 4843 Tank containment damaged/buckling
