## Schneider Energy Gebauer 1-23 Flow Line Unintended Release

Inspectors Notes: Through end of day 4-24-2024

Gebauer 1-23

Unintended release April 2024

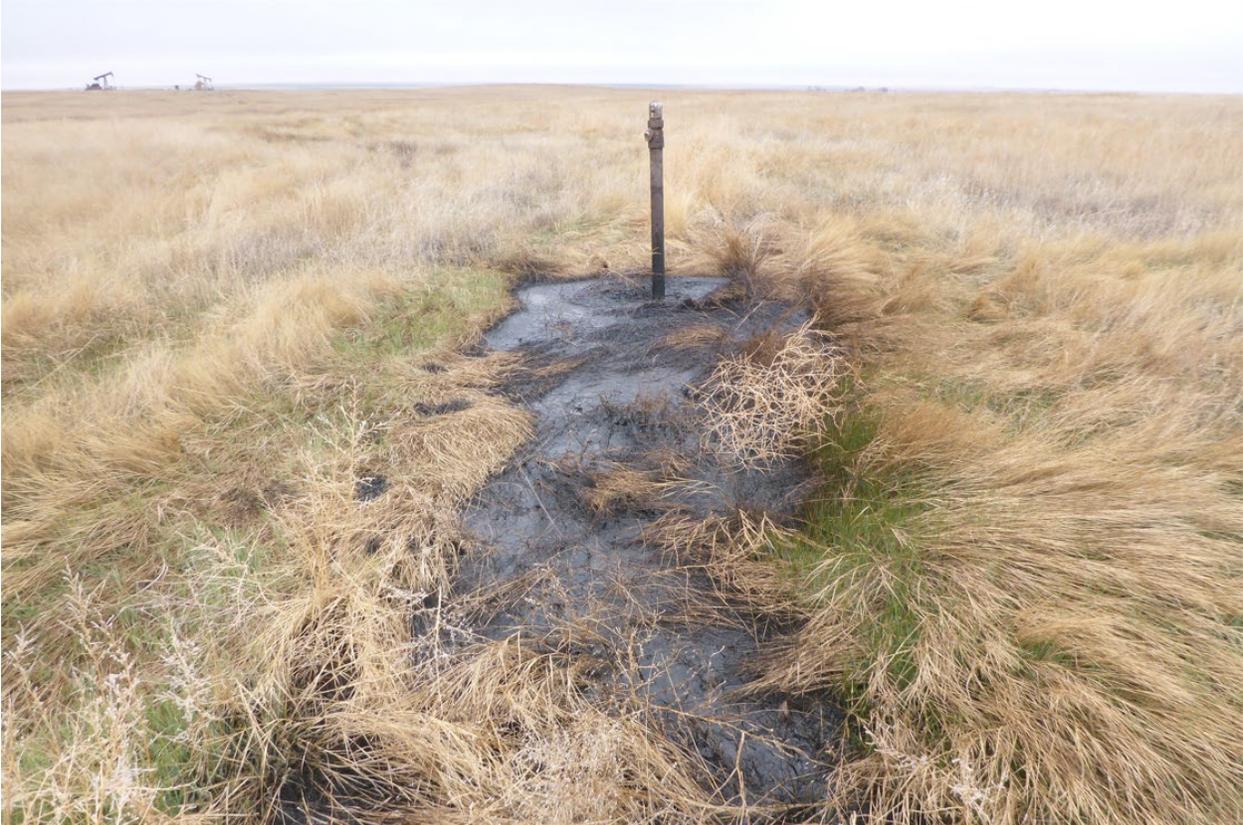
Produced liquid appears to be originating from riser.

Taken from the south most point of the surface  
contamination looking North toward pumping unit

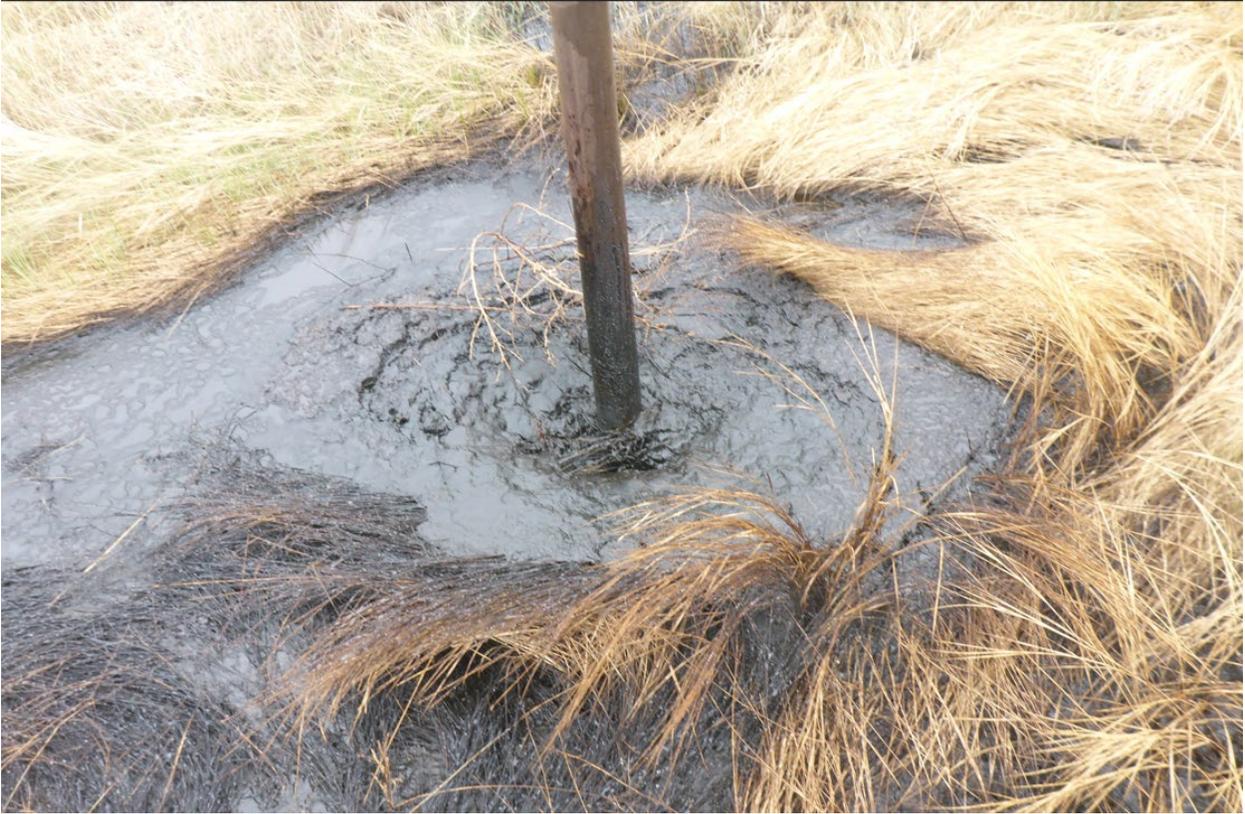
Base of the riser. Shows contraction indicating there is no longer a discharge.

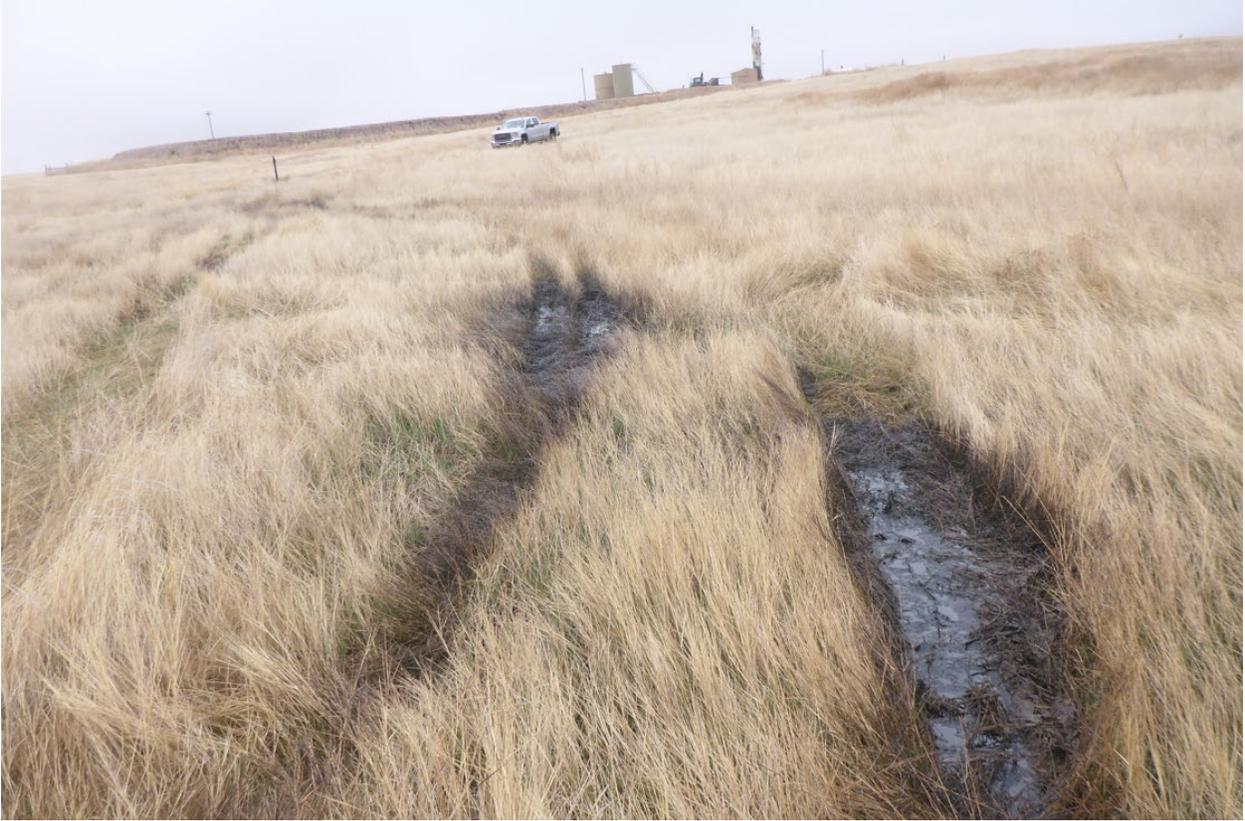
Standing at the north most point looking south toward the tank battery

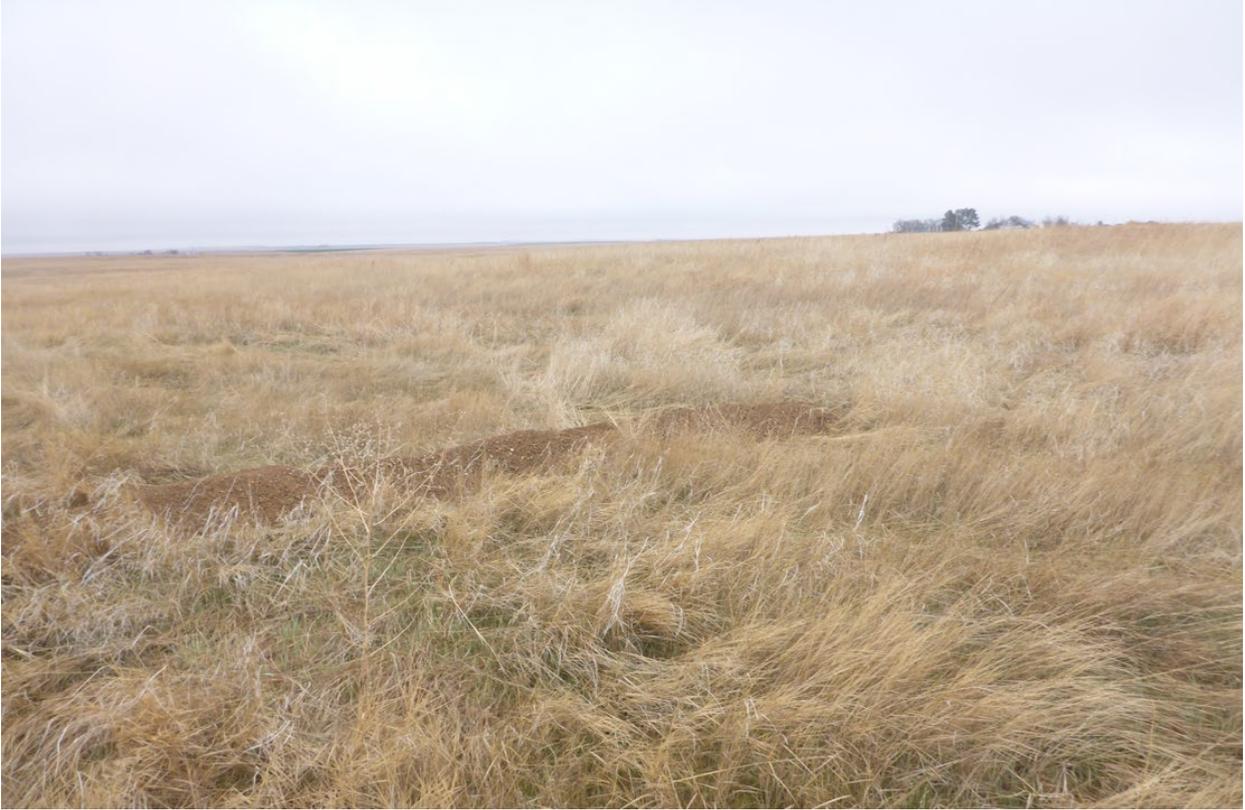
Berm installed as counter measure to prevent further expansion of surface contamination.

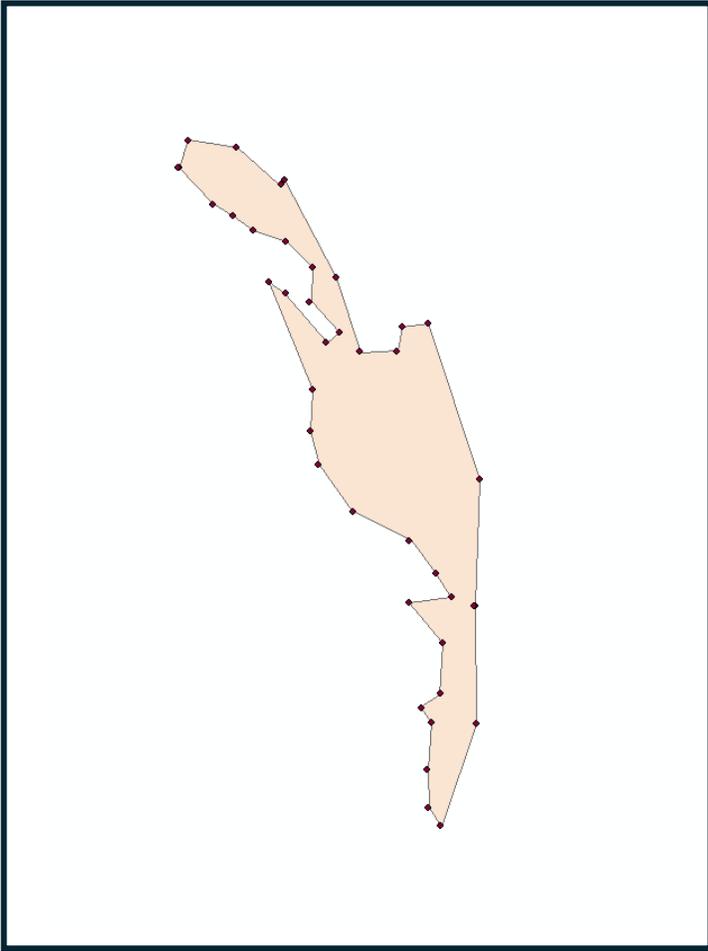
Polygon of surface area showing  
production fluid.  
Length 547.32'  
Area 3796.13 Sq Ft

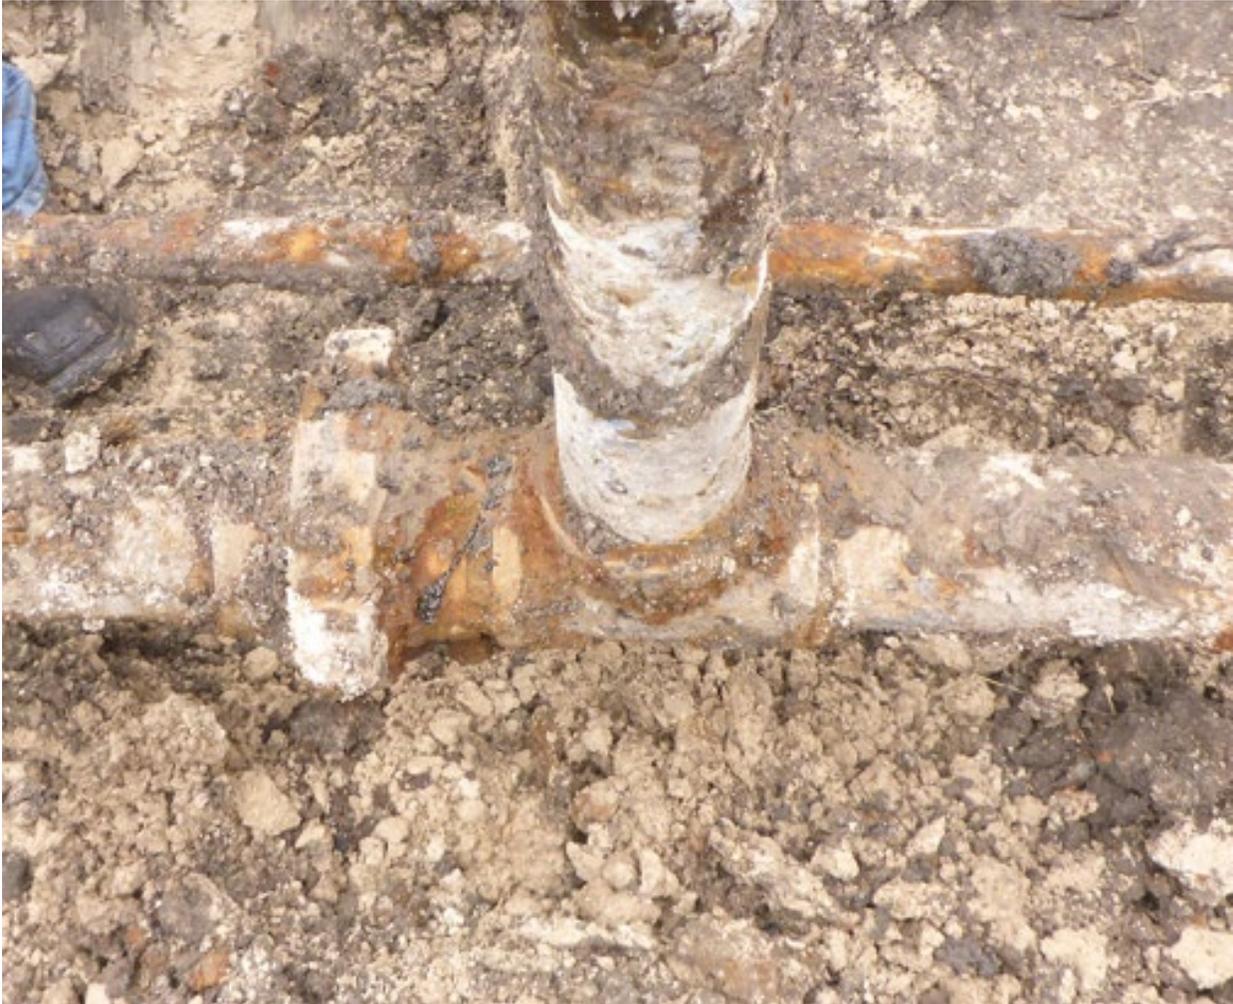
Failure point

Continued excavation of the apparent point of origin revealed a buried 3" light wall tee, 3" x close nipple and 3" LP hammer union. The point of failure is the hammer union. No destructive examination has been done at this point, however it is unquestionable based on excavation findings that this was the point of origin. Suspected causes may include thermal cycles and intermittent livestock intervention, as there was no guard surrounding the riser and it is clear that this area is used to pasture livestock.

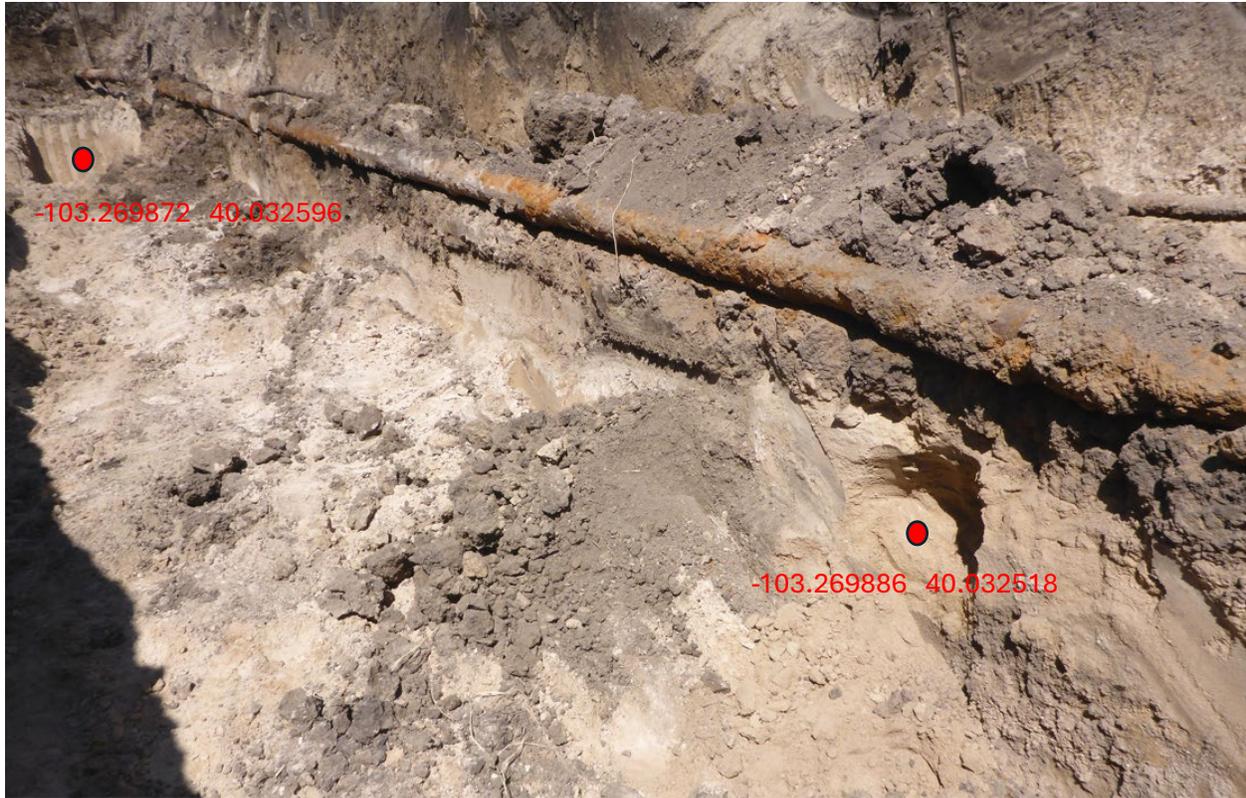
The line south of the point of failure was excavated and soil samples were taken with a PID throughout the process. Please see pictures and excel spread sheets for applicable information. After excavating the line approximately 60' south there were two PID tests roughly 10' apart that revealed no hydrocarbon contamination, at which point the excavation to the south was stopped. The point of origin was obviously saturated and no PID sampling was done at that point. The first sample below the pipe was done at approximately 15' to the south which revealed a result of 1200 ppm. At this point vertical sampling began (see results in excel spread sheet) the over all depth impact appears to be approximately 16' / 17'.

Sample points during excavation to determine extent of leaching.

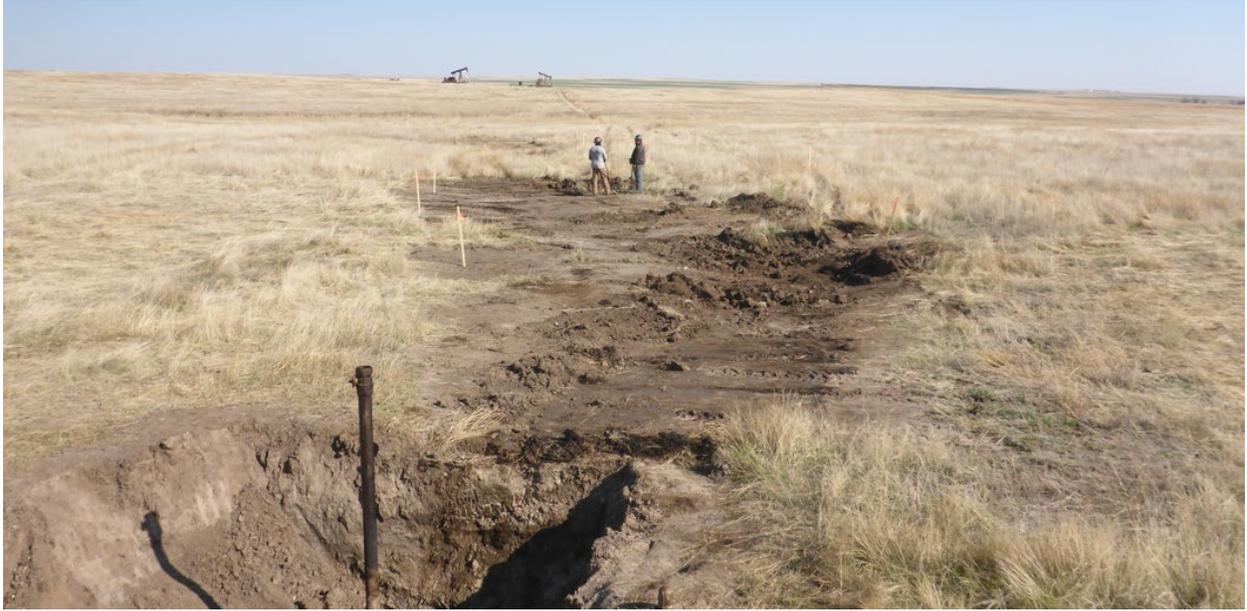
Removal of surface contamination. Lath and flag indicate area perimeter.

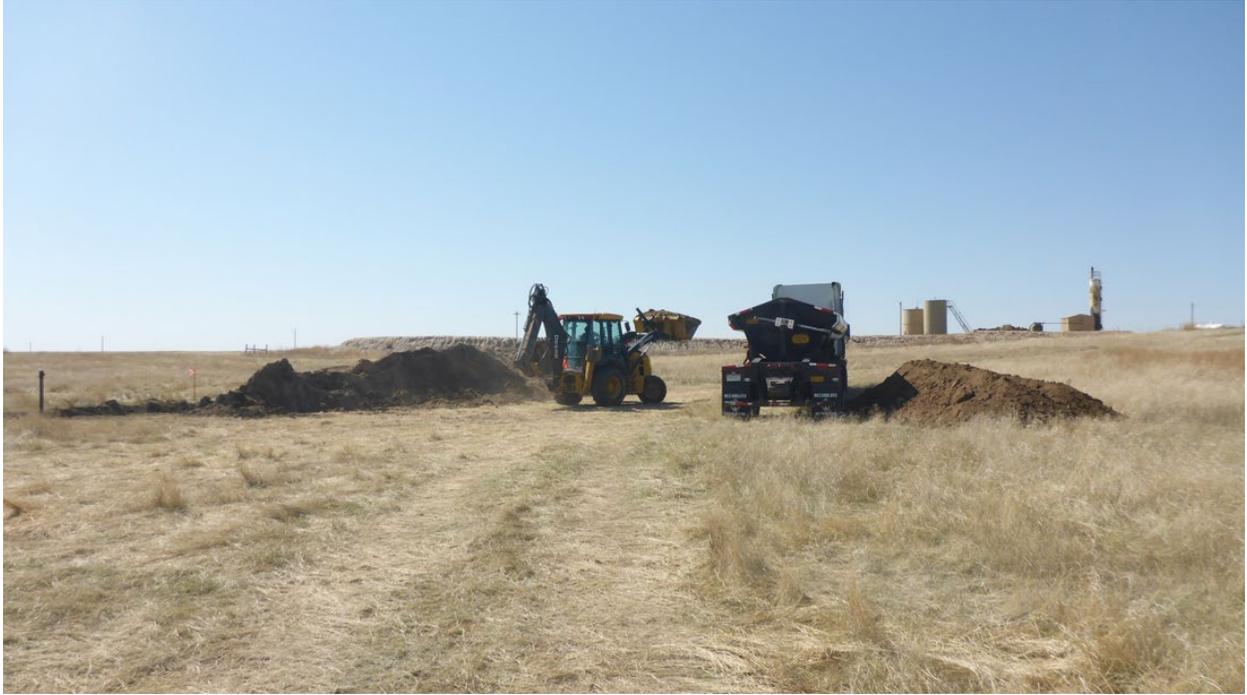
Clean topsoil staged to the west (right). Contaminated soil being loaded from the pile to the east (left).
