## Inspection Photos

Location Name: TEP Rocky Mountain LLC GIBSON GULCH UNIT 10-30 Pad

Location # 335265

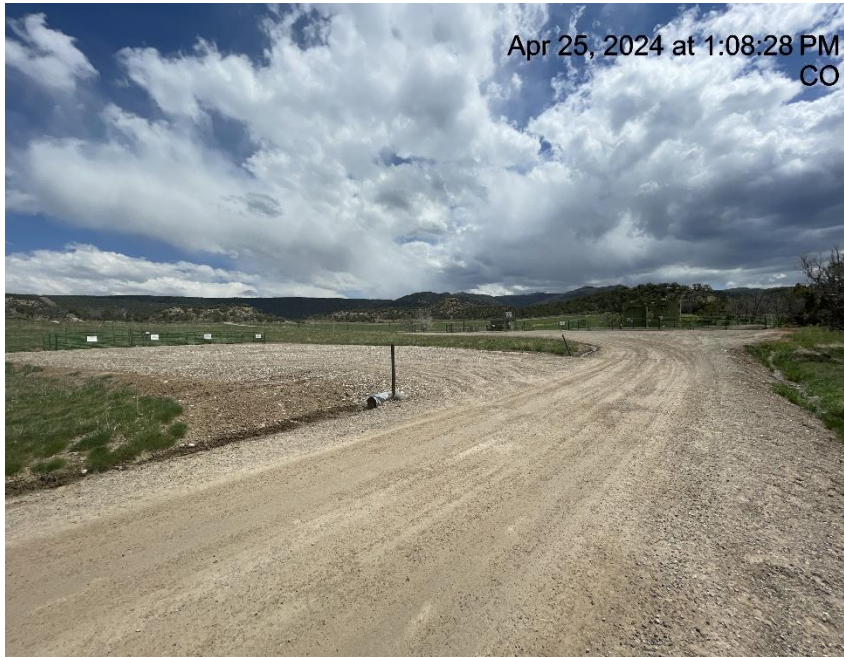
Photo # 5104 From entrance to location

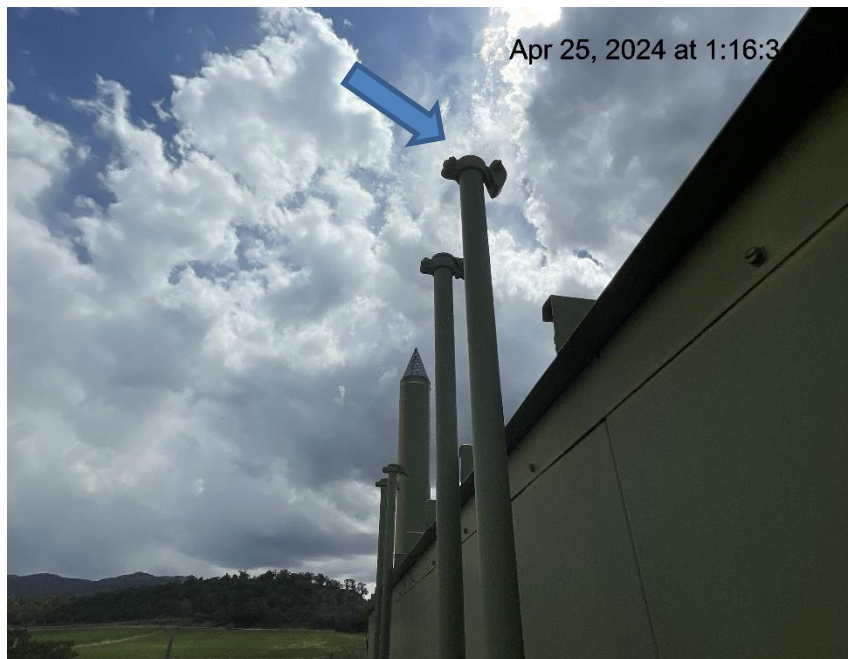
**Photo # 5110 PRV vent line cap damaged/PRV vent line does not comply with CECMC pressure safety device rules**

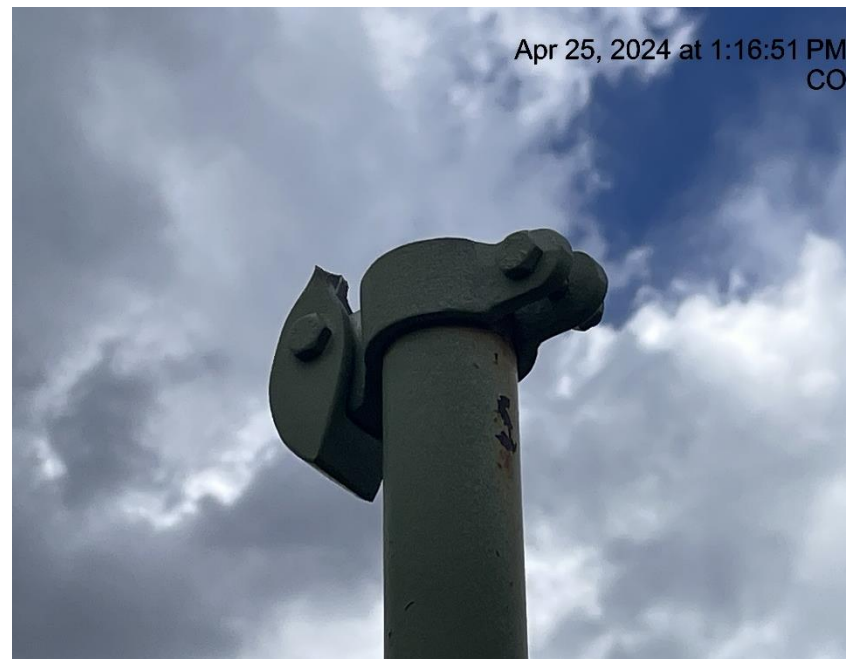
**Photo # 5111 PRV vent line cap damaged/PRV vent line does not comply with CECMC pressure safety device rules**

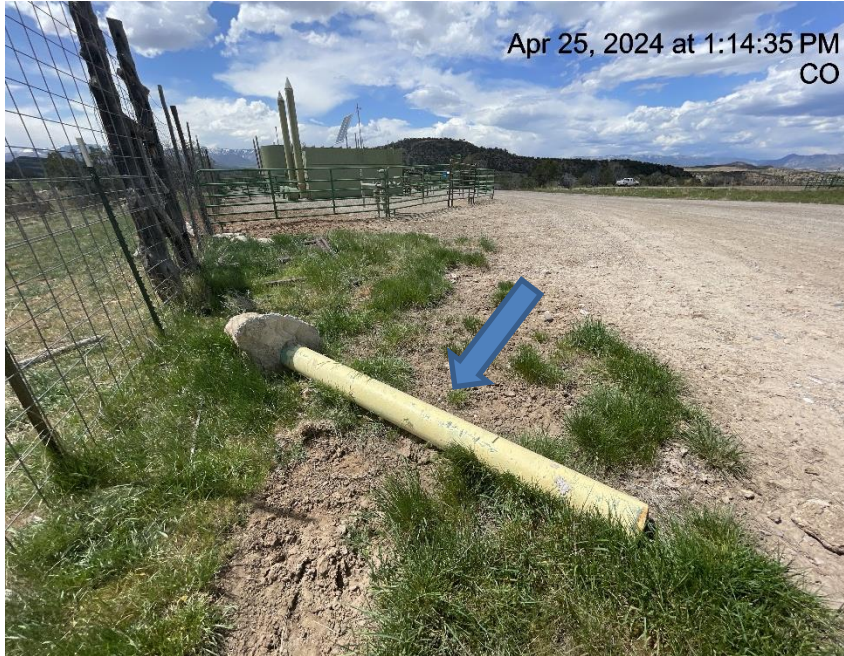
Photo # 5112 Debris

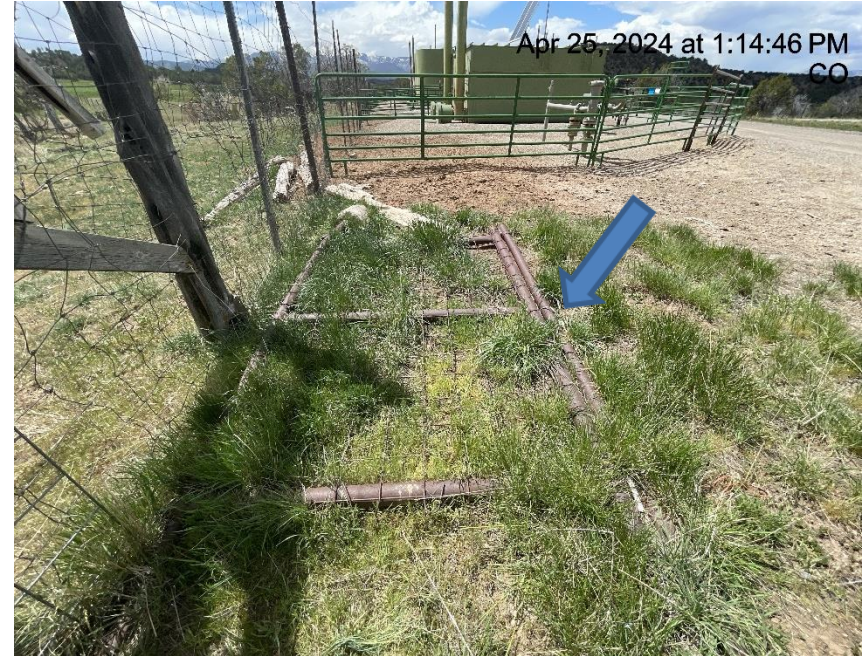
Photo # 5113 Debris
