Interim Reclamation and Stormwater Inspection

April 15, 2024

Operator: WOODBURY RESOURCES LLC- #10761

Inspection Photos
Location Name: Fuqua 18-15 Pad
Location ID: 324766

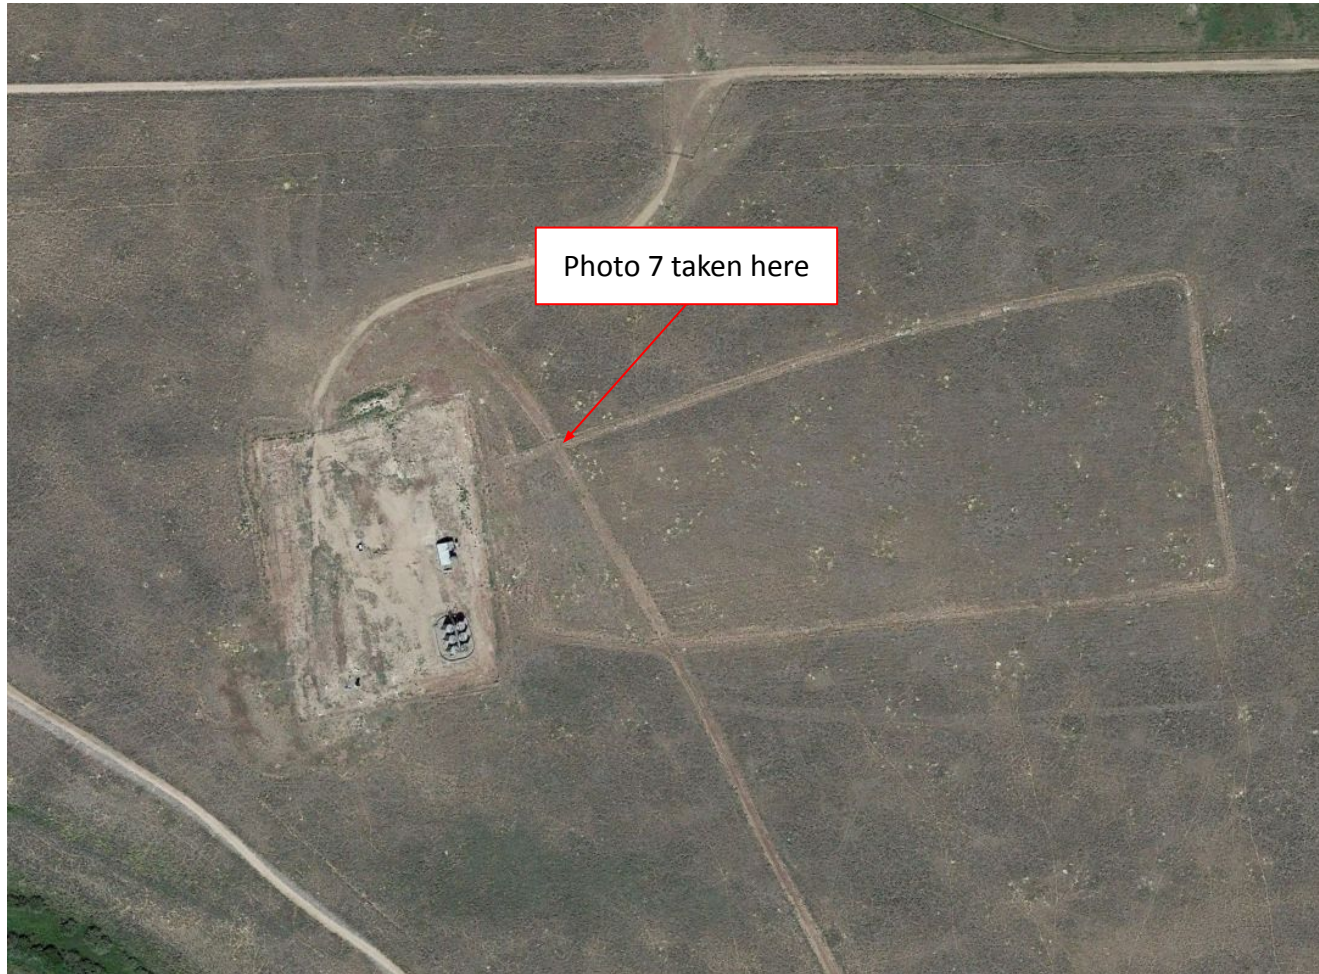
Photo 1. Google Earth aerial imagery from 8/27/2019 illustrating the location and a portion of the access road. The disturbances east of the location were from the Operator and have been reclaimed- refer to Photo 7. There is a disturbance to the southwest of the location that will need further investigation by ECMC.

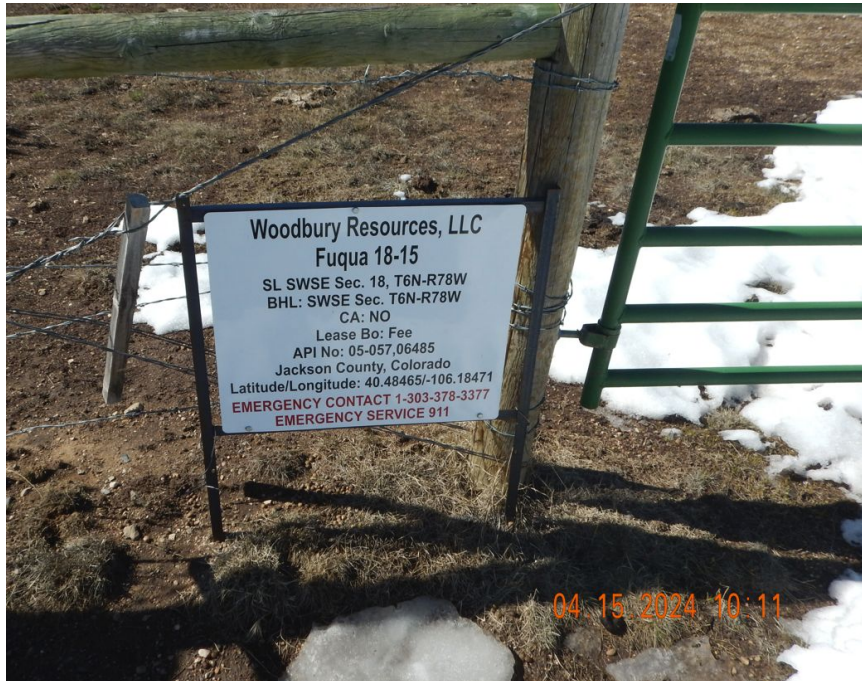
Photo 2. Photo taken from the entrance of location. Photo illustrates the Operator sign, which needs to be corrected due to an inaccurate Well API #.

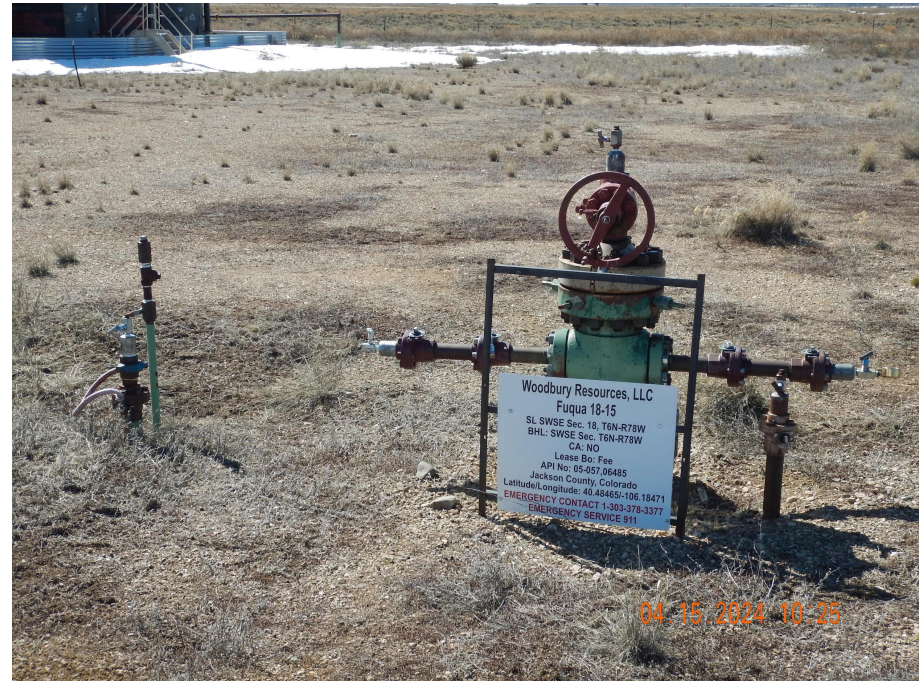
Photo 3. Photo taken from the wellhead. See comments on Photo 2 regarding the Operator sign.

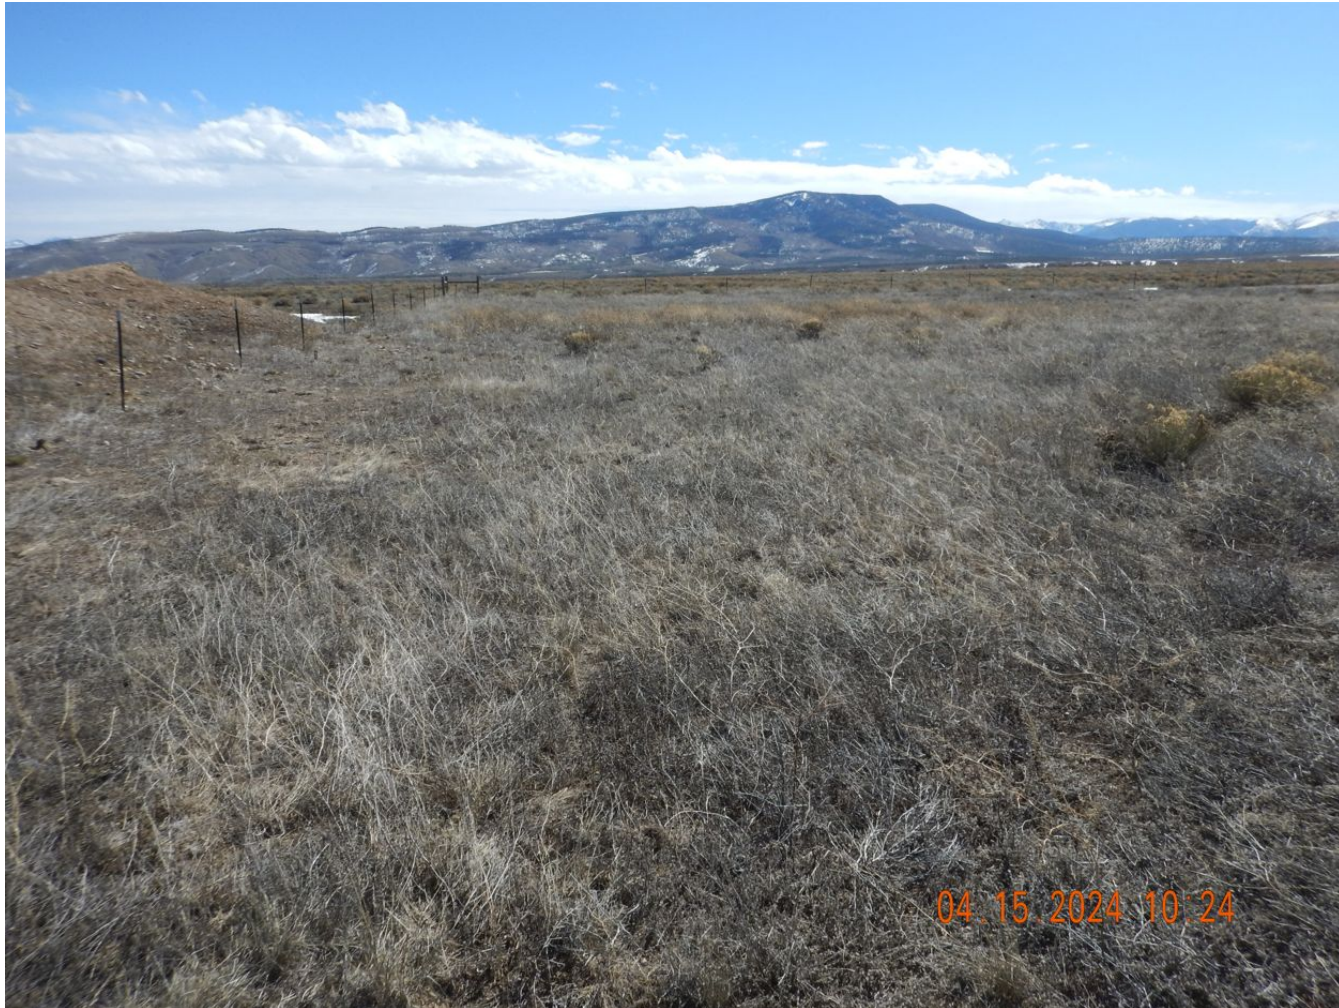
Photo 4. Photo taken from the northern interim reclamation area, facing East. Photo illustrates the area consists mostly of annual vegetation, which is not reflective of reference area conditions. Refer to Photo 7 documenting reference area vegetation.

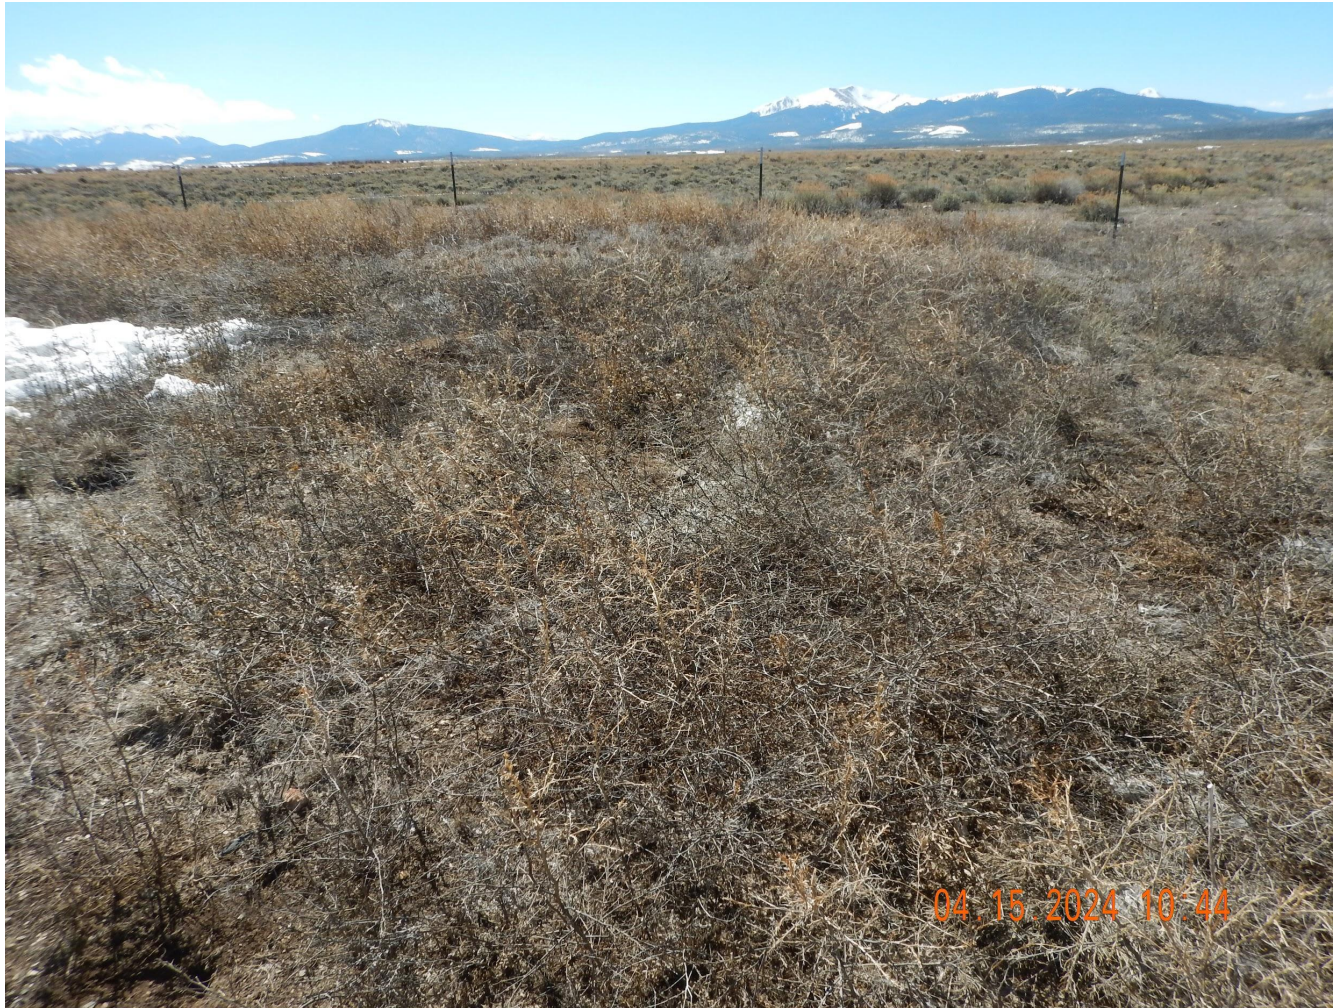
Photo 5. Photo taken from the southeastern interim reclamation area, facing South. Photo illustrates the area consists mostly of unmanaged annual, weedy Russian thistle vegetation that is not reflective of reference area conditions. Refer to Photo 7 documenting reference area vegetation.

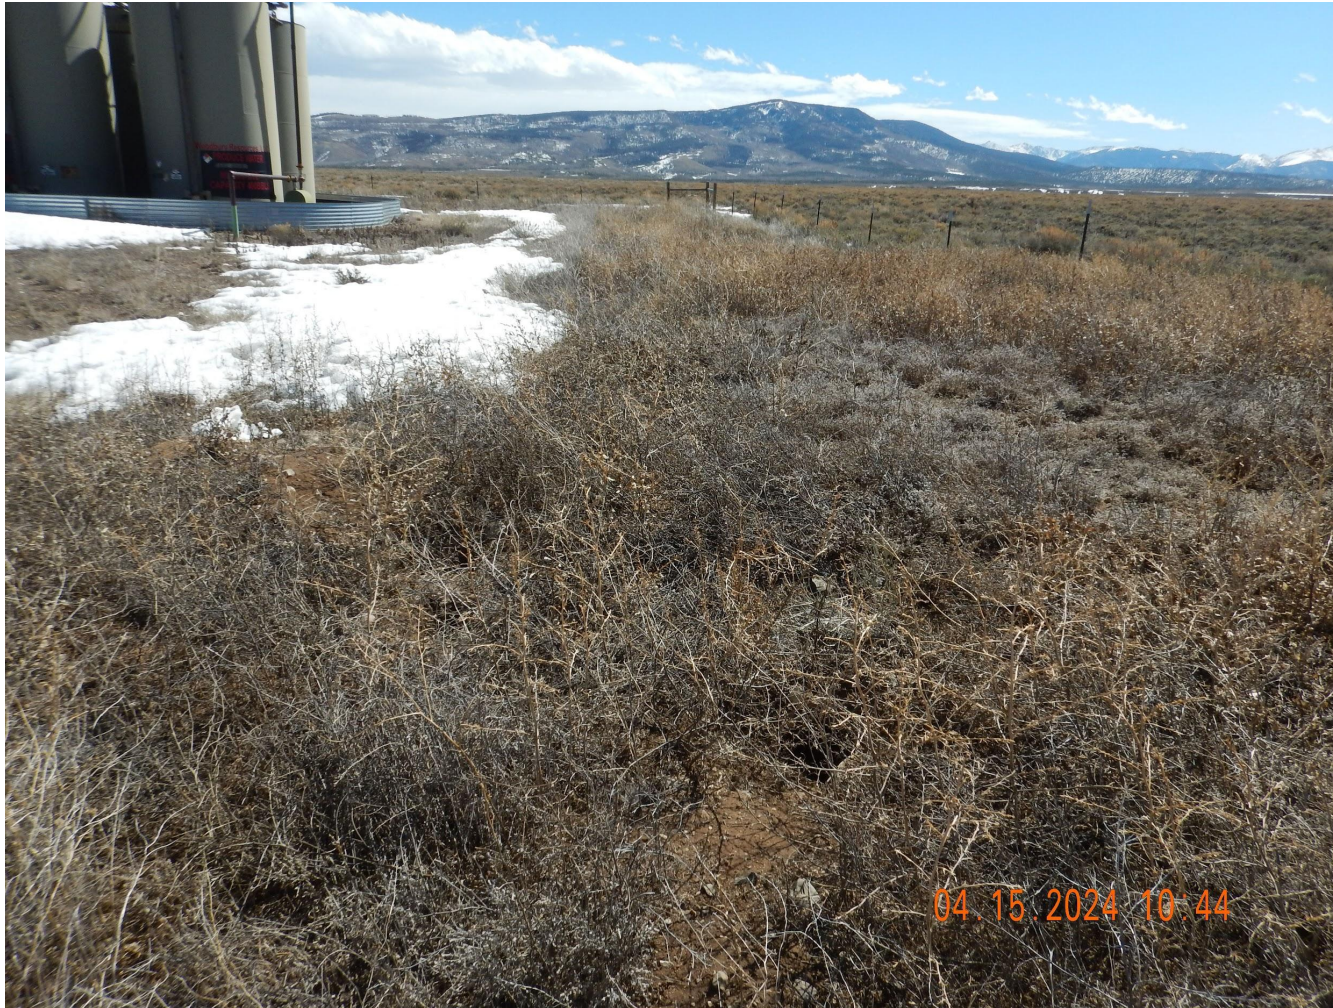
Photo 6. Photo taken from the southern interim reclamation area, facing East. Photo illustrates the area consists mostly of unmanaged annual, weedy Russian thistle vegetation that is not reflective of reference area conditions. Refer to Photo 7 documenting reference area vegetation.

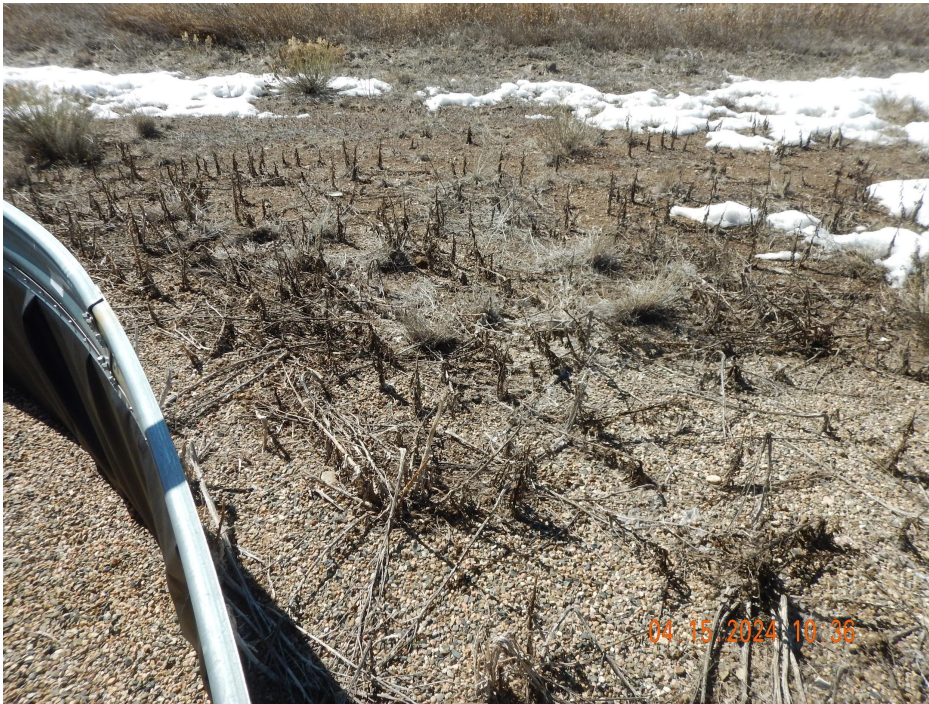
Photo 7. Photo taken from the southeastern interim reclamation area near the southern tank battery. Photo illustrates a List B Colorado noxious weed, Canada thistle. Note- there were other areas along the southern interim area with Canada thistle.

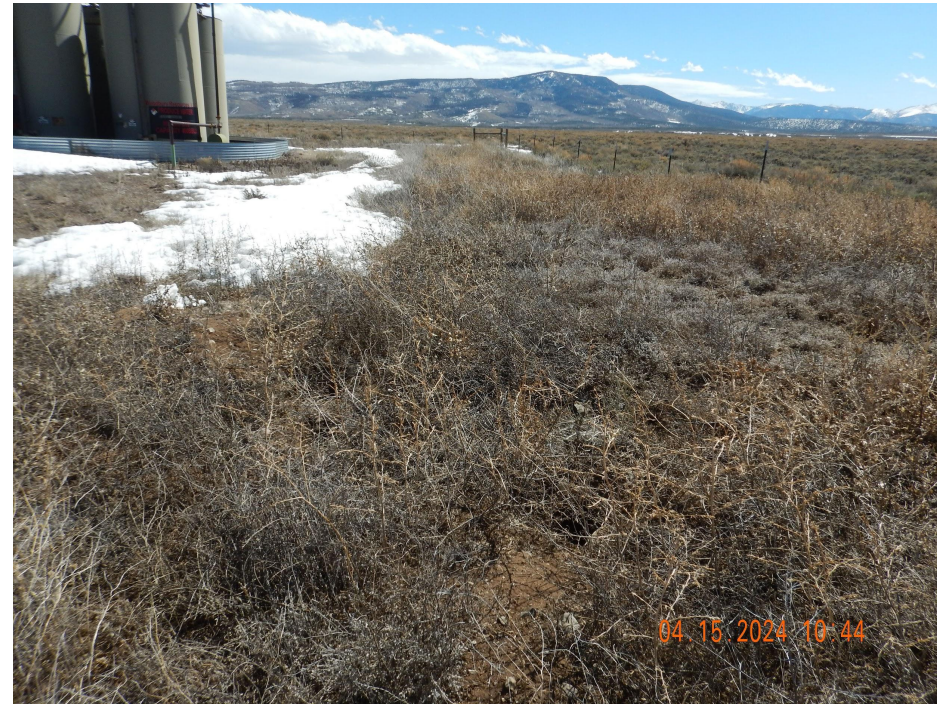
Photo 8. Photo taken from the southern interim reclamation area, facing East. Photo illustrates the area consists mostly of unmanaged annual, weedy Russian thistle vegetation that is not reflective of reference area conditions.

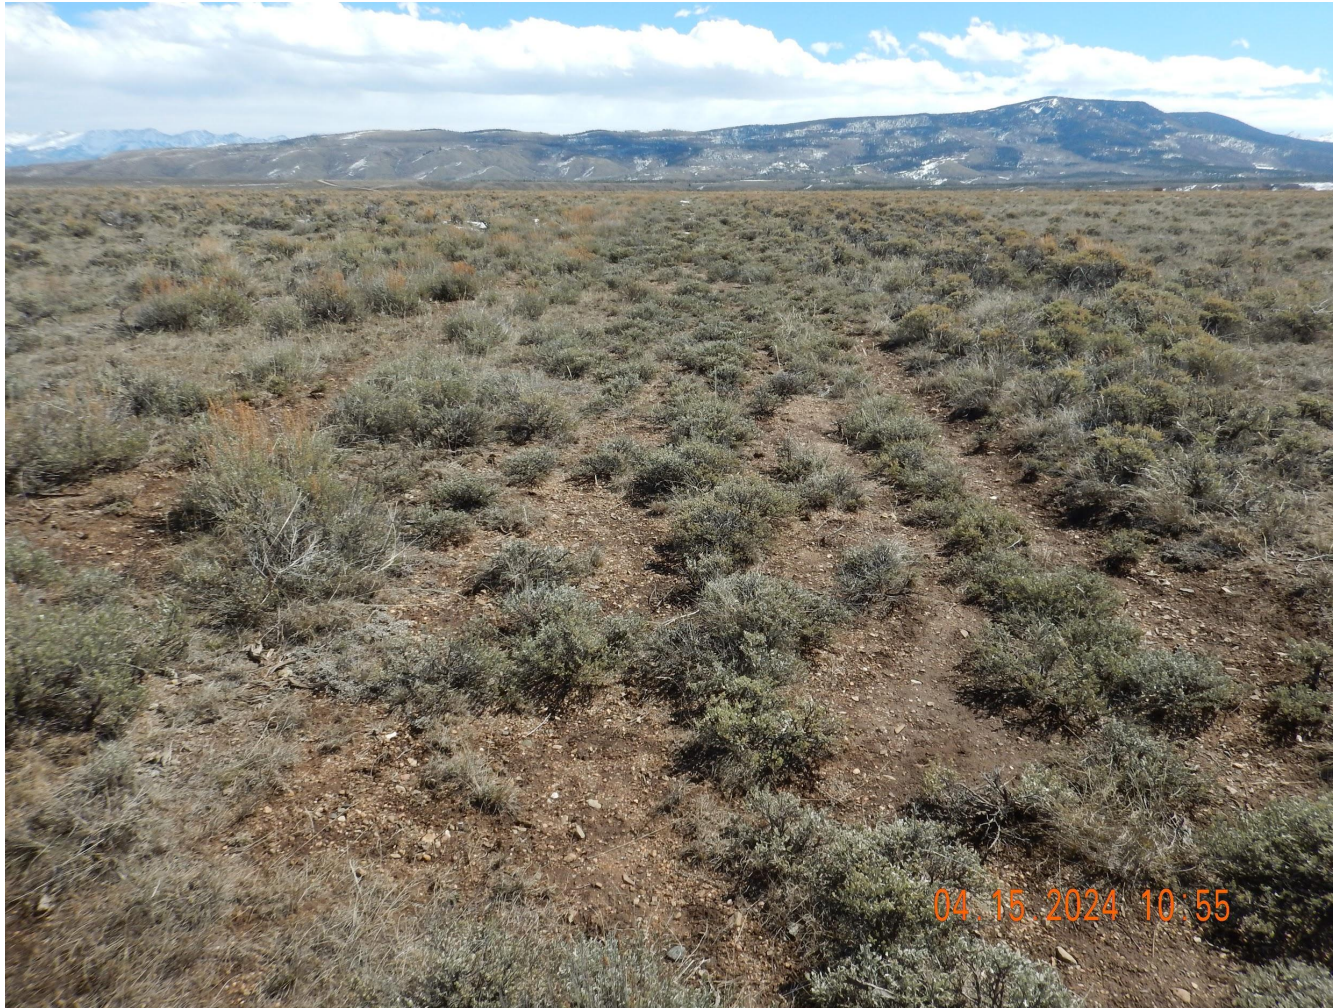
Photo 7. Photo taken from the disturbance feature shown in Photo #1, facing East. Photo illustrates the Operator bulldozed the disturbance feature in response to a 2012 E&P waste release for a proposed controlled burn. The disturbance feature has reclaimed back to reference area conditions.

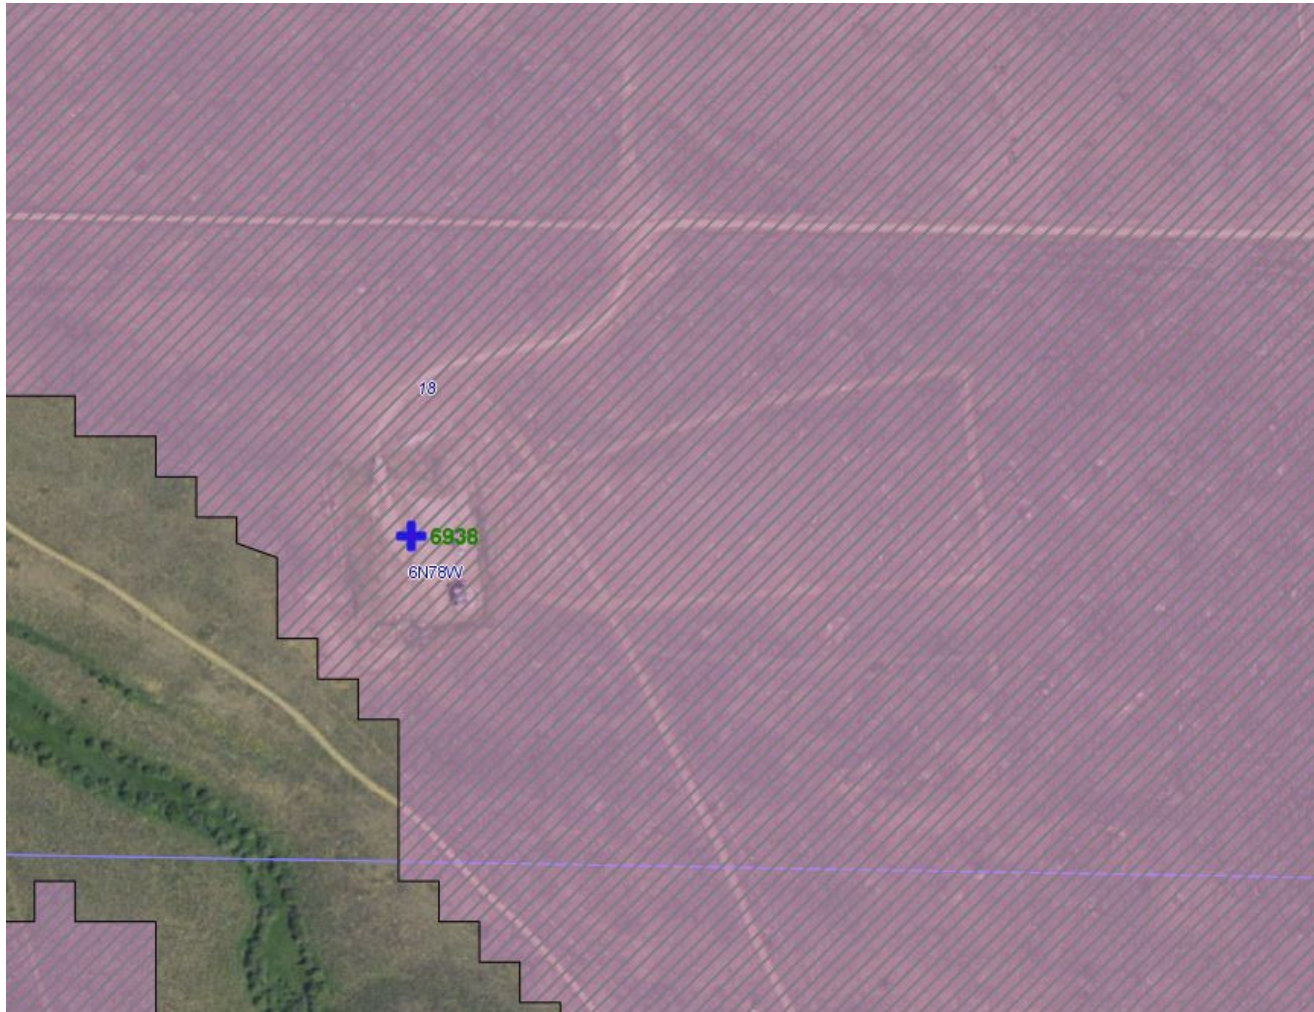
Photo 8. ECMC GIS aerial imagery illustrates the location falls within Greater Sage Grouse General Habitat Management Area.
