Inspection Photos
Location Name: Godsey 43-20
API Number: 125-08461

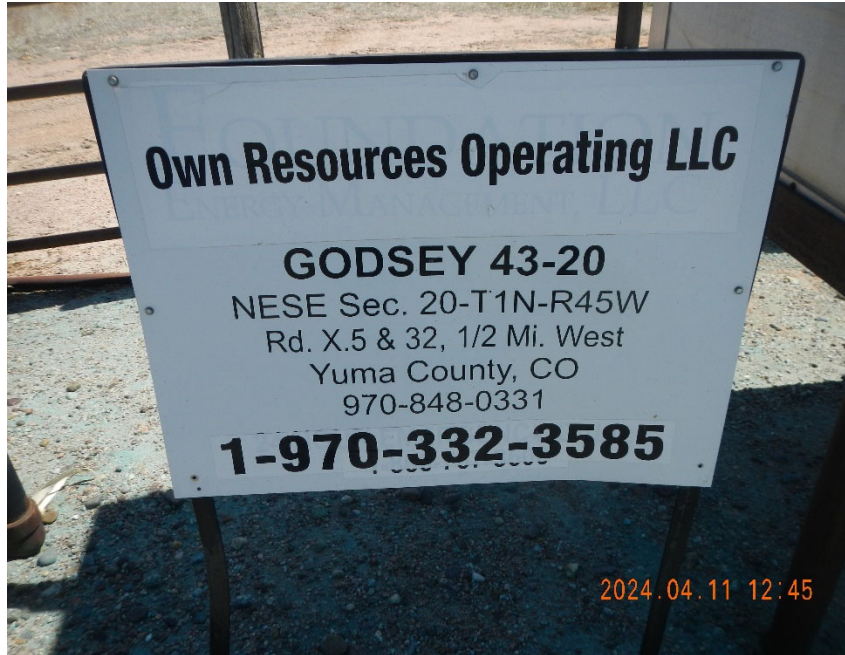
1. Lease sign at well location.

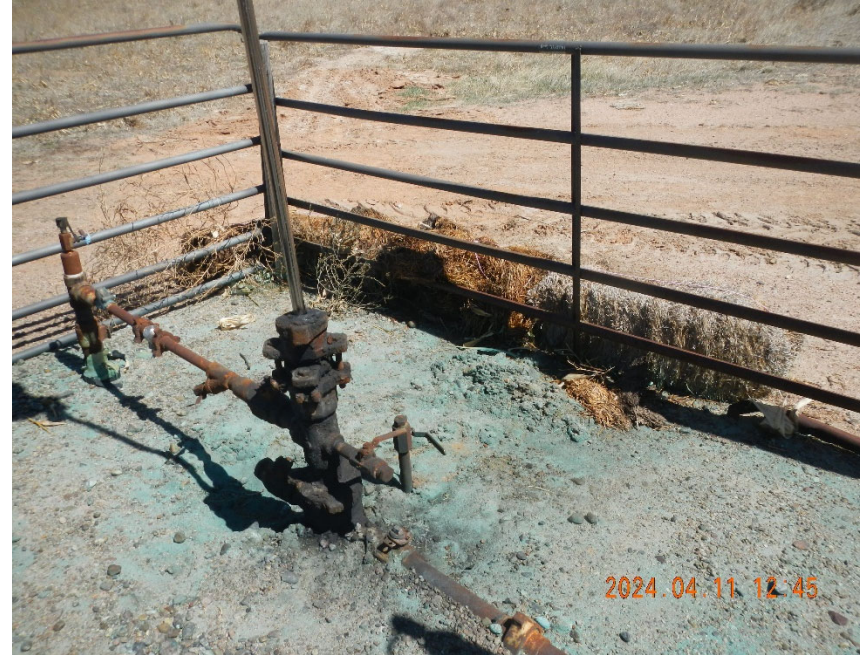
2. View of wellhead with straw bales visible at fencing.

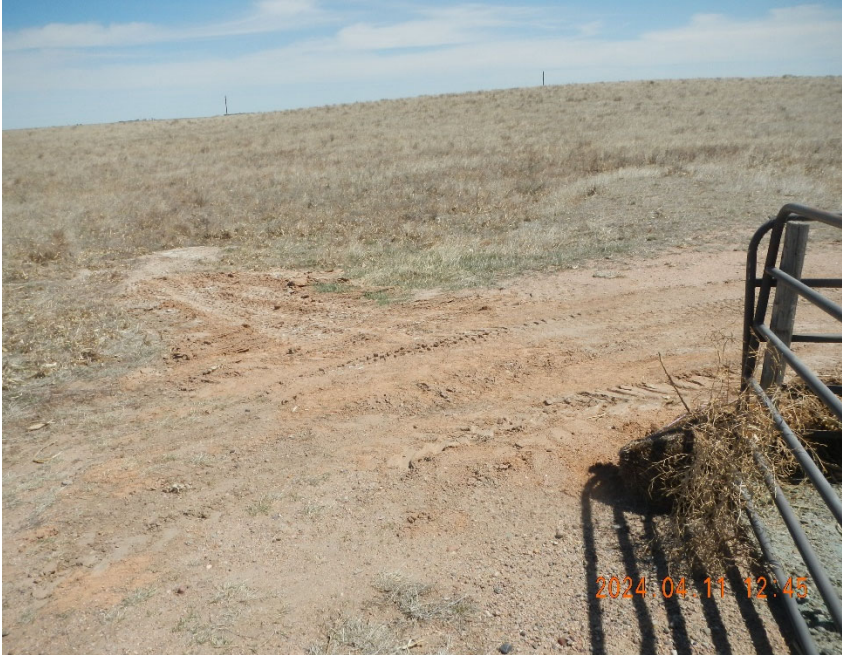
3. View looking down grade at repaired erosion channeling.

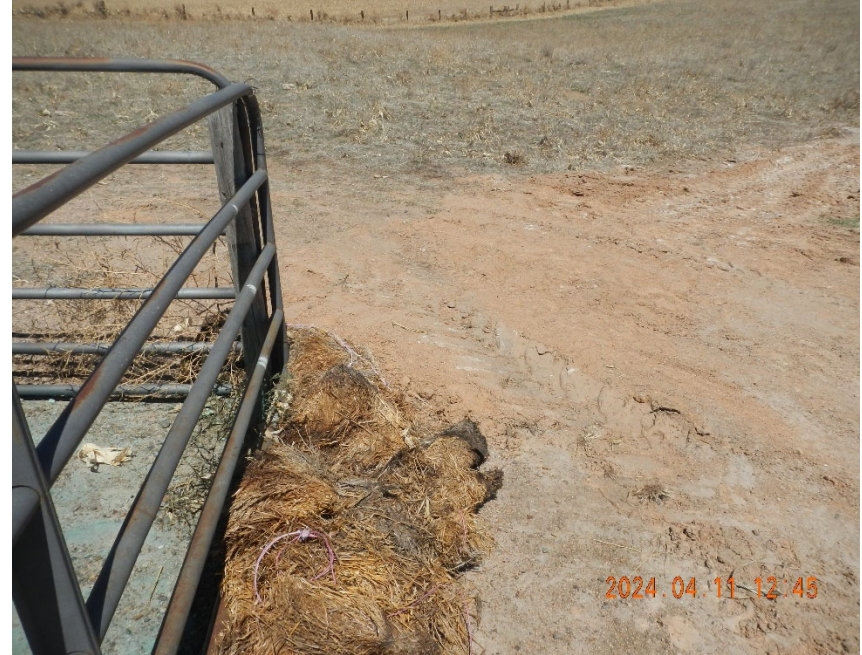
4. View of straw bales and mulch outside fencing.

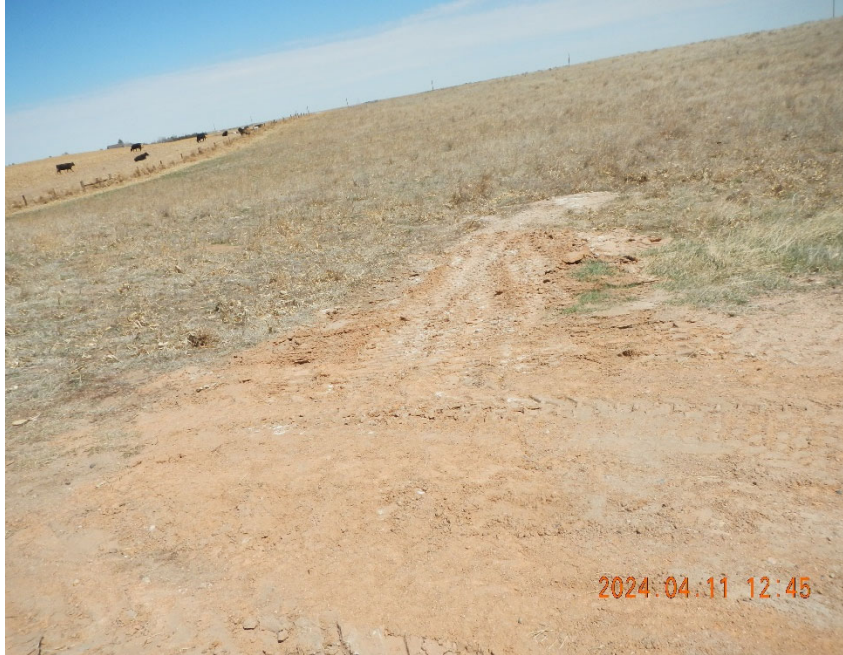
5. View of repaired erosion looking down slope from well.

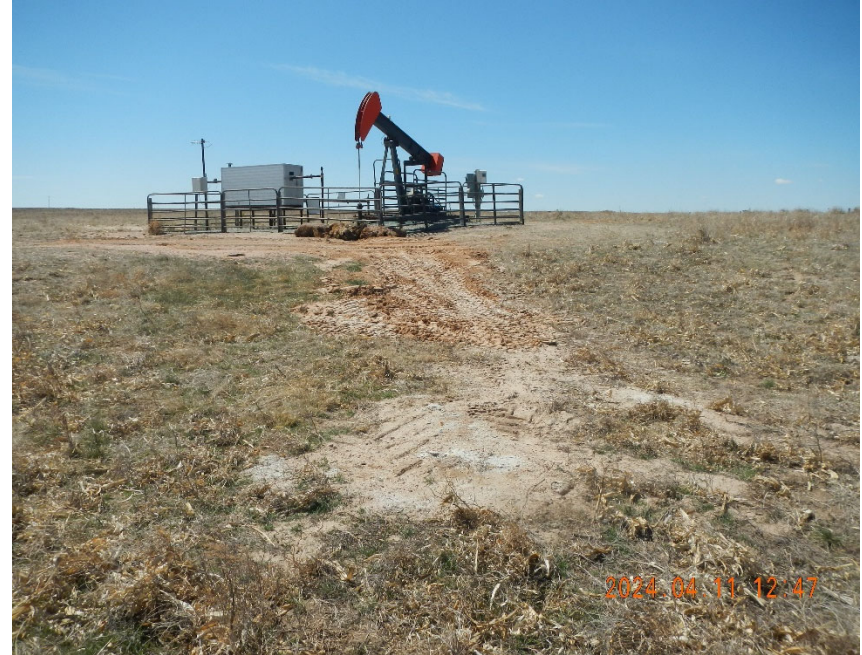
6. View of repaired erosion looking up slope towards well.
