Taproot – Pintail Lateral – Produced Water Release

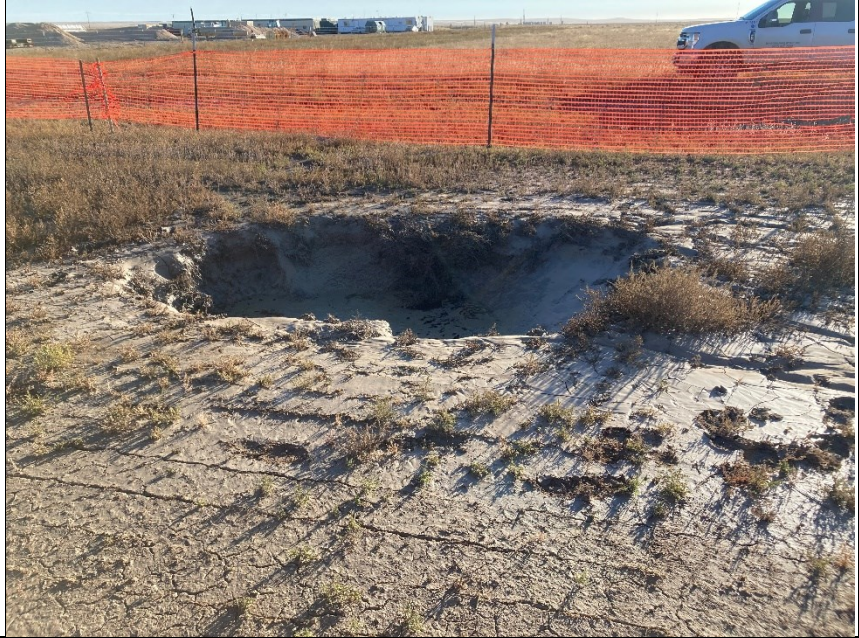
Photo: 1**Description:**

Release location looking east. Photo taken at 8:00 AM 11/18.

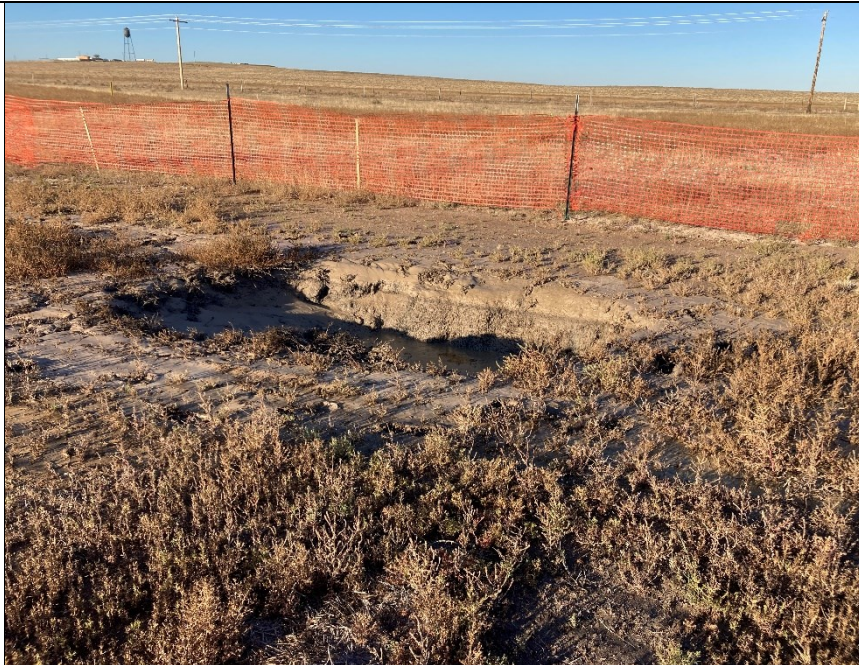
**Photo: 2****Description:**

Release location looking southwest.

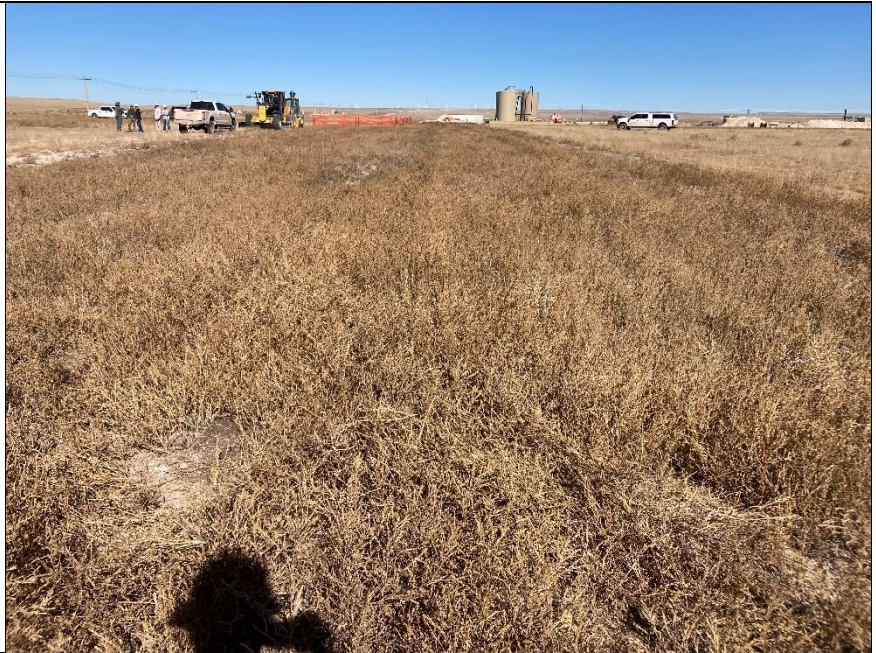
Photo: 3

South end of the impacted area looking north towards the release location. Maximum extents were determined by wet soil and surveyed by a professional surveyor.

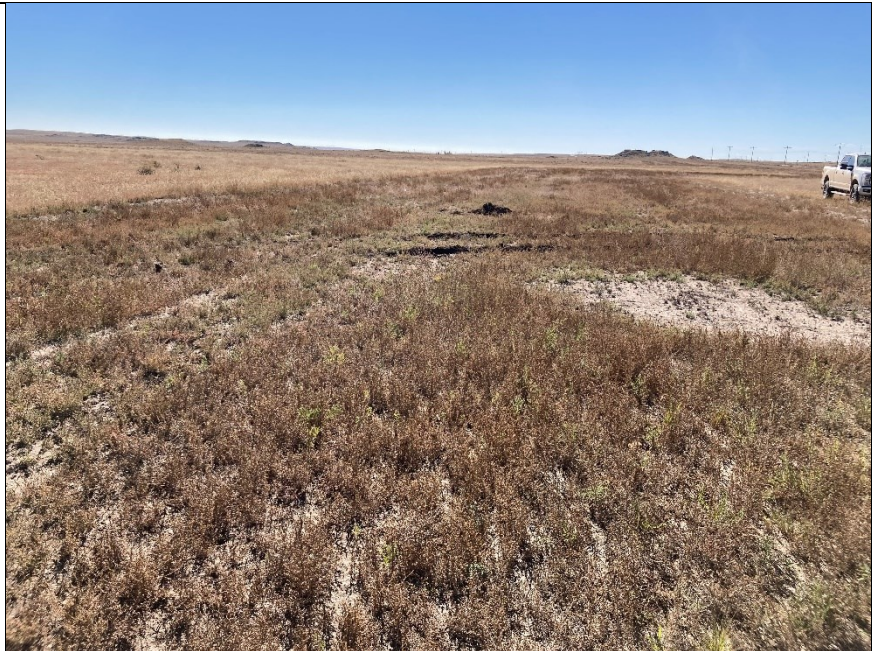
Photo: 4

Impacted area looking south from the release location.

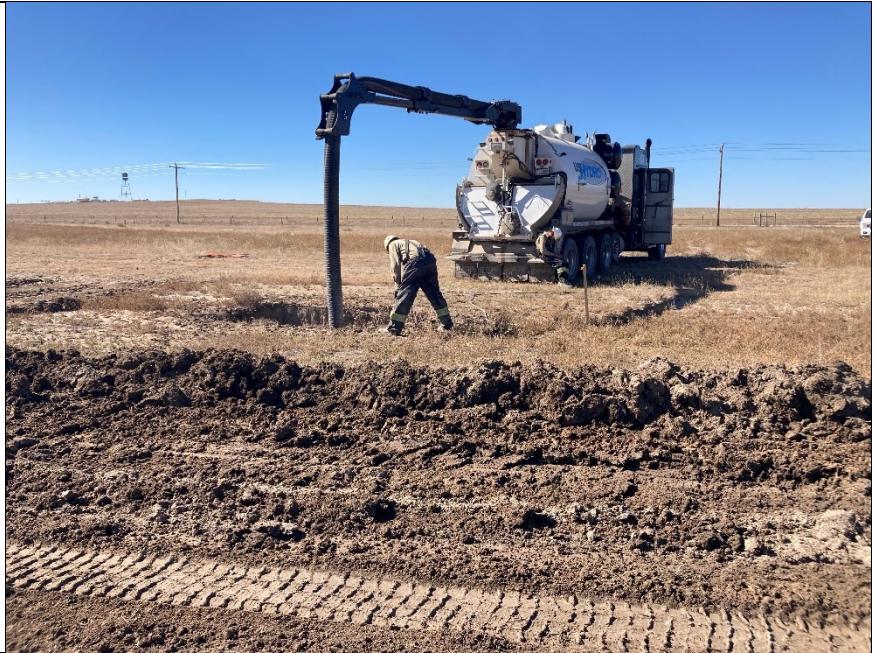
Photo: 5

Hydro excavator working in the primary excavation area to locate the pipeline failure.

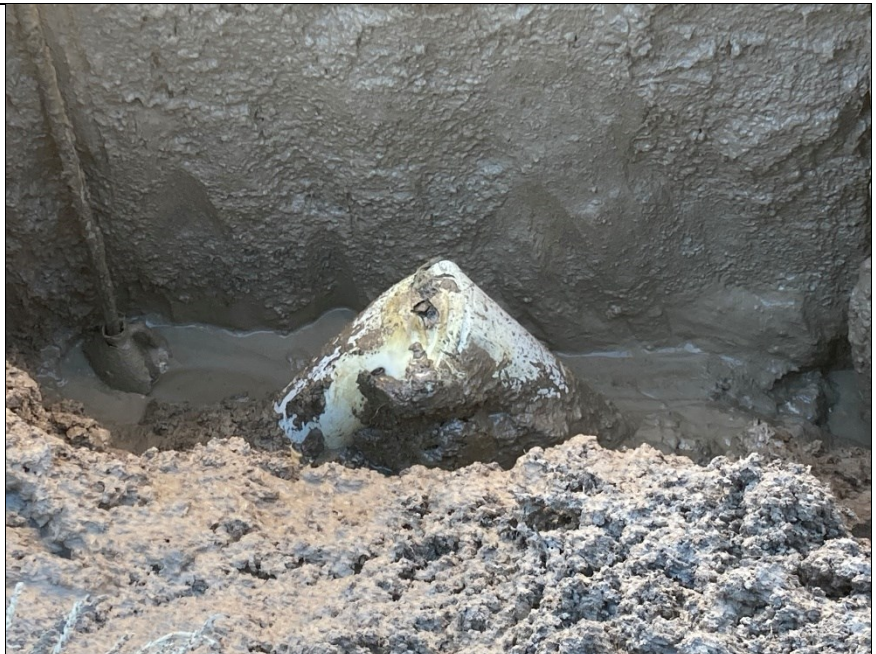
Photo: 6

The failure in the pipeline. Deformed Thermoflex 6" pipe.

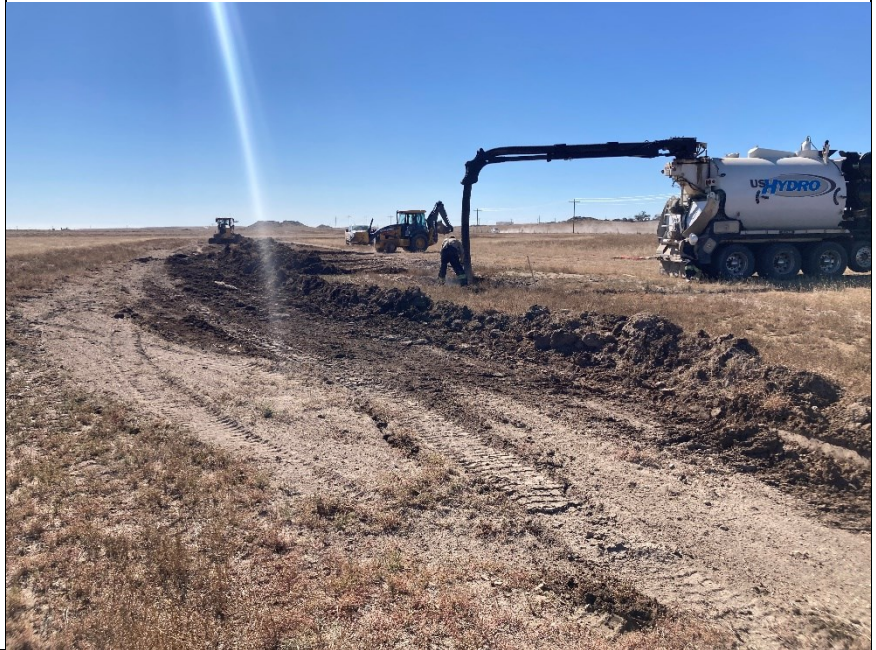
Photo: 9

Looking south at the primary and secondary excavation areas on 11/18

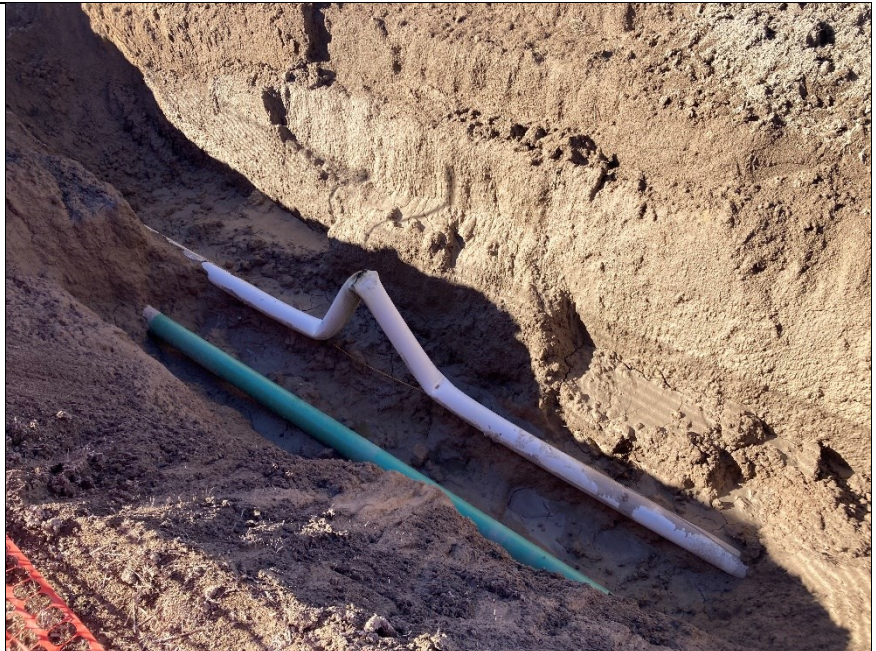
Photo: 10

Primary excavation area after exposing failed pipeline. Day 2 of hydroexcavation 10/19/22.

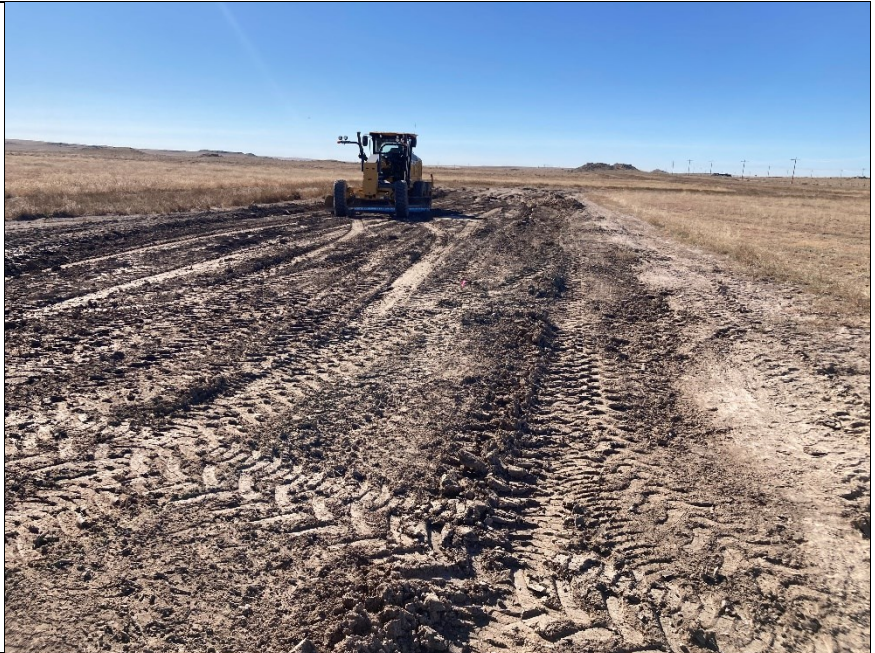
Photo: 11

Secondary excavation area after surface scrape looking south.

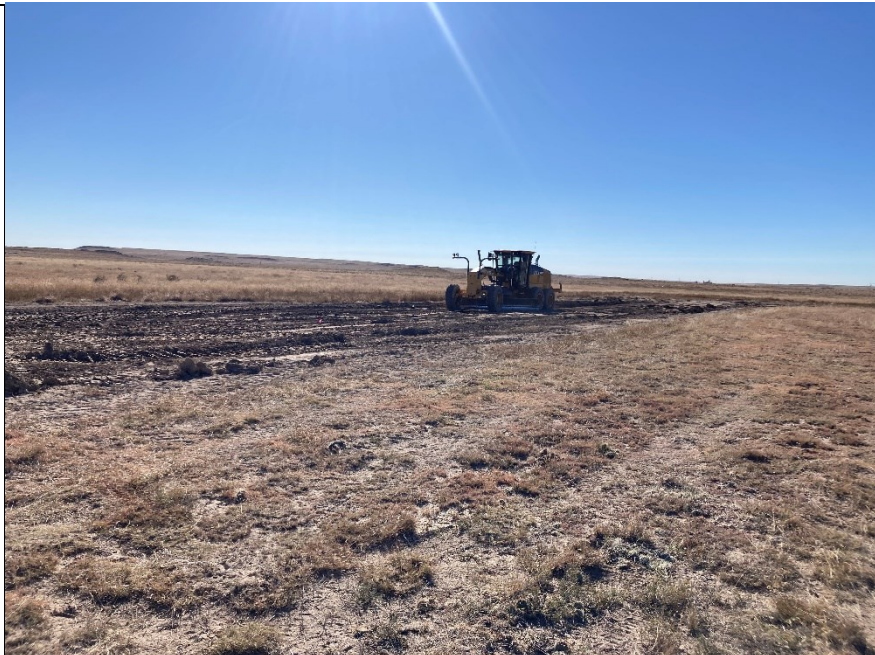
Photo: 12

Secondary excavation area after surface scrape looking southeast.

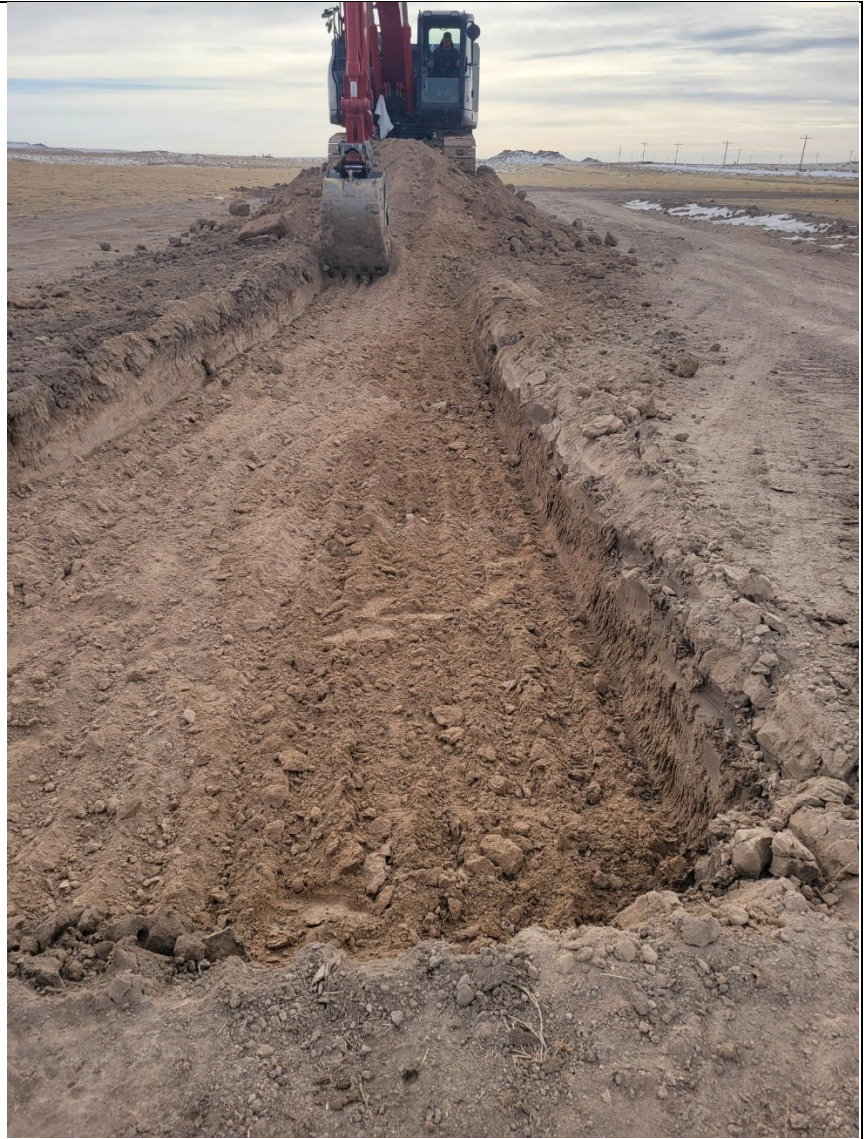
Photo: 13

Secondary excavation looking South. Following impacts with visual observations of impacts, as well as with a soil conductivity meter. Impacted soil was observed >4.0 mmhos/cm on the darker soil on the right, and <0.5 mmhos/cm in the lighter soil on the left.

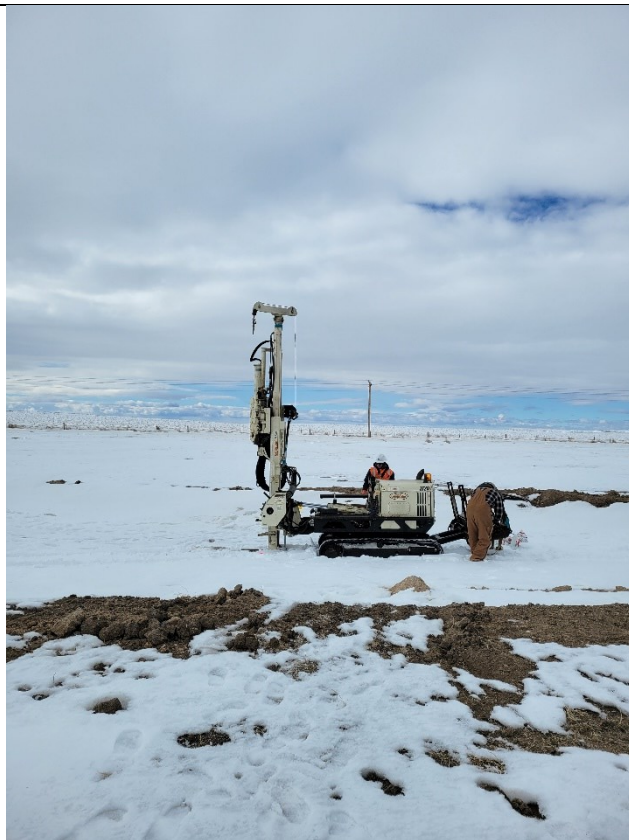
**Photo: 16****Description:**

Drilling investigation completed 2/9/2023

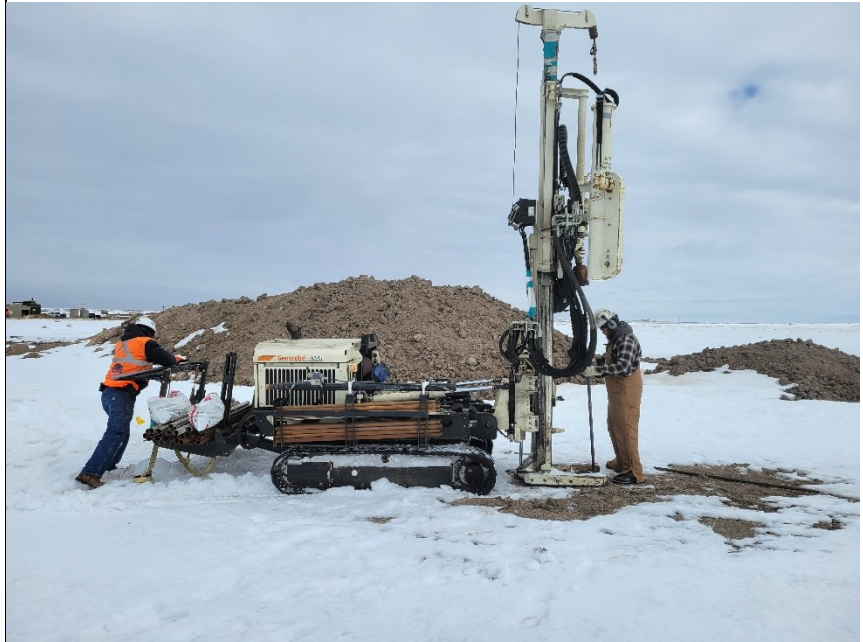
Photo: 17

Drilling investigation
completed 2/9/2023

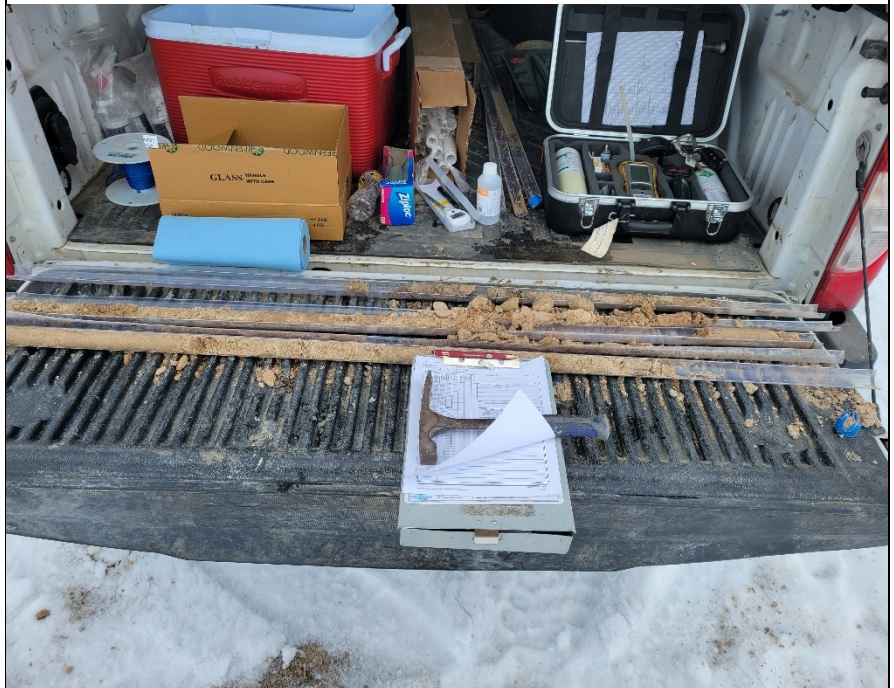
Photo: 18

Drilling investigation
completed 2/9/2023.
Borings advanced to refusal
in dense, dry claystone.

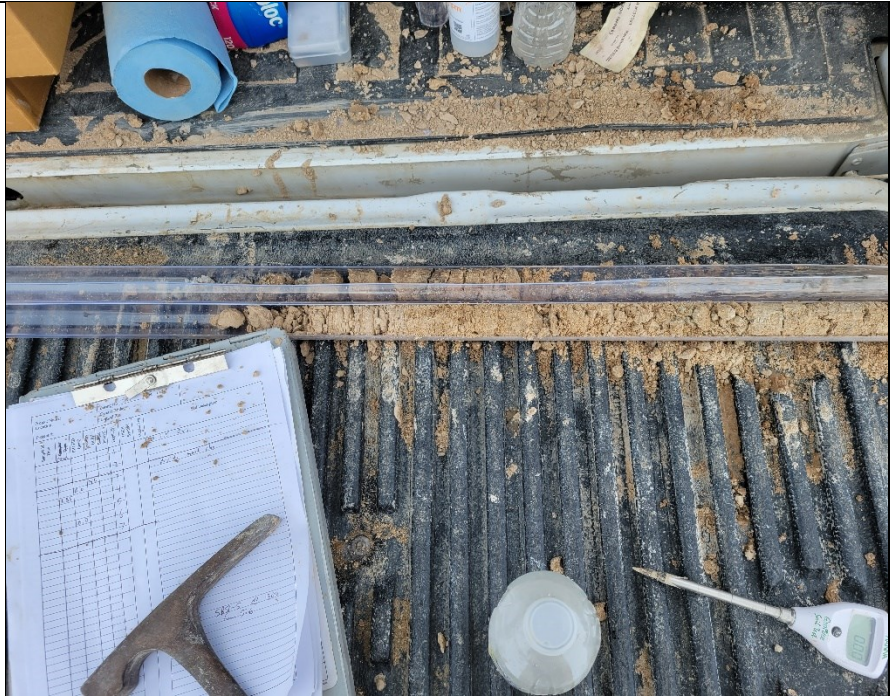
Photo: 19

Drilling investigation
completed 2/9/2023.
Borings advanced to refusal
in dense, dry claystone.
