Inspection Photos

04/29/2024

Operator: CAERUS PICEANCE LLC - 10456

Location ID: 334899

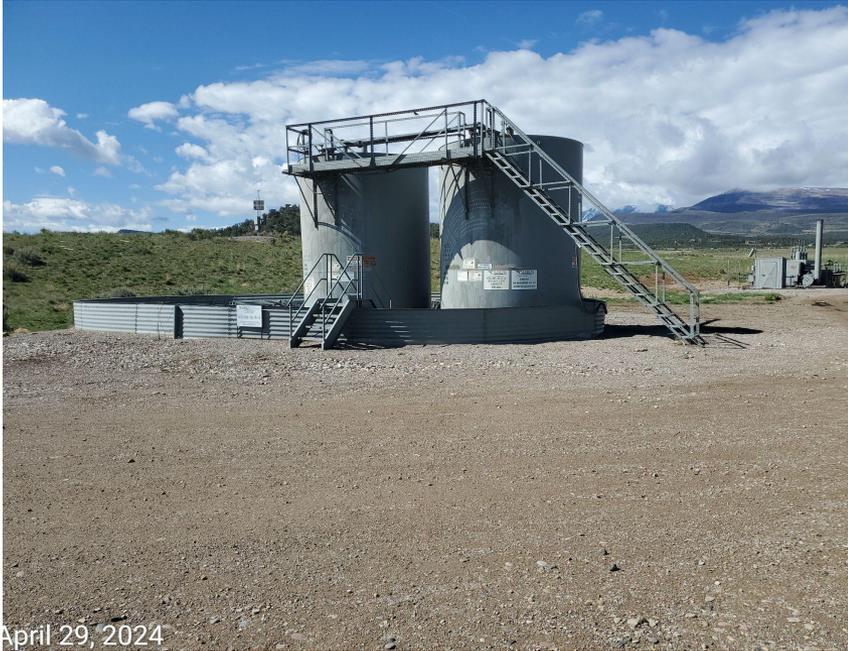
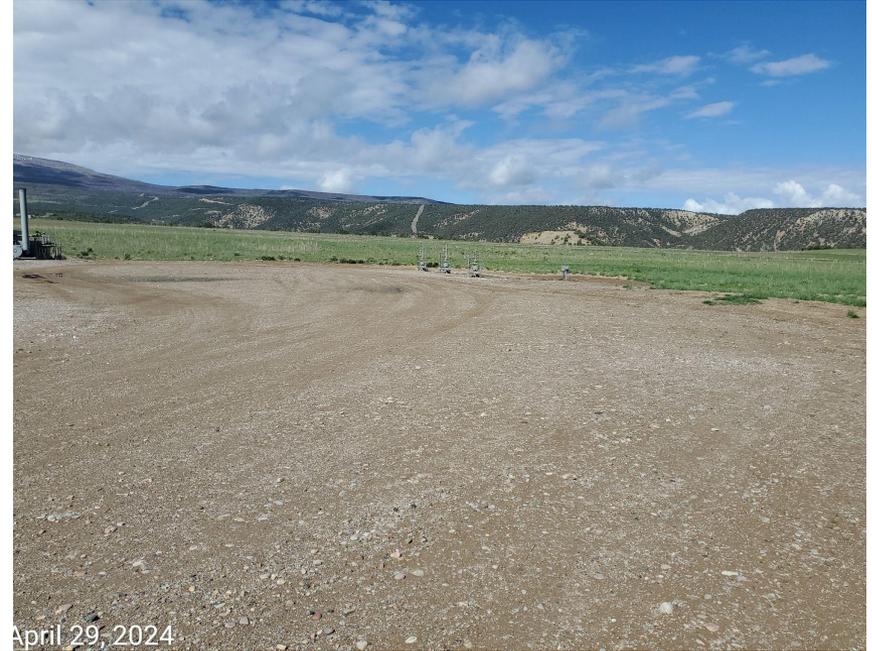
Photo 1: Photo taken from the east end of the Location, facing southwest and west. Photo provides an overview of the Location.

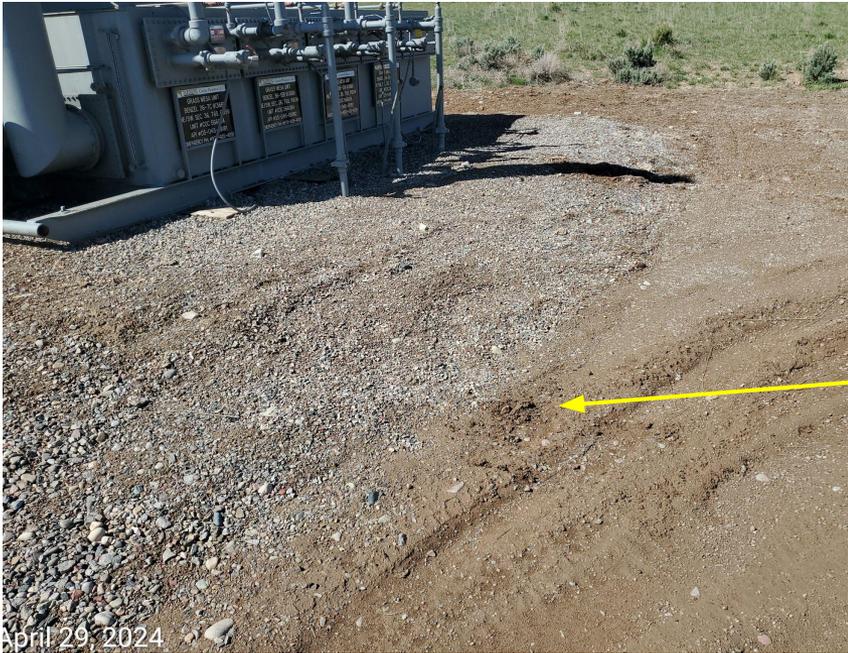
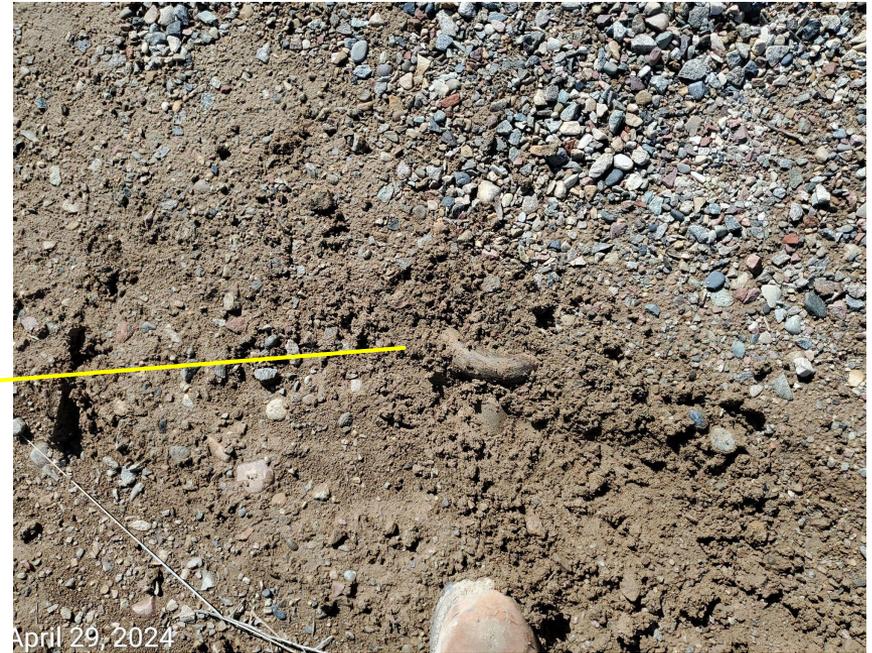
Photo 2: Photo taken from the separator equipment on the southwest end of the Location. Photo shows unmarked anchor on the Location.

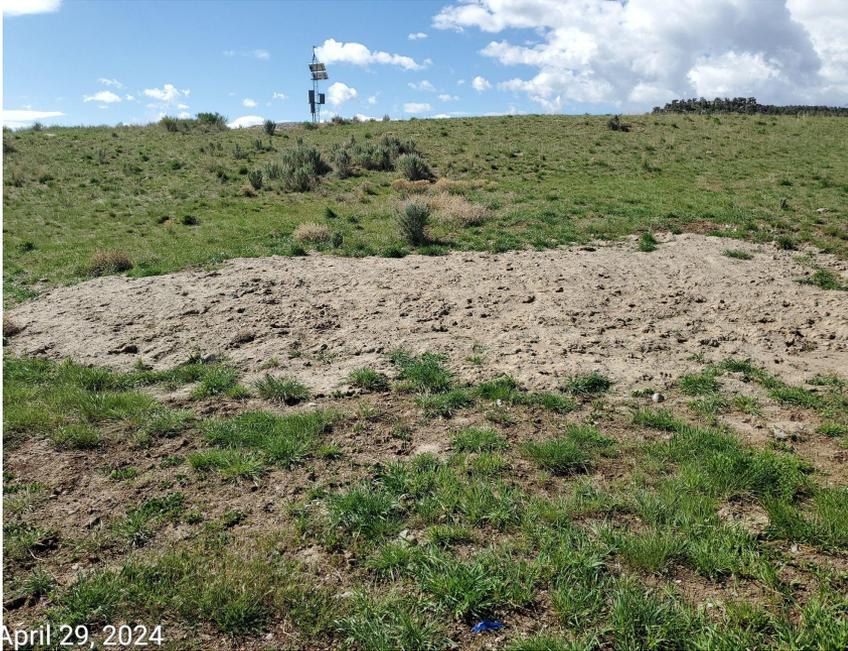
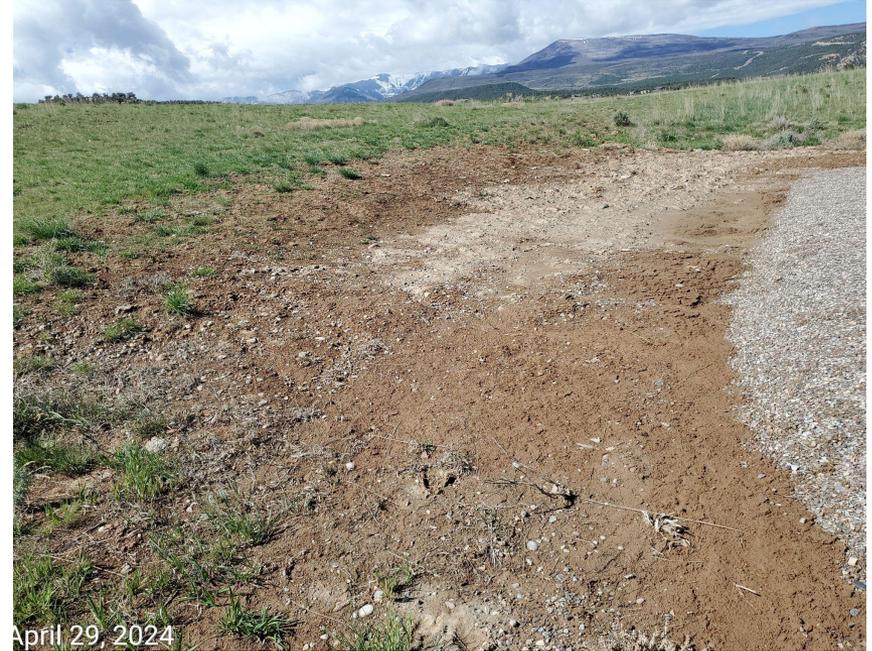
Photo 3: Photos taken from the southern interim areas of the Location. Photos shows interim areas that are bare and unvegetated. Additional reclamation required within these areas.

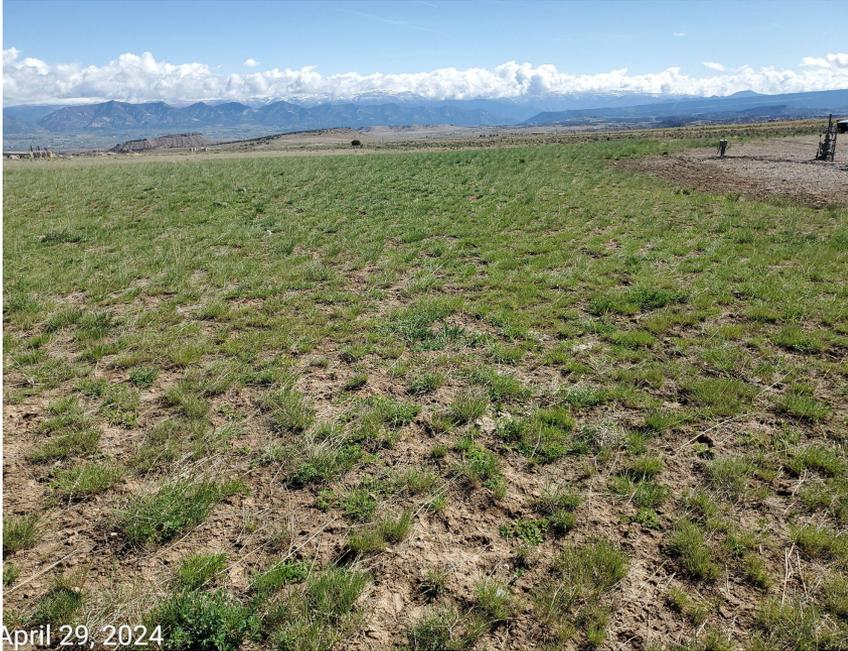
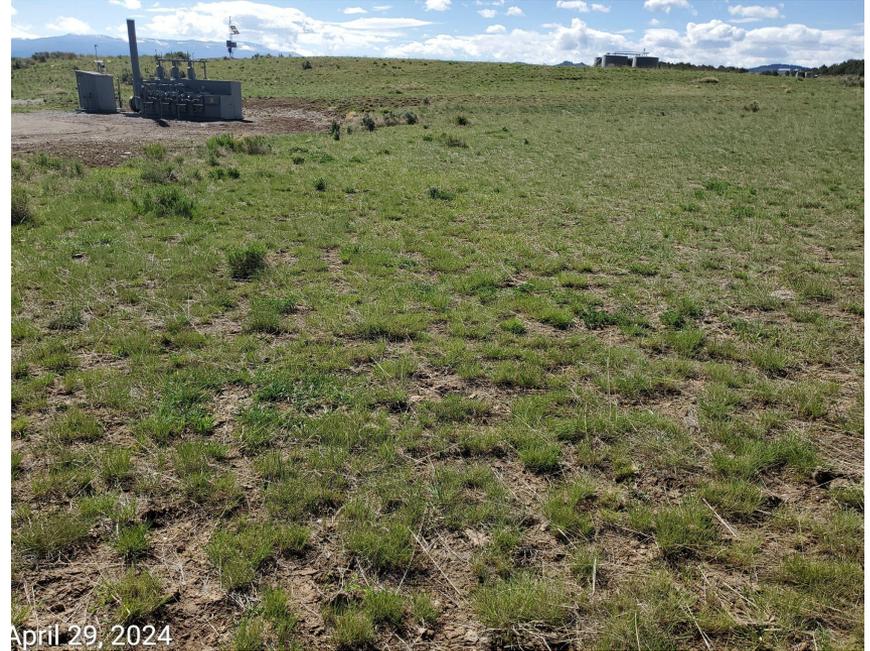
Photo 4: Photo example showing interim areas. Interim areas on the west, north and east end of the Location have met 1003.e revegetation requirements.

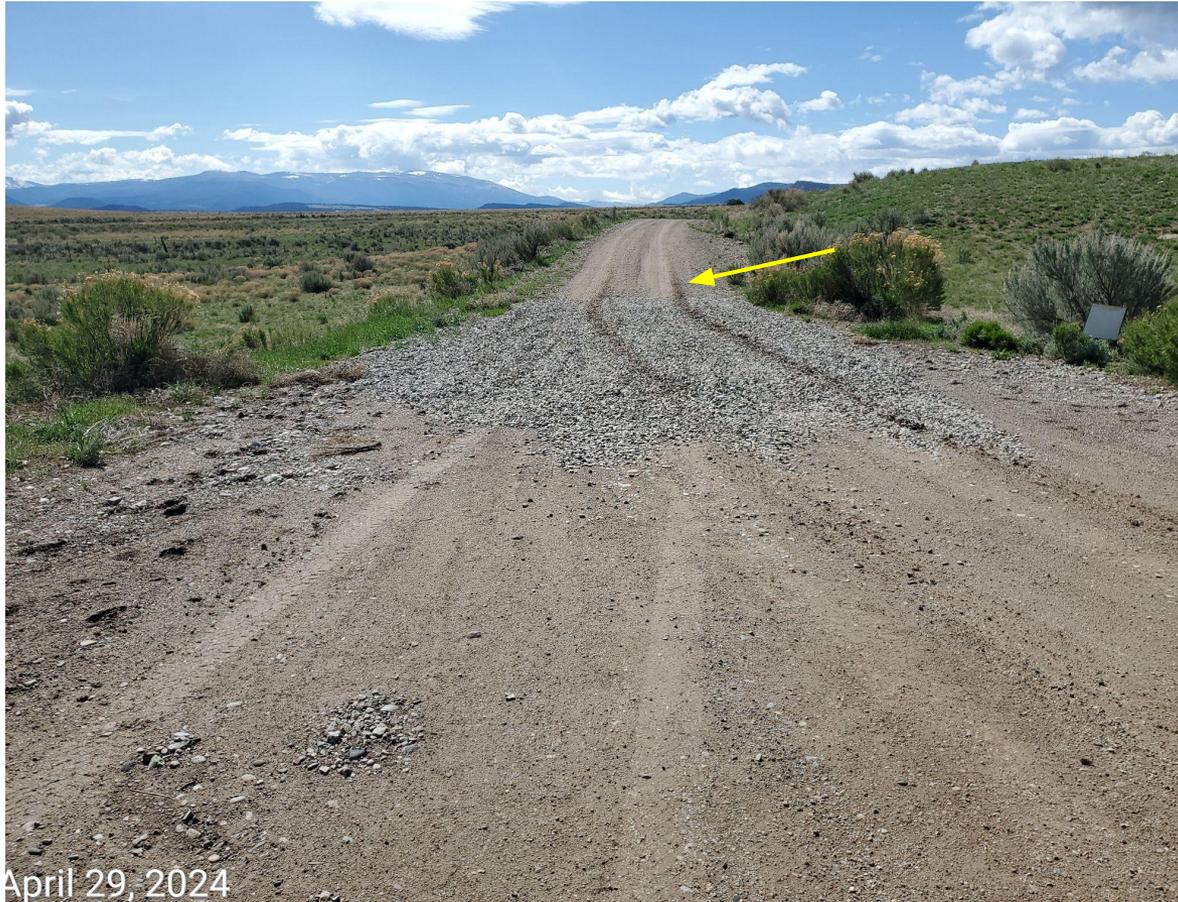
Photo 5: Photo taken from the Location entrance, facing south. Operator has placed a thick layer of gravel has been placed at the Location entrance as a "VTC"; aggregate appears to be single sized material- BMP has not been constructed with course multiangular rock of appropriate size; BMP does not appear to be per good engineering practices and is unlikely to be effective during wet or muddy conditions; sediment tracking/transport evident.
