Inspection Photos

Location Name: CAERUS PICEANCE LLC, Mesa/C23-697

Location ID: 335512

Date: 4/25/2024

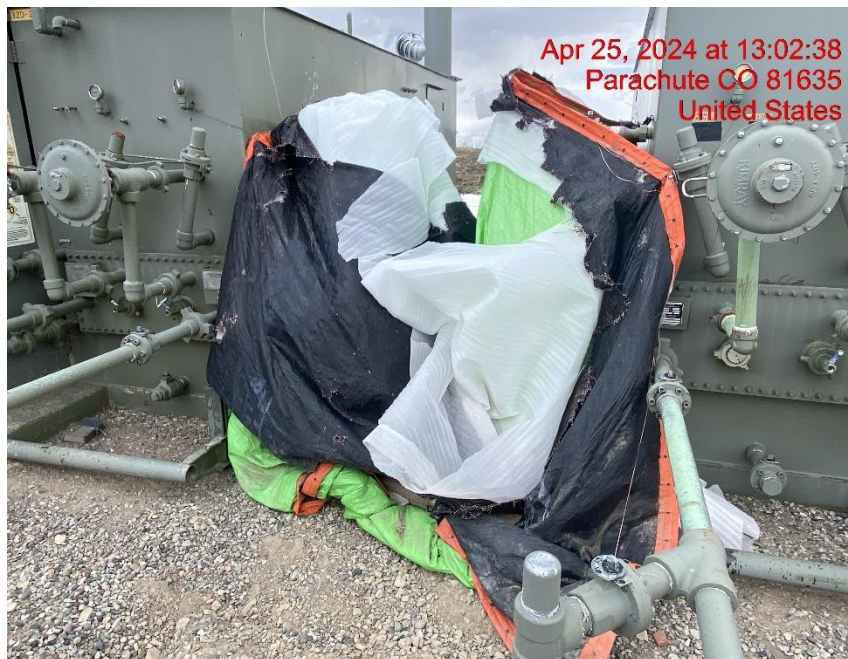
Trash/Debris – Photo #00877

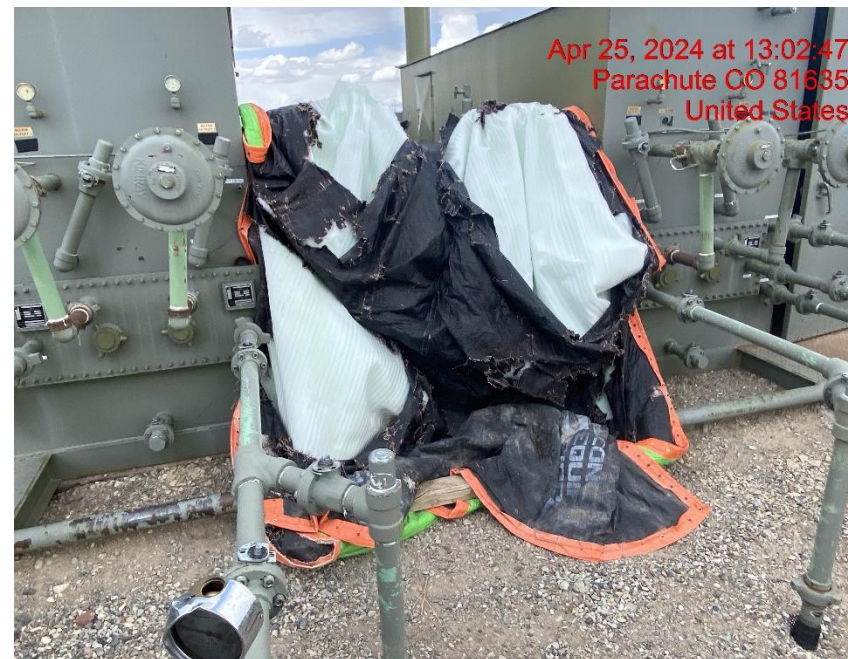
Trash/Debris – Photo #00878

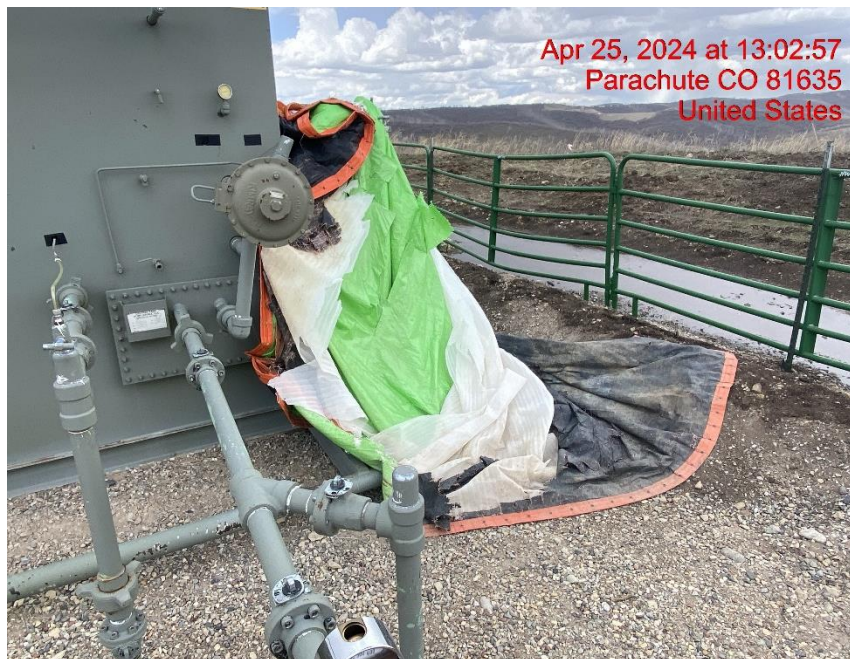
Trash/Debris – Photo #00879

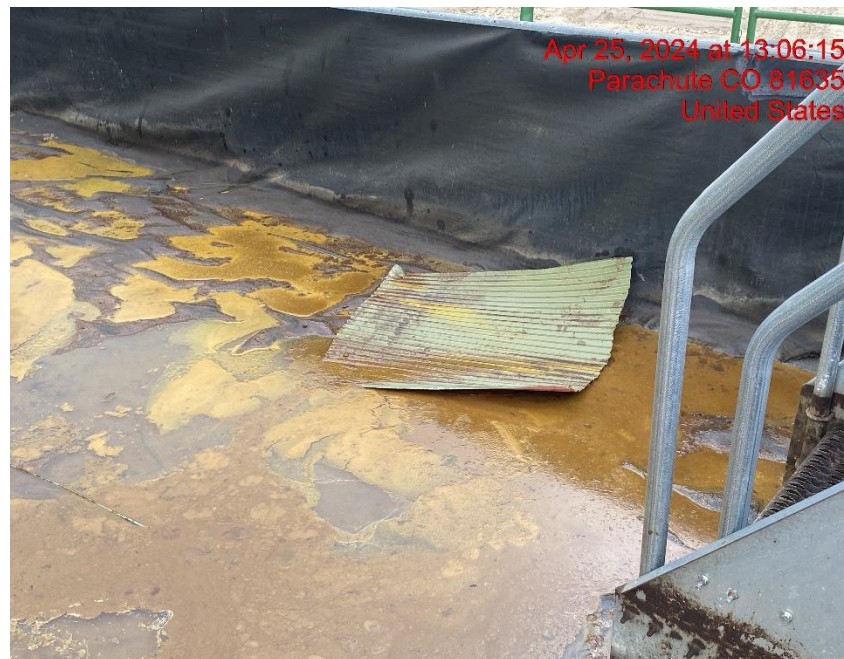
Debris – Photo #00887

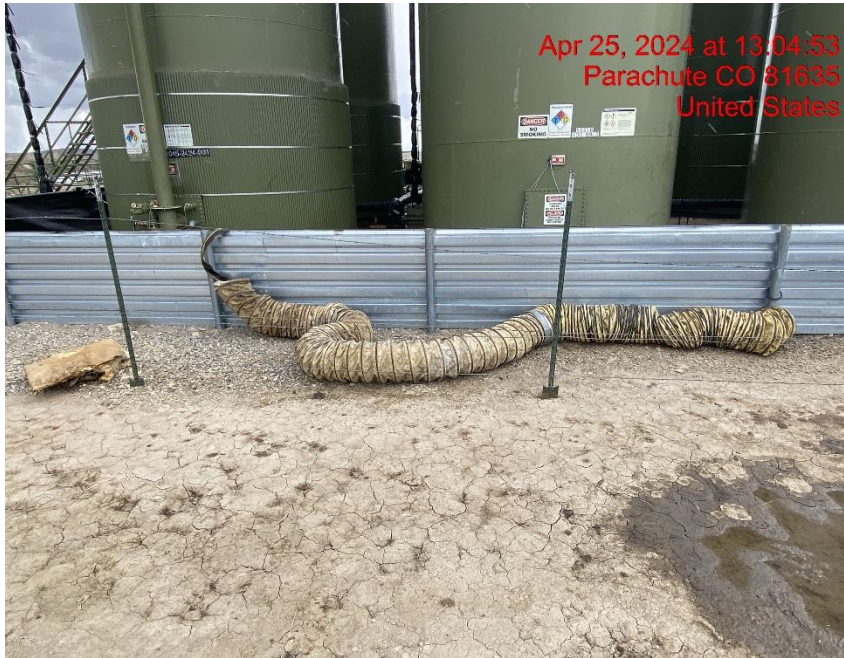
Stored Equipment/Debris – Photo #00882

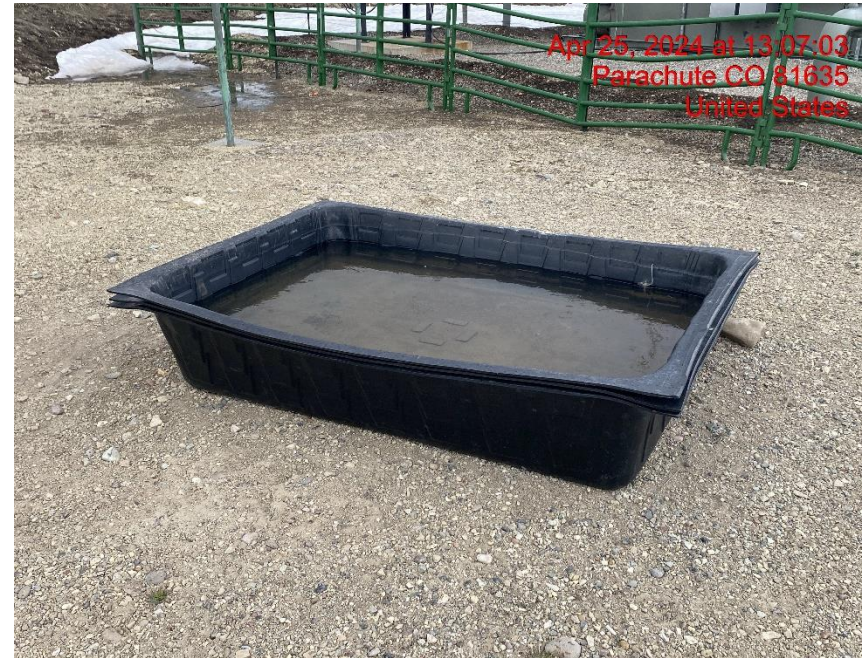
Stored Supplies/Equipment – Photo #00890

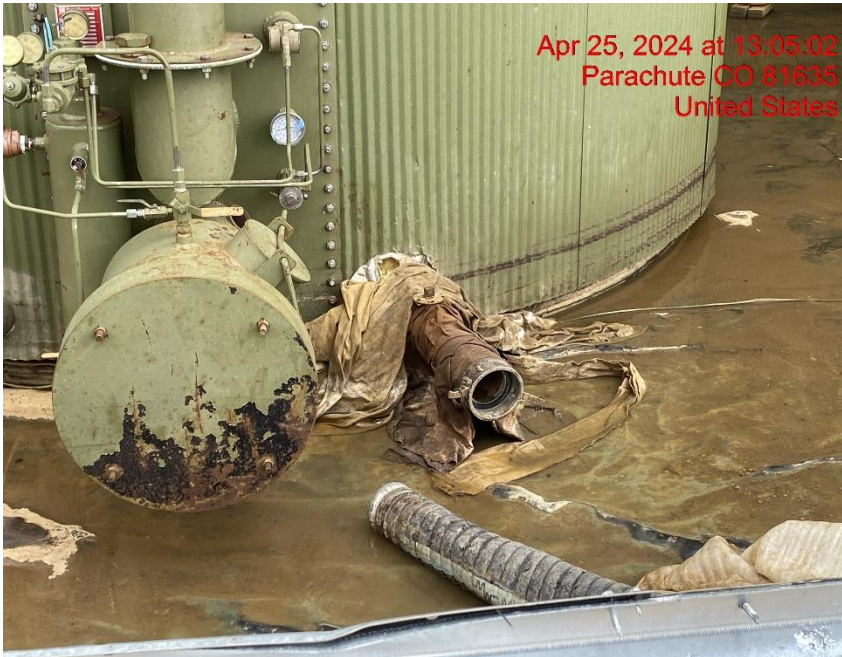
Open-Ended Line/Stored Equipment/Trash – Photo #00883

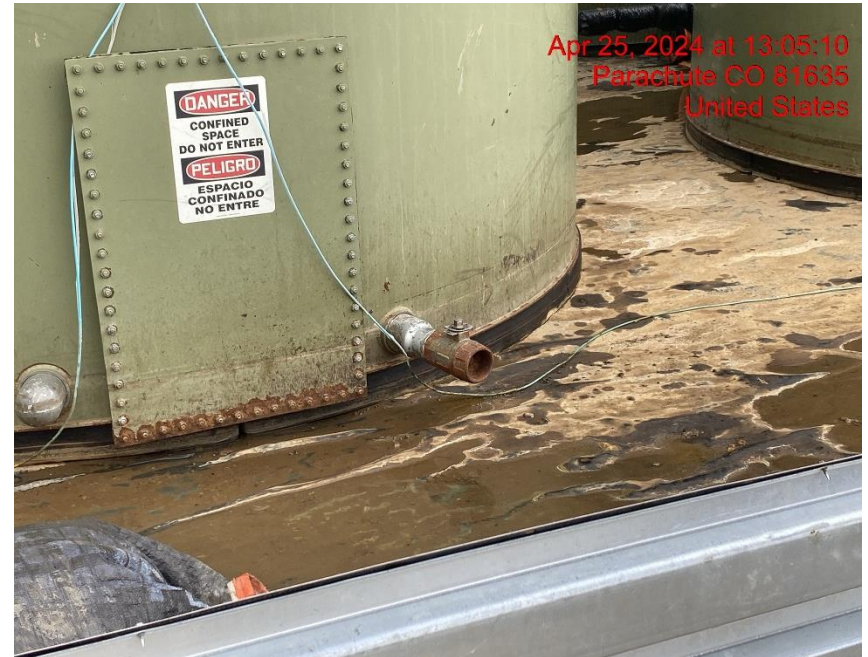
Open-Ended Line – Photo #00884

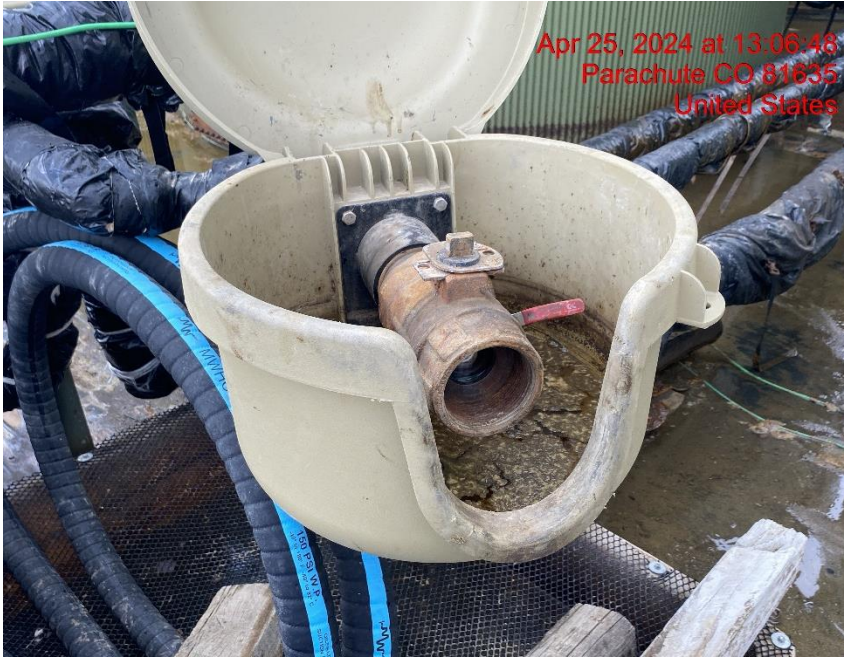
Open-Ended Load Line/Stored Equipment – Photo #00889

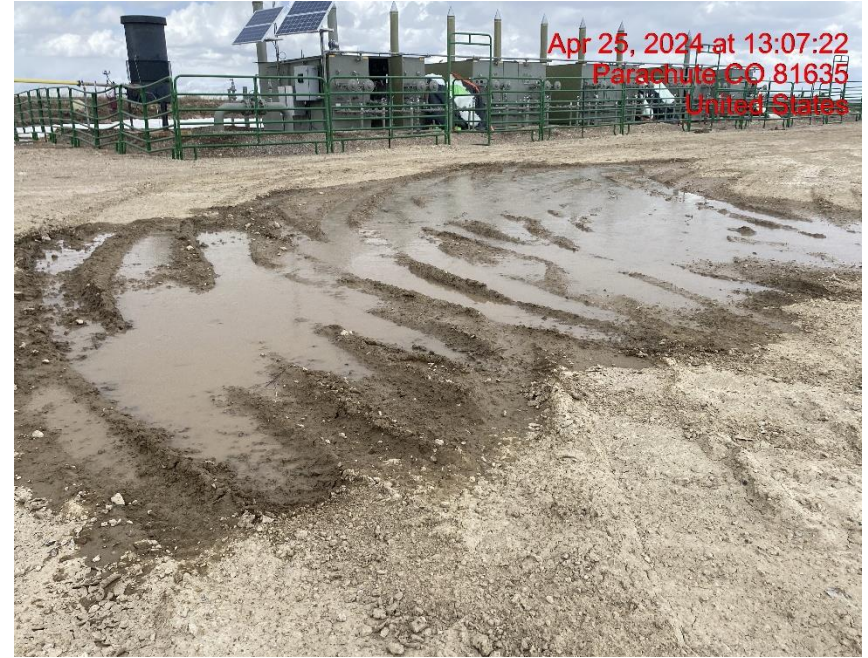
Lack of Stabilization – Photo #00891

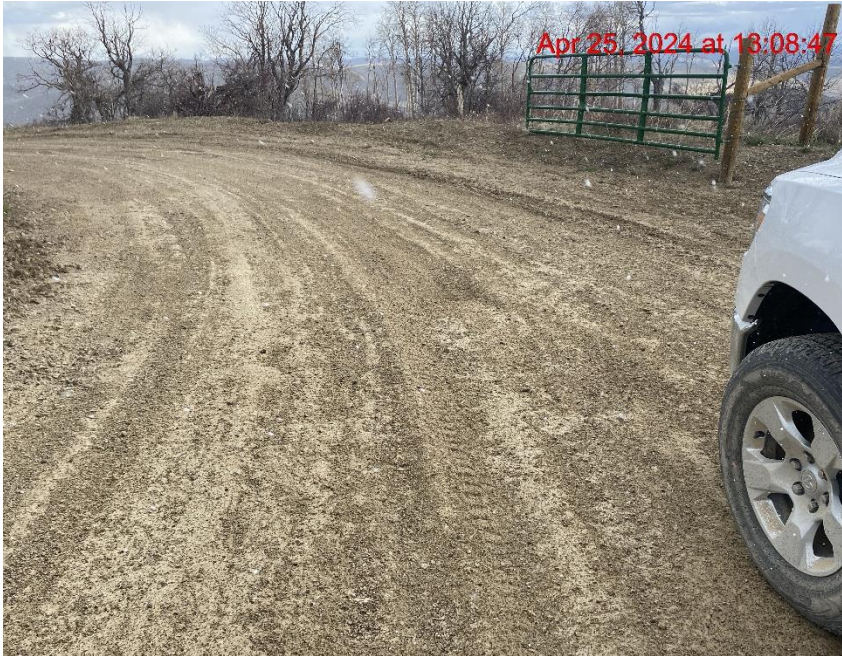
**Insufficient Vehicle Tracking BMPs at Location Entrance/Exit
– Photo #00892**

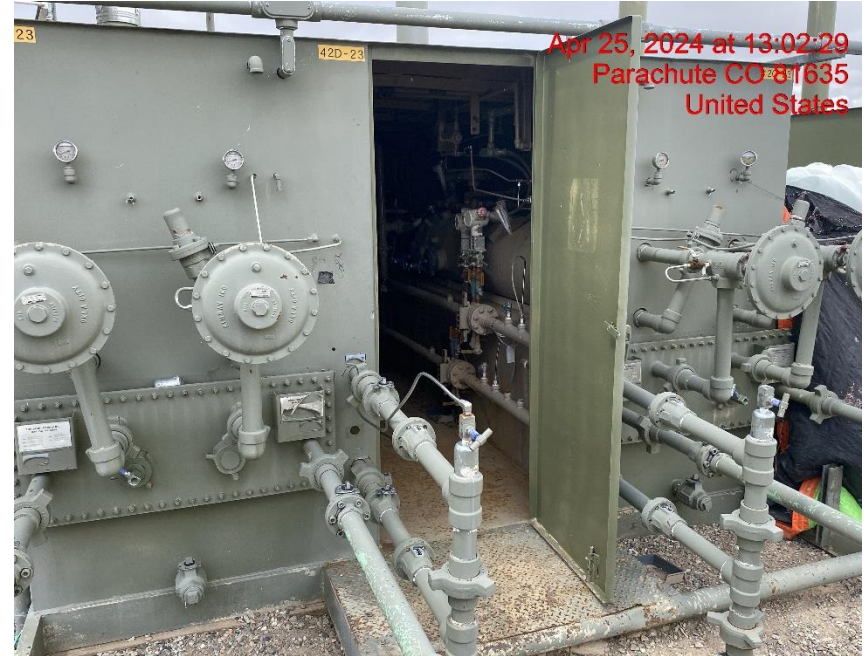
Unsecured Separator – Photo #00876
