Inspection Photos

Location Name: TEP Rocky Mountain LLC GIBSON GULCH UNIT 9-30 Pad

Location # 324012

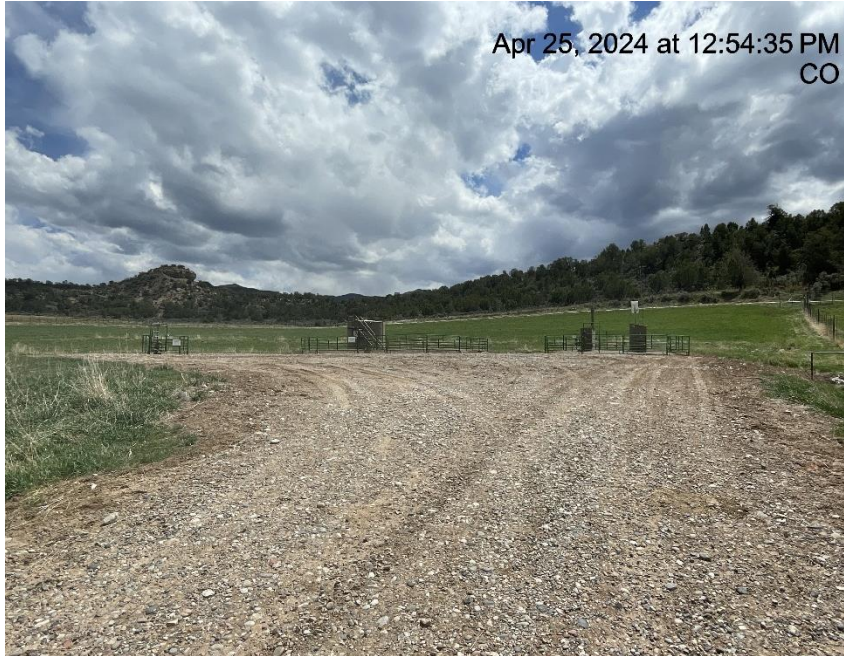
Photo # 5083 From entrance to location

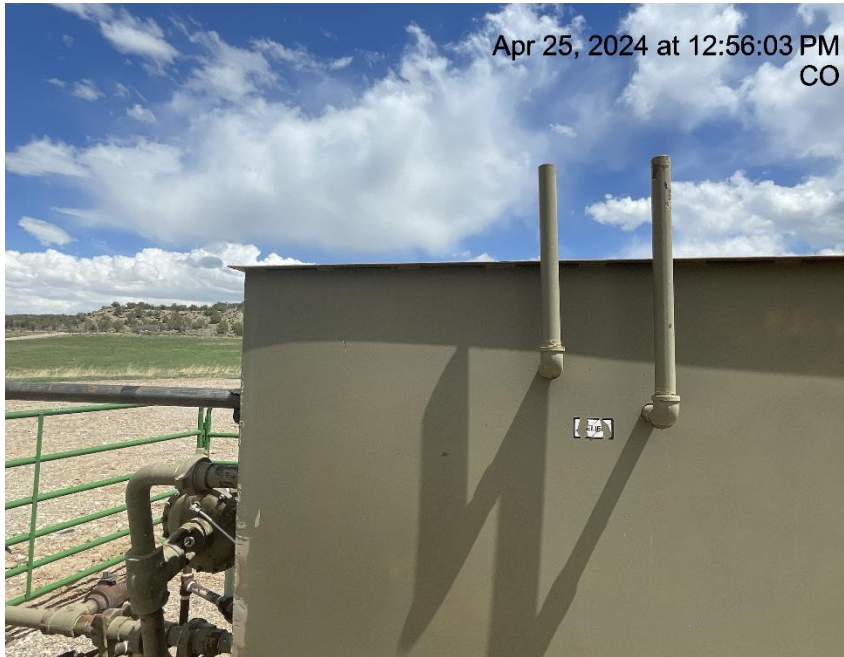
Photo # 5087 PRV & rupture disc vent lines do not comply with CECMC pressure safety device rules

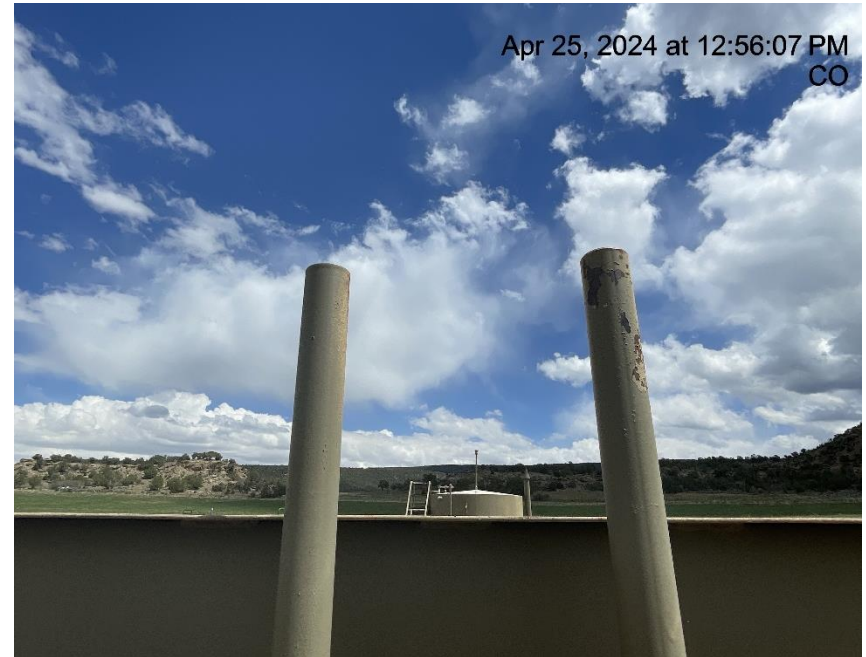
Photo # 5088 PRV & rupture disc vent lines do not comply with CECMC pressure safety device rules
