Inspection Photos

Location Name: TEP Rocky Mountain LLC GIBSON GULCH UNIT 3-31B Pad

Location # 311685

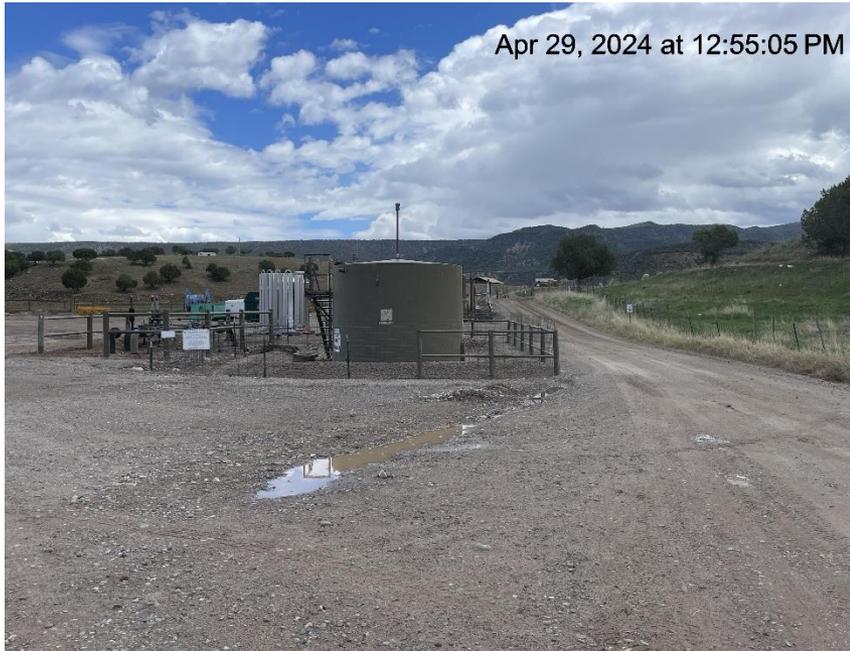
Photo # 5368 From entrance to location

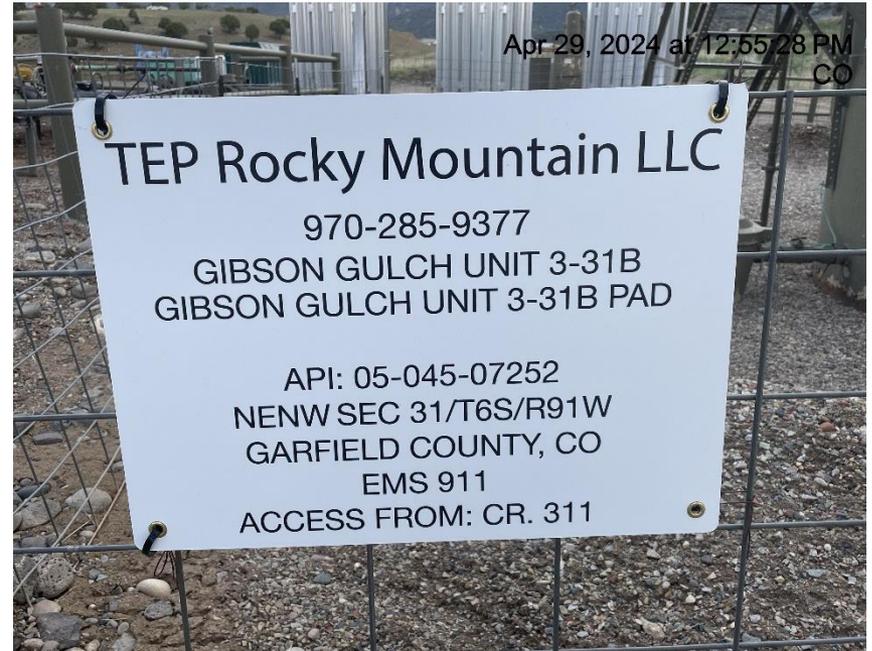
Photo # 5369 Location

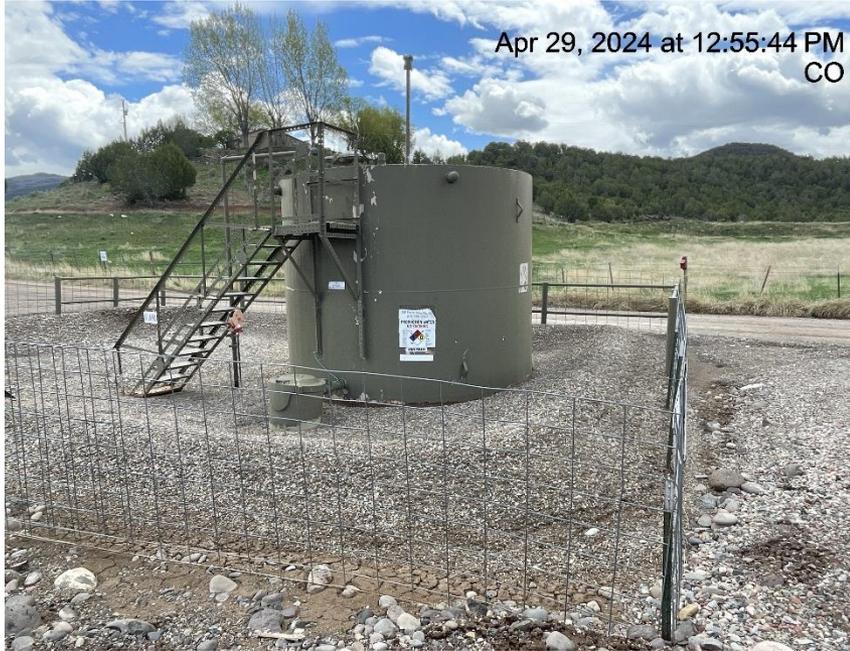
Photo # 5370 Location

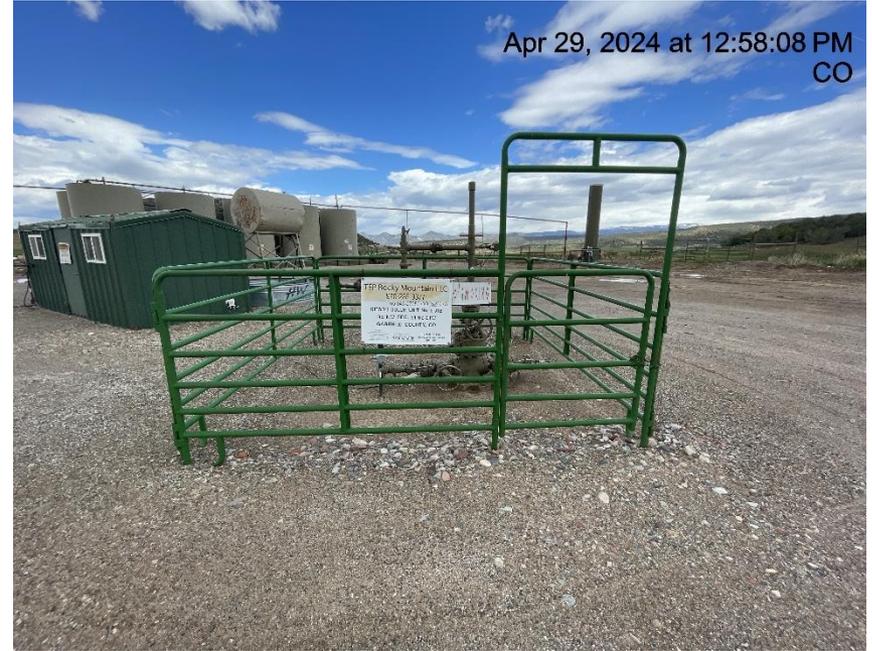
Photo # 5371 Location

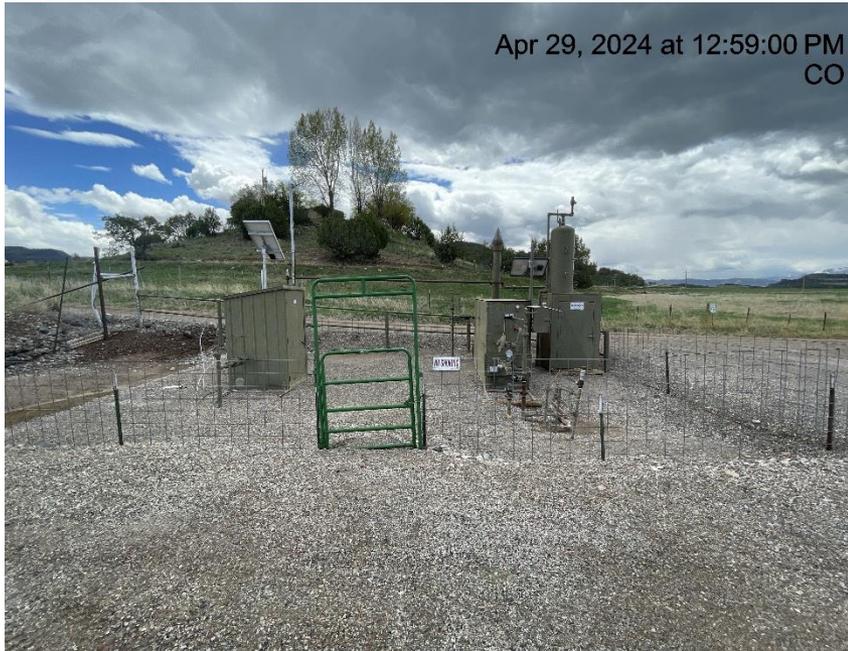
Photo # 5372 Location

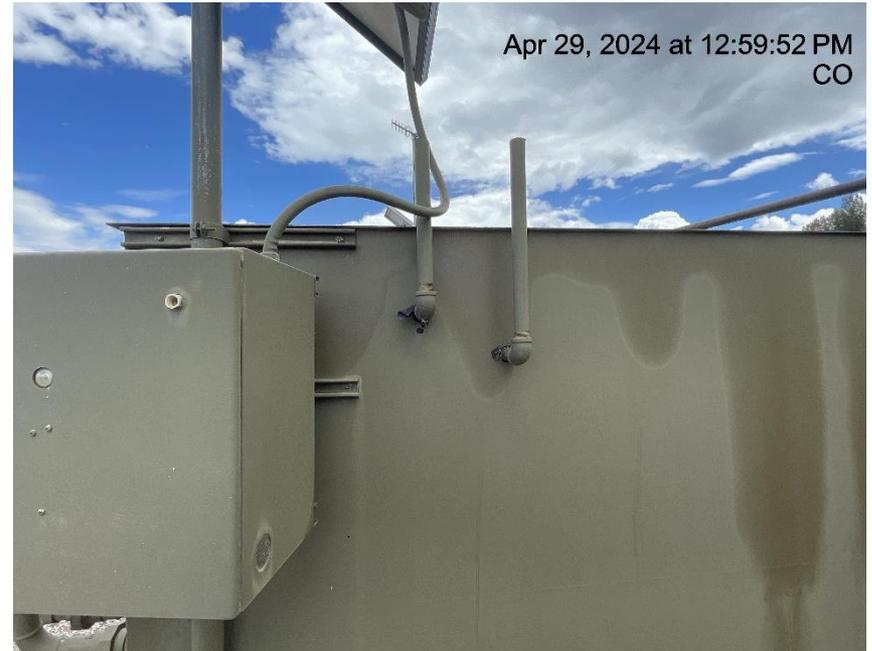
Photo # 5373 PRV & rupture disc vent lines do not comply with CECMC pressure safety device rules

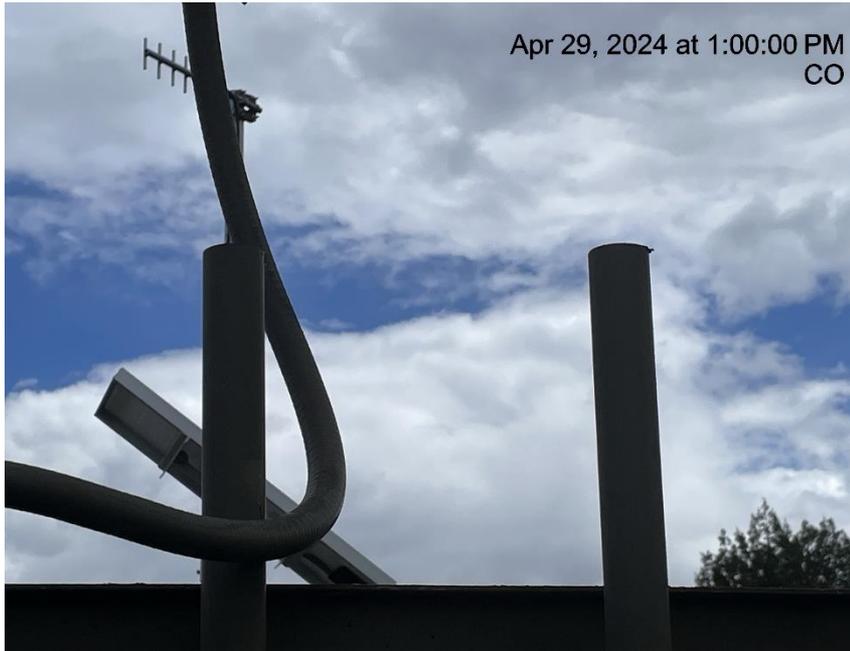
Photo # 5374 PRV & rupture disc vent lines do not comply with CECMC pressure safety device rules

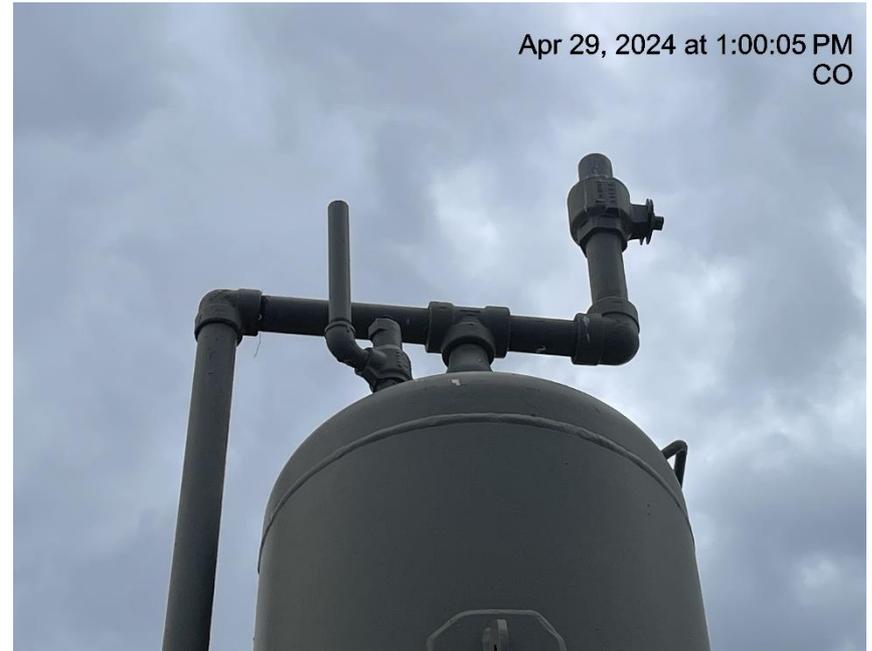
Photo # 5375 PRV vent line does not comply with CECMC pressure safety device rules

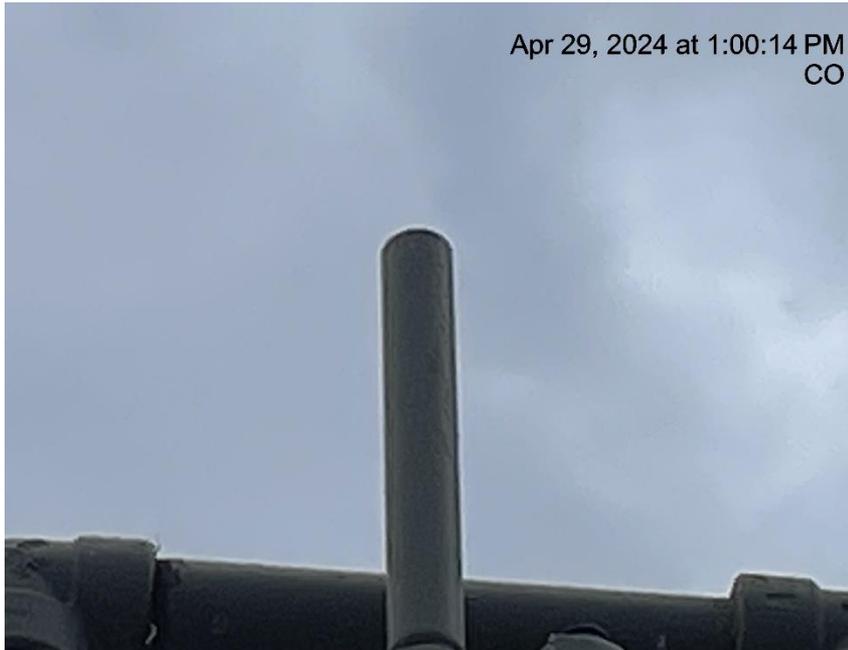
**Photo # 5376 PRV vent line does not comply with CECMC
pressure safety device rules**
