# Inspection Photos

Loc: 380504

Operator: CHACO ENERGY COMPANY

Inspection Date: 5/1/2024

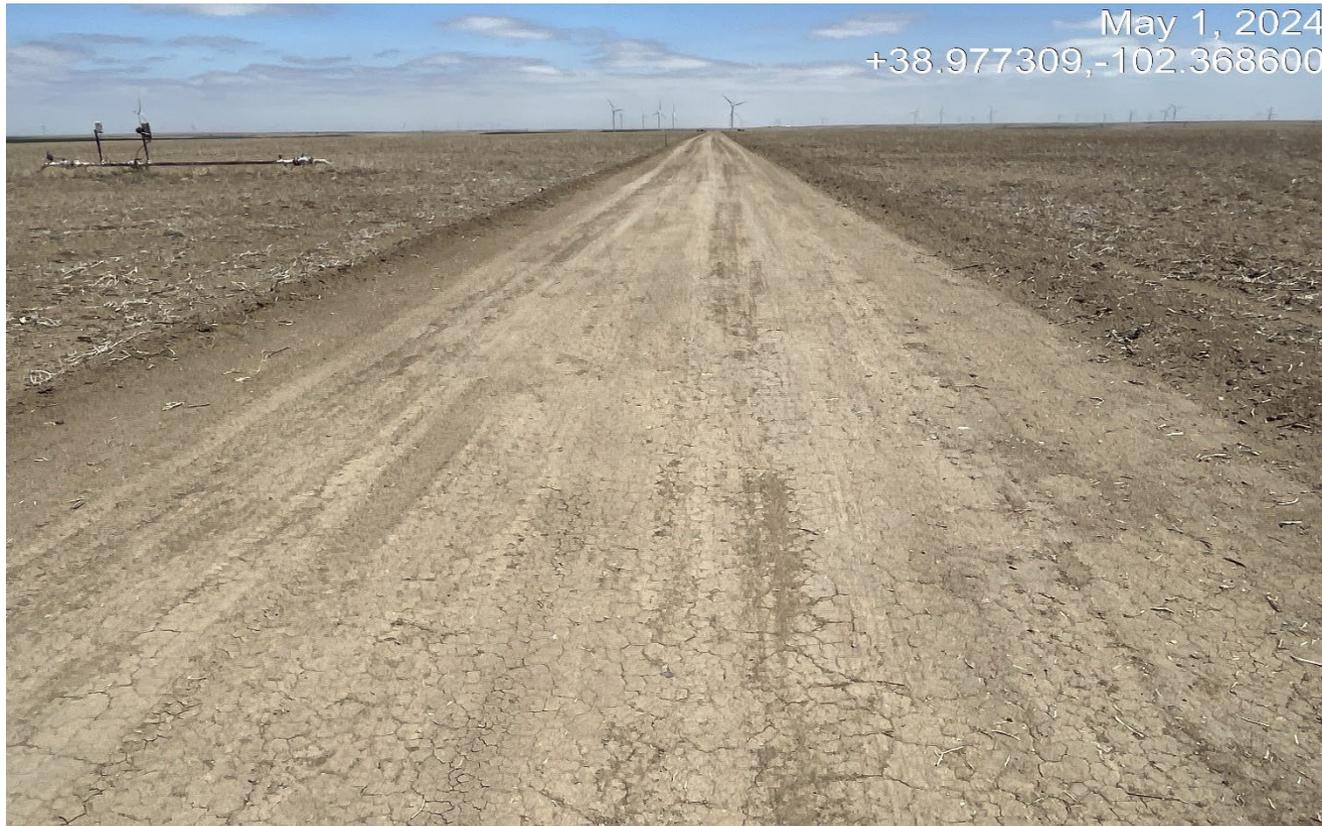
**Photo 1.** Facing east along the access road. Topsoil was not adequately salvaged and soils are heavily compacted along the road.

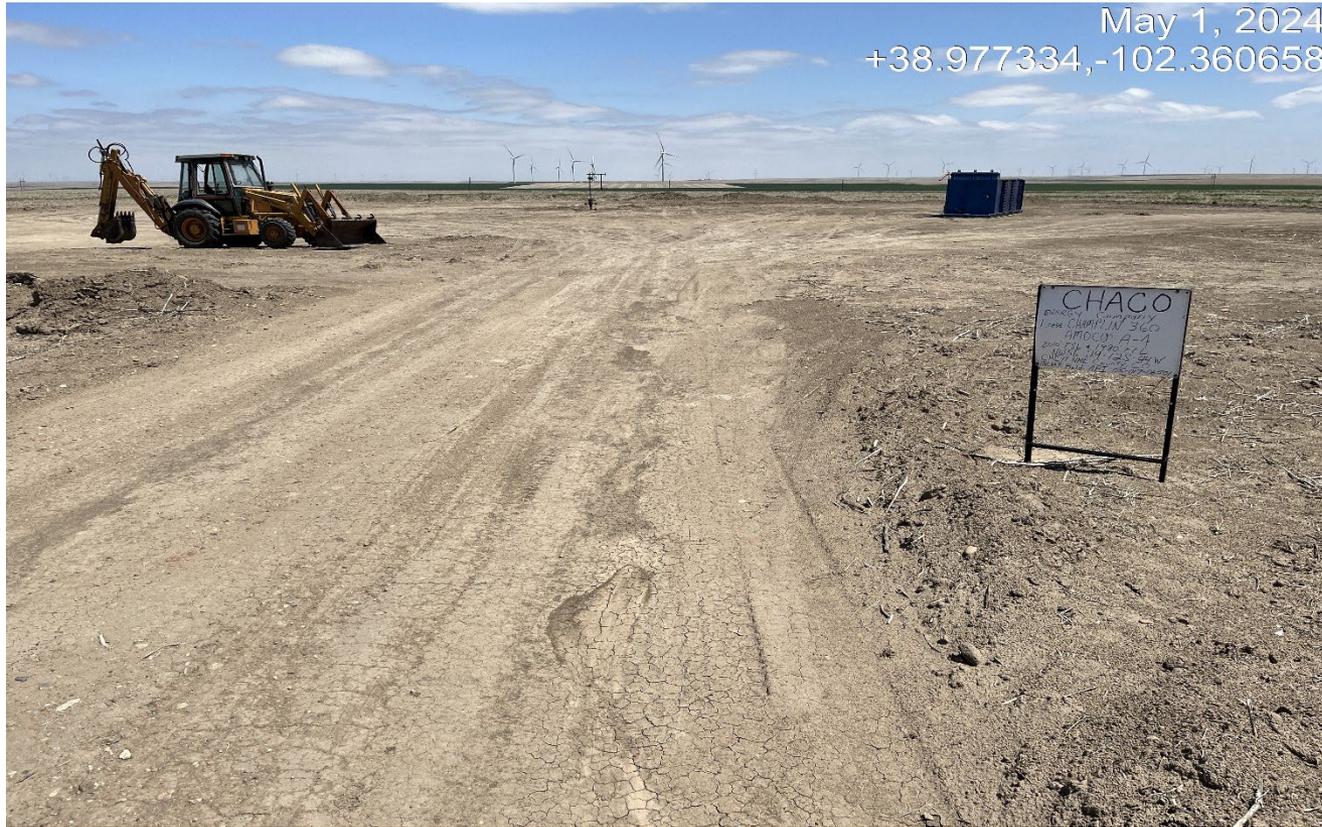
Photo 2. Facing east toward the location. .

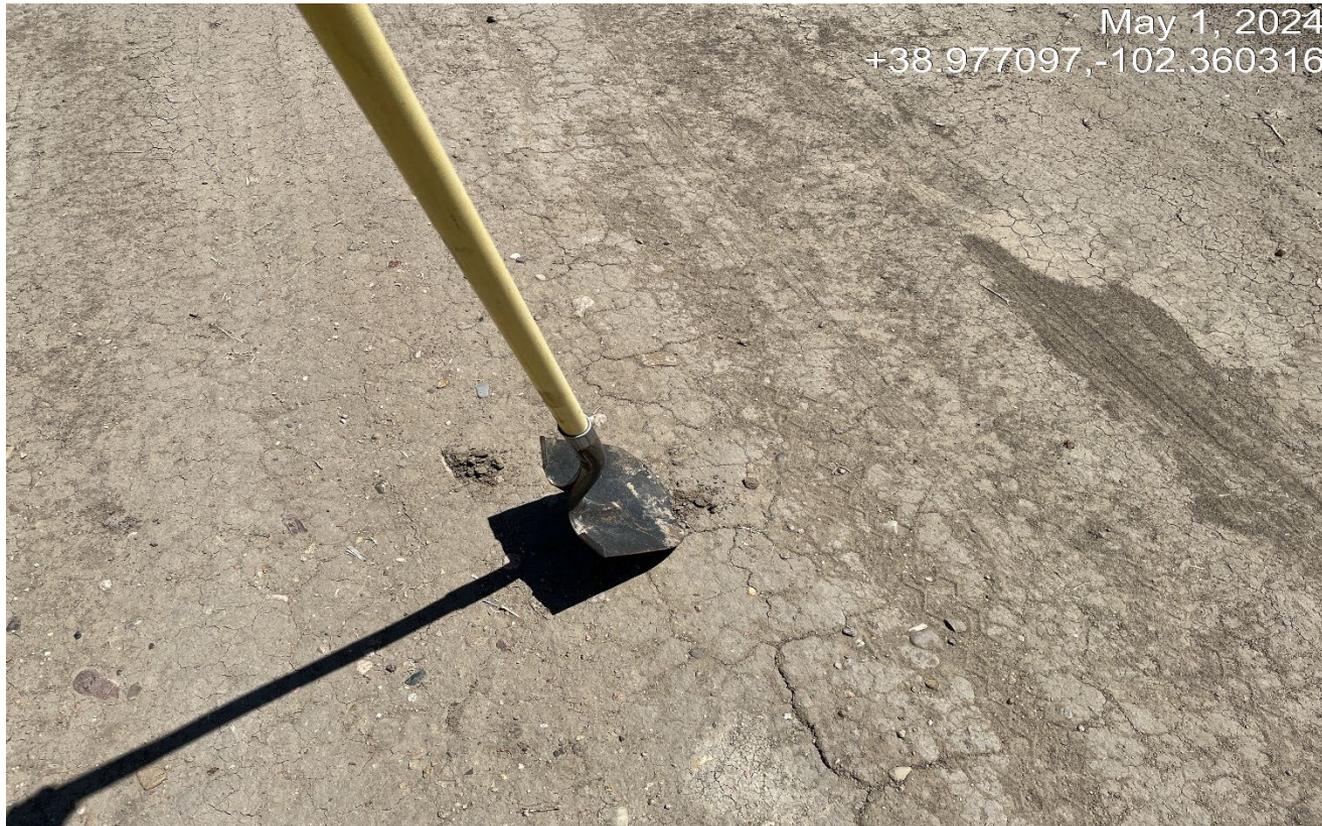
**Photo 3.** The soils are heavily compacted and were not protected.

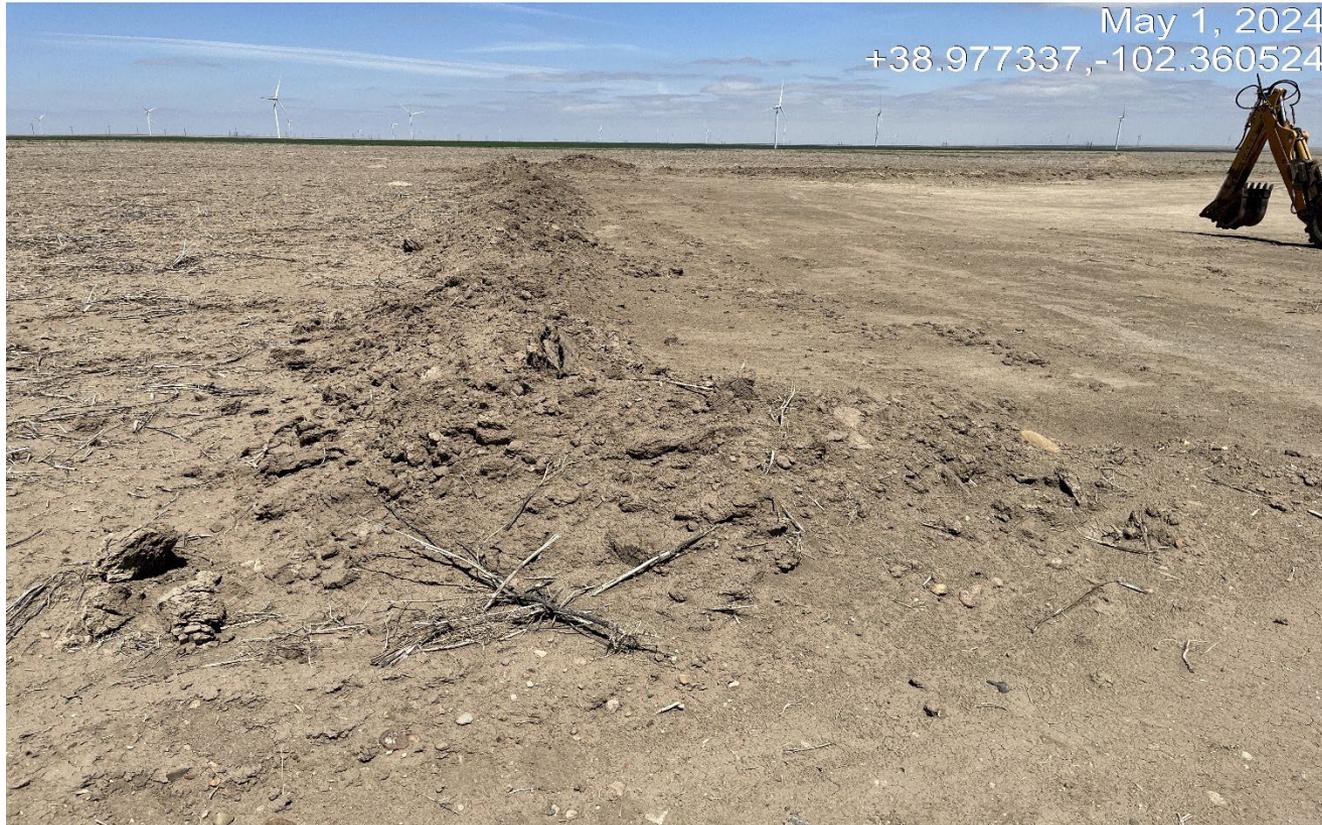
**Photo 3.** Facing north at the west side of the location. There is a small ~2ft. tall topsoil pile which is insufficient and not stabilized.

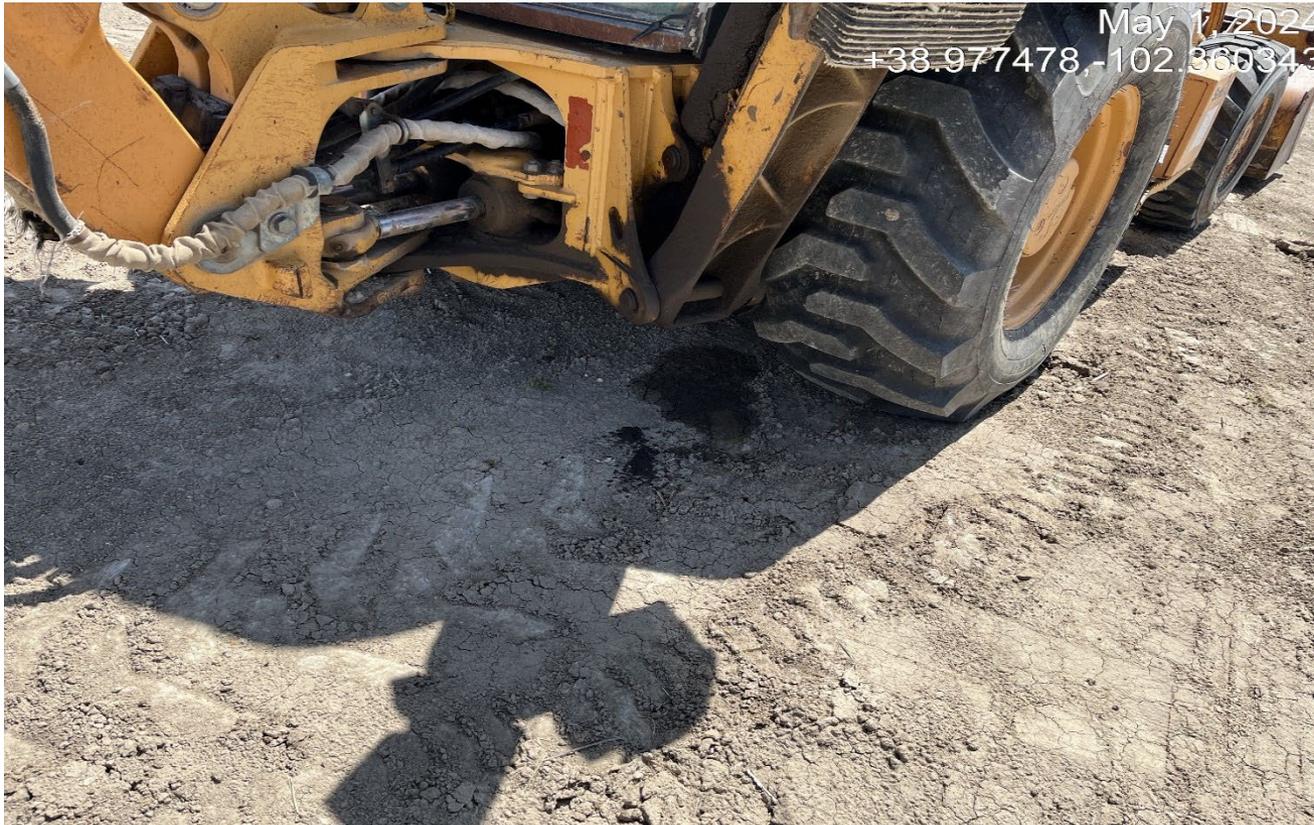
**Photo 4.** The backhoe onsite is leaking oil which needs to be cleaned up.

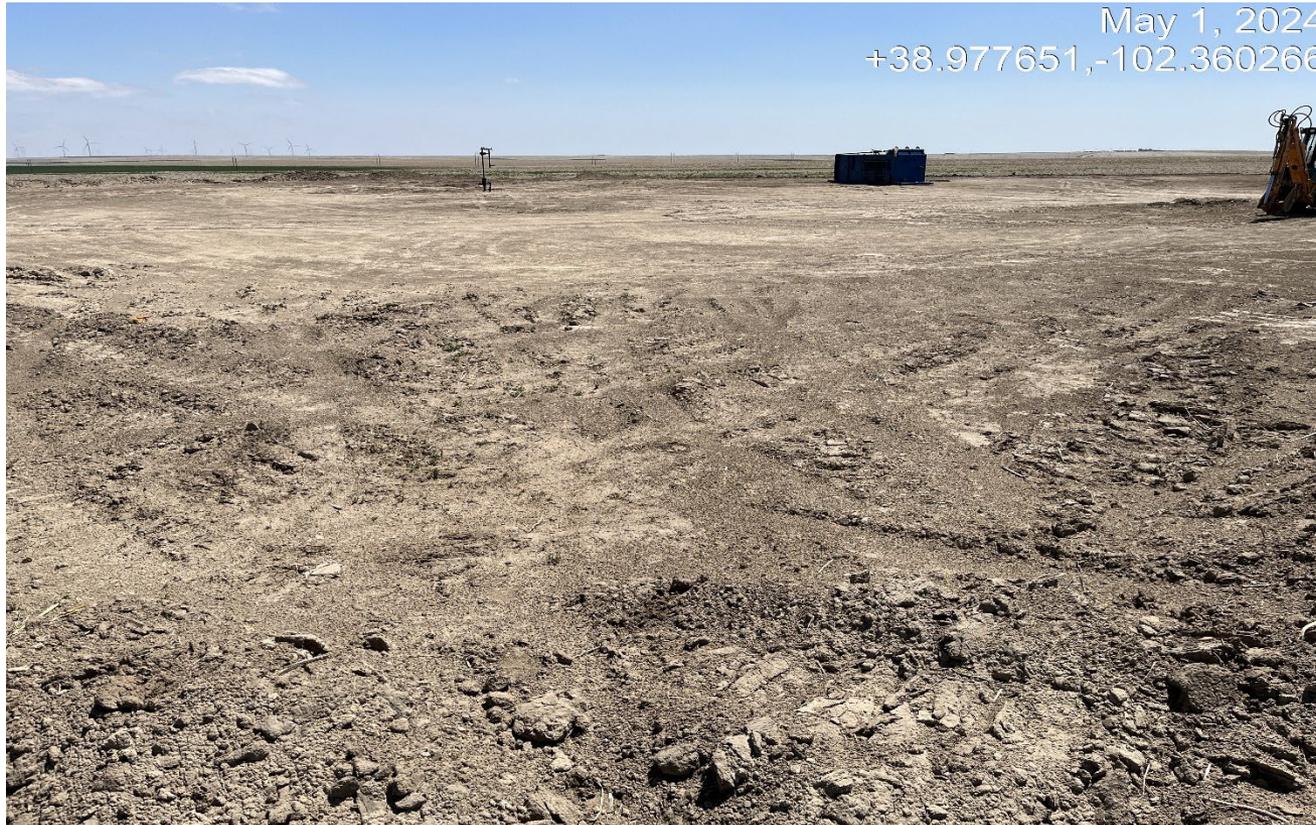
**Photo 6.** Northwest corner facing southwest.

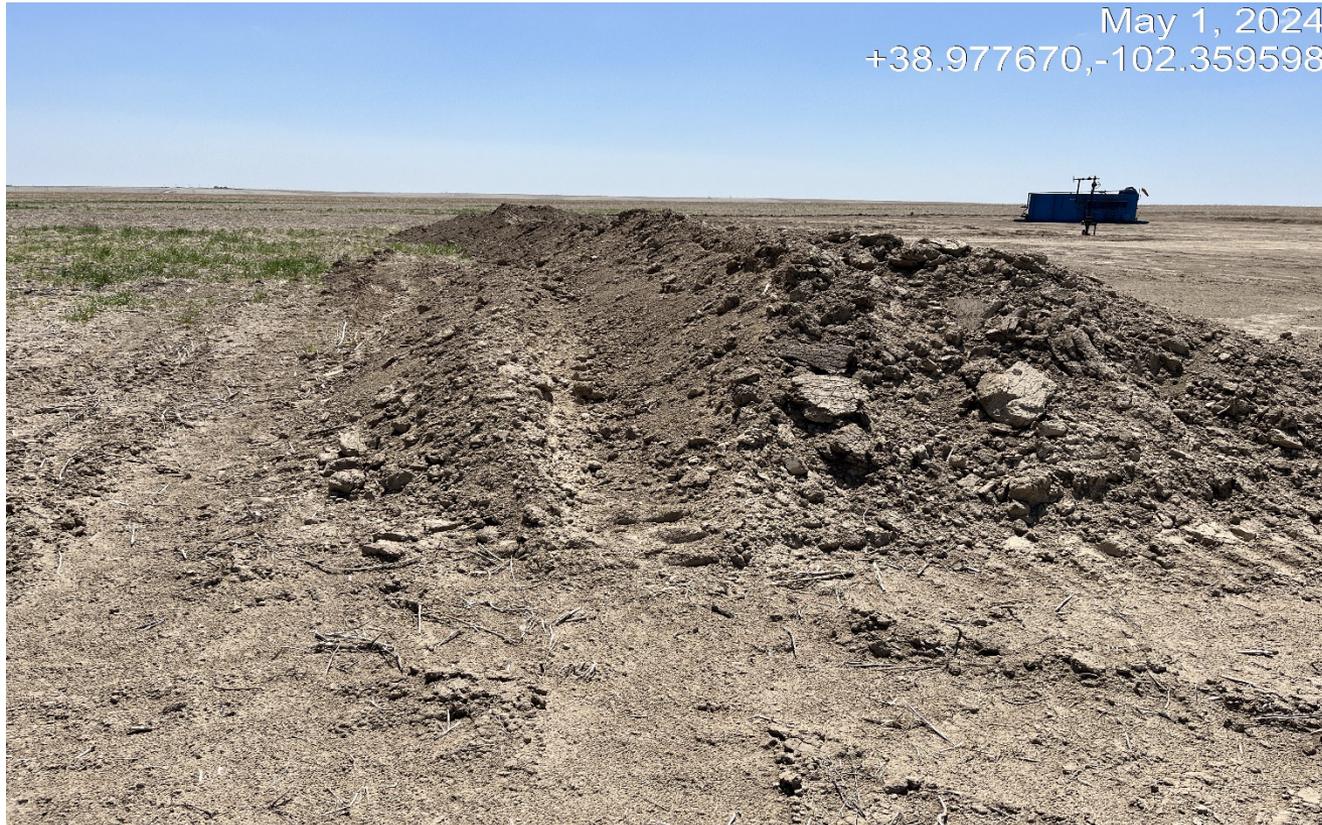
**Photo 7.** Northeast corner facing south. There are no stormwater controls around the location and soil pile is not stabilized.

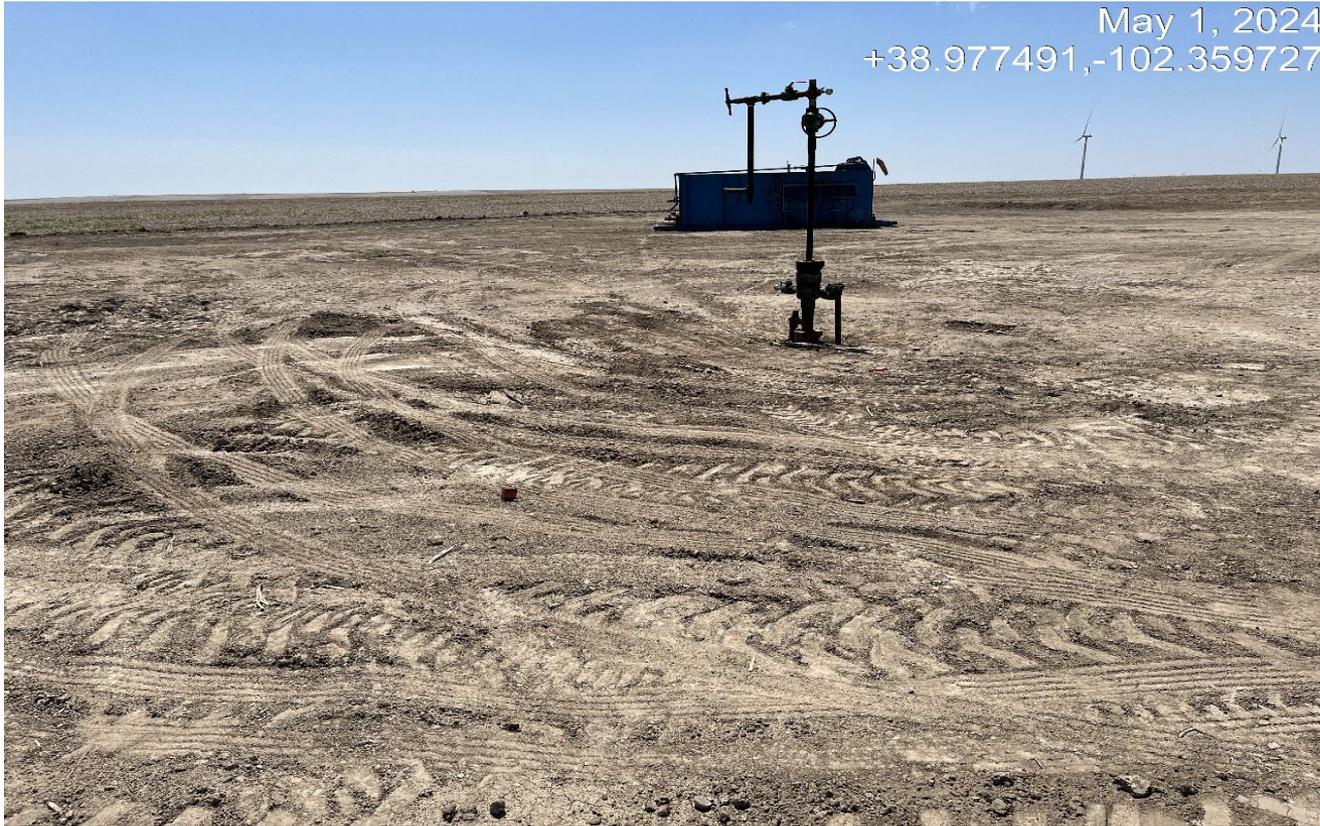
**Photo 8.** Facing southwest toward the wellhead.

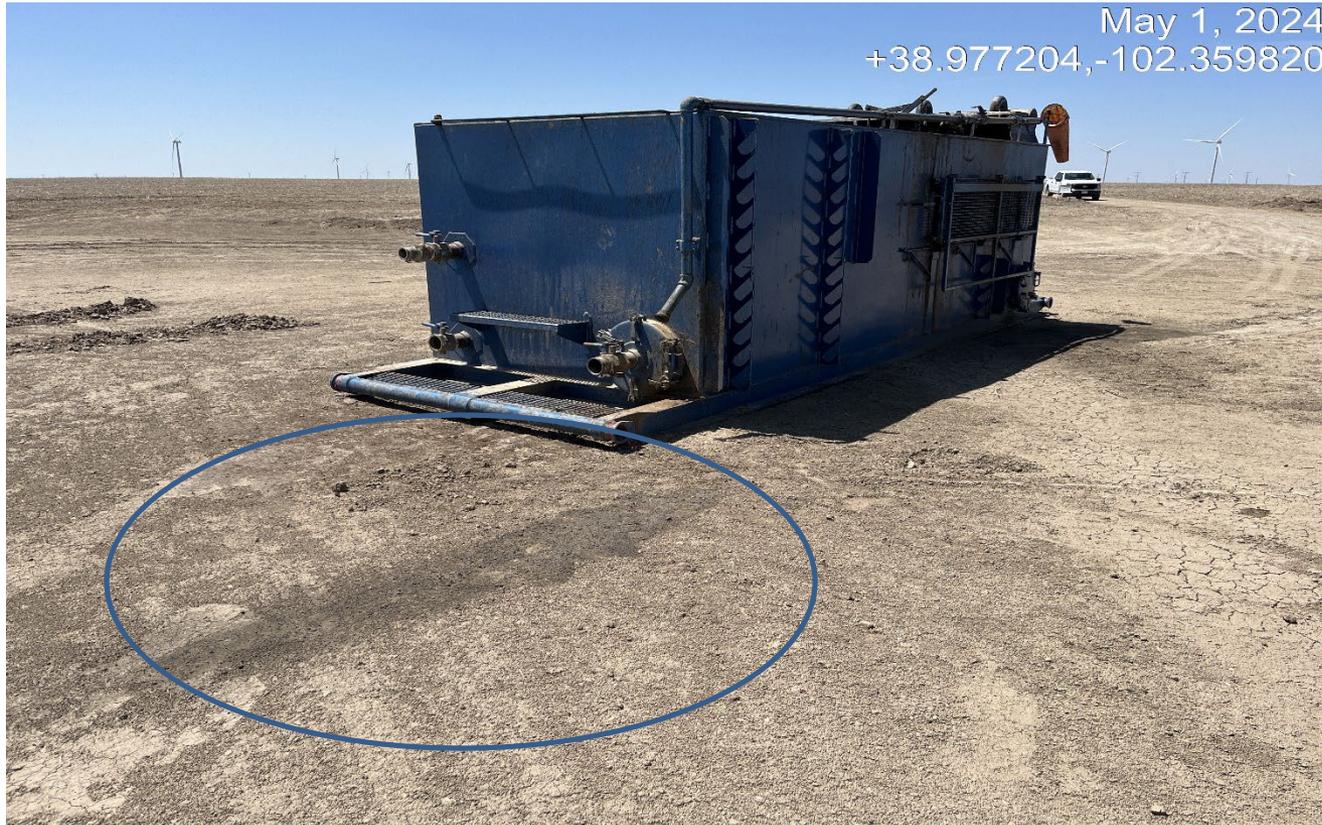
**Photo 9.** Facing toward the open top tank. There are stained soils shown in the circled area near the tank..

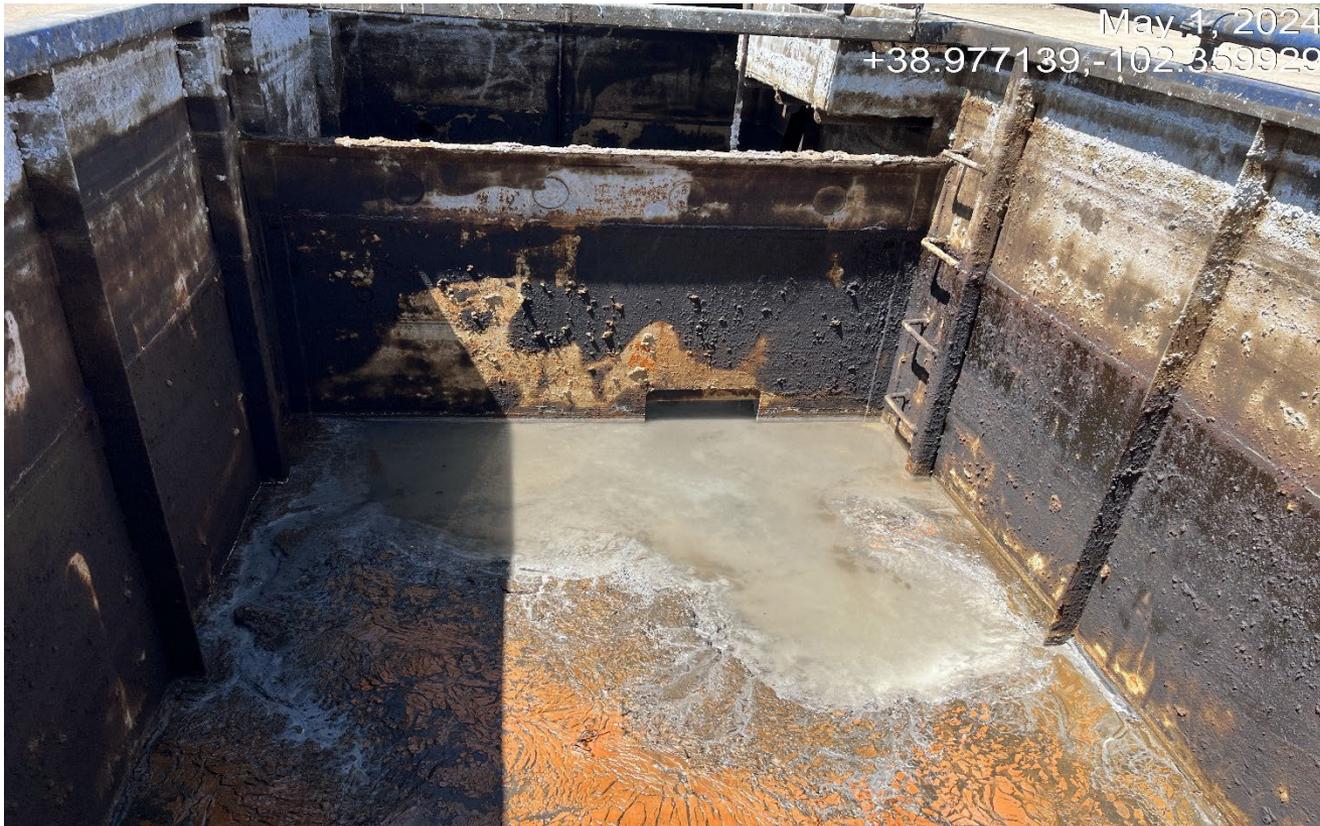
**Photo 10.** There is no netting on the open top tank for wildlife bird protection.

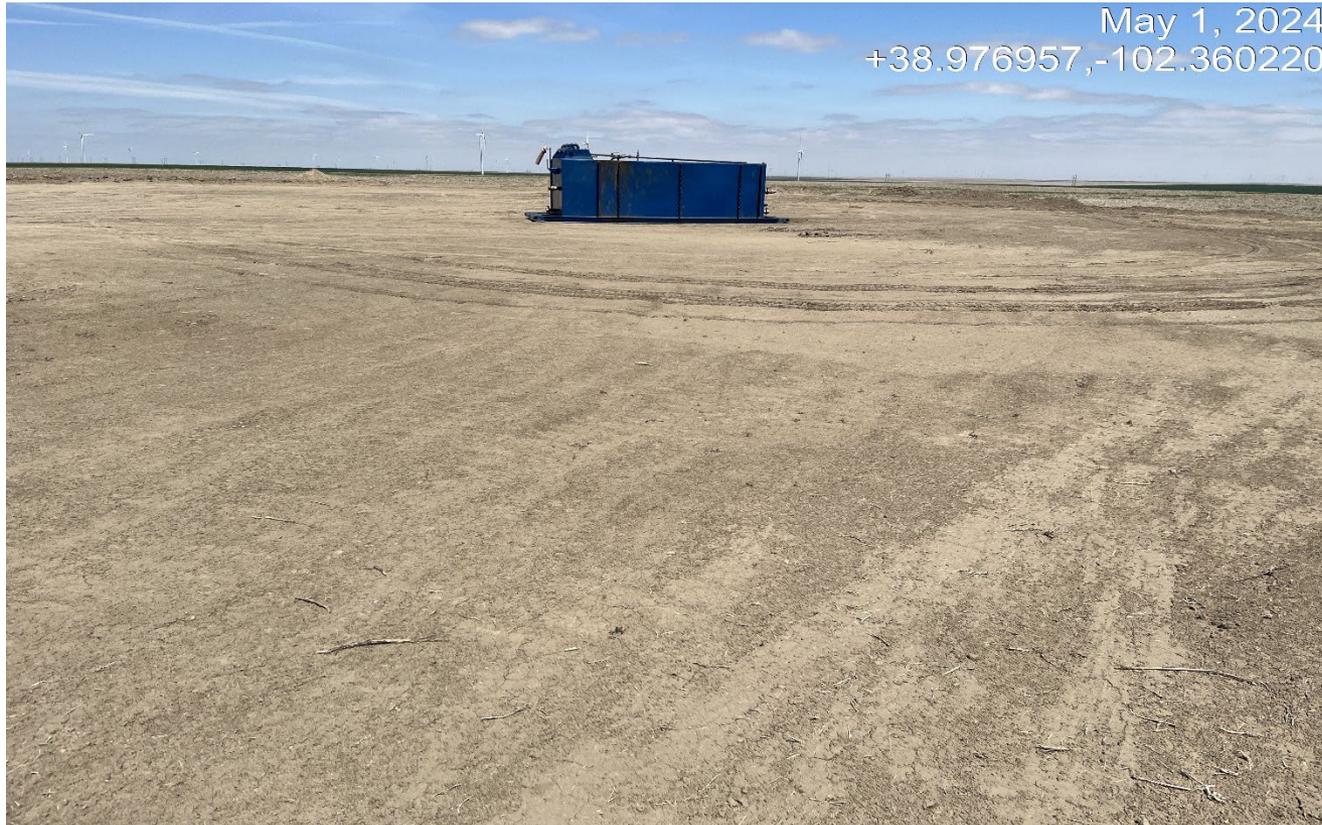
**Photo 11.** Facing northeast at the location.
