COLORADO
Energy & Carbon Management
Commission
Department of Natural Resources

API 057-06598 Rabbit Ears Photo taken on 3/28/24
Photo #1 sign at wellhead. Pumping unit.

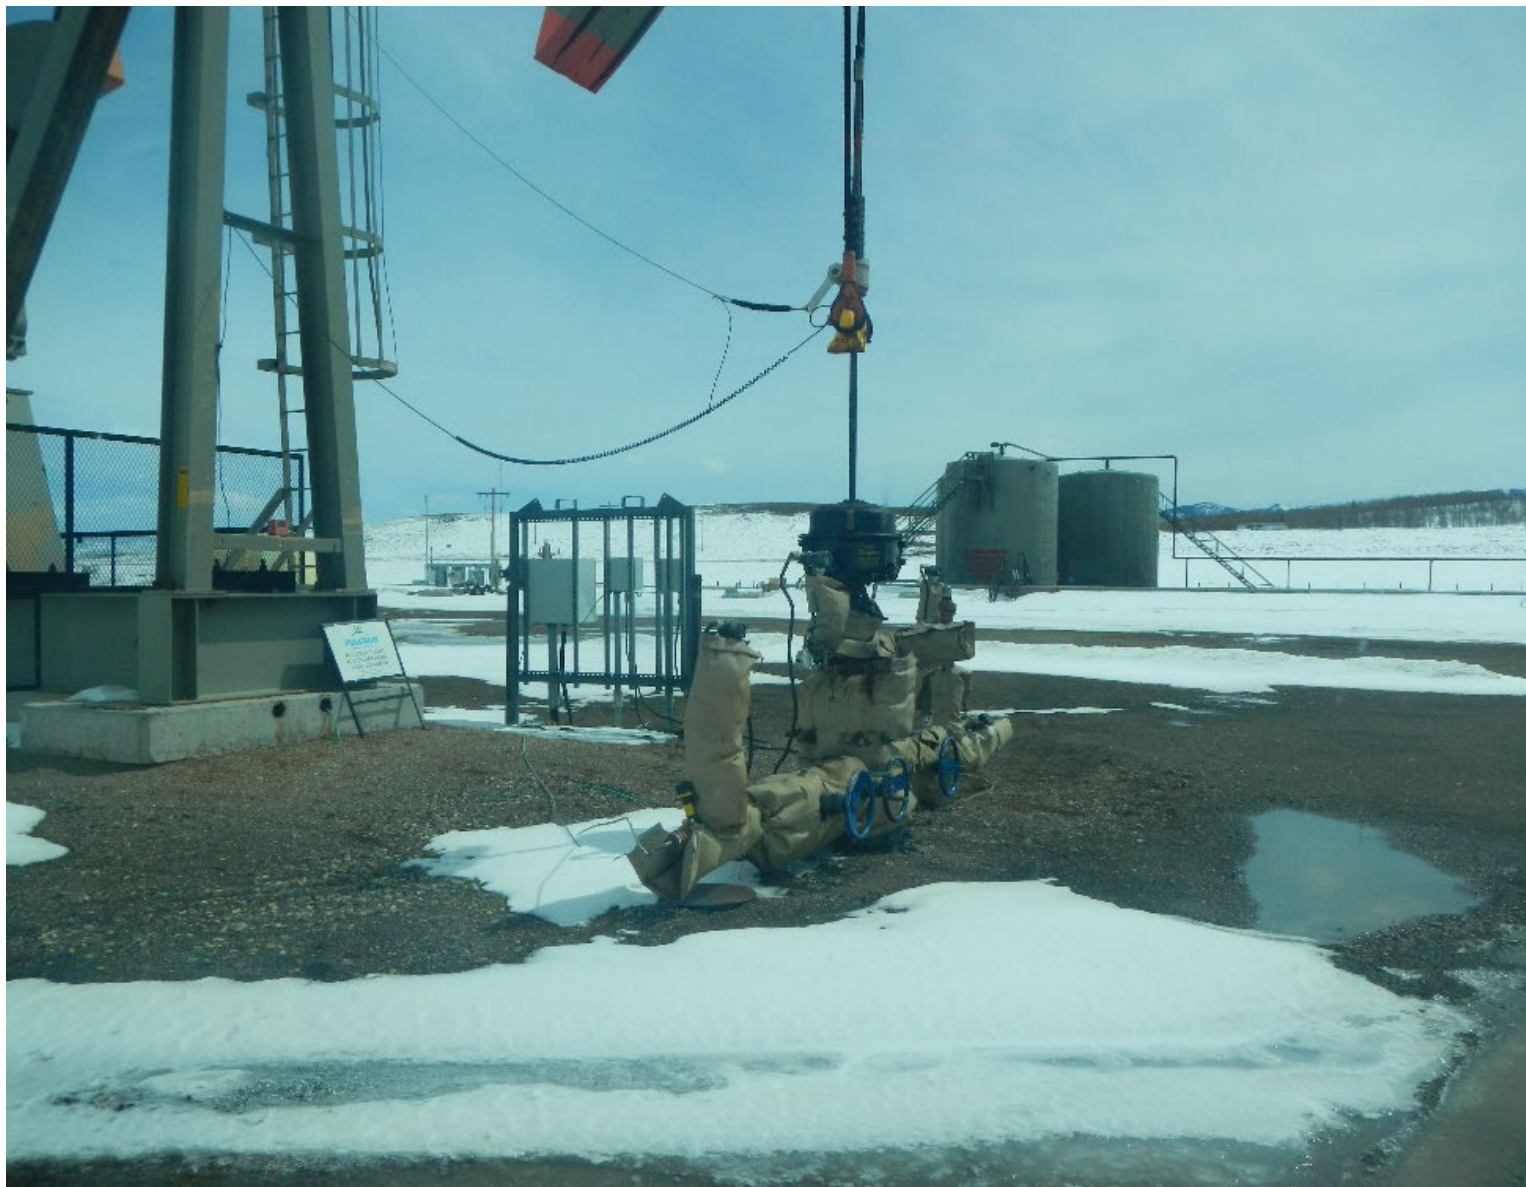
API 057-06598 Rabbit Ears Photo taken on 3/28/24
Photo #2 . Pumping unit was SI at the time of inspection.

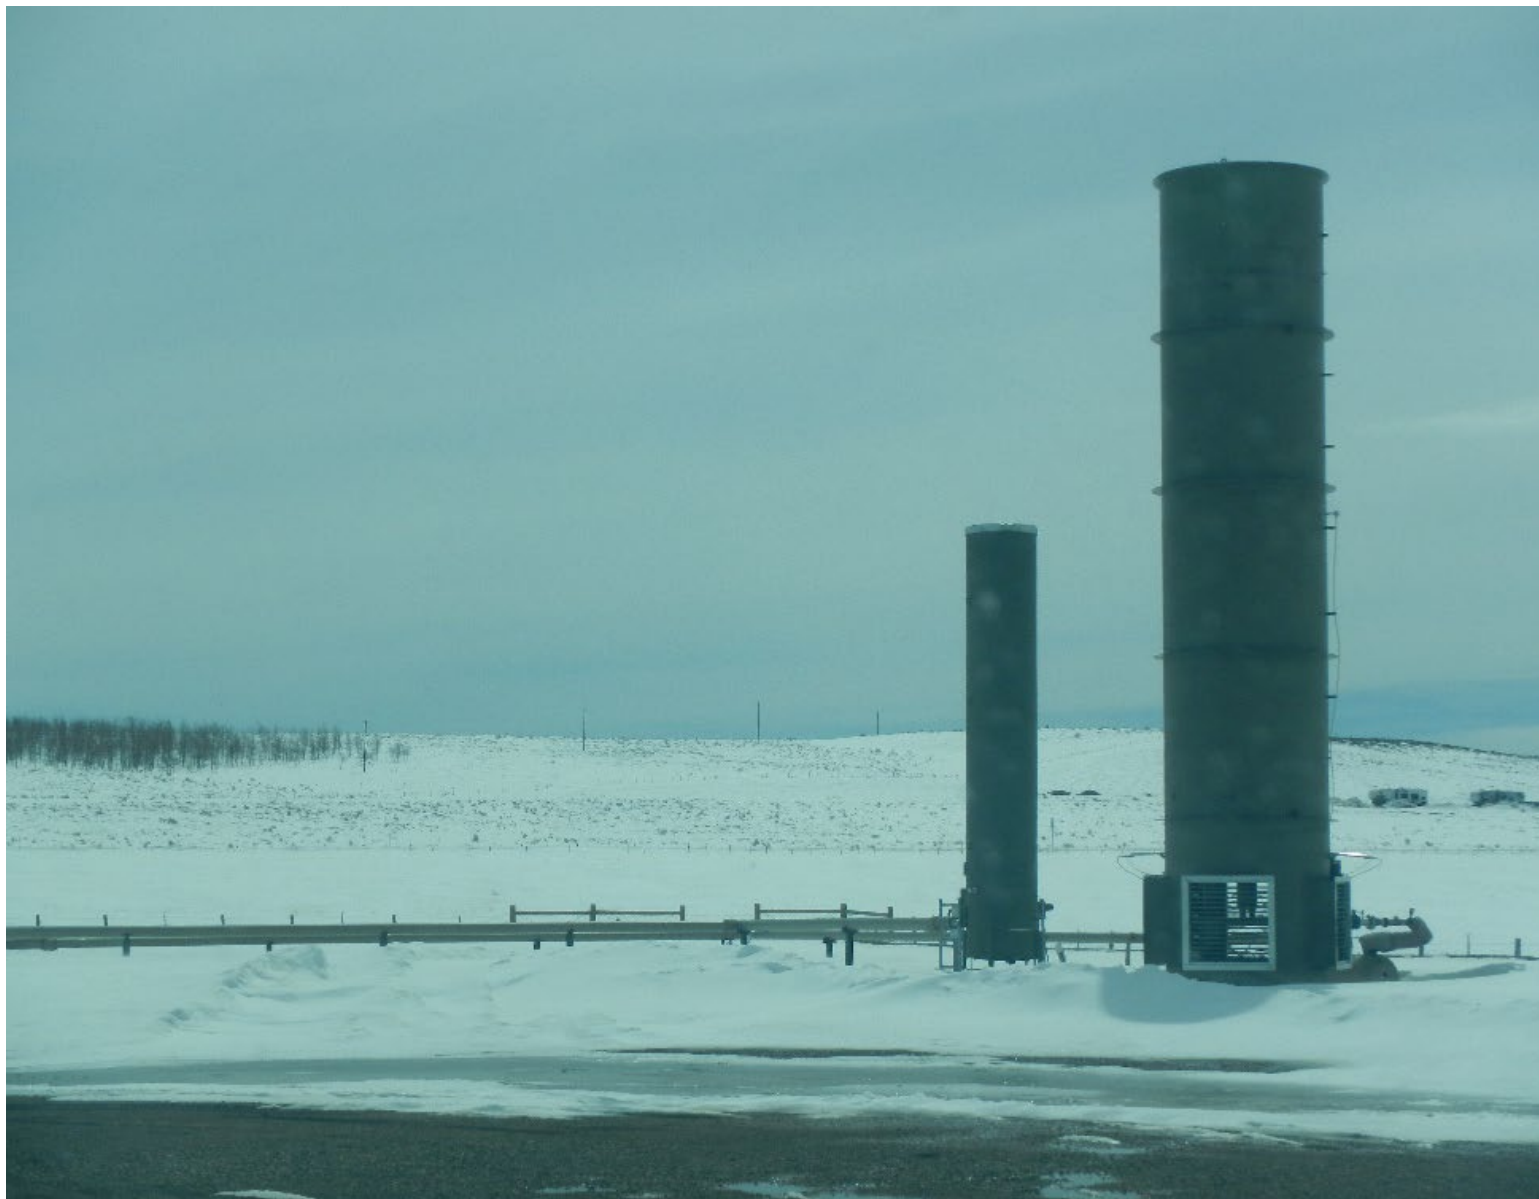
API 057-06598 Rabbit Ears Photo taken on 3/28/24

Photo #3 Combustors, they did not appear to be fired at the time of inspection.

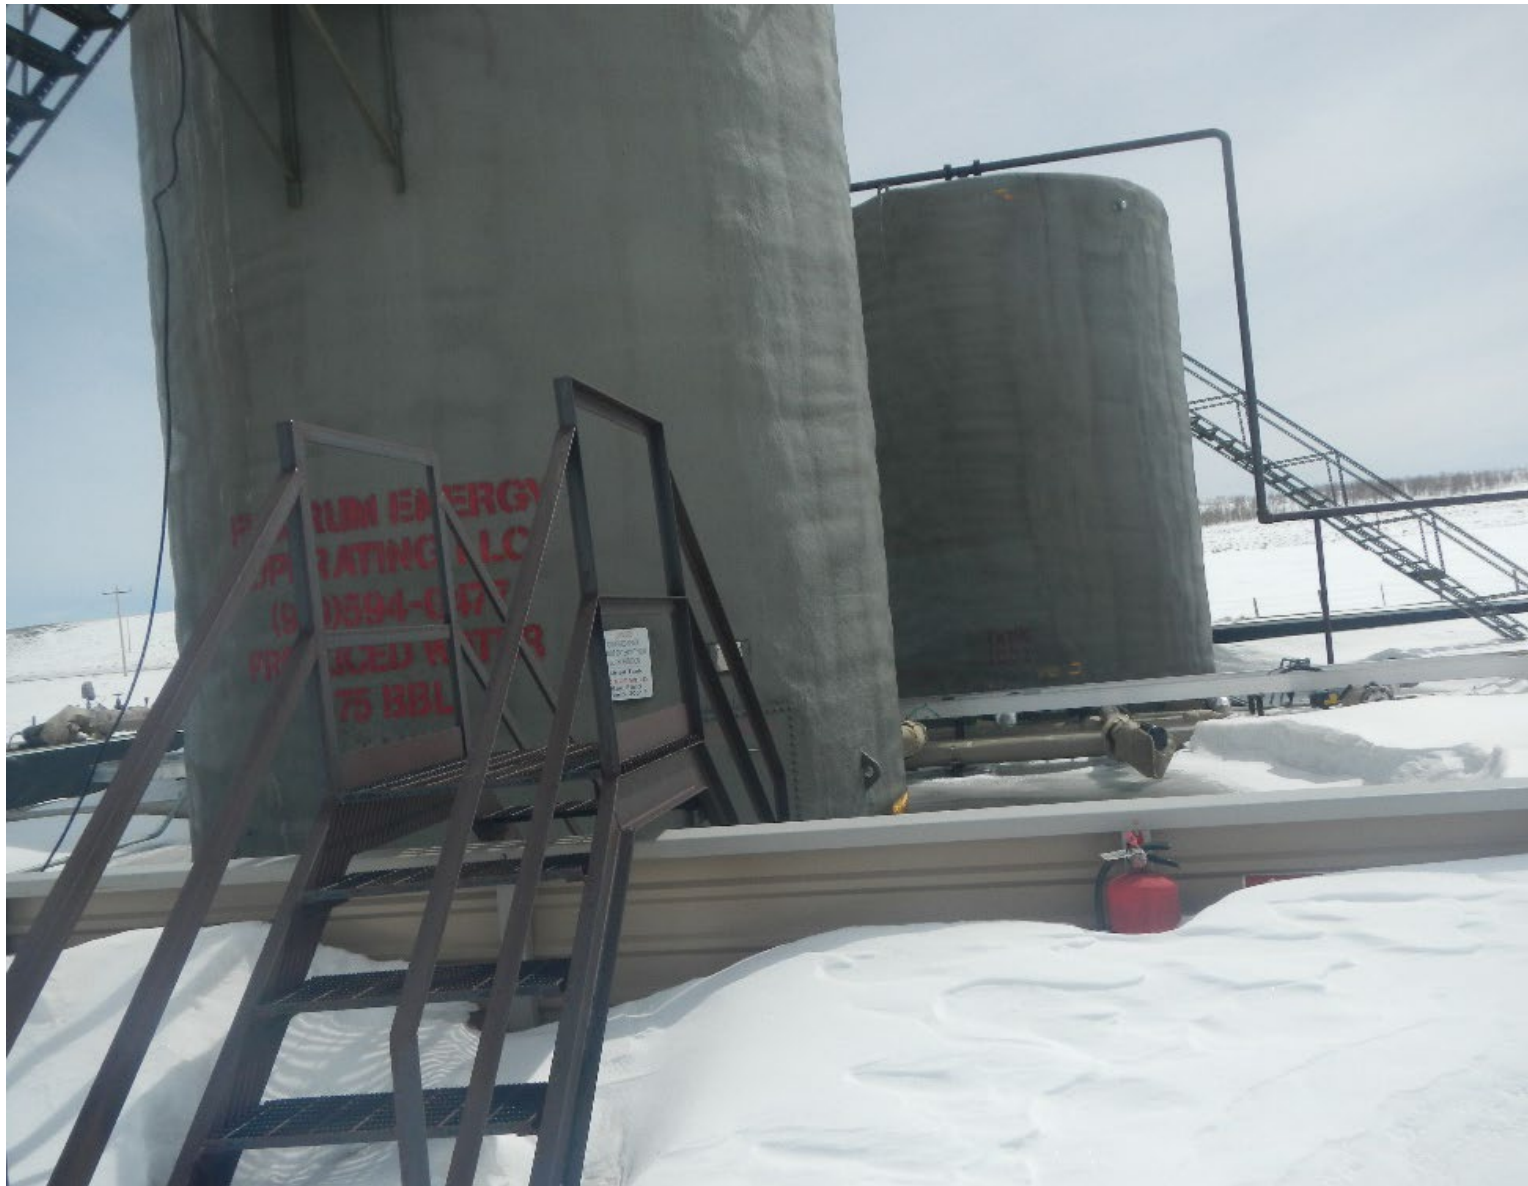
API 057-06598 Rabbit Ears Photo taken on 3/28/24
Photo #4 Tank battery .

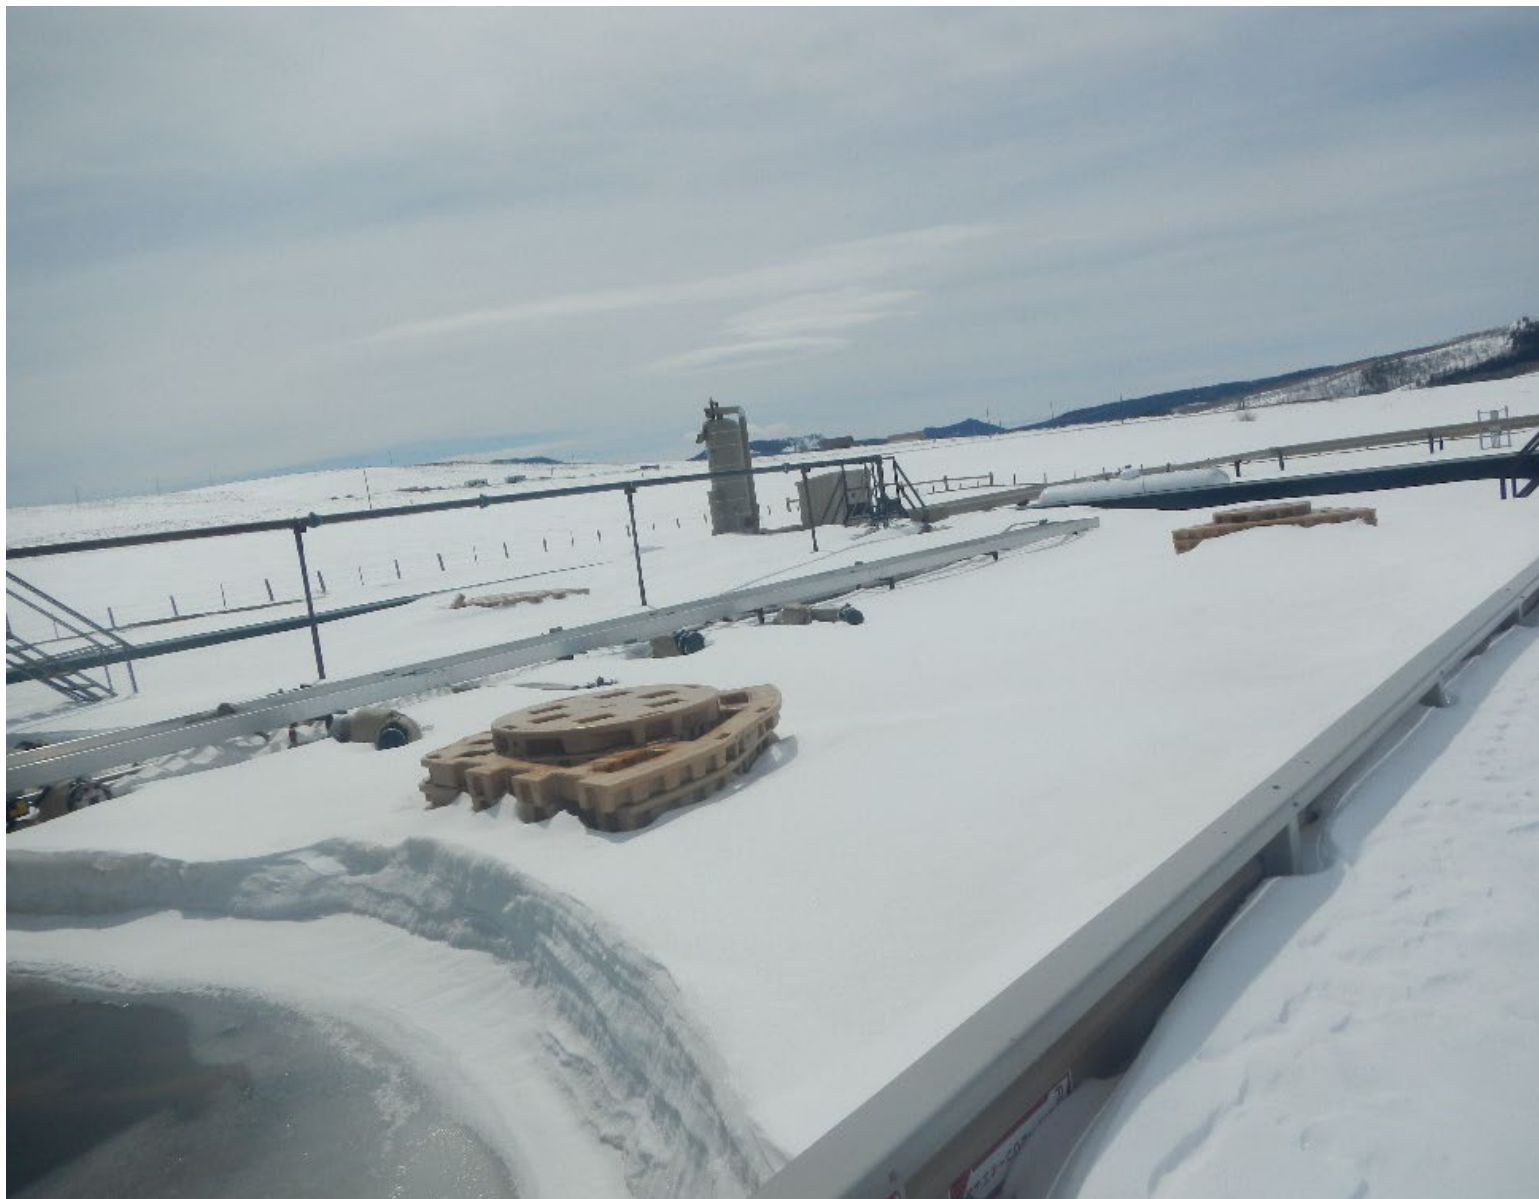
API 057-06598 Rabbit Ears Photo taken on 3/28/24
Photo #5 Secondary containment .

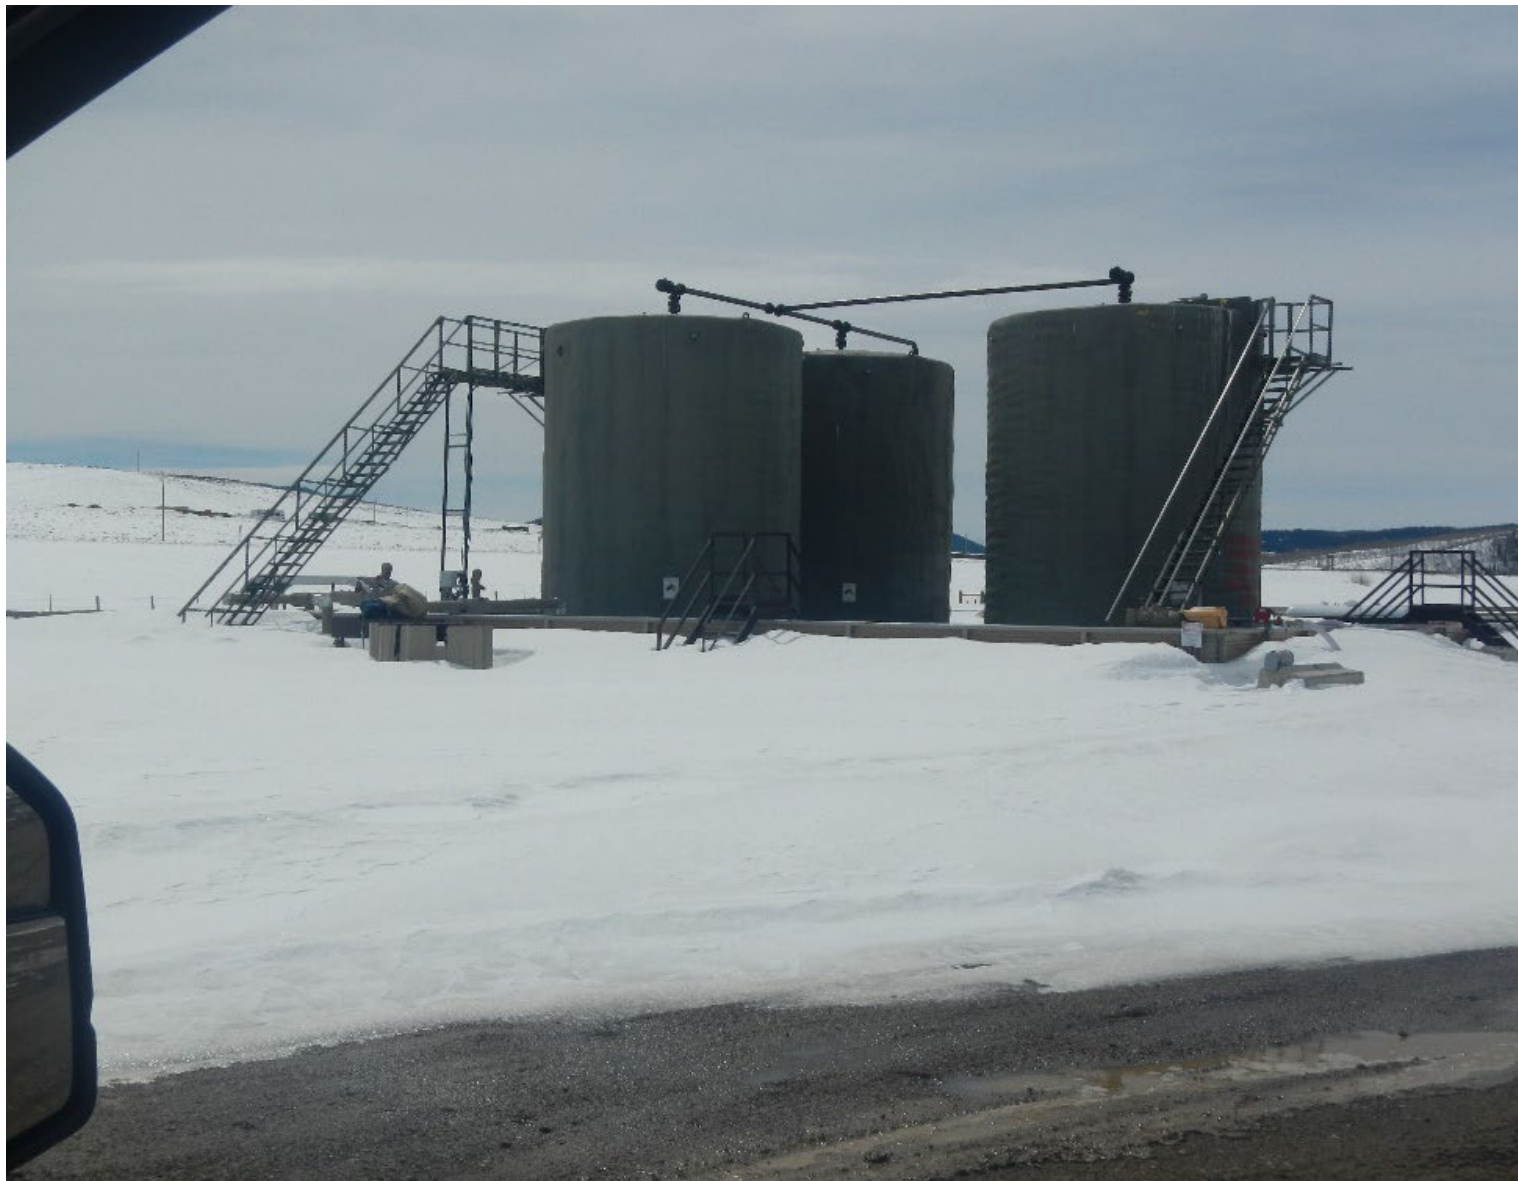
API 057-06598 Rabbit Ears Photo taken on 3/28/24
Photo #6 3 AGT's in secondary containment.

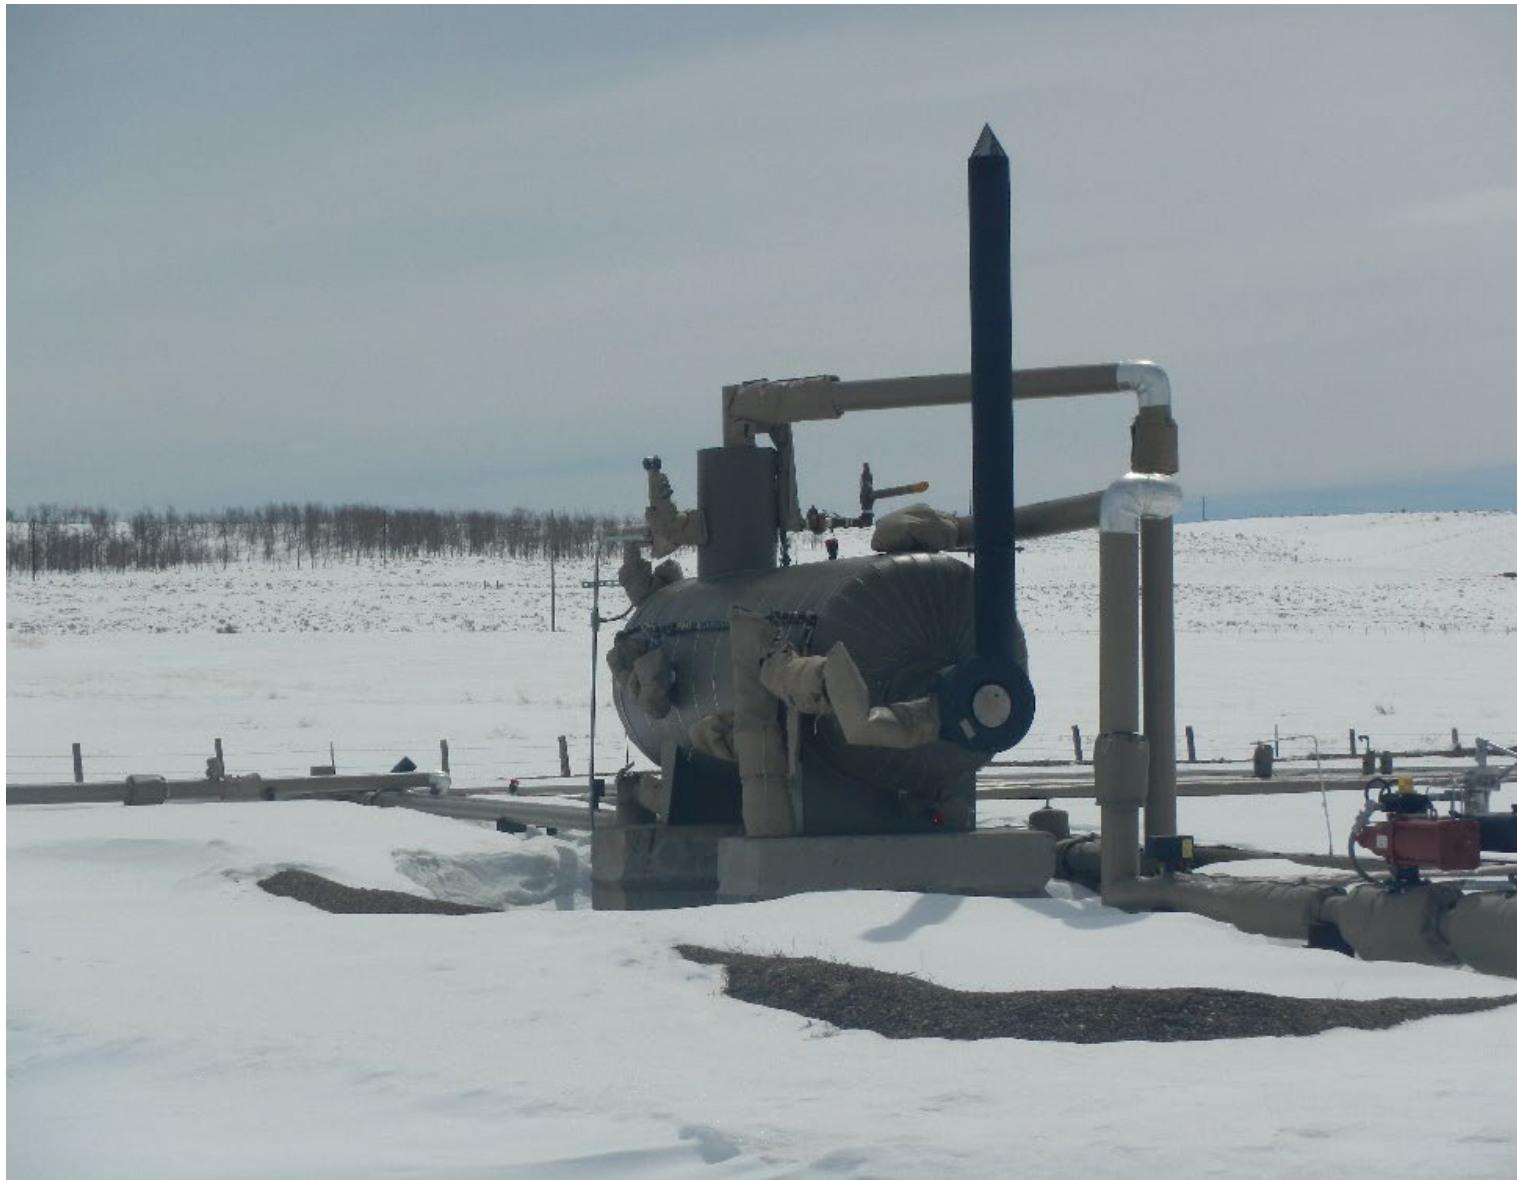
API 057-06598 Rabbit Ears Photo taken on 3/28/24
Photo #7 Production equipment in dirt berm .
