Inspection Photos

Location Name: TEP Rocky Mountain LLC NORCROSS A Pad

Location # 335544

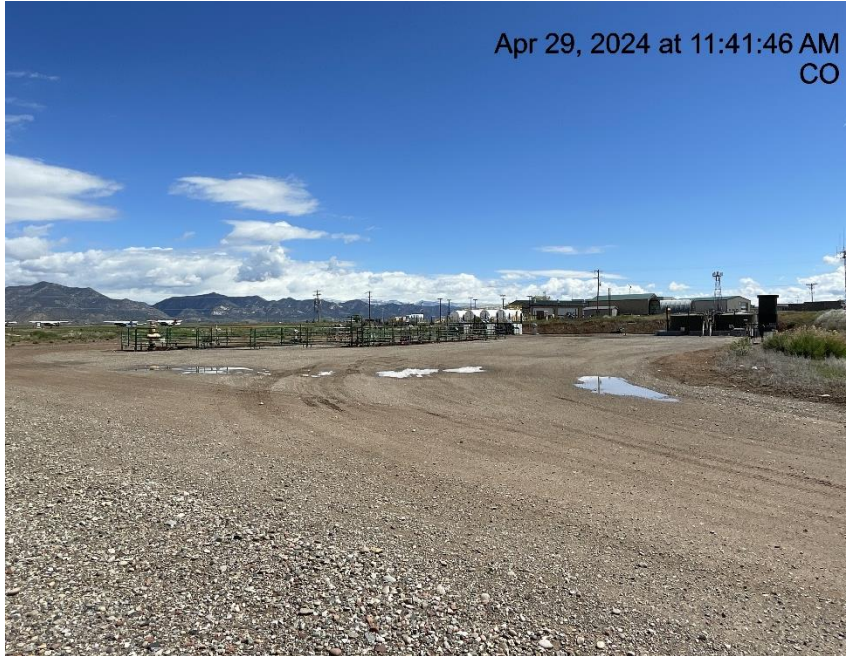
Photo # 5308 From entrance to location

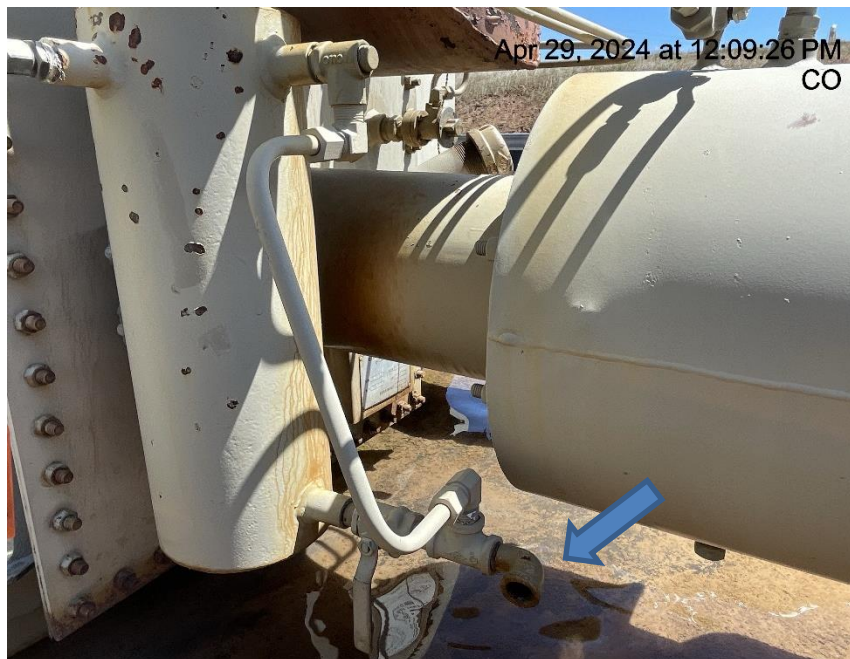
Photo # 5316 PRV vent line does not comply with CECMC pressure safety device rules & general safety rules

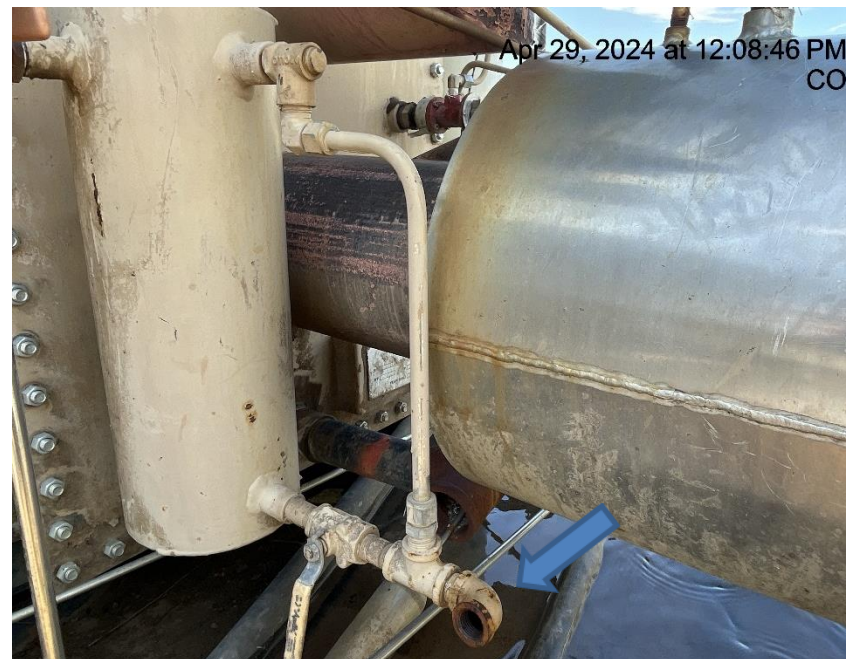
Photo # 5317 PRV vent line does not comply with CECMC pressure safety device rules & general safety rules
