## Tank Battery Closure Checklist

SBJ 22-13 HZ O SA

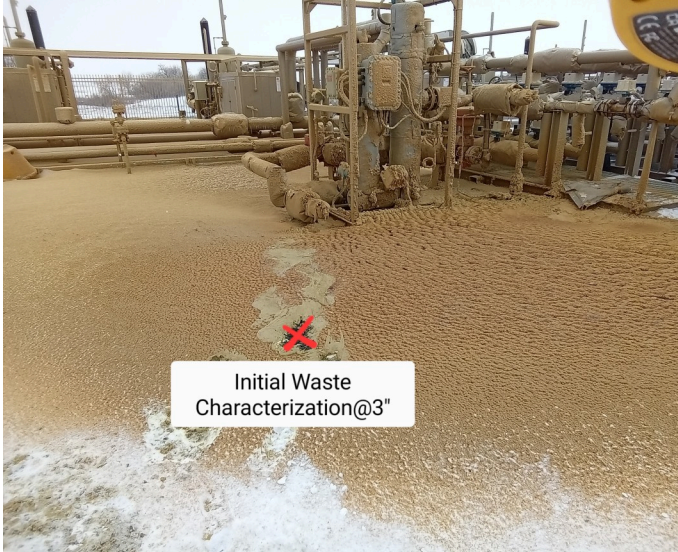
R1 - P1

Looking west

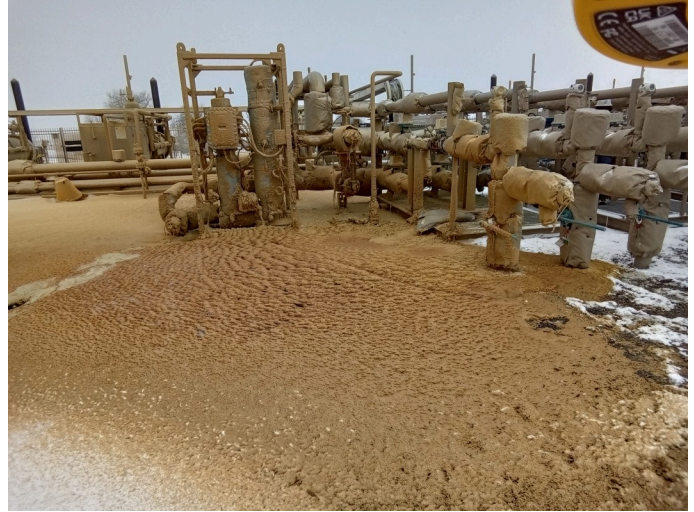
R1 - P2

Looking southwest

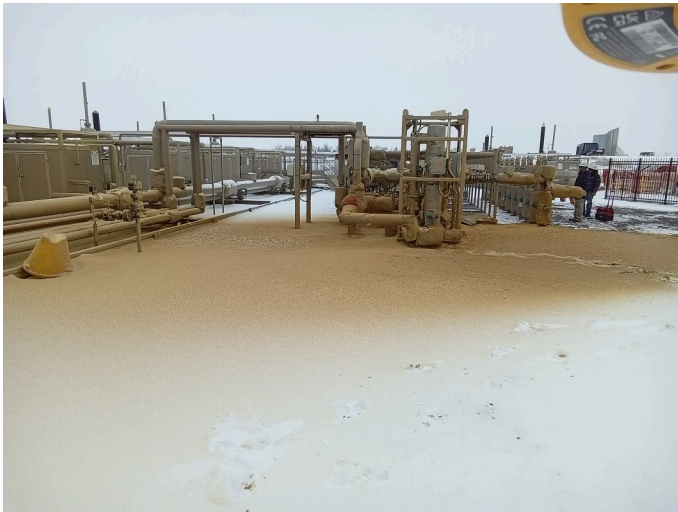
R1 - P3

Looking north

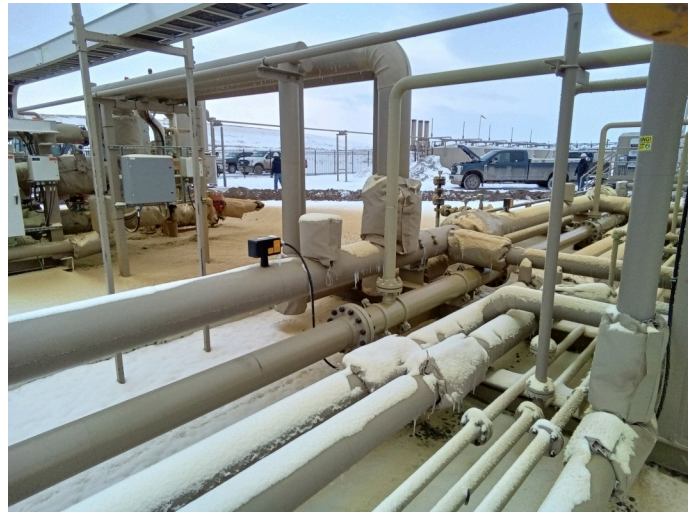
R1 - P4

Looking southwest

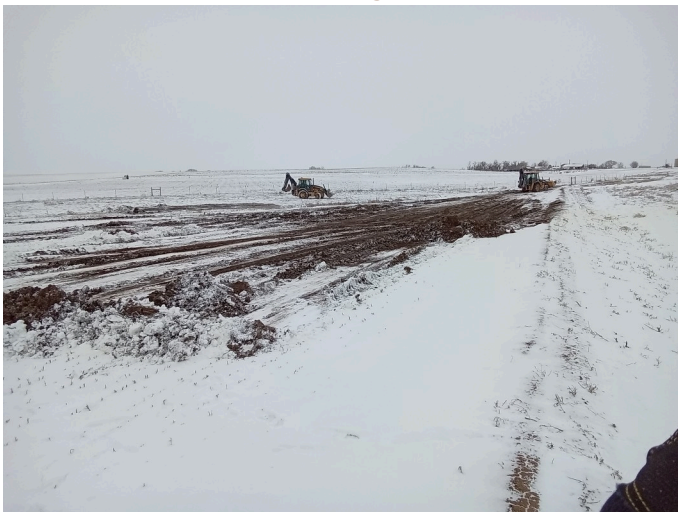
R1 - P5

Looking north
