Inspection Photos  
Location Name: Brecken LD28-747 Production Facility  
Location ID: 441926

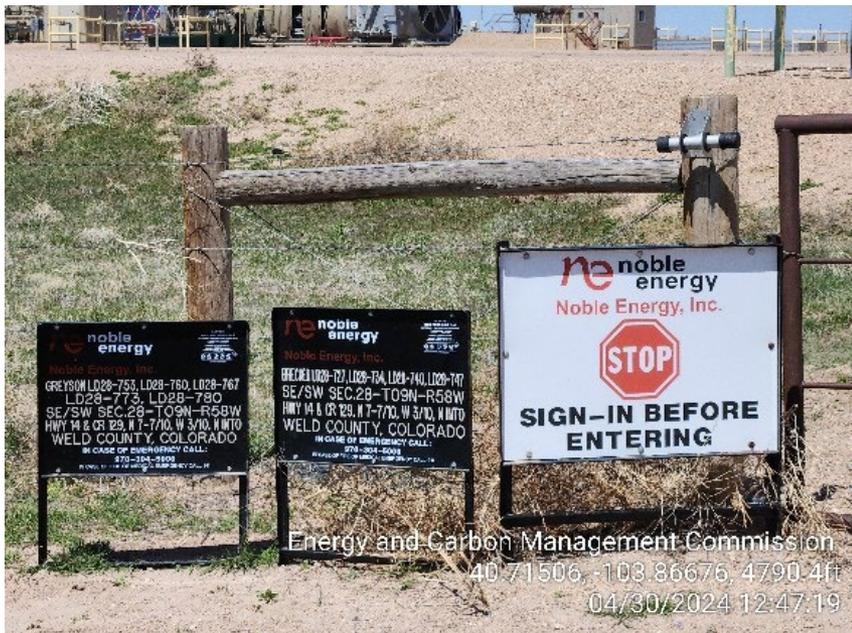
Photo 1 – Signs at Entrance

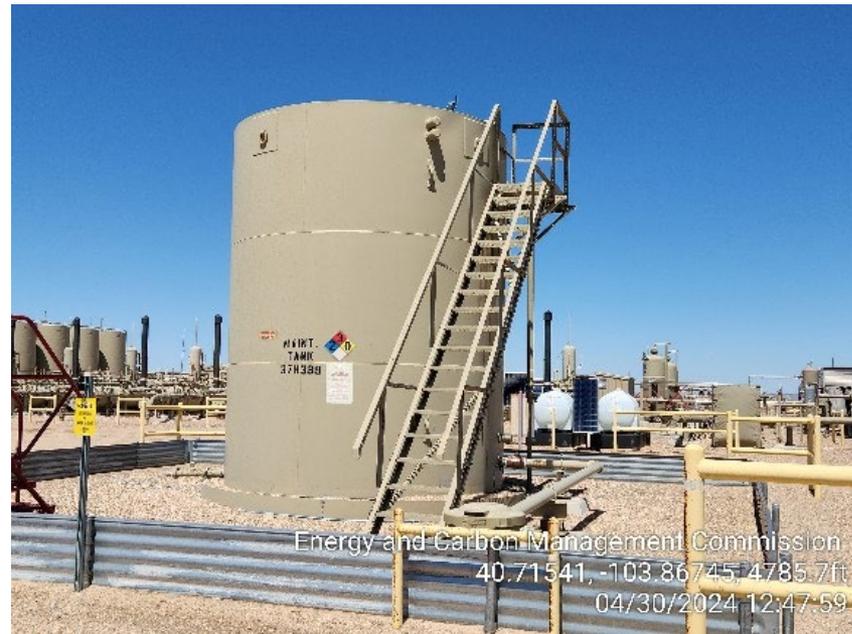
Photo 2 – Maintenance Tank

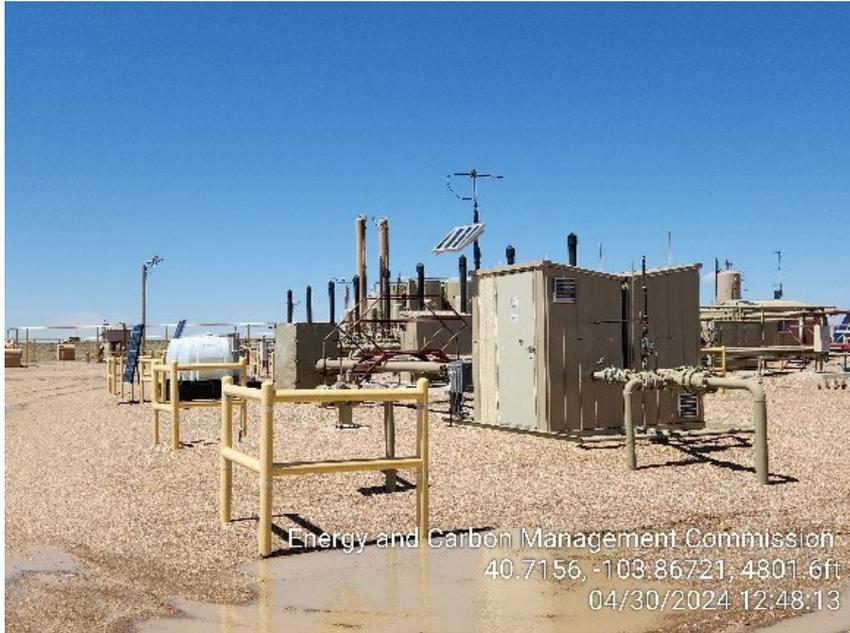
**Photo 3 – Gas Meters**

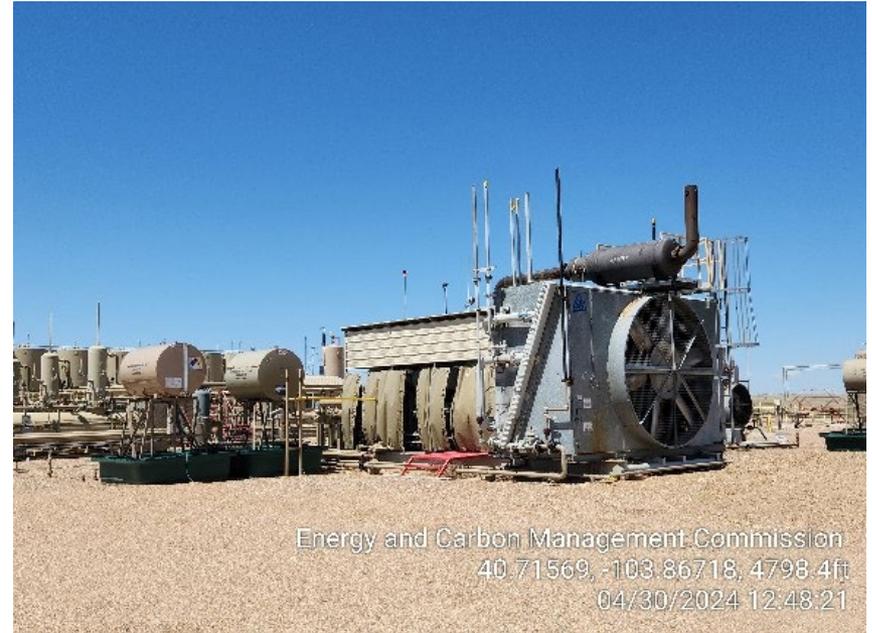
**Photo 4 – Compressor**

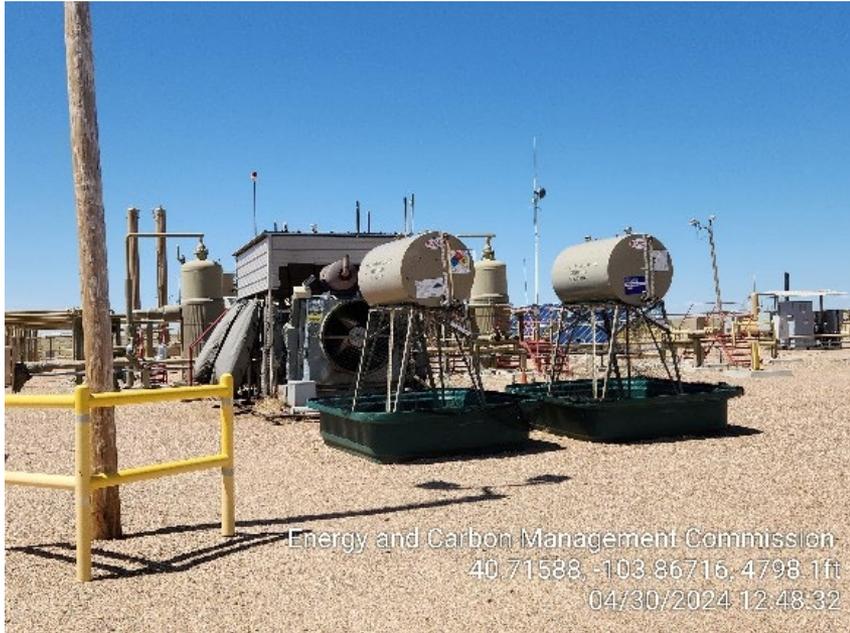
**Photo 5 – Compressor**

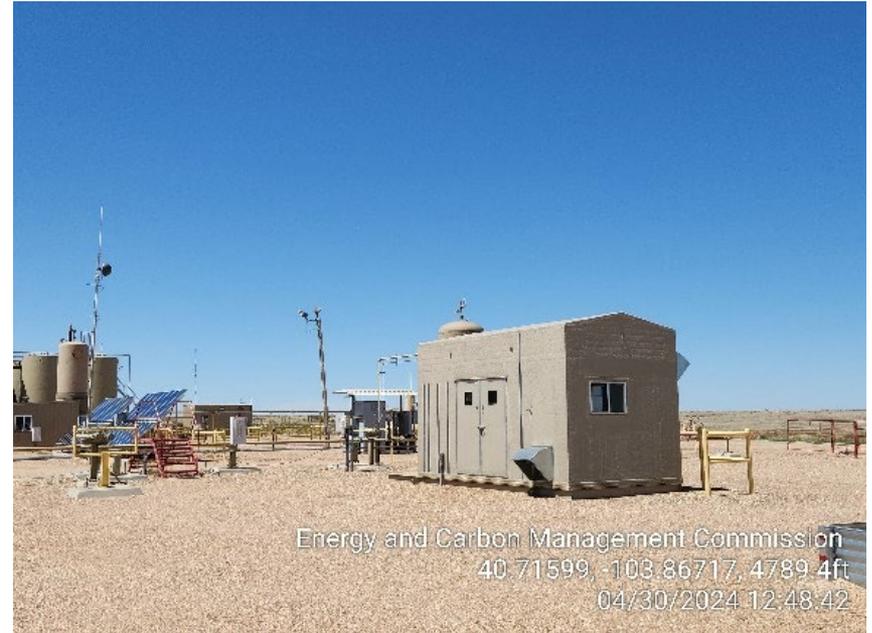
**Photo 6 – LACT**

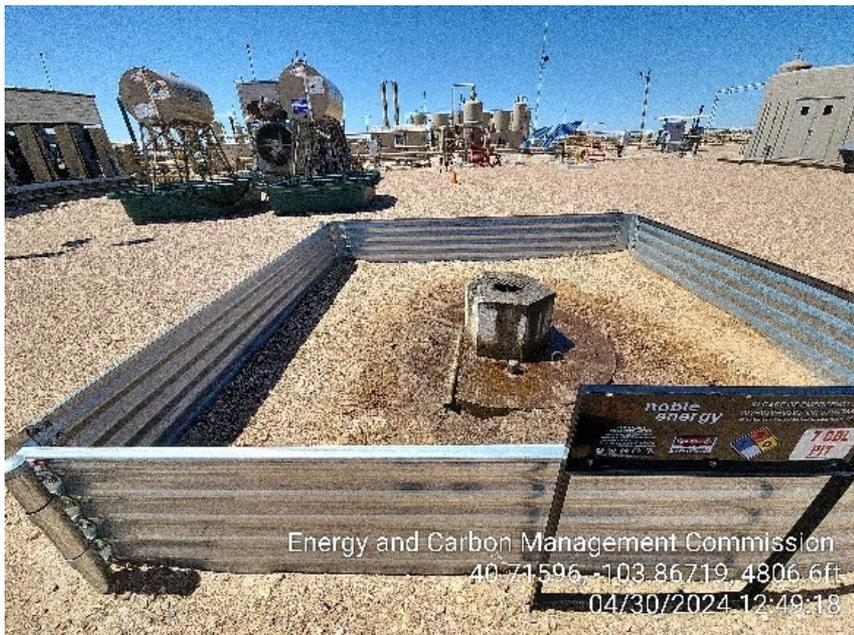
**Photo 7 – Compressor Drain Vault – Stained Soil**

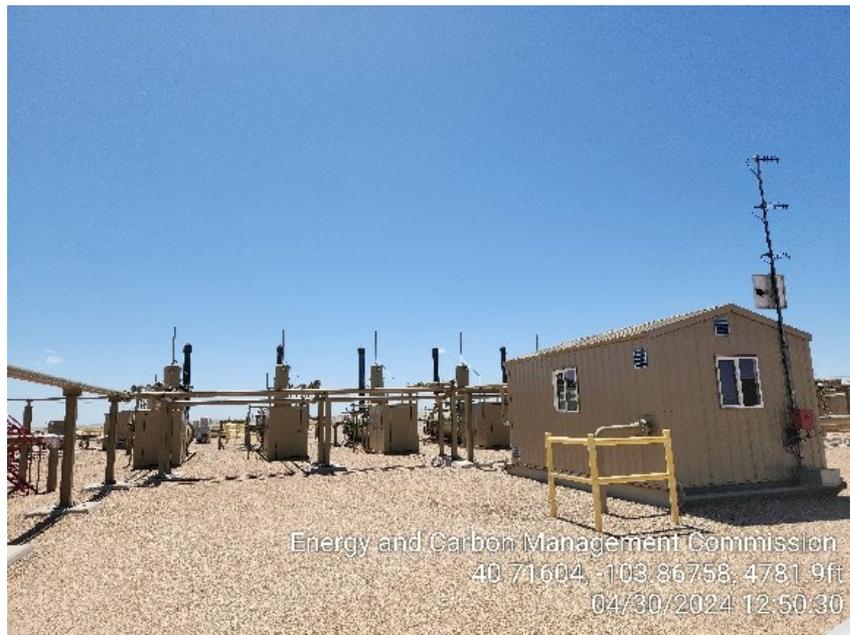
**Photo 8 – Separators**

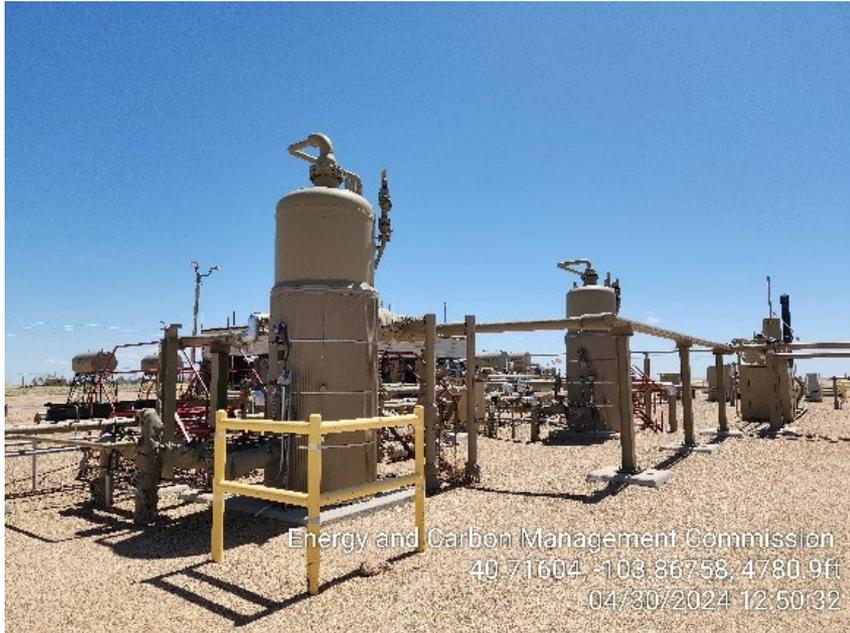
**Photo 9 – Production Equipment**

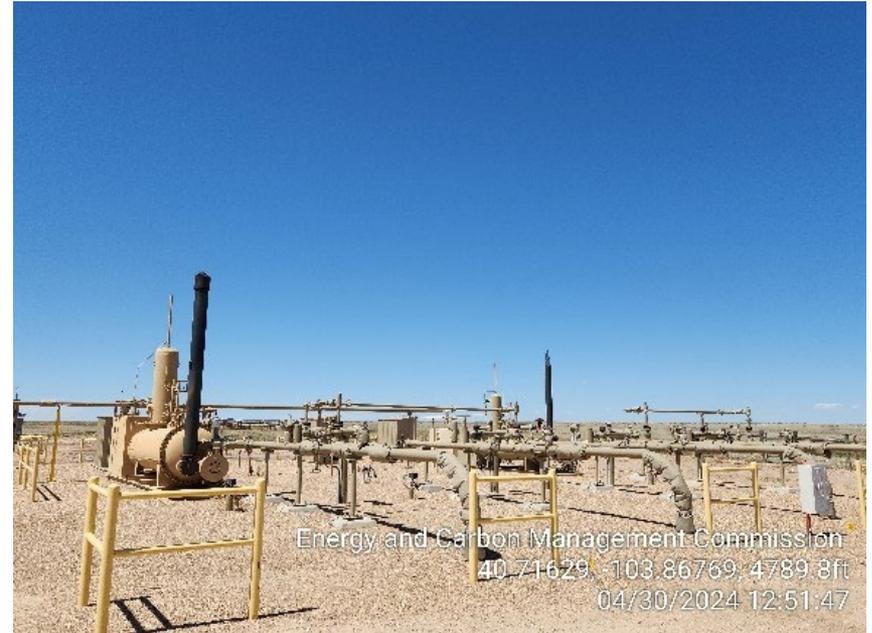
**Photo 10 – Separators**

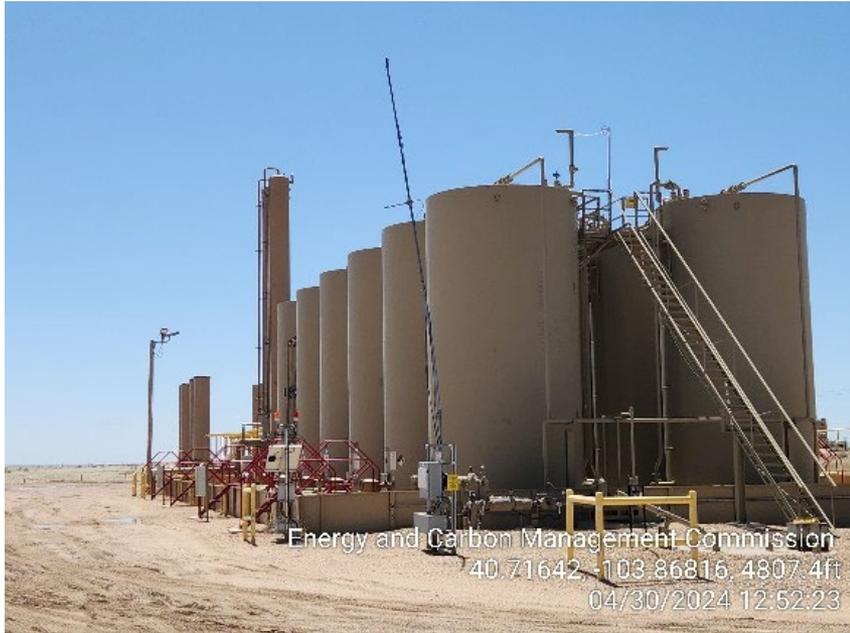
**Photo 11 – Tank Battery**

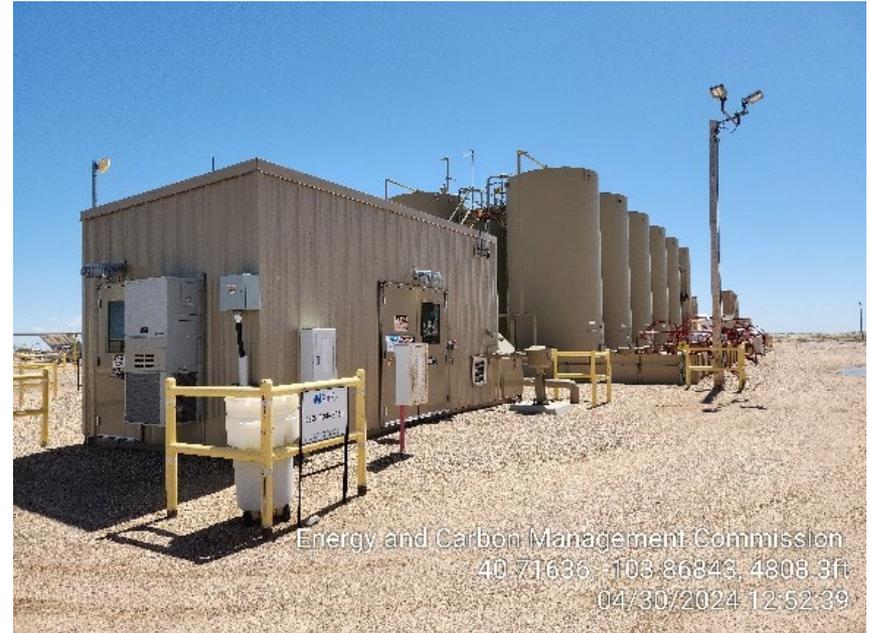
**Photo 12 – LACT**

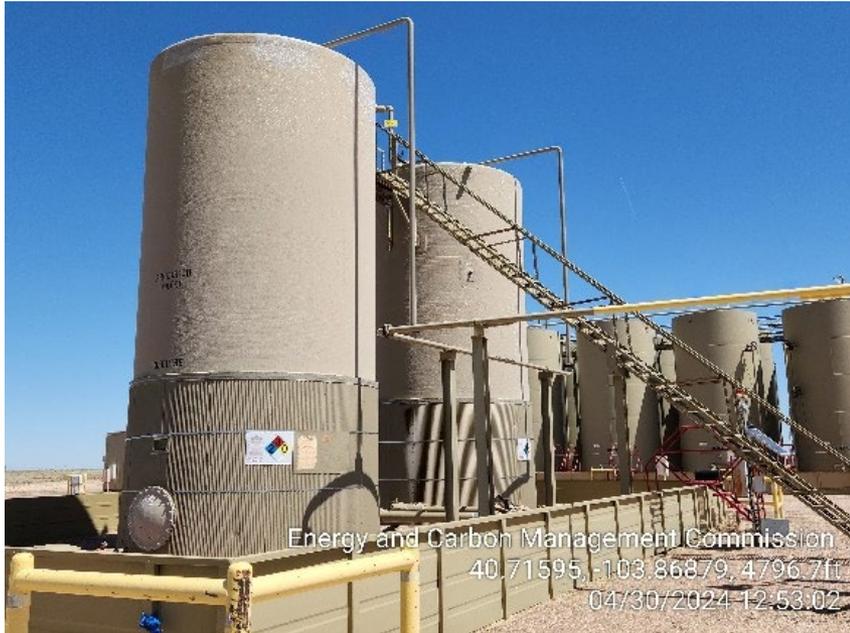
**Photo 13 – Water Tanks**

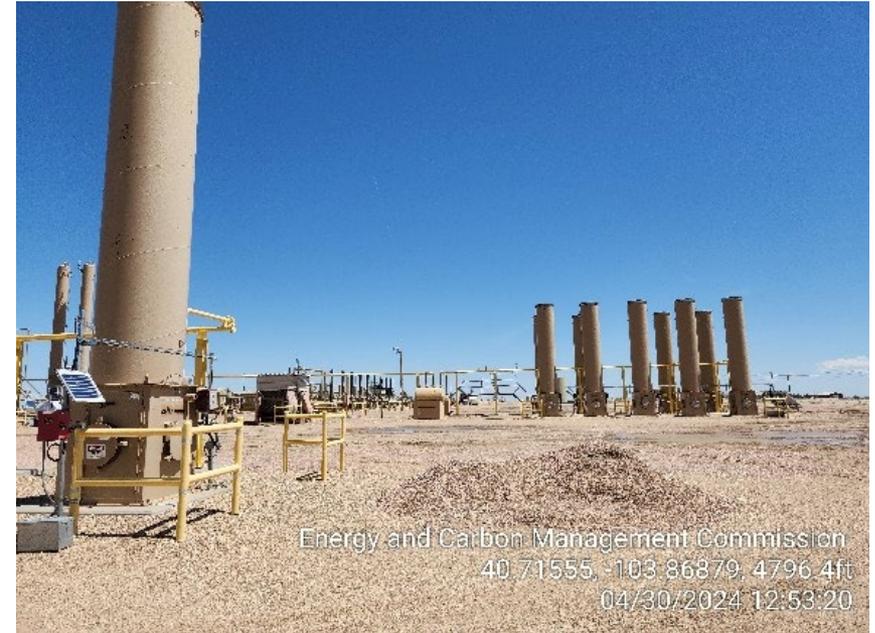
**Photo 14 – ECDs**

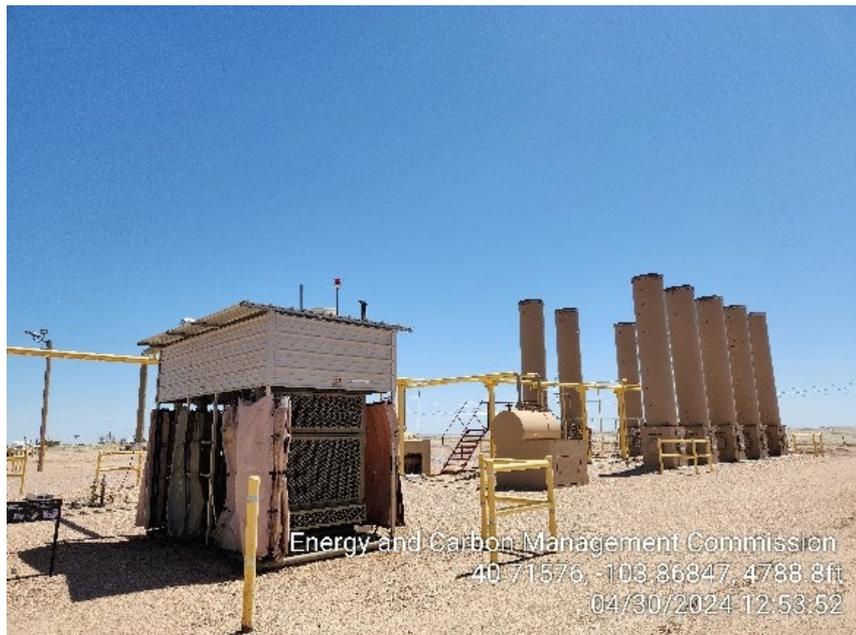
**Photo 15 – VRU**

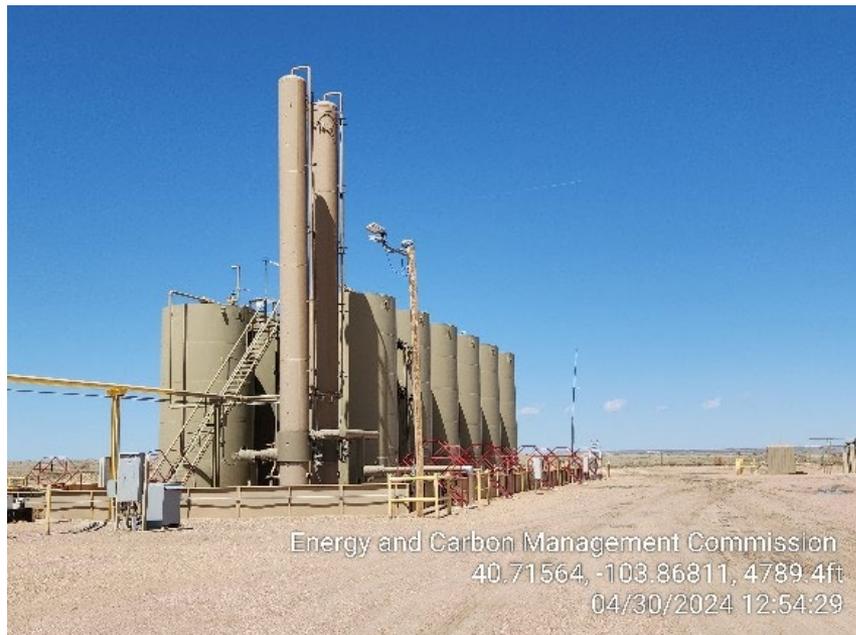
**Photo 16 – VRTs**

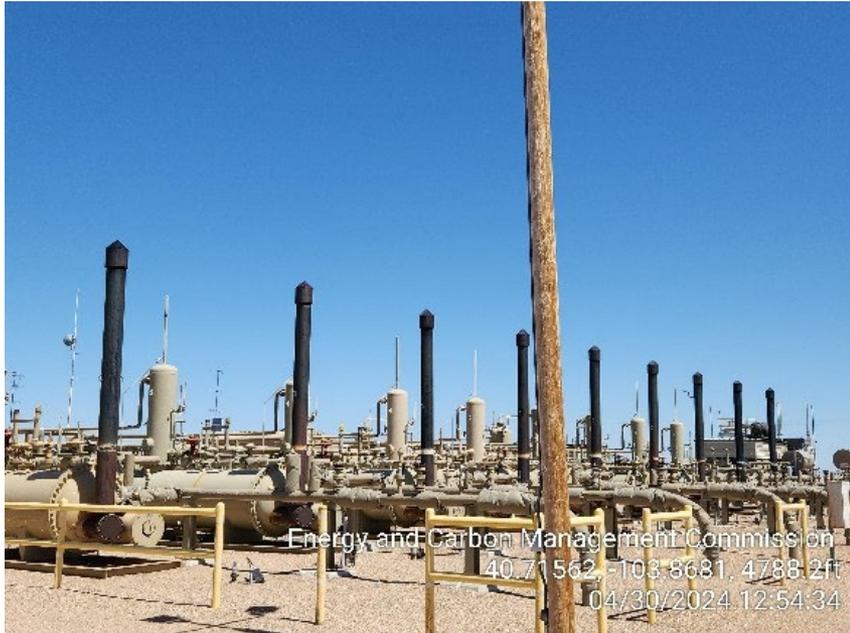
**Photo 17 – Separators**
