# Interim Reclamation and Stormwater Inspection

Operator: KP KAUFFMAN COMPANY INC - 46290

Location ID: 332971

Inspection Photos  
Location Name: Hladky O'Gorman #3  
Location ID: 332971

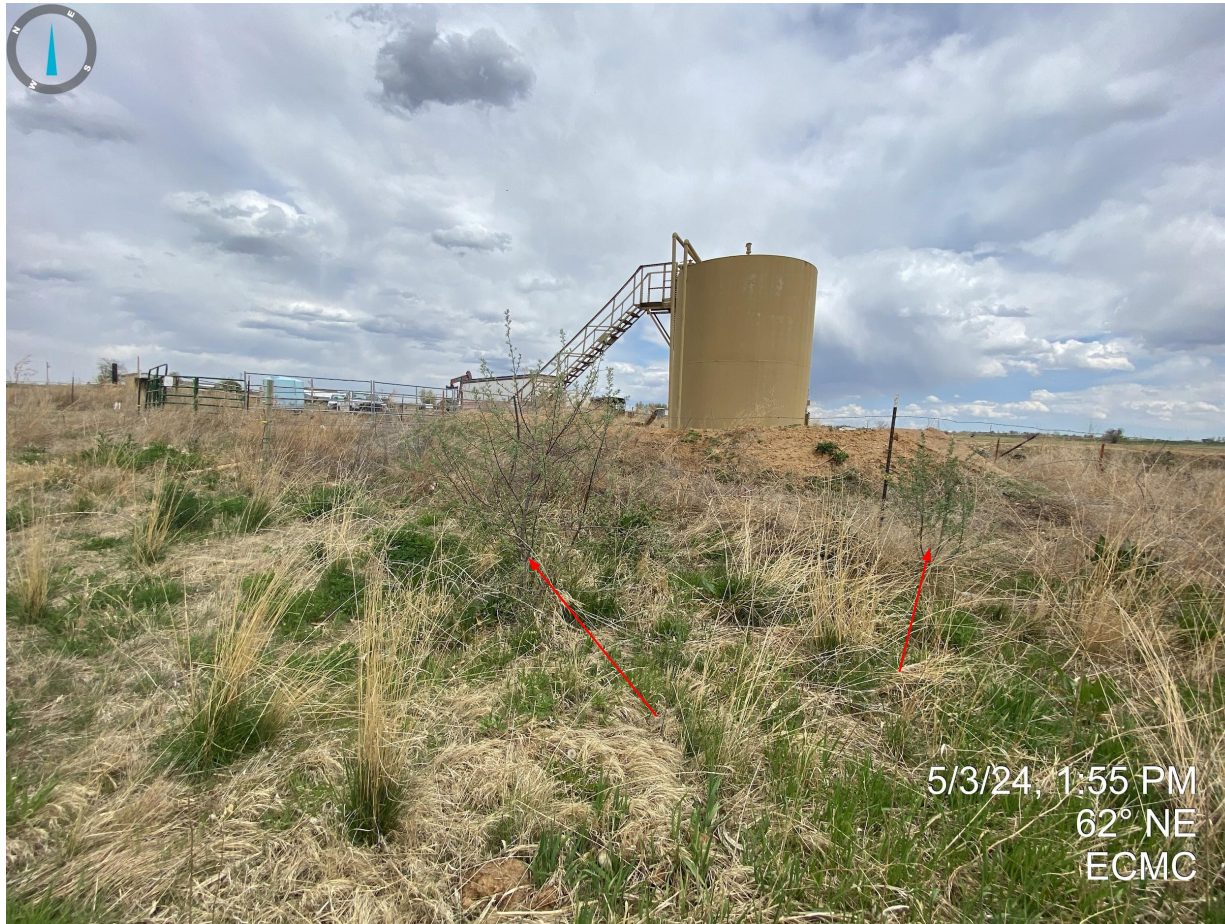
**Photo 1.** Russian Olive (CO List B Noxious Weed) observed growing on the southwest portion of the interim areas.

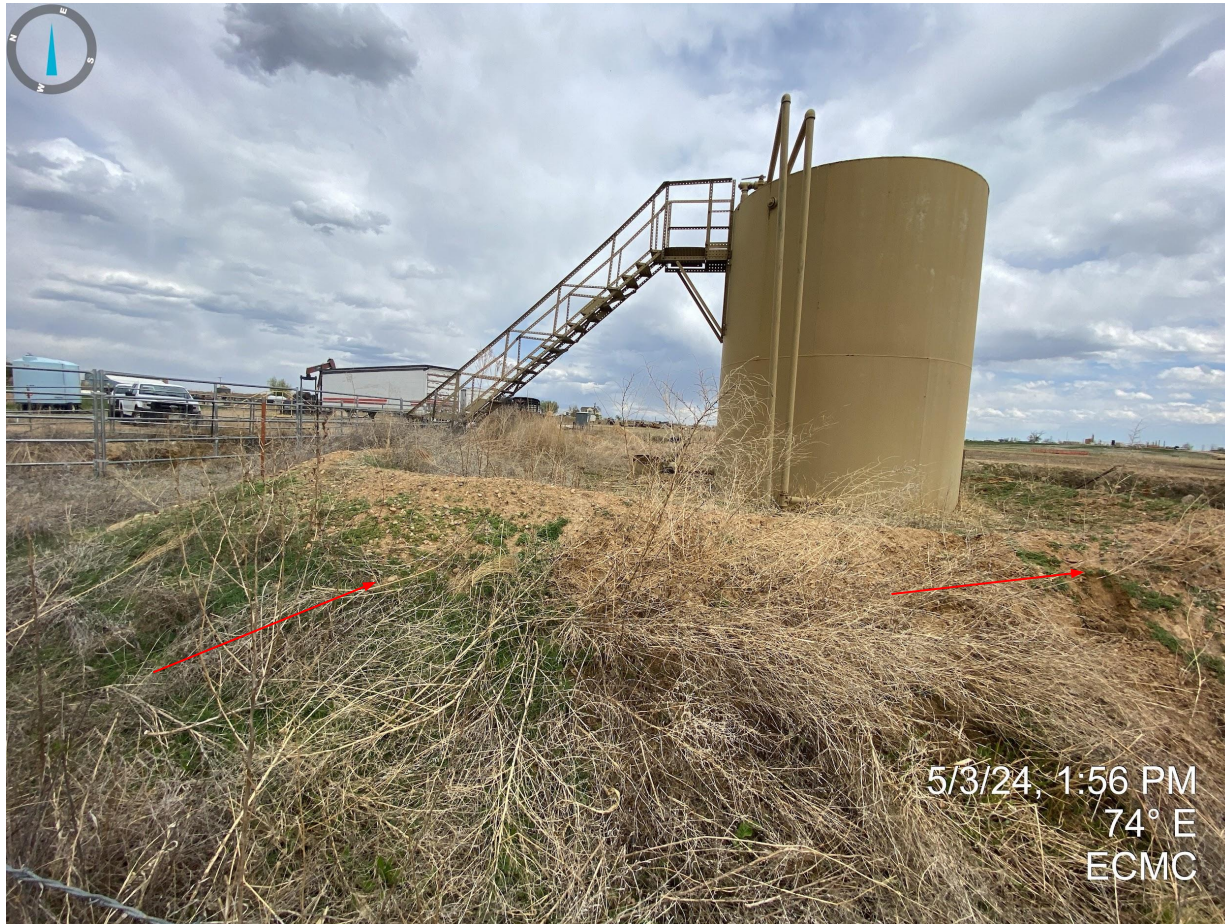
**Photo 2.** Undesirable vegetation (kochia) growing throughout the tank battery secondary containment.

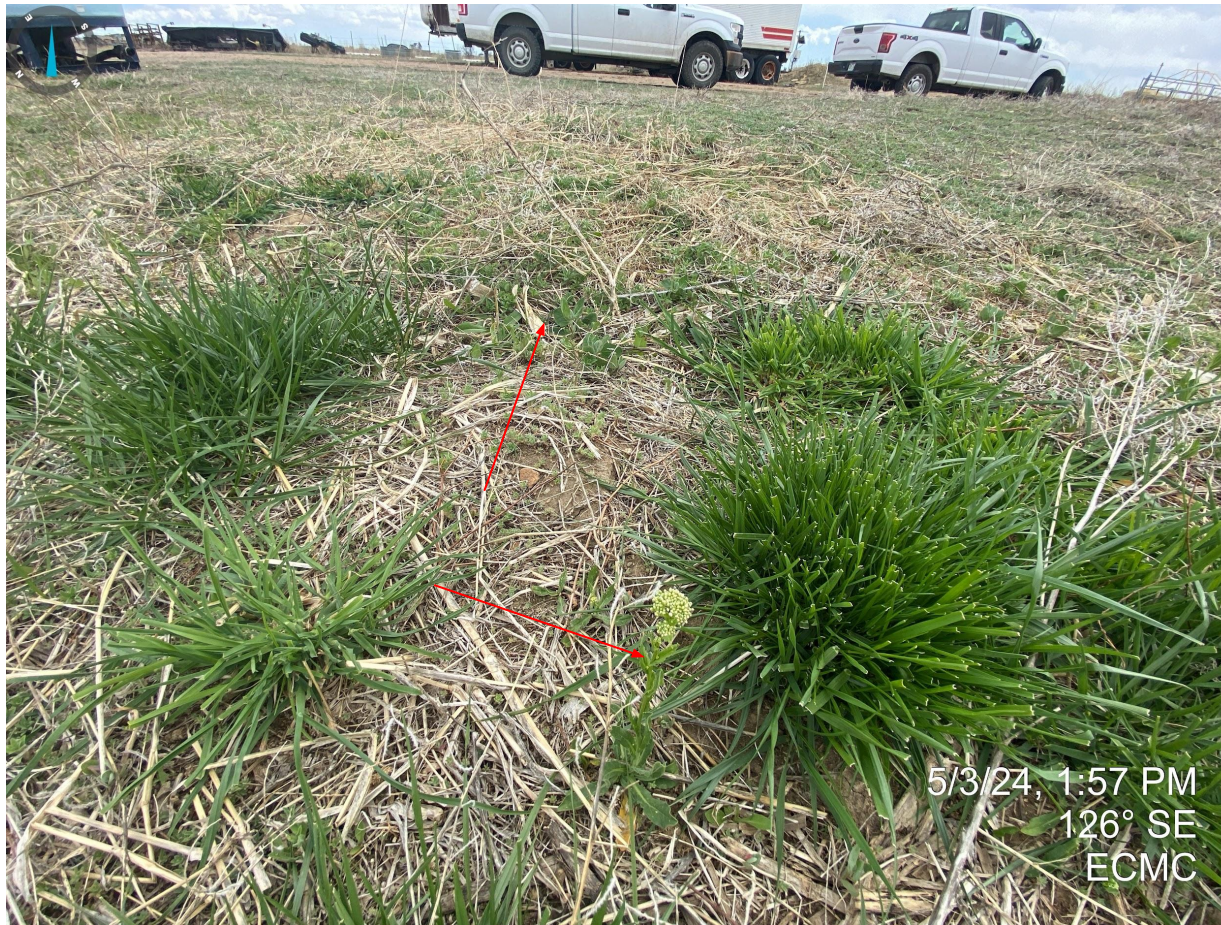
**Photo 3.** Close up example of hoary cress (CO List B Noxious Weed) growing throughout the location. Note - hoary cress was observed throughout the interim areas, western area pictured.

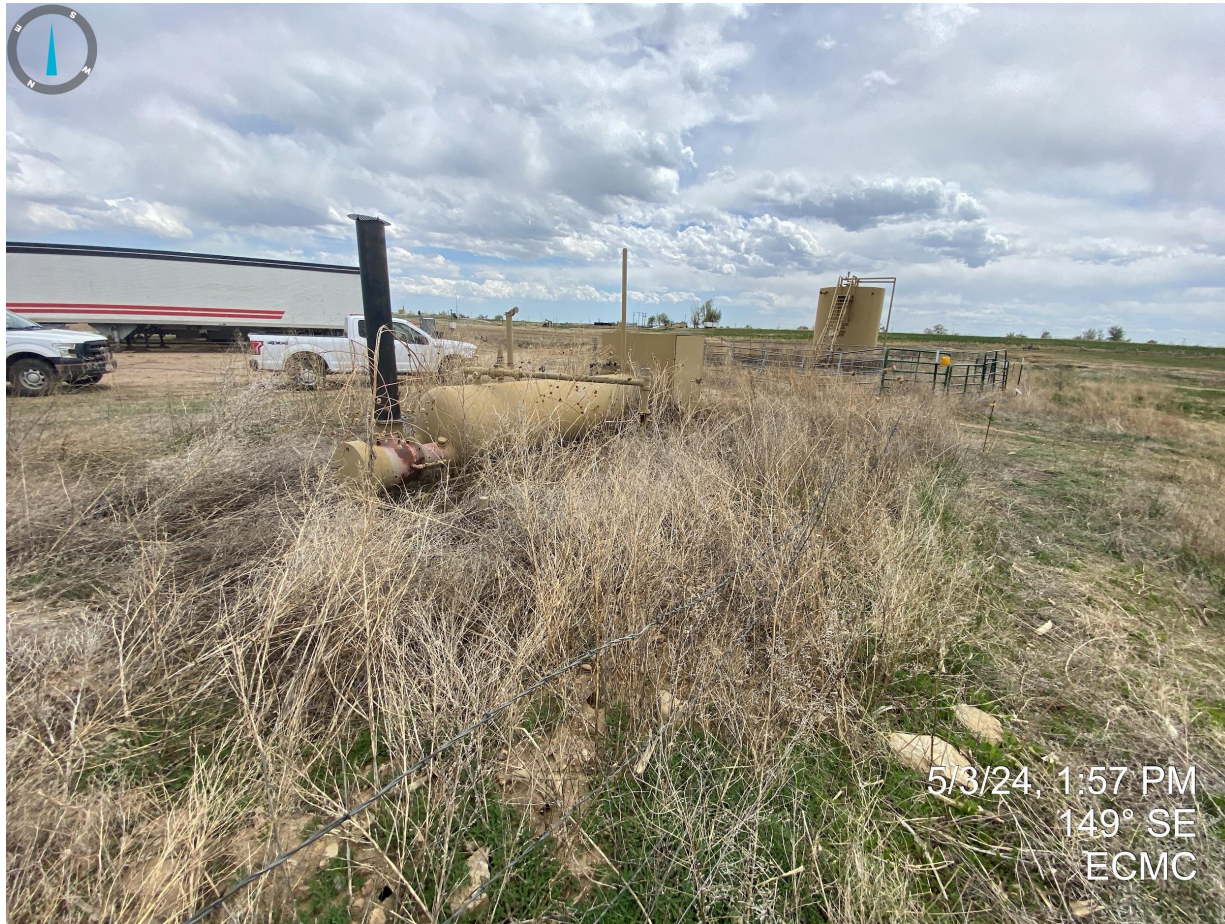
**Photo 4.** Weed debris observed throughout the location and equipment, separator pictured.

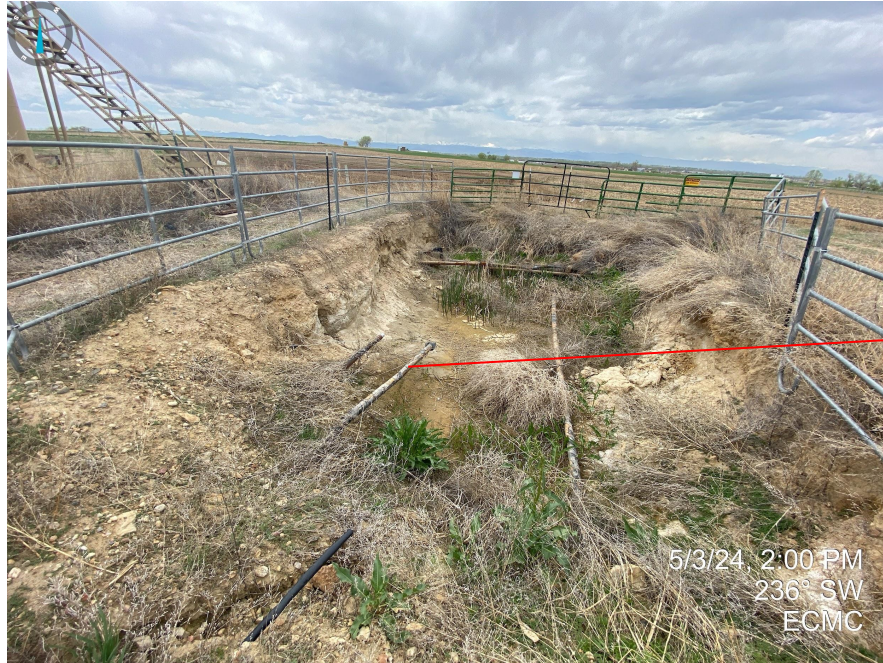
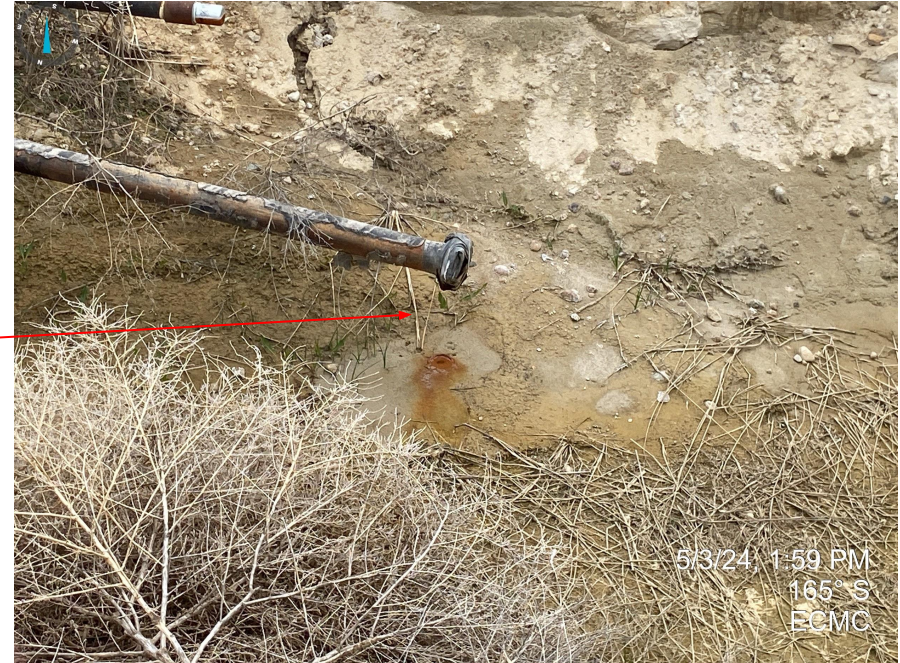
**Photo 5 & 6.** Open excavation with exposed flowlines. During this inspection, it was observed that the taped flowline was dripping with an unknown fluid with a discolored area directly underneath the flowline. Undesirable vegetation (curly dock) and older weed debris was observed within the open excavation.

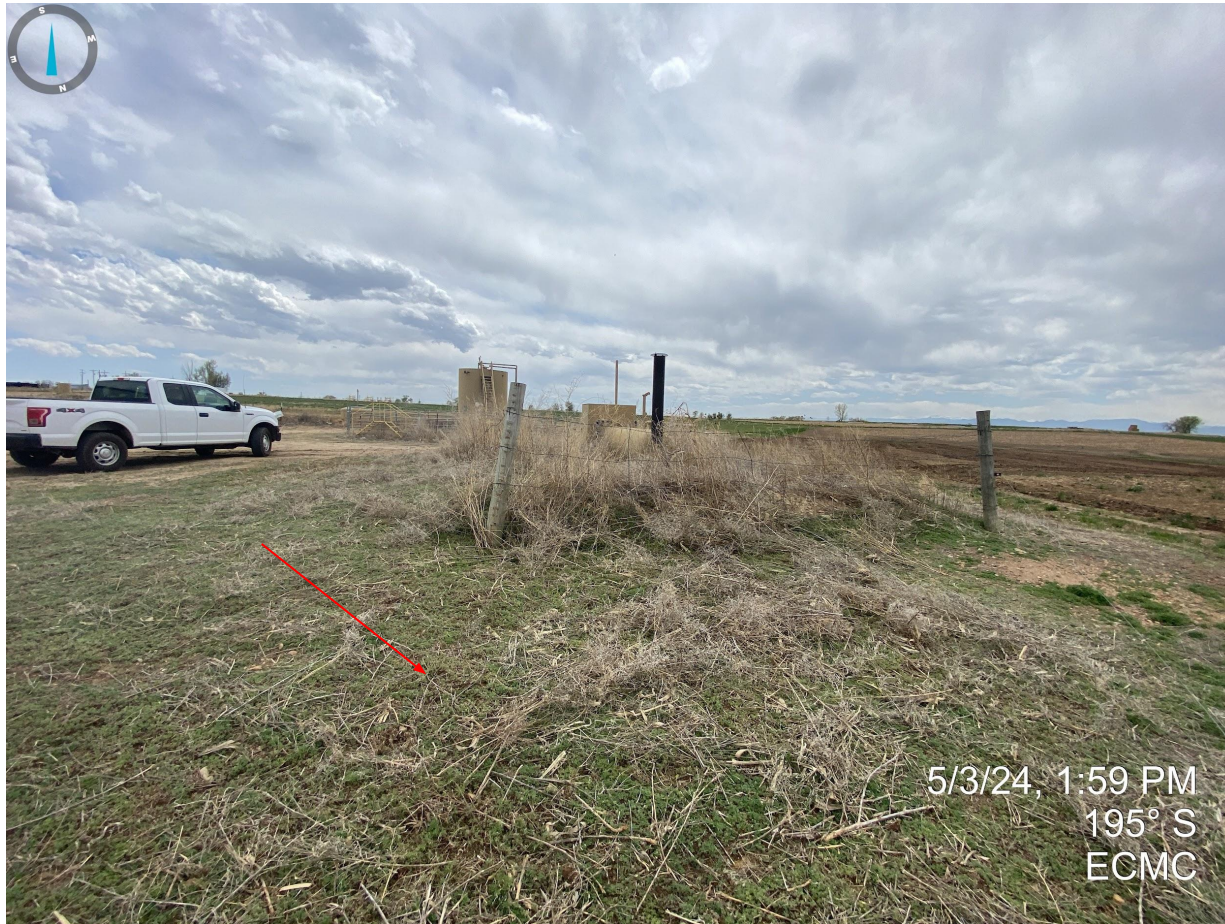
**Photo 7.** Production areas are predominantly undesirable vegetation (kochia).

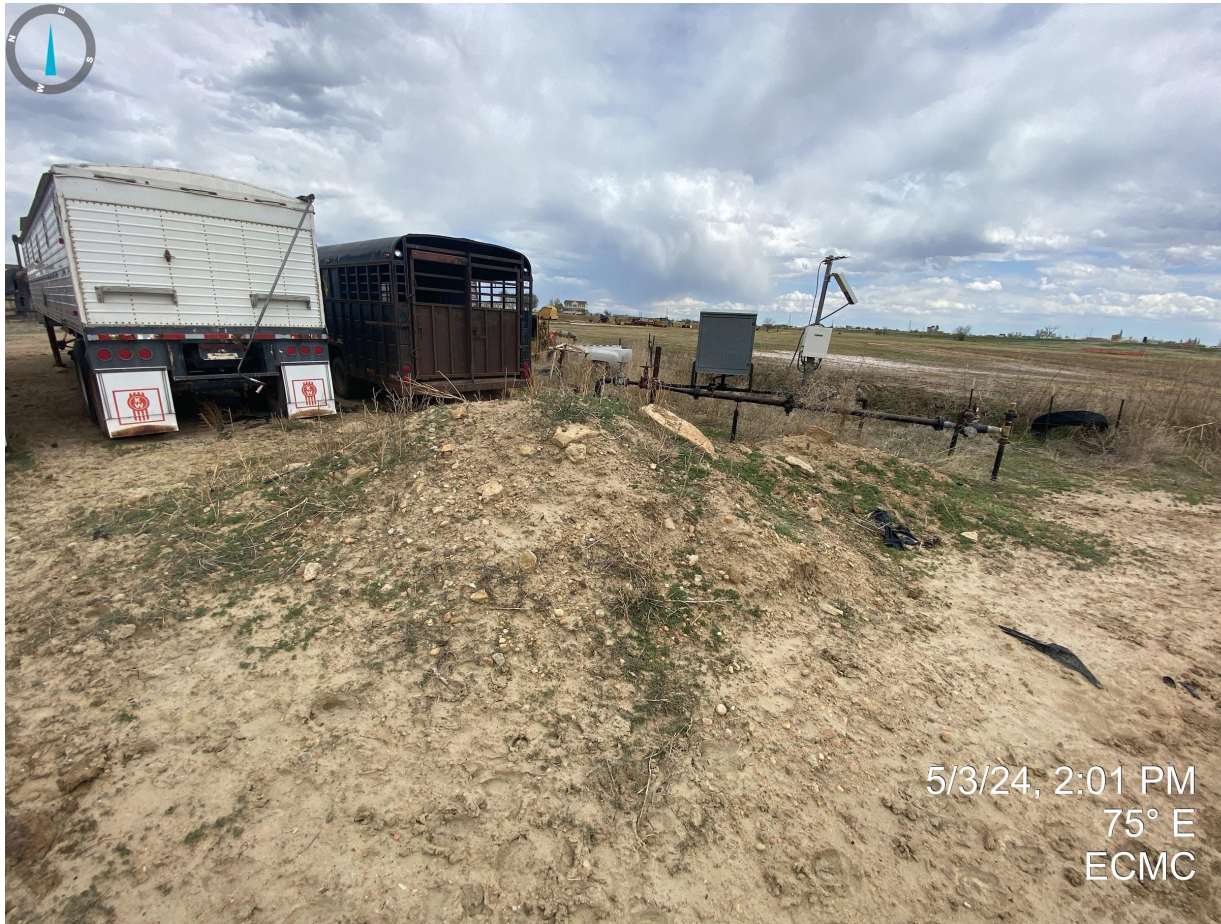
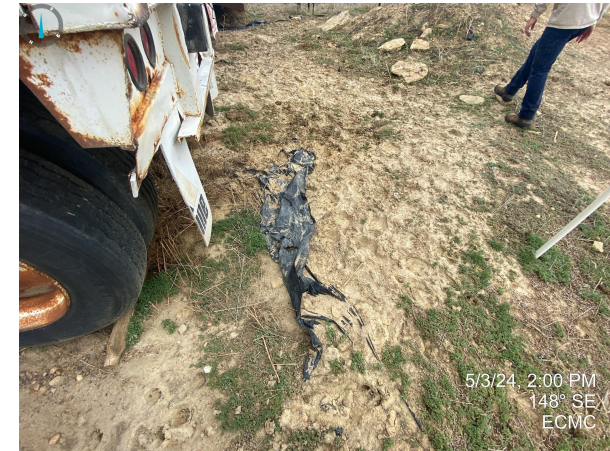
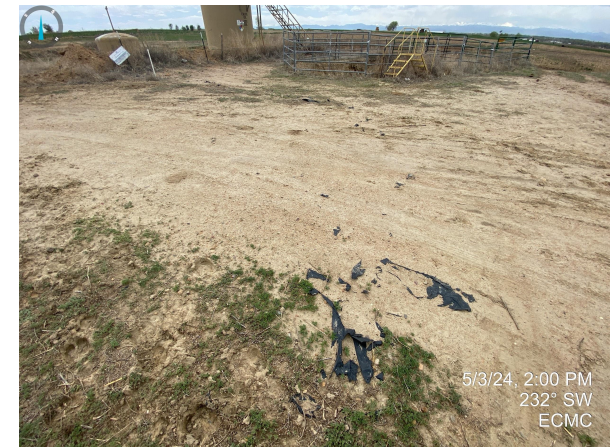
**Photo 8 , 9 & 10.** Stockpiled material from the open excavation does not have adequate secondary containment or proper stormwater control measures/BMPs to prevent stormwater from commingling with impacted materials and discharging off location into adjacent areas. Liner is deteriorating and not adequate.

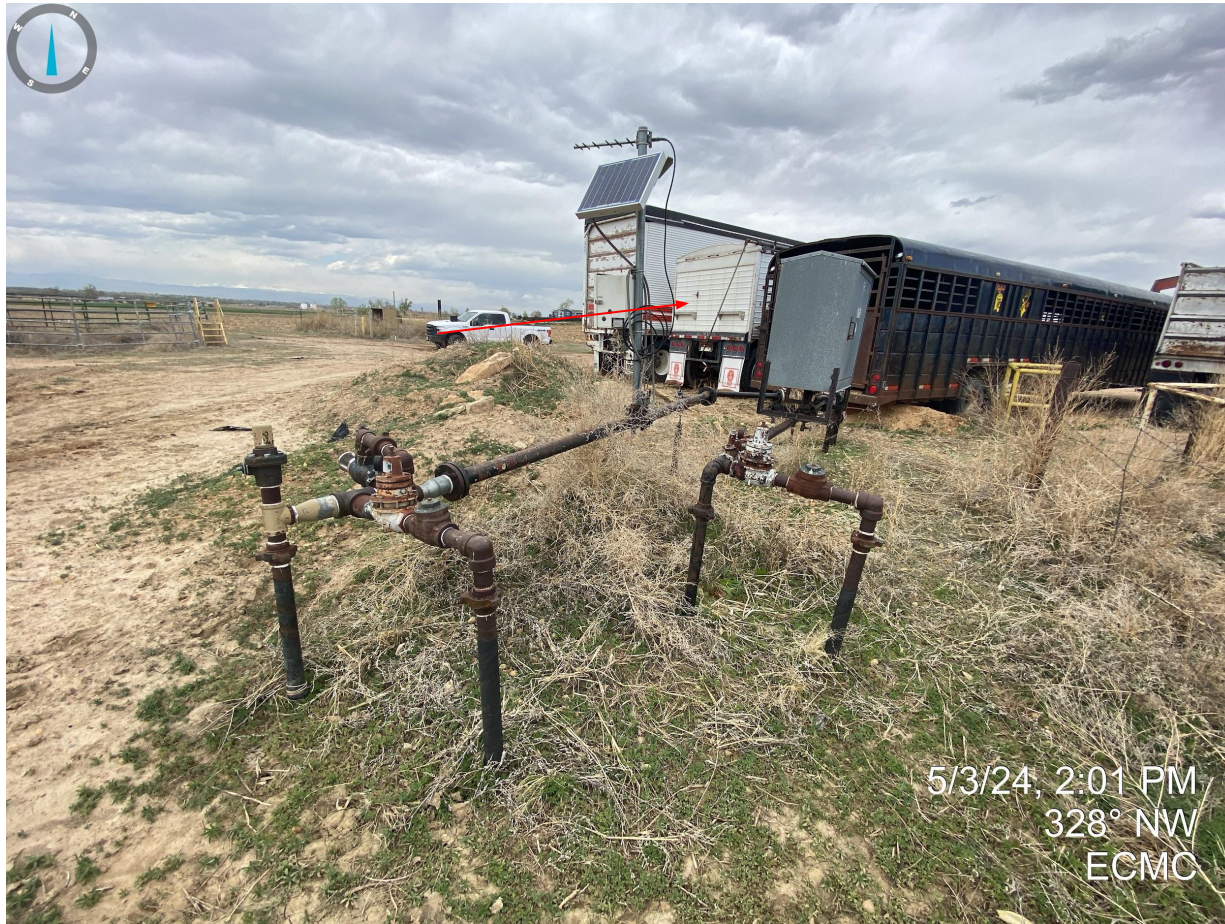
**Photo 11.** Equipment (e.g. trailers, tanks, etc) not needed for production operations is being stored on location.

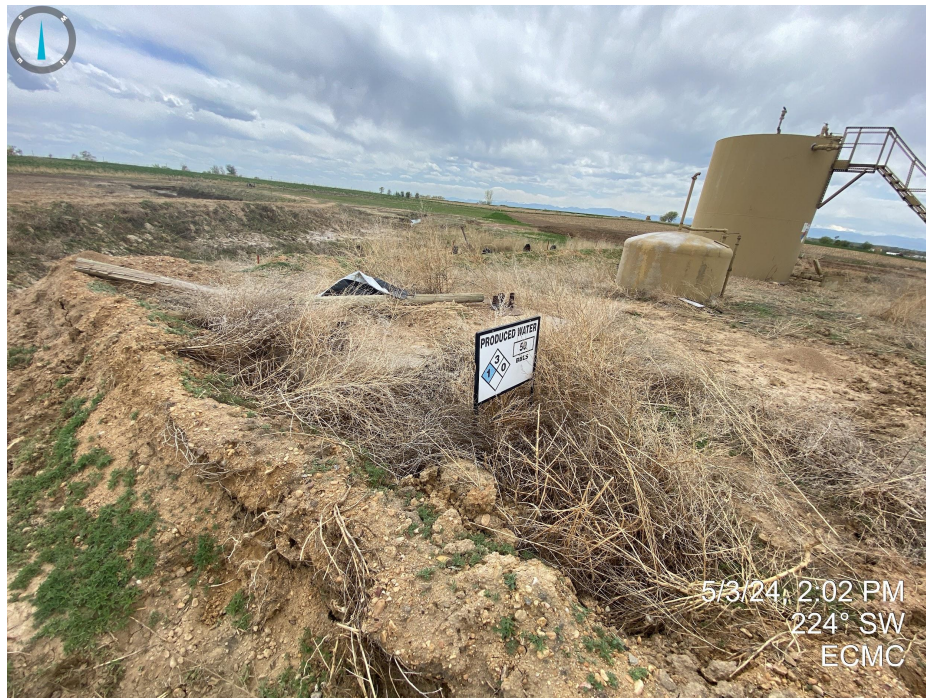
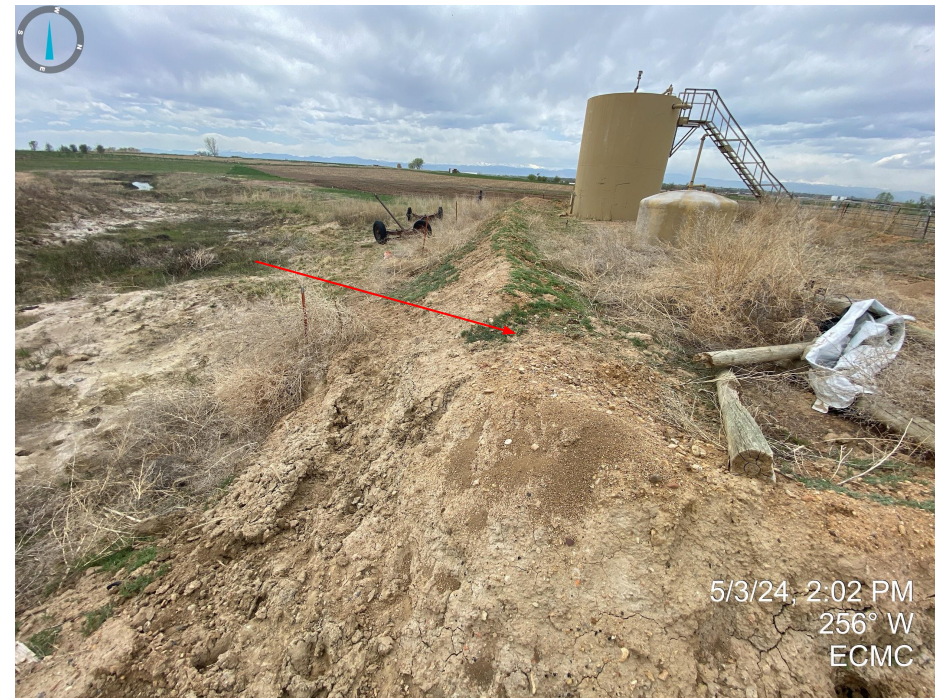
**Photo 12 & 13.** Secondary containment/berms around tank battery facility is not adequate as evidenced by unconsolidated materials and damage to berms (right photo, red arrow). Debris, trash and undesirable vegetation (kochia) also observed throughout.

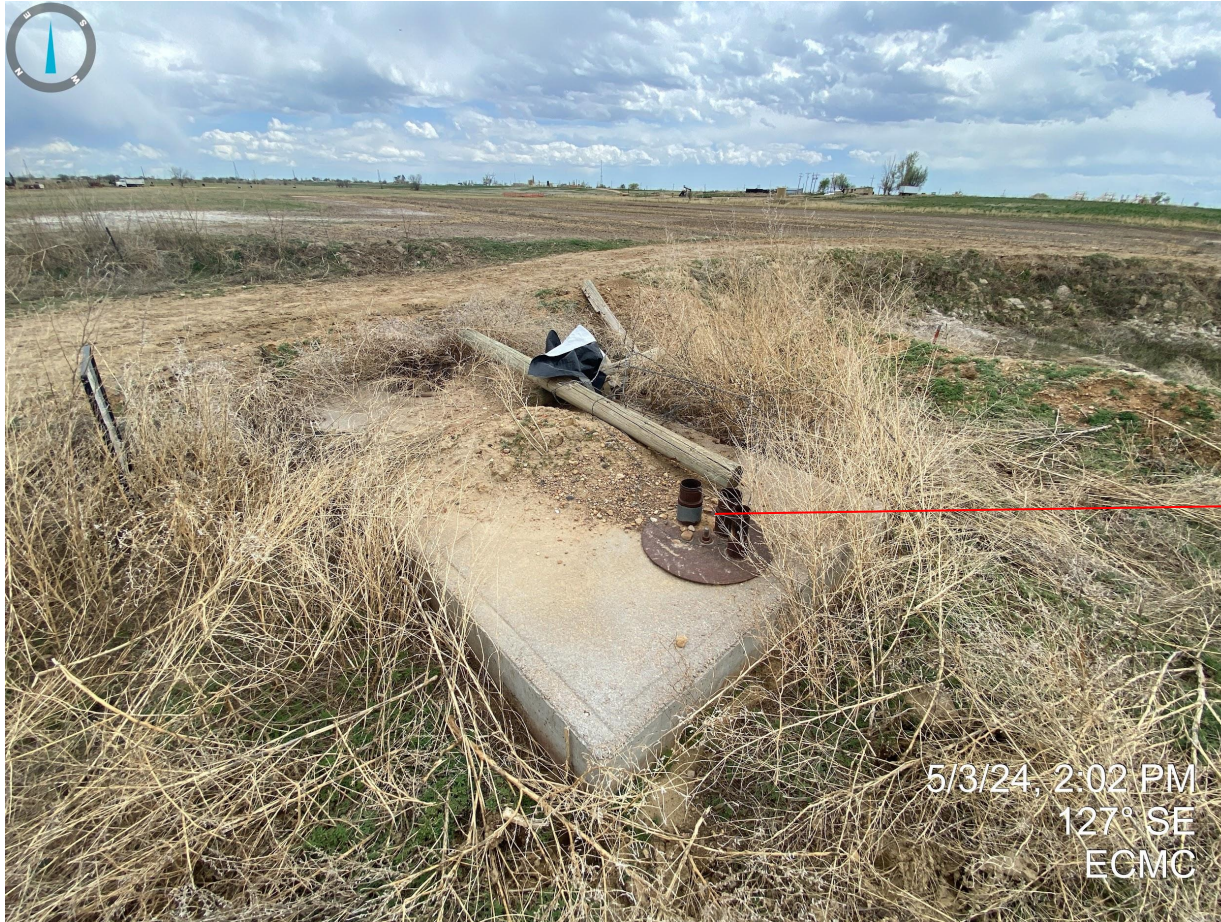
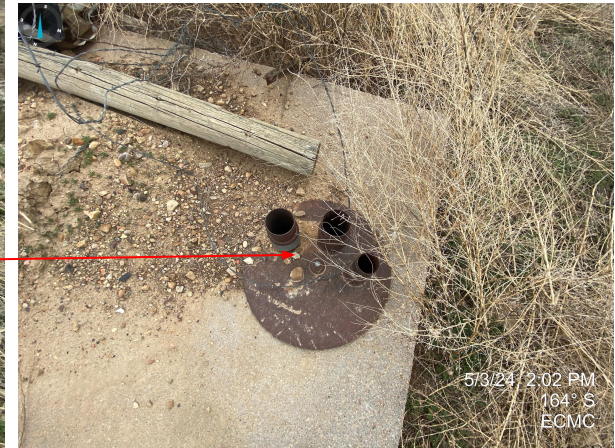
**Photo 14 & 15.** Buried produced water vault does not have adequate wildlife exclusion devices installed at openings.

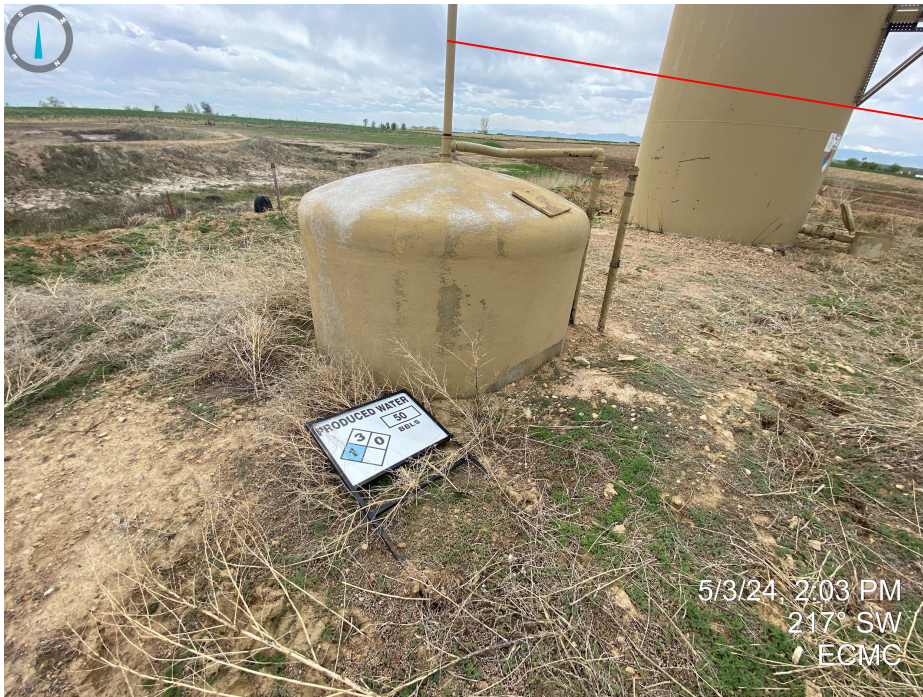
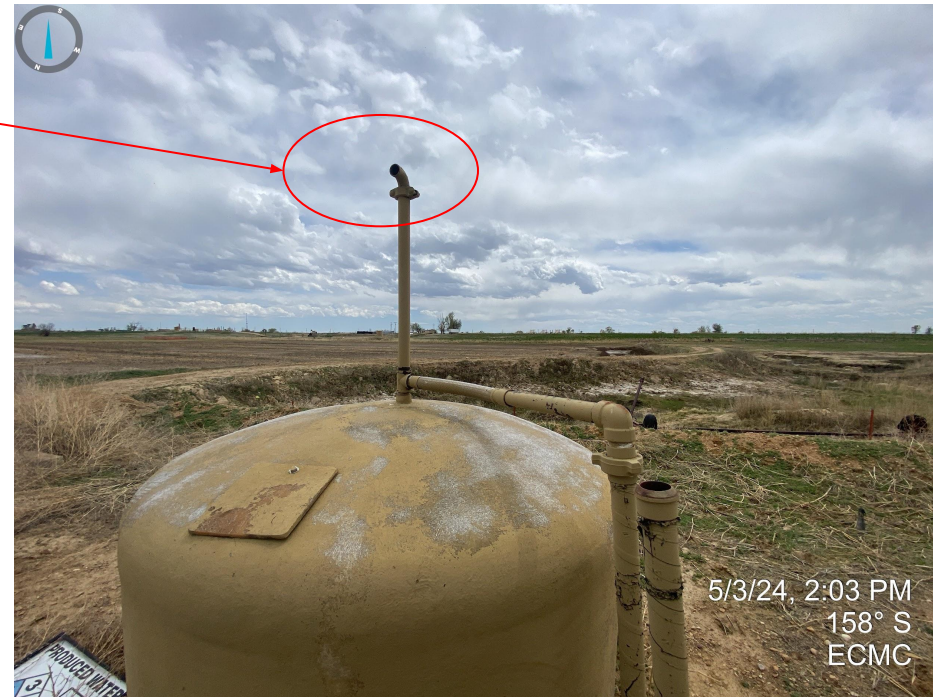
**Photo 16 & 17.** Fiberglass tank does not have adequate wildlife exclusion devices installed at openings.

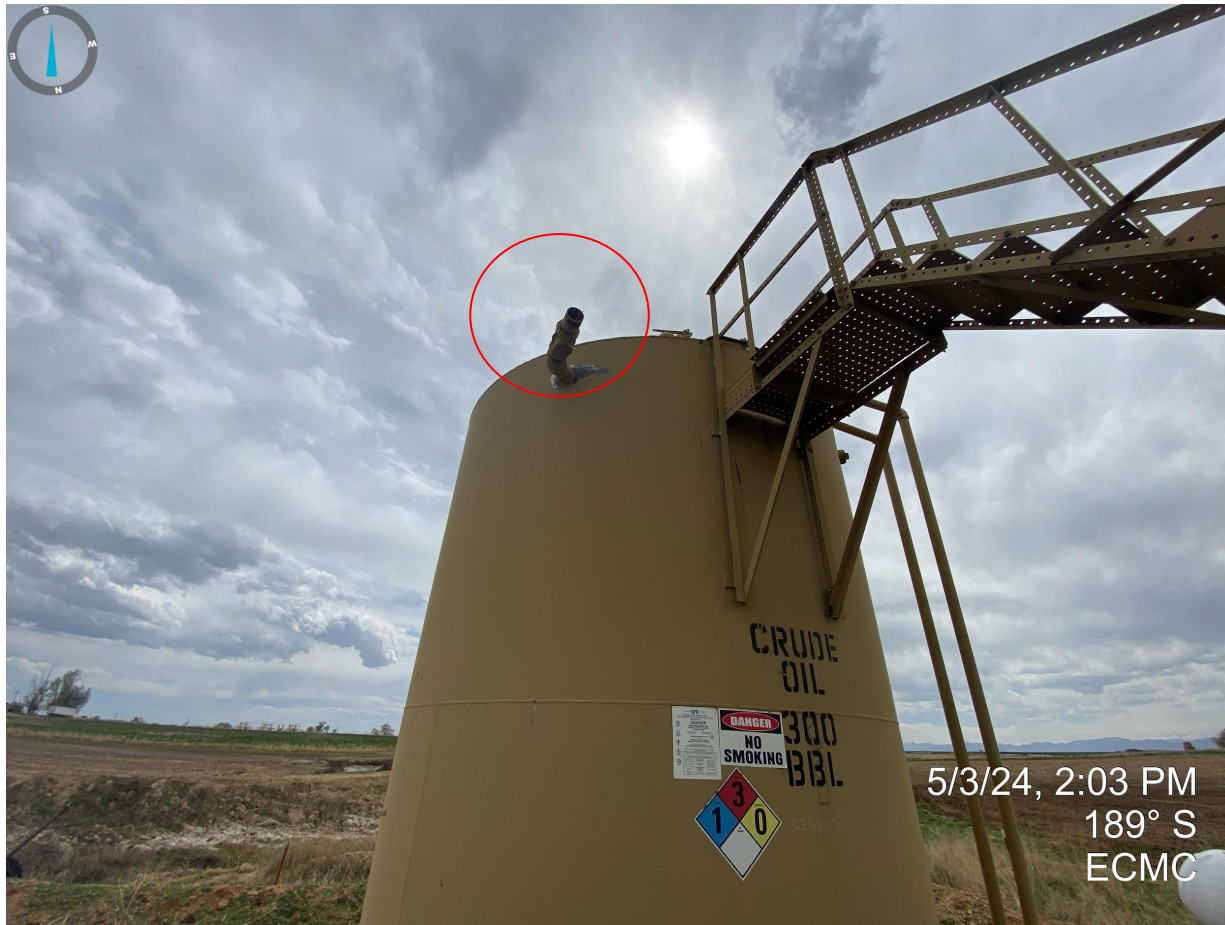
**Photo 18.** Tank battery does not have adequate wildlife exclusion devices installed at openings.

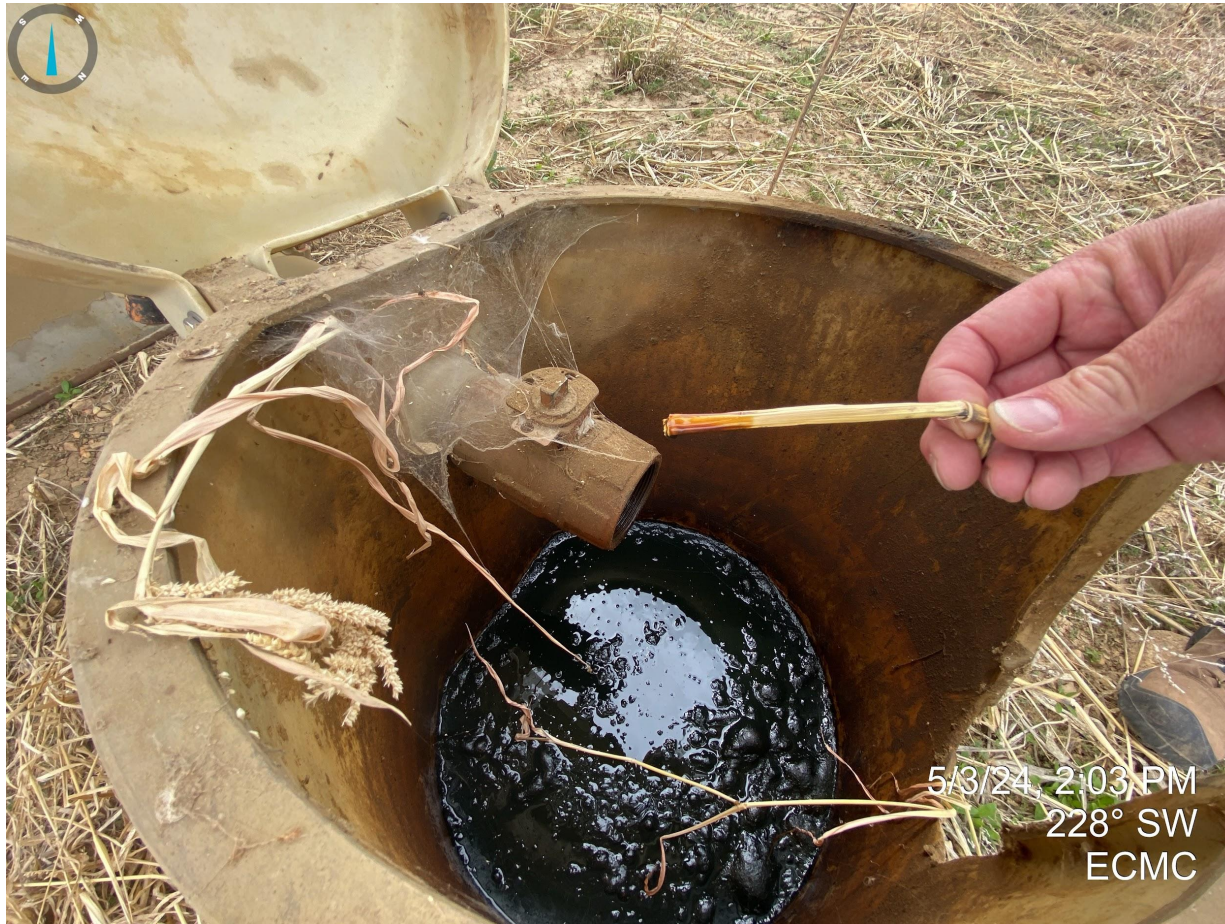
**Photo 19.** Free fluids observed within loadout line collection bucket need to be properly cleaned and disposed of.

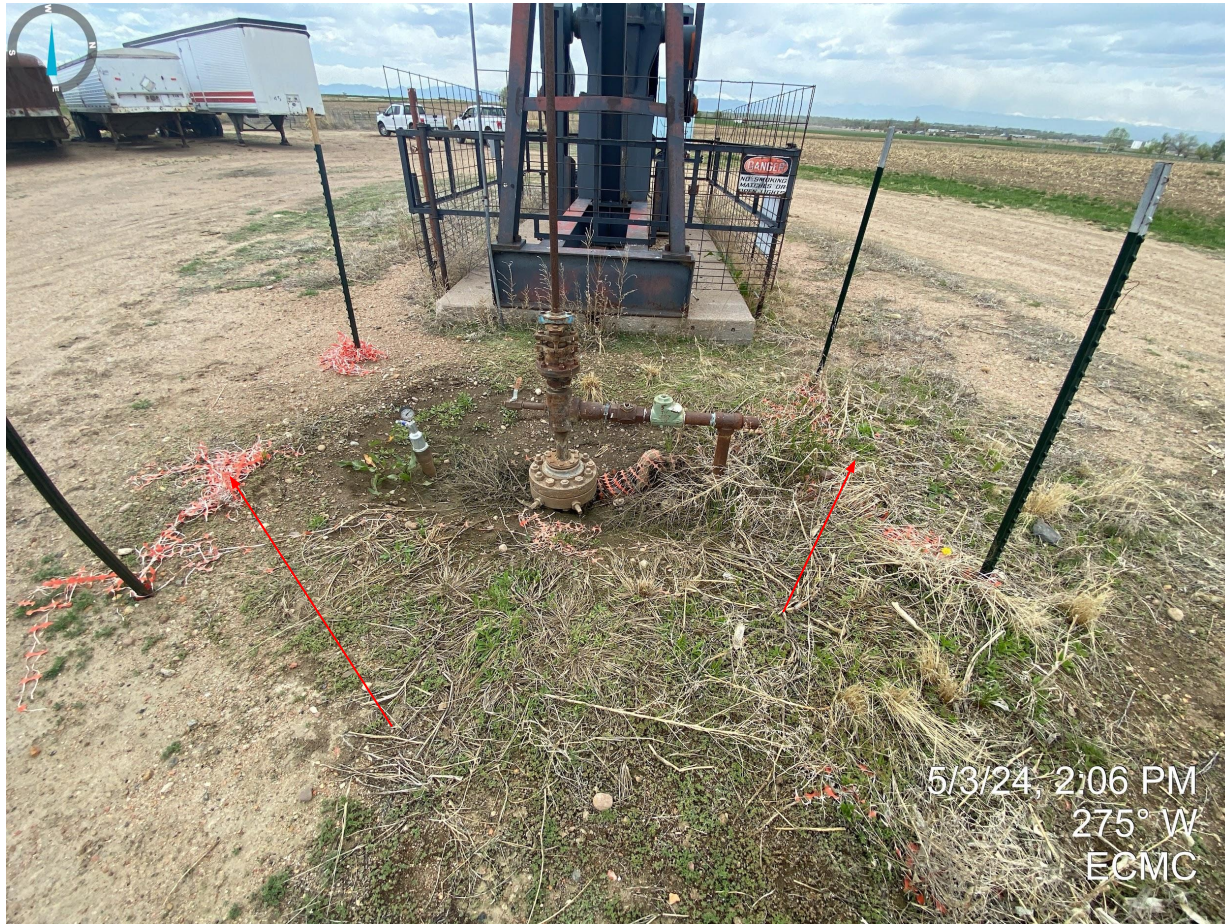
**Photo 20.** Trash and debris observed around wellhead.

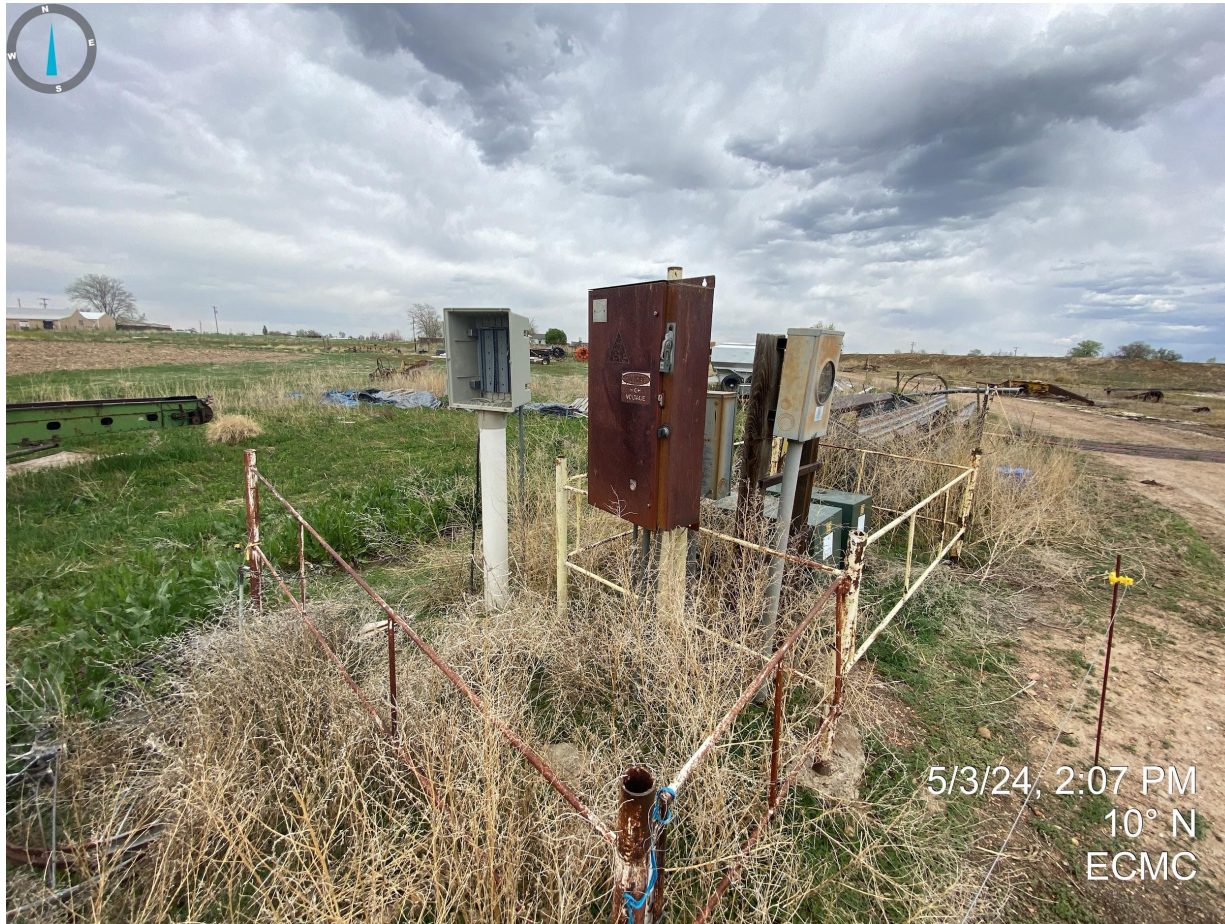
**Photo 21.** Weed debris observed throughout production equipment (electrical panels).

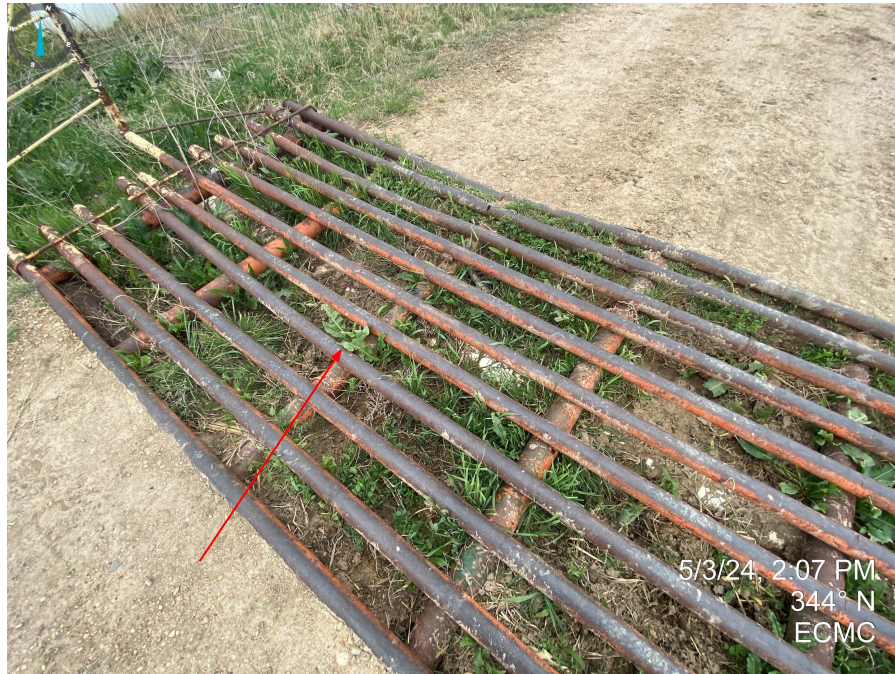
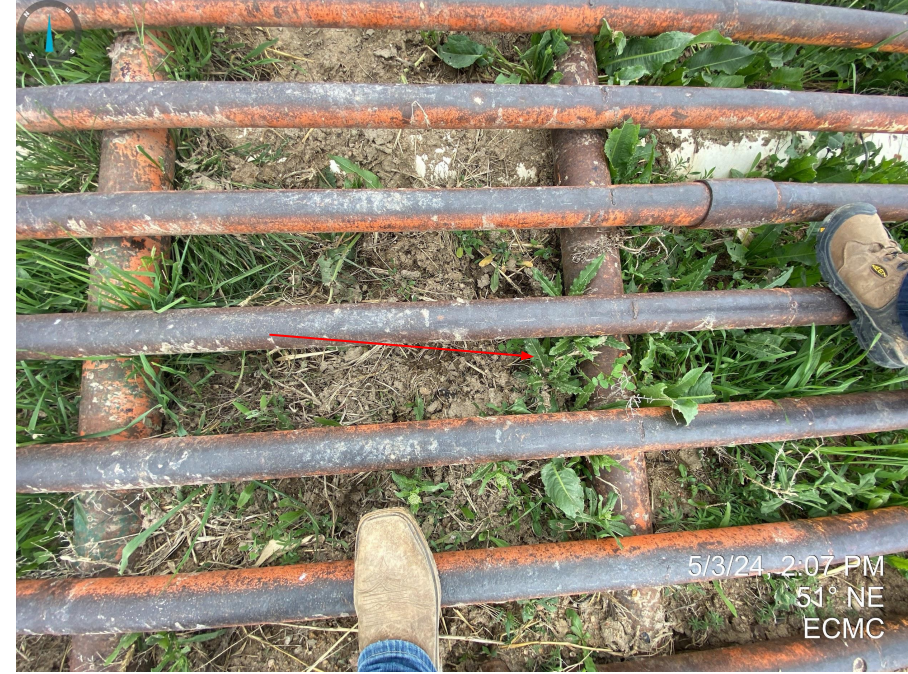
**Photo 22 & 23.** Undesirable vegetation (curly dock) and CO List B Noxious Weed (canada thistle) growing within cattle guard.

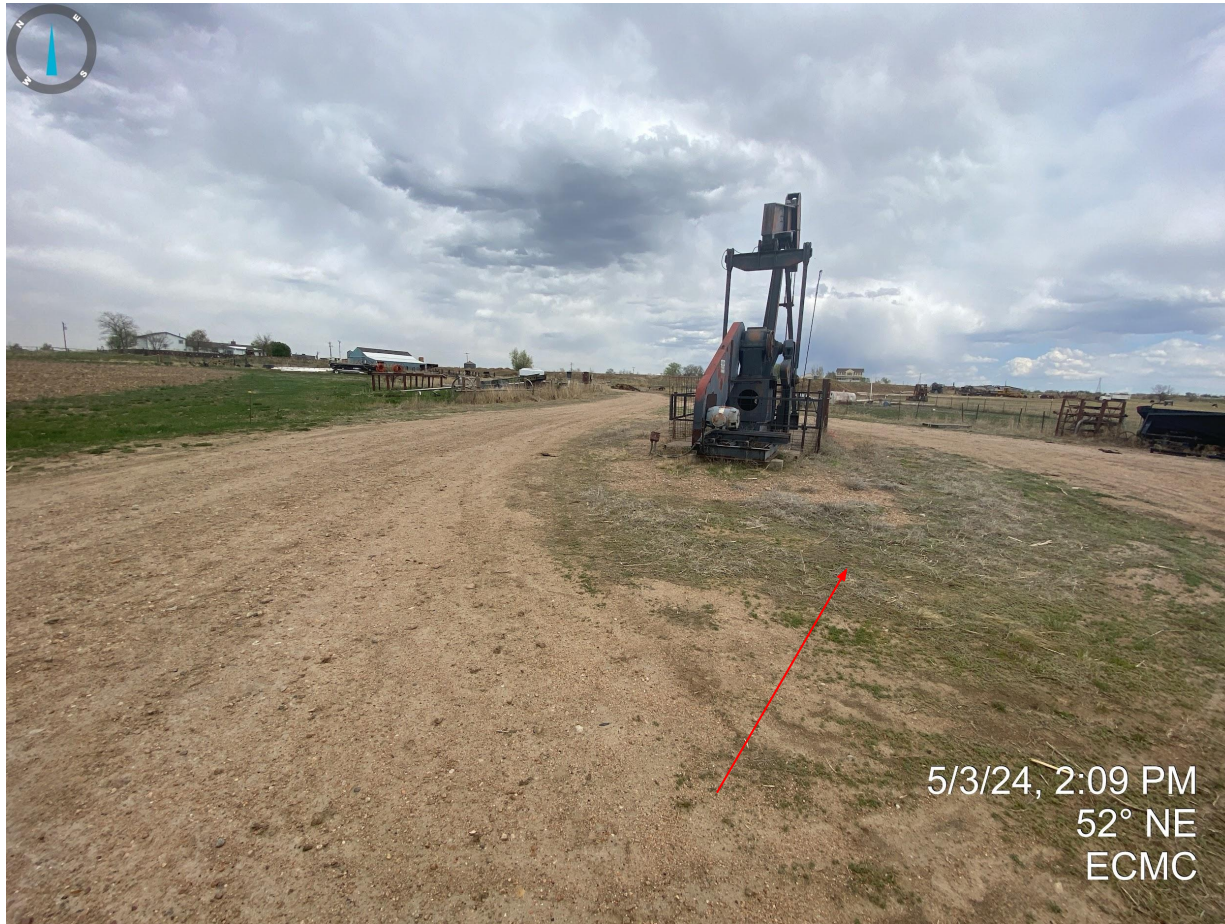
**Photo 24.** Undesirable vegetation (kochia) growing within the production areas.
