Inspection Photos

Operator: Maralex Resource Inc. - 53255

Location ID: 333984

Inspection Document #: 714000732

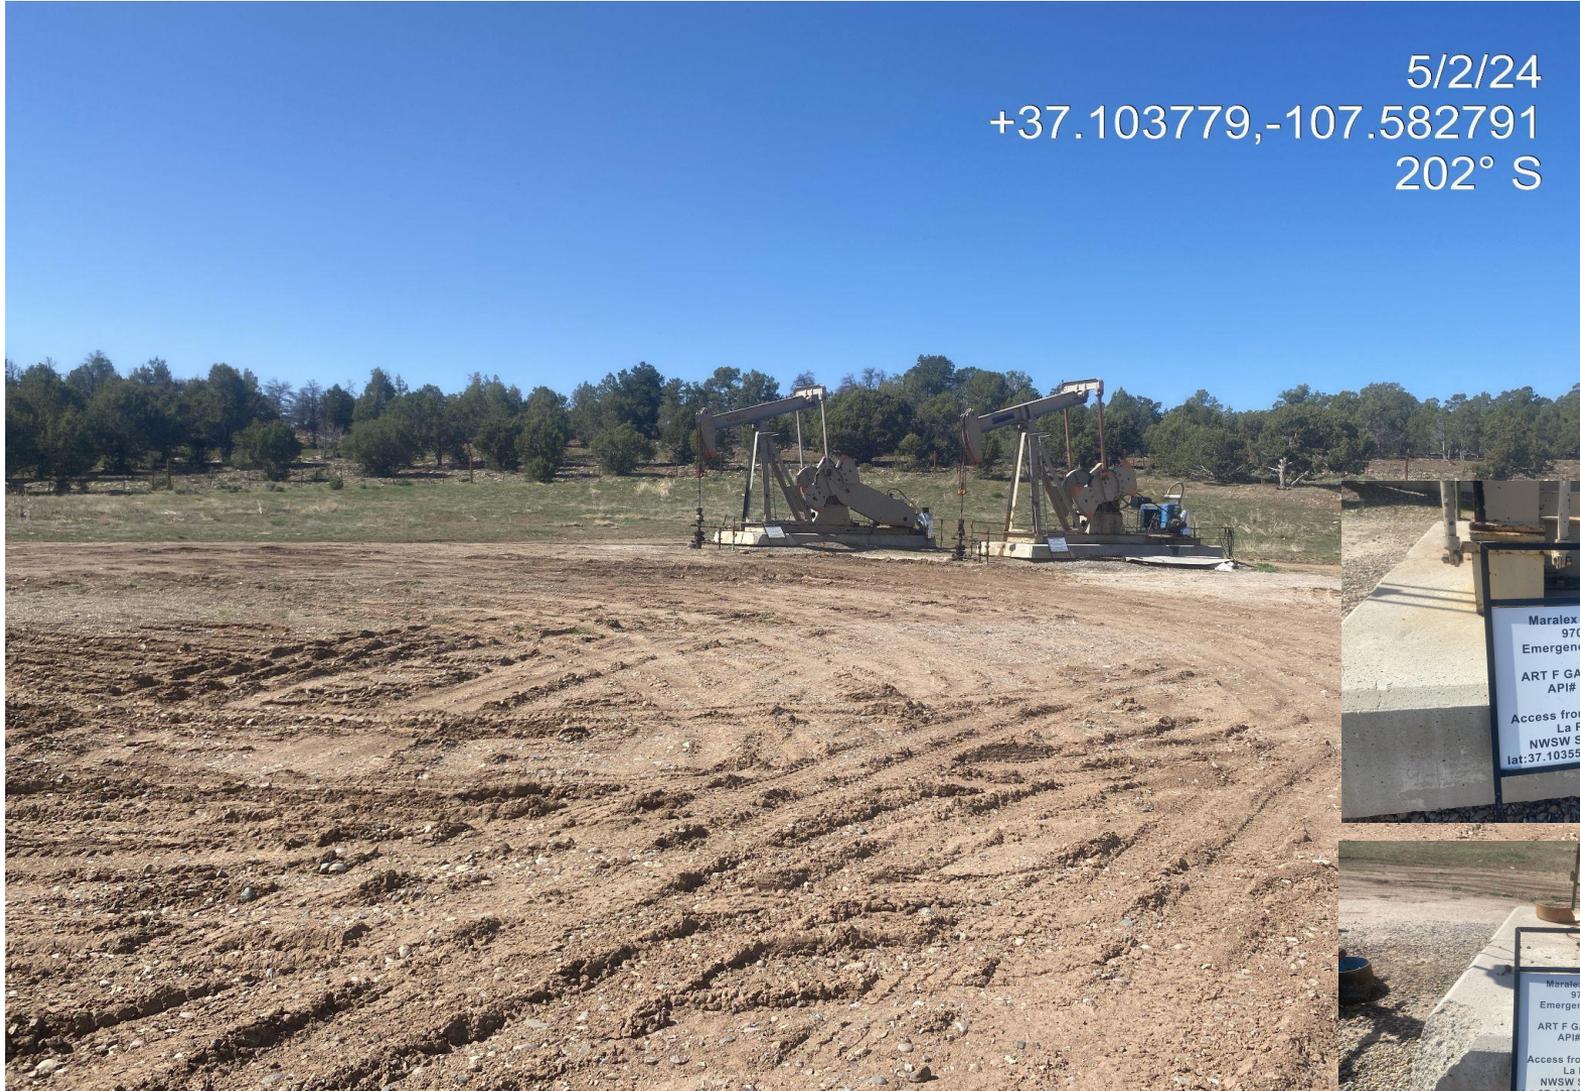
Photo 1. View of the well disturbance from the access point facing center.

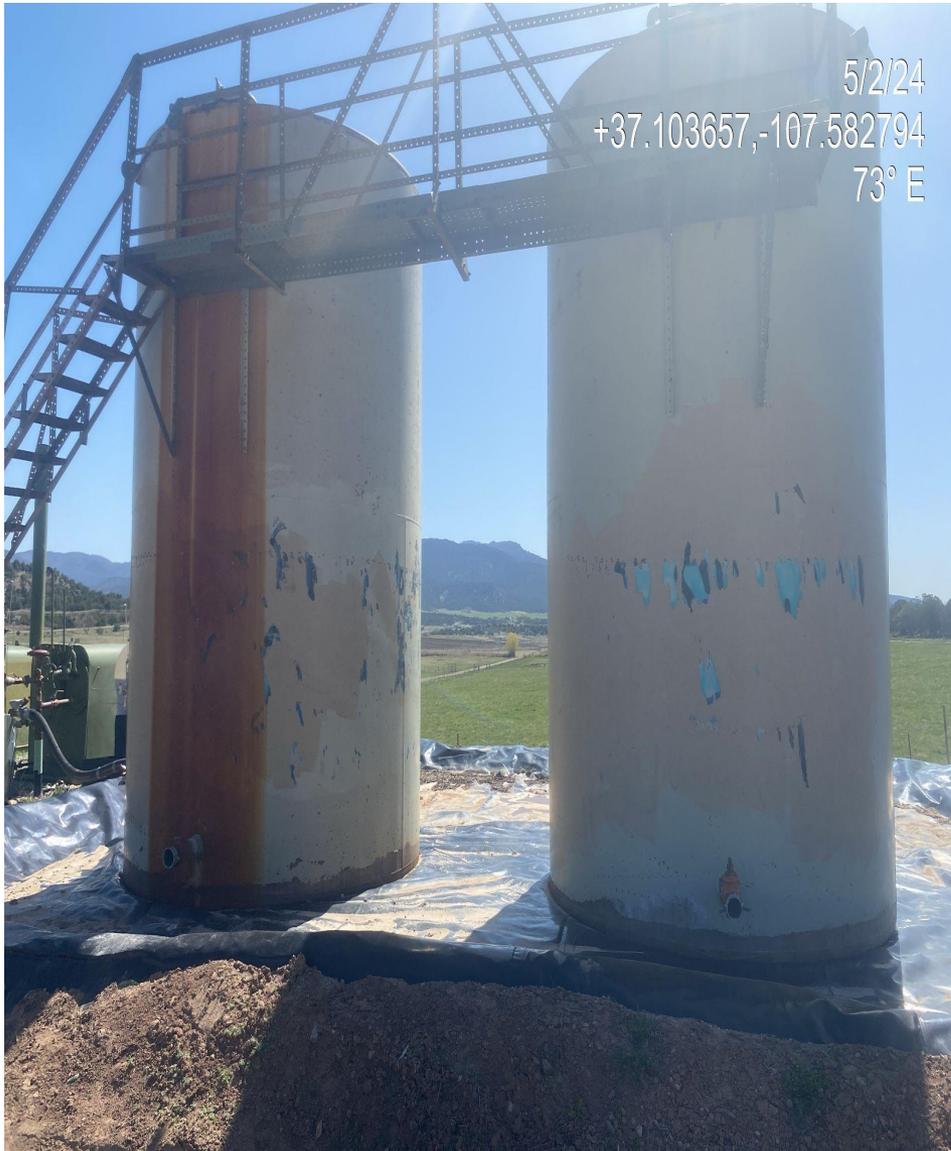
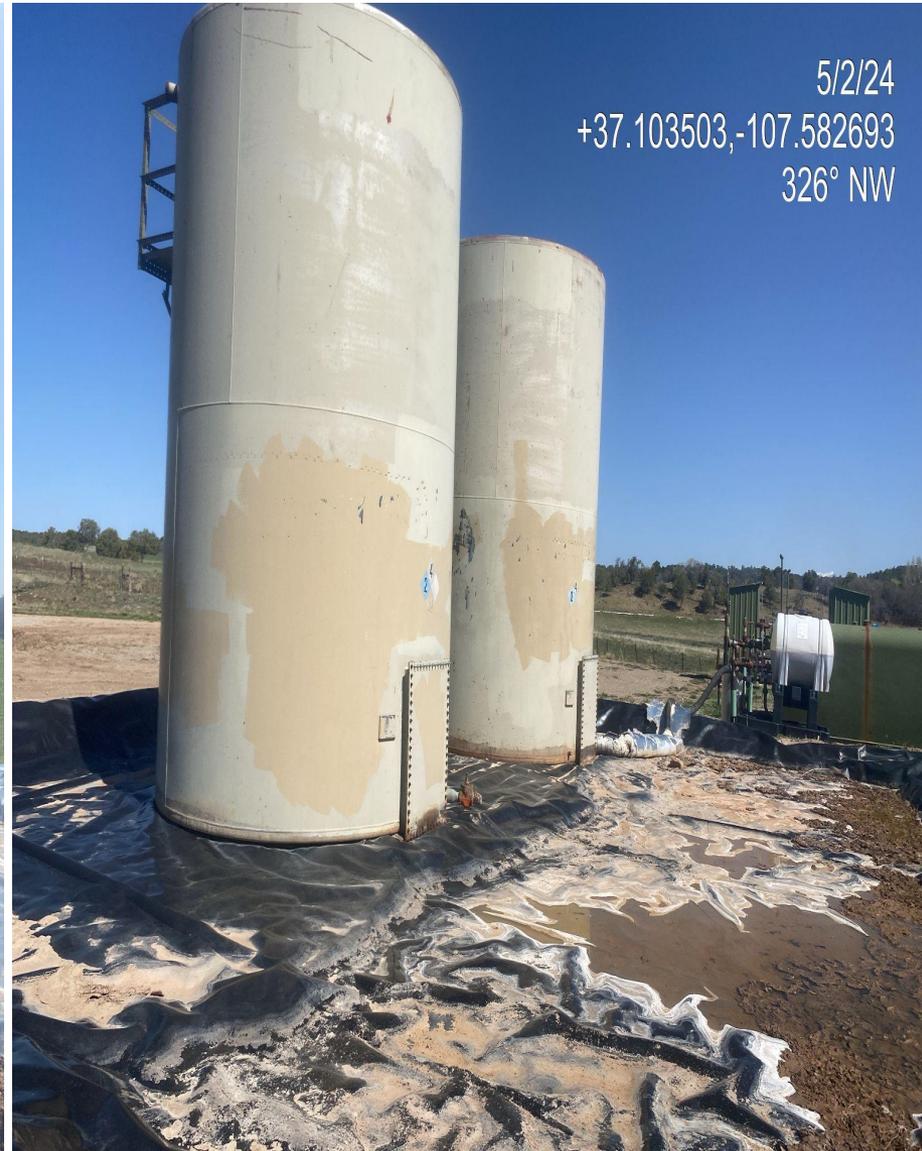
Photo 3. Produced water tanks on location are in use but are not marked.

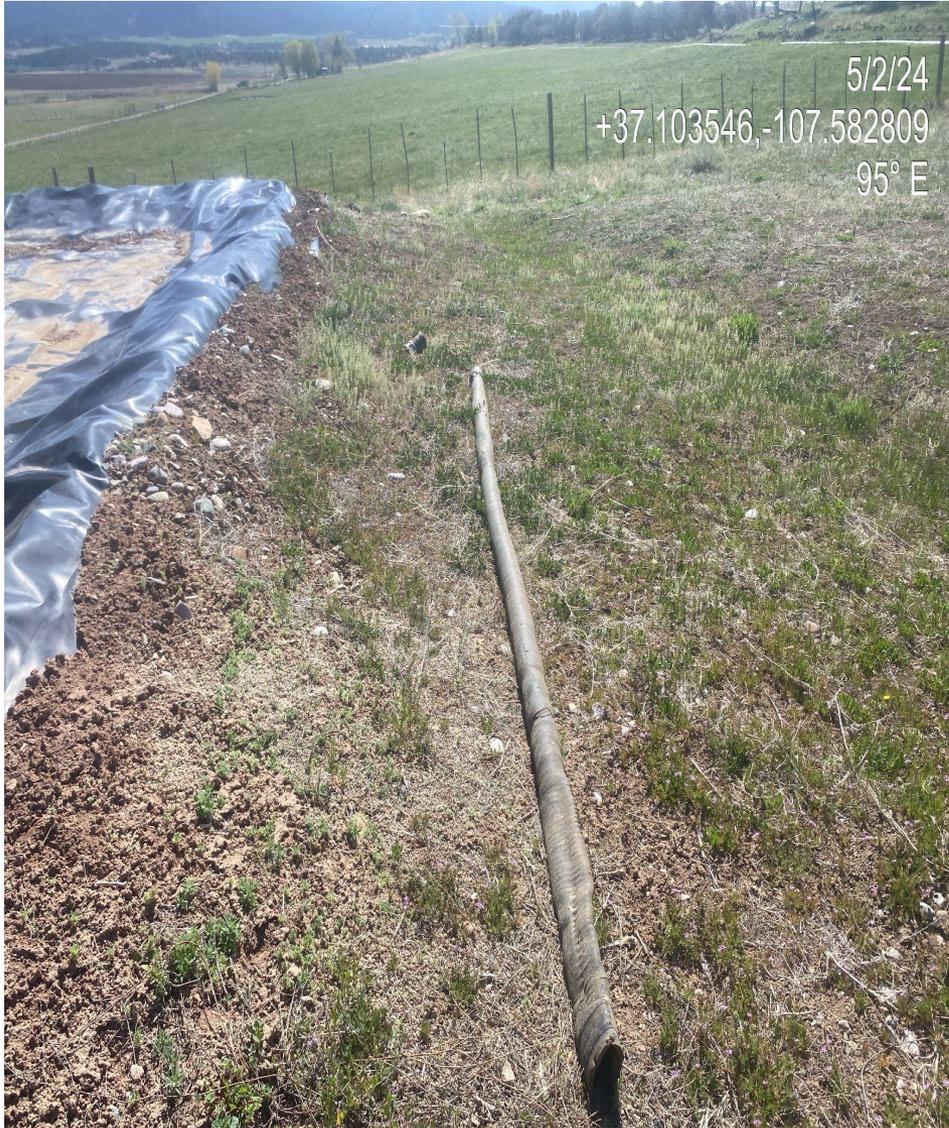
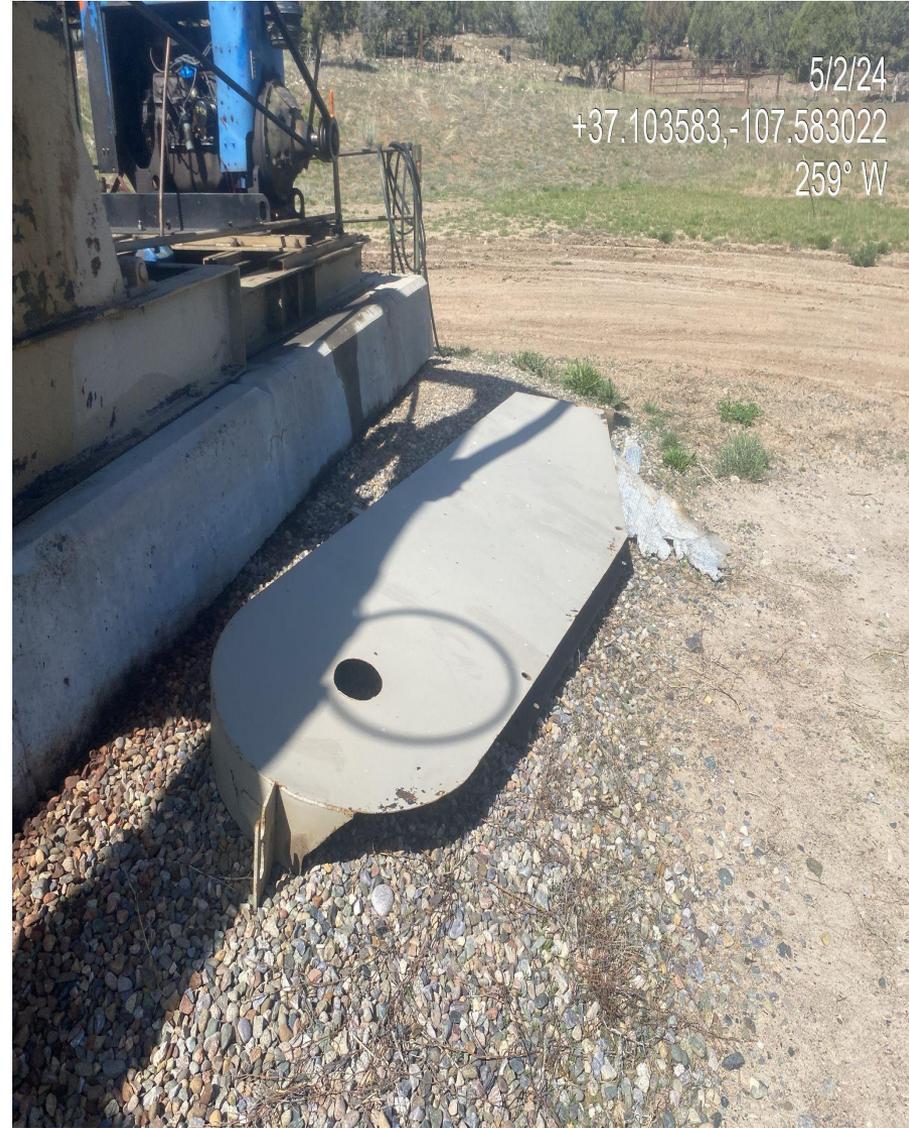
Photo 4. View of plastic tubing trash and unused oil and gas equipment on location.

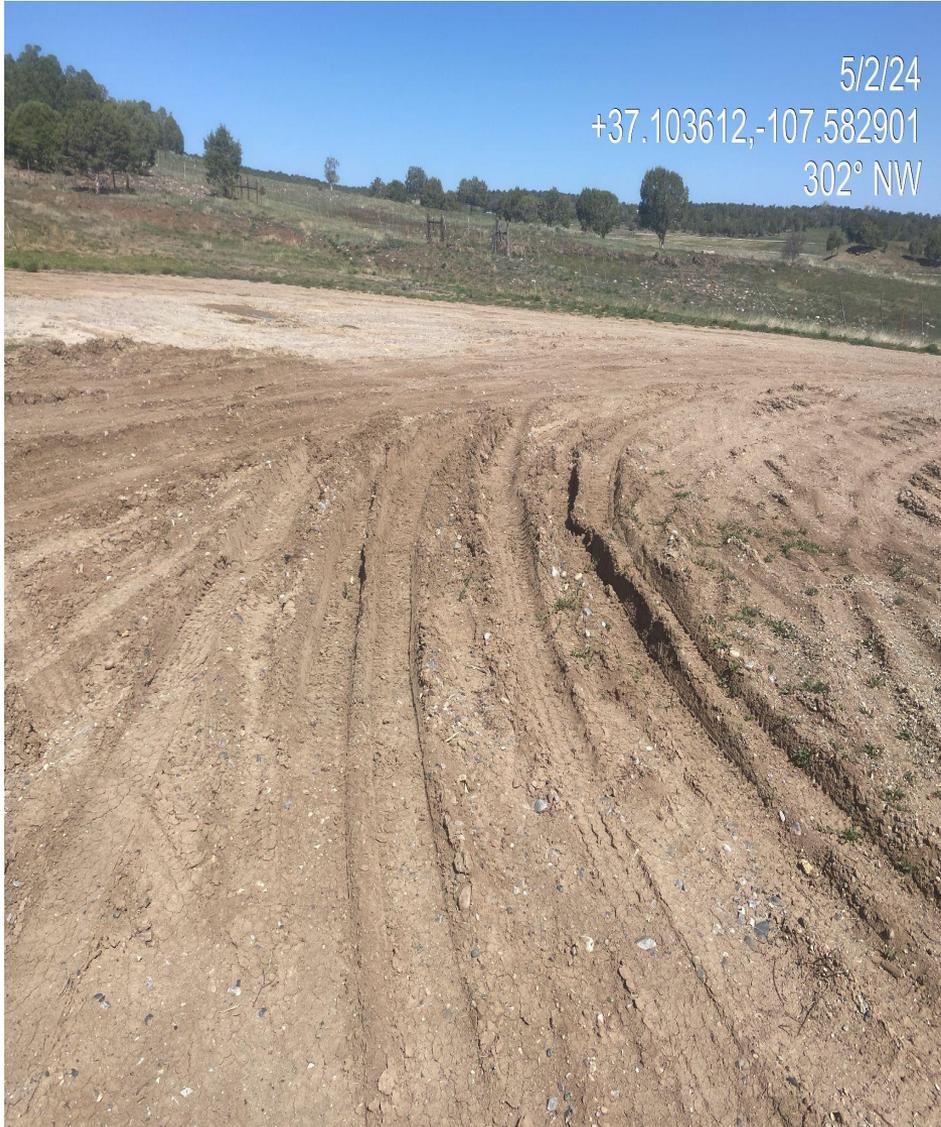
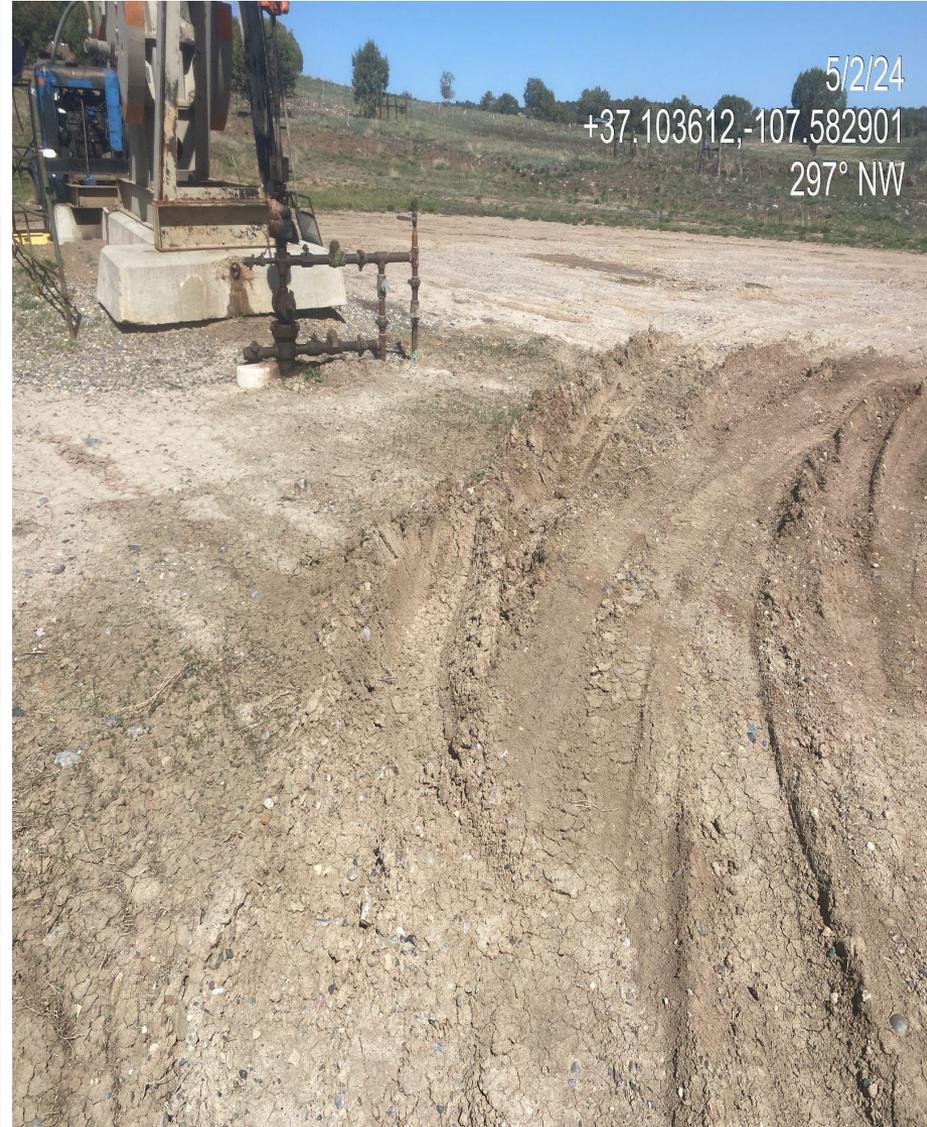
Photo 5. View of rutting observed on the active pad. Additional stabilization is needed to minimize site degradation.

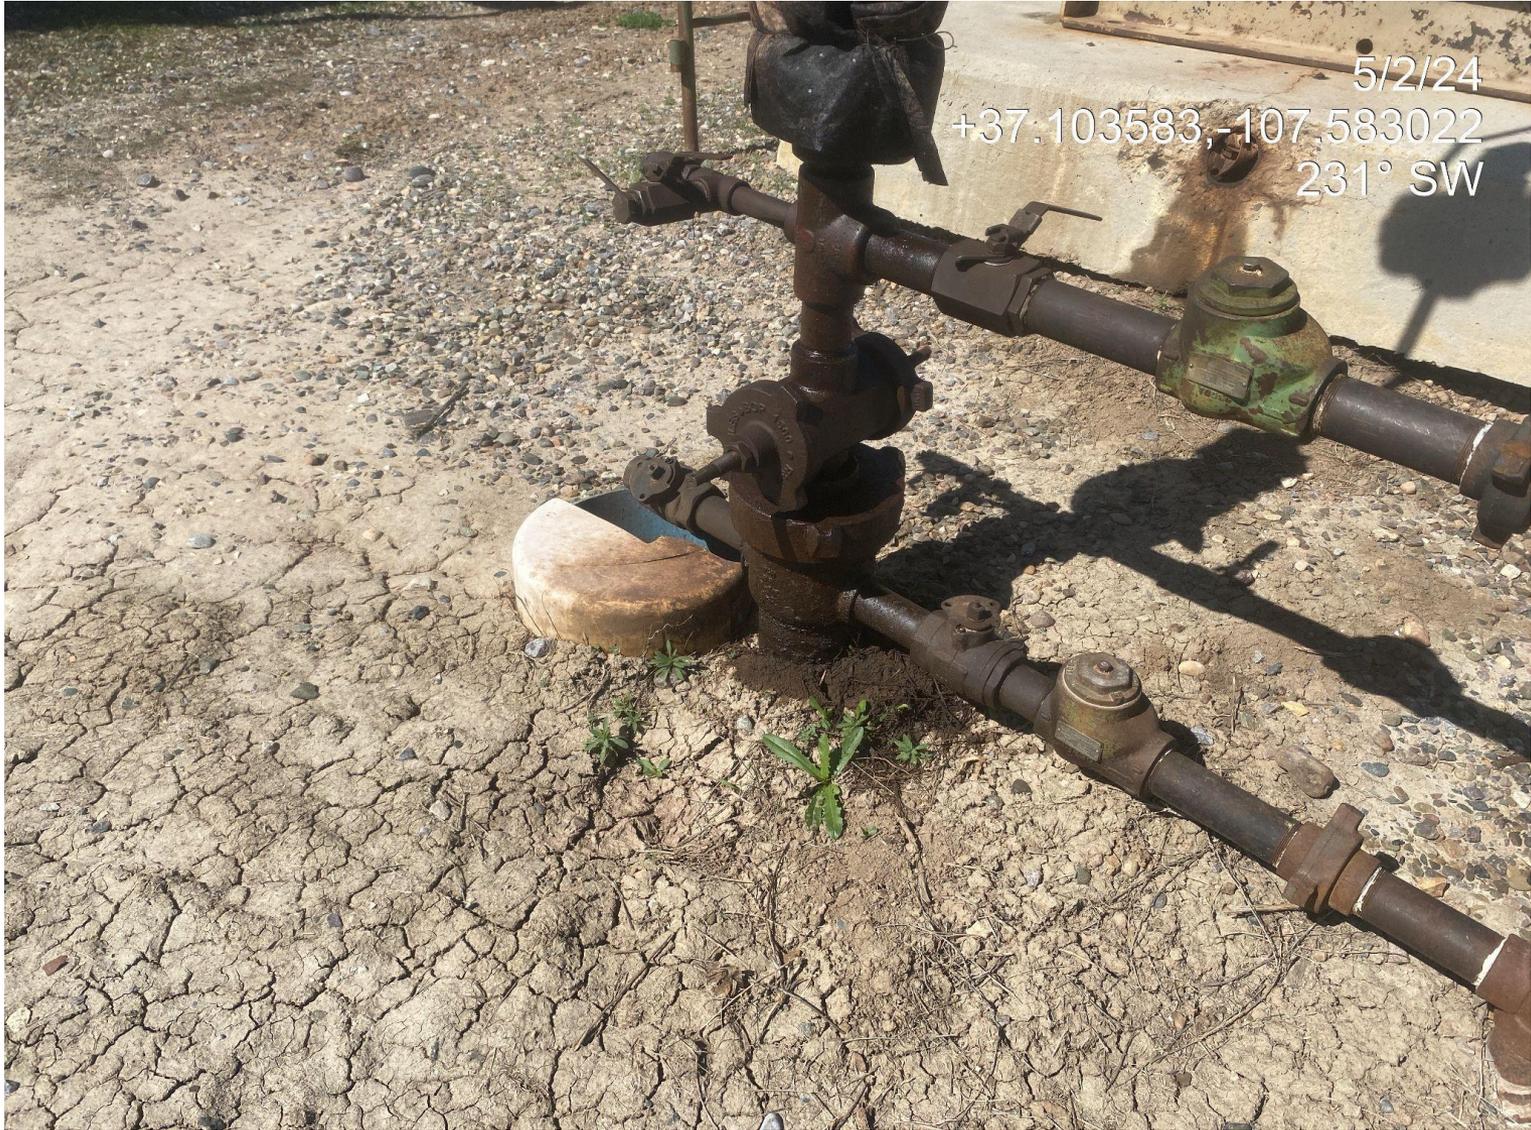
Photo 6. Impacted surface material observed at the 2A well head.

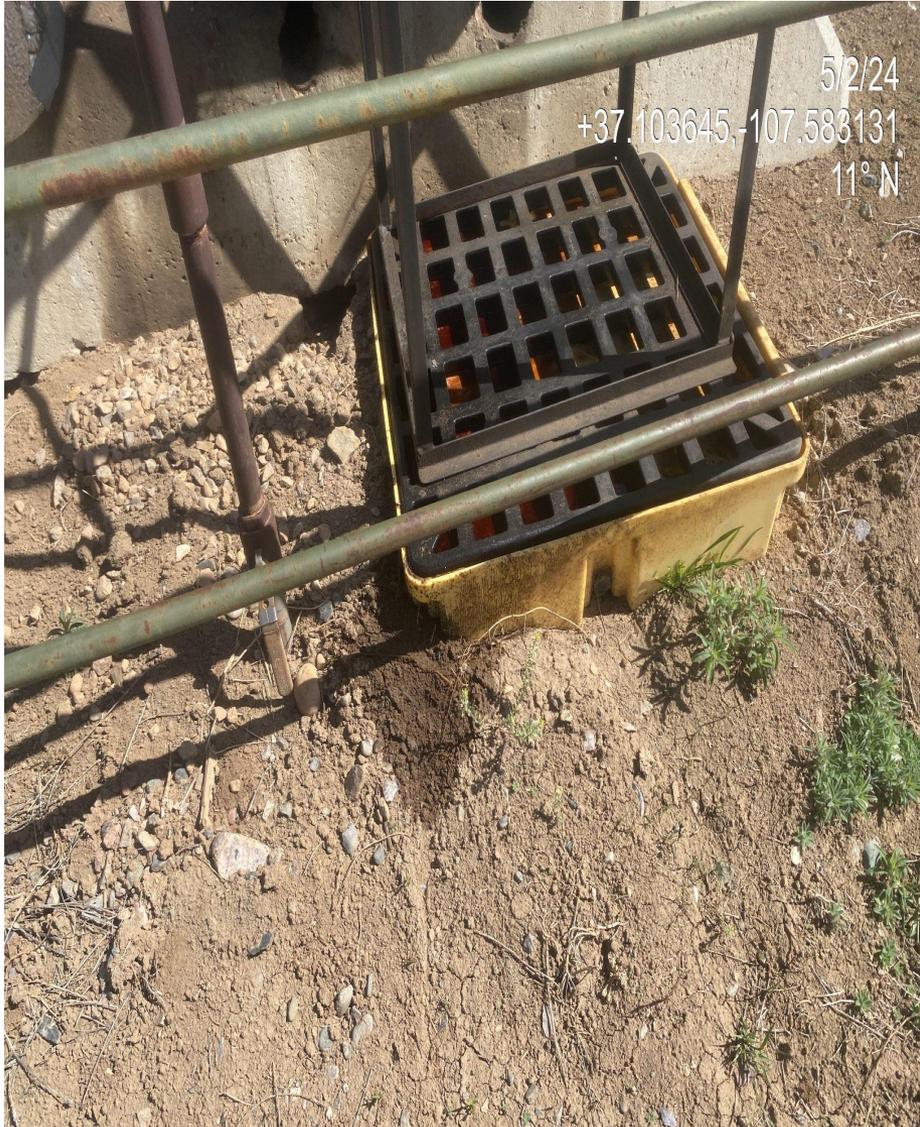
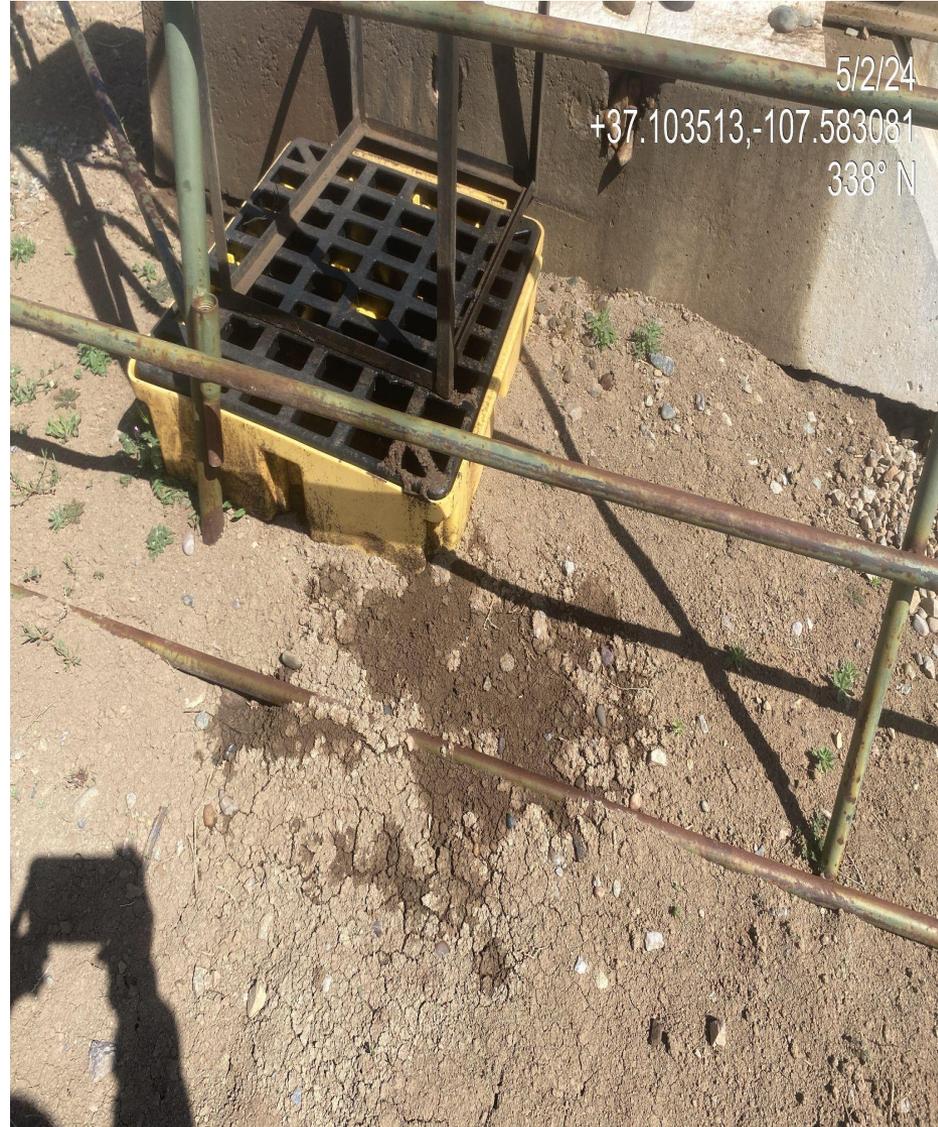
Photo 7. View of impacted surface material at both lube oil tanks secondary containments at both pump jacks.

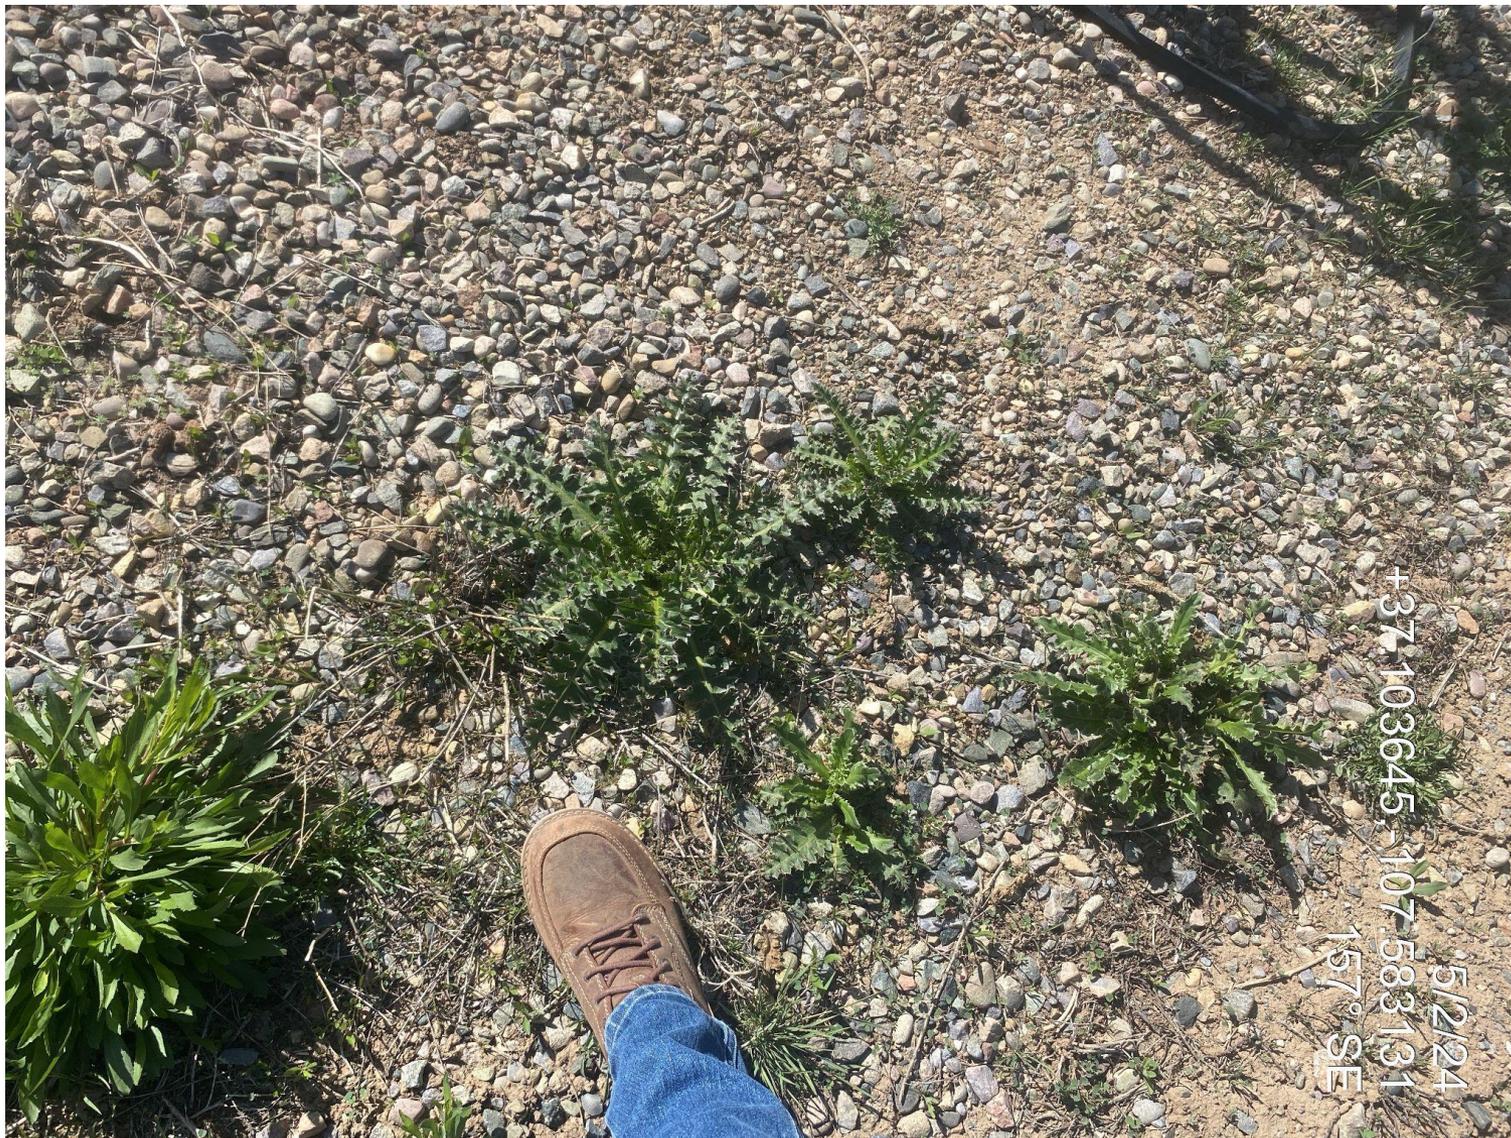
Photo 8. Musk thistle observed on the active pad.
