# Inspection Photos

Operator: Maralex Resources Inc - 53255

Location ID: 311958

Inspection Photos  
Location Name: Mary Catherine 33-7-3 2A, 3C  
Location ID: 311958

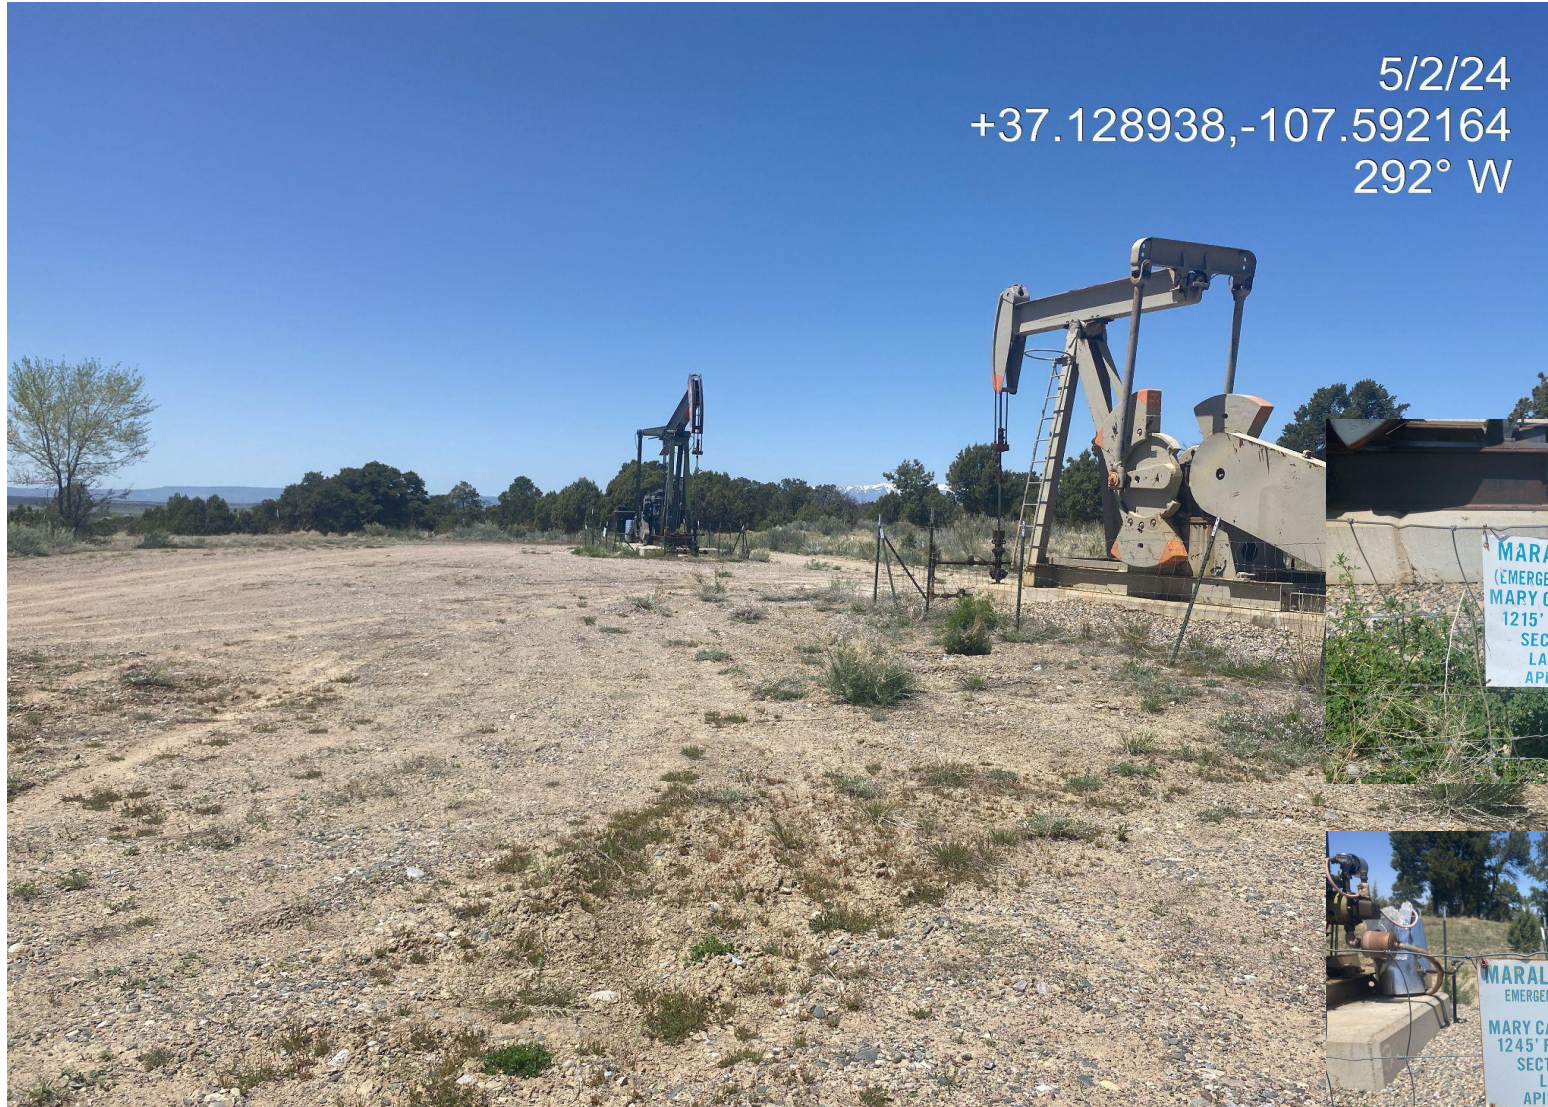
**Photo 1.** View of the well disturbance taken from the entrance facing center.

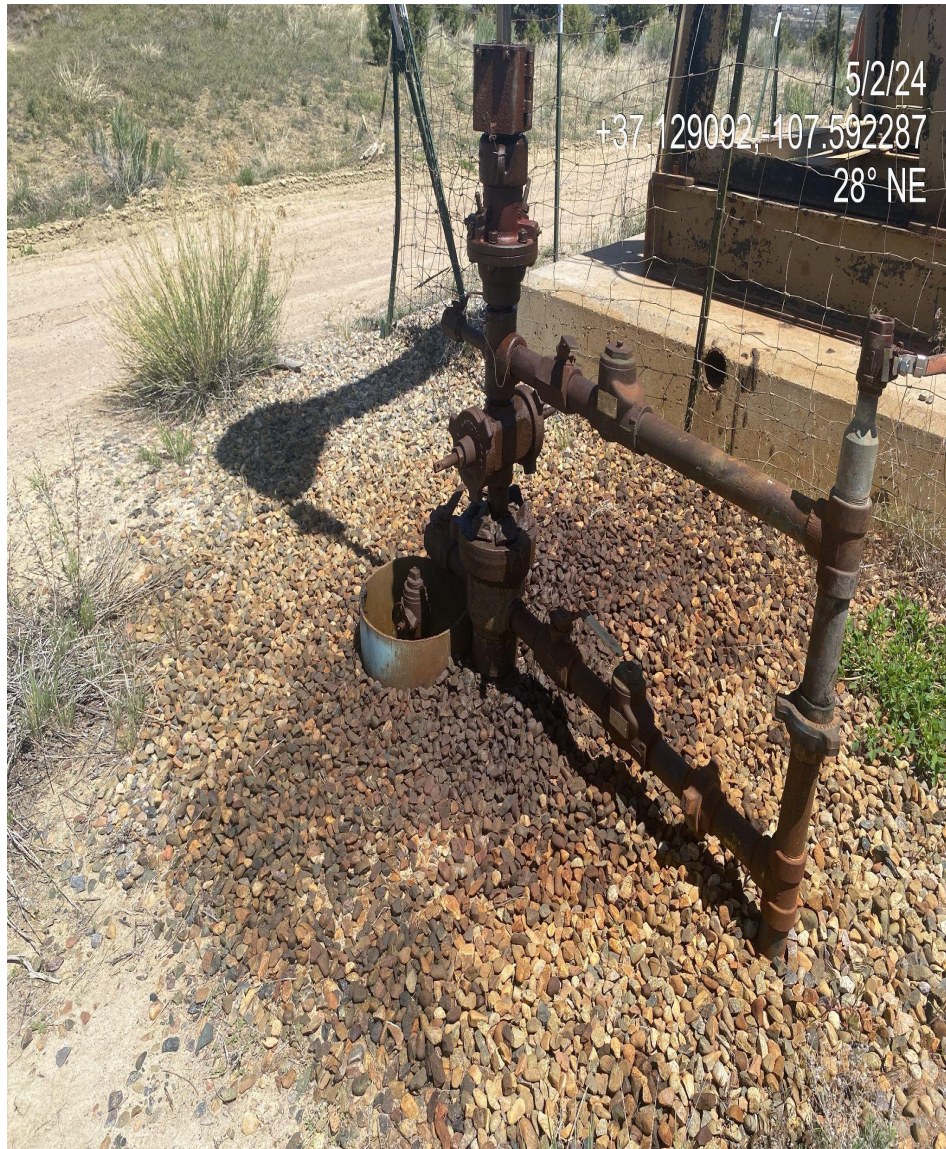
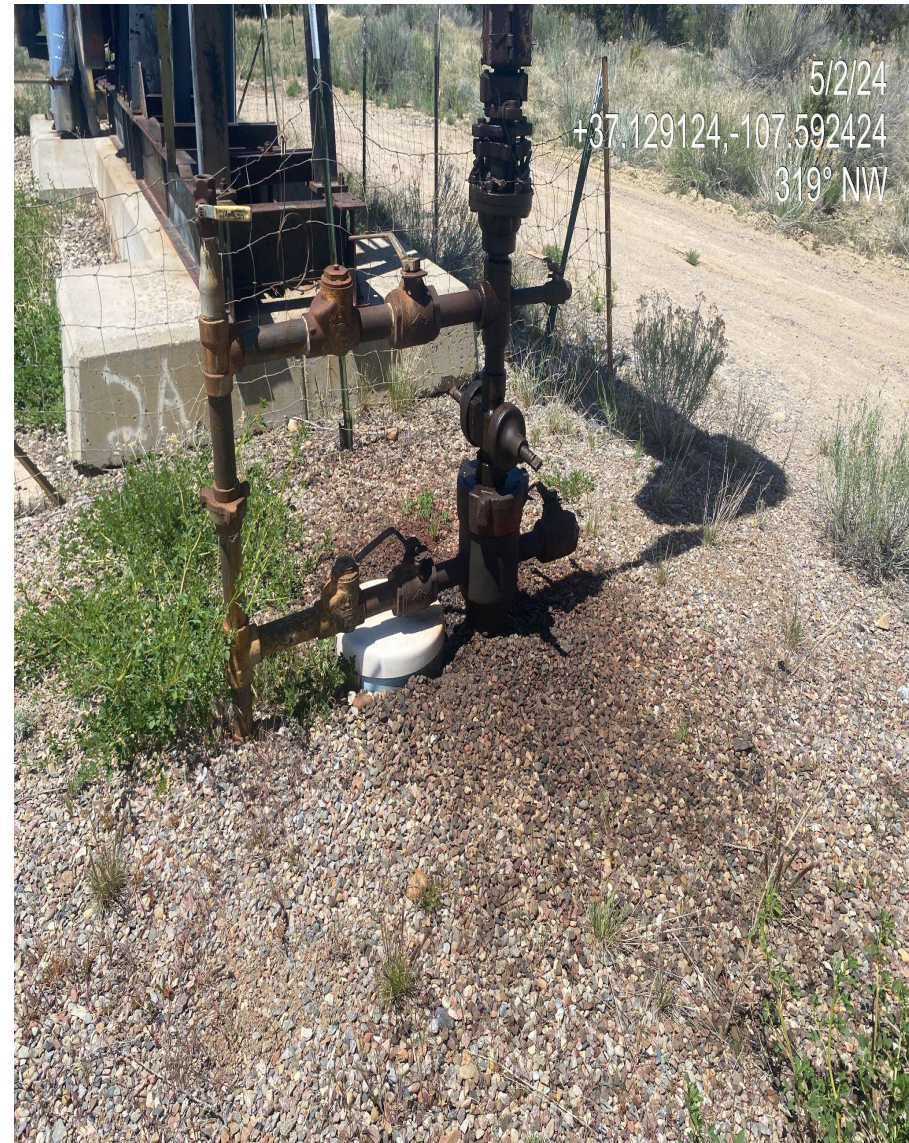
**Photo 2.** Impacted surface material remains at both well heads.

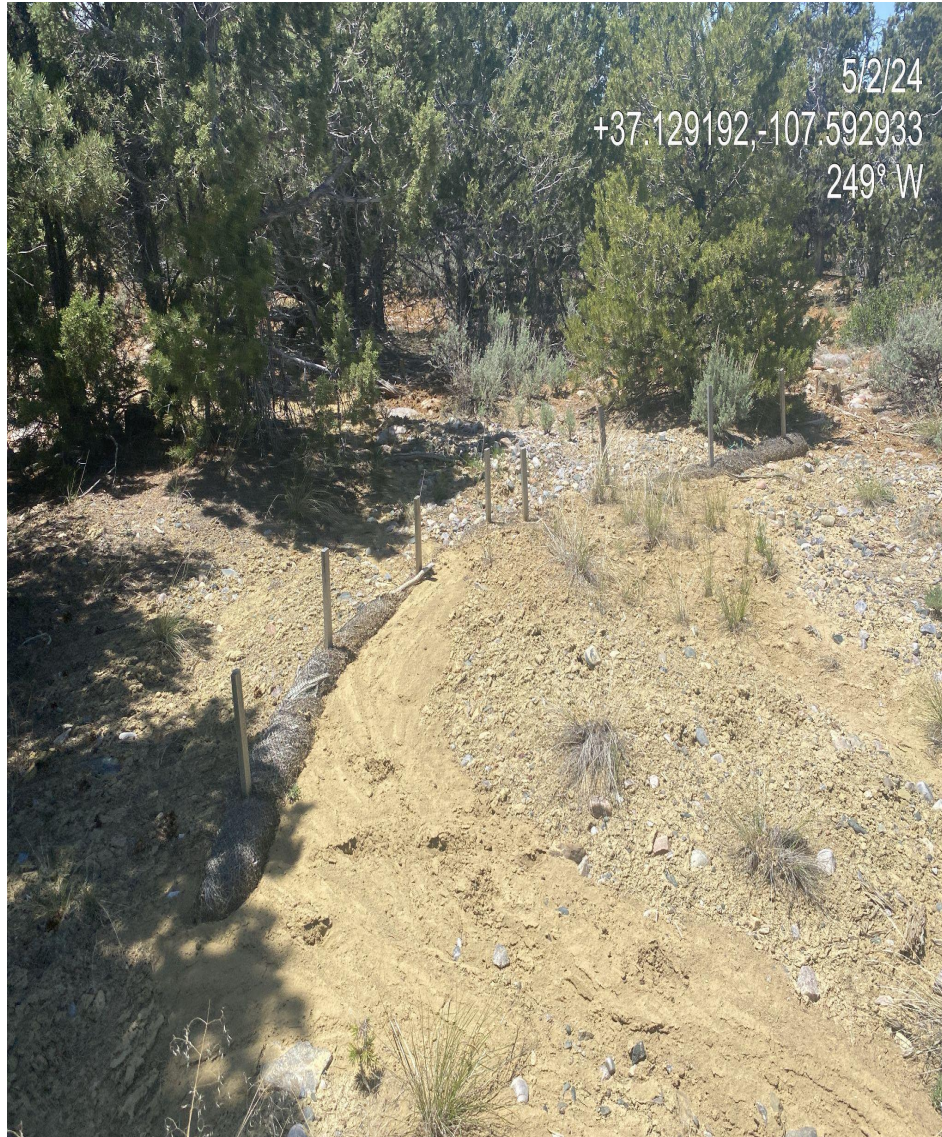
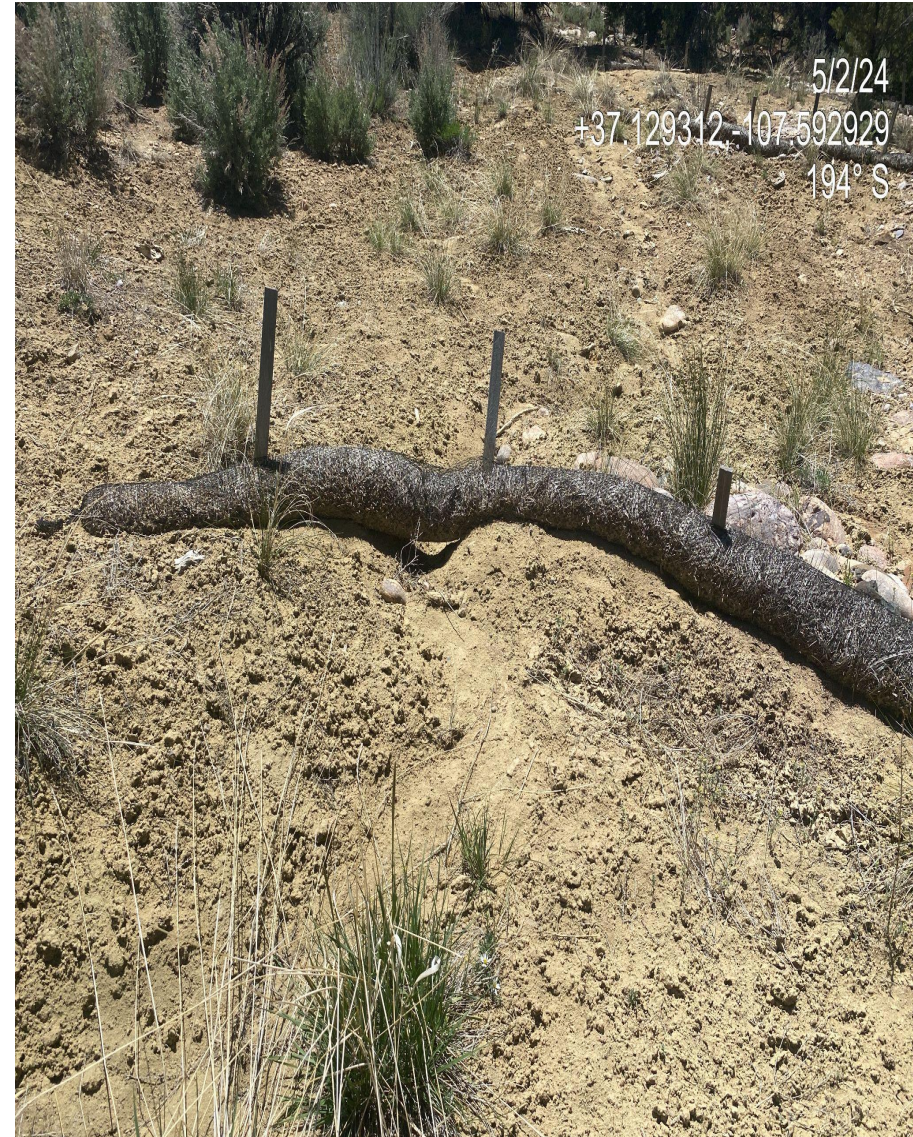
**Photo 3.** Failing storm water BMPs observed in the western interim reclamation area, maintenance is required.

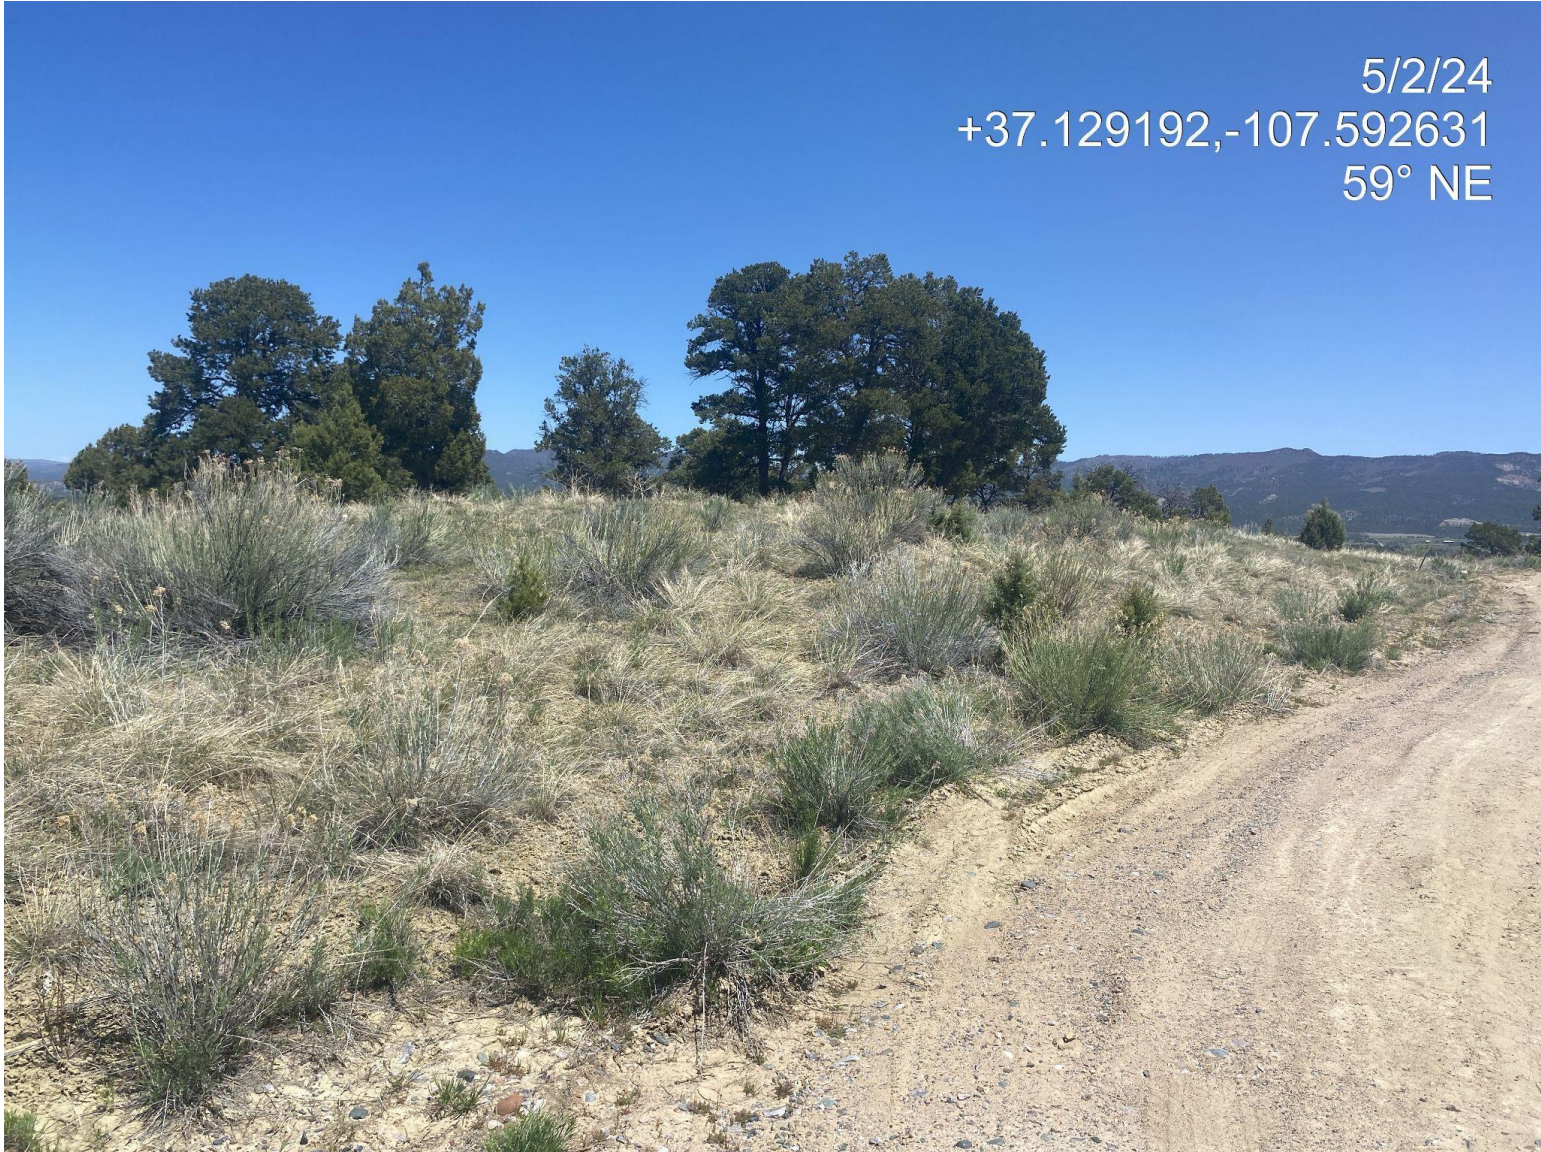
**Photo 4.** View of the northern interim reclamation area facing north east.  
Vegetation comprised of indian rice grass and rabbit brush.

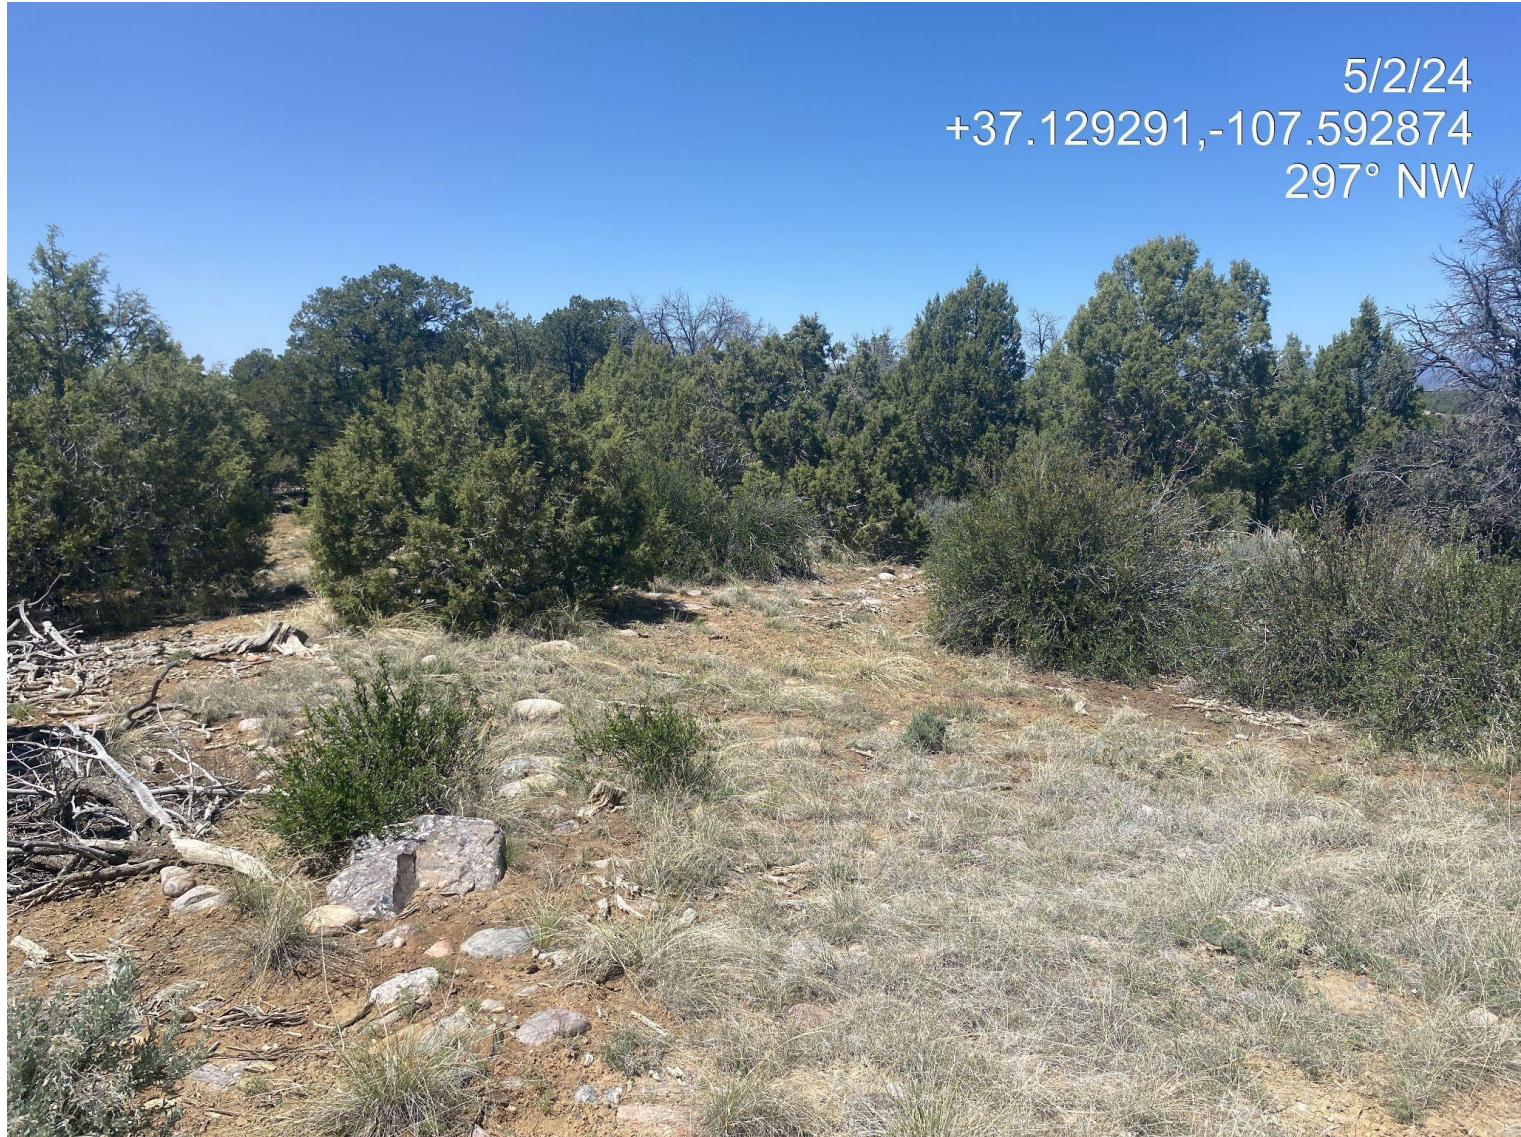
**Photo 5.** Reference area comprised of indian rice grass, sage brush, juniper and antelope bitterbrush.
