Inspection Photos

Location Name: TEP ROCKY MOUNTAIN LLC PA 311-5 Pad

Location ID: 334725

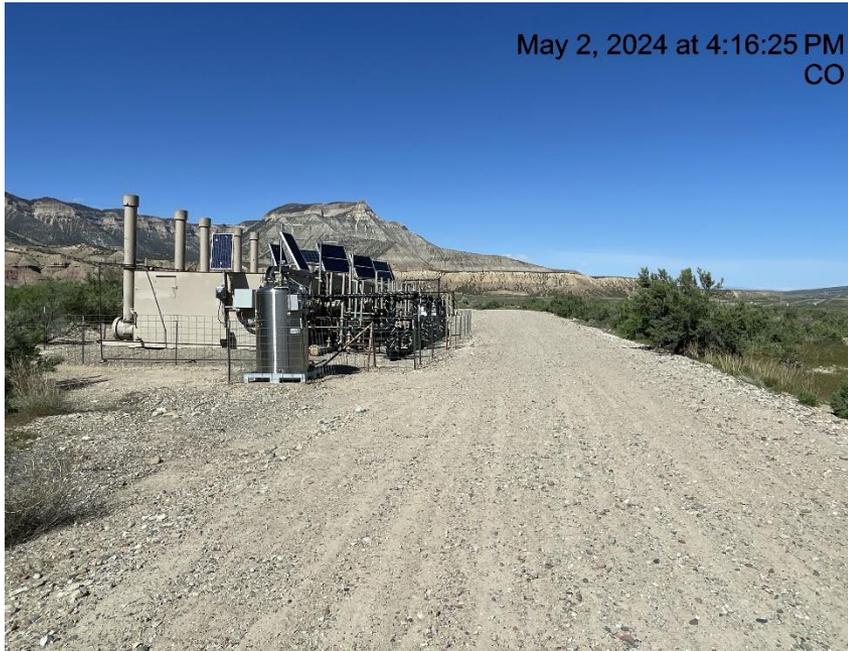
Photo # 5819 From entrance to location

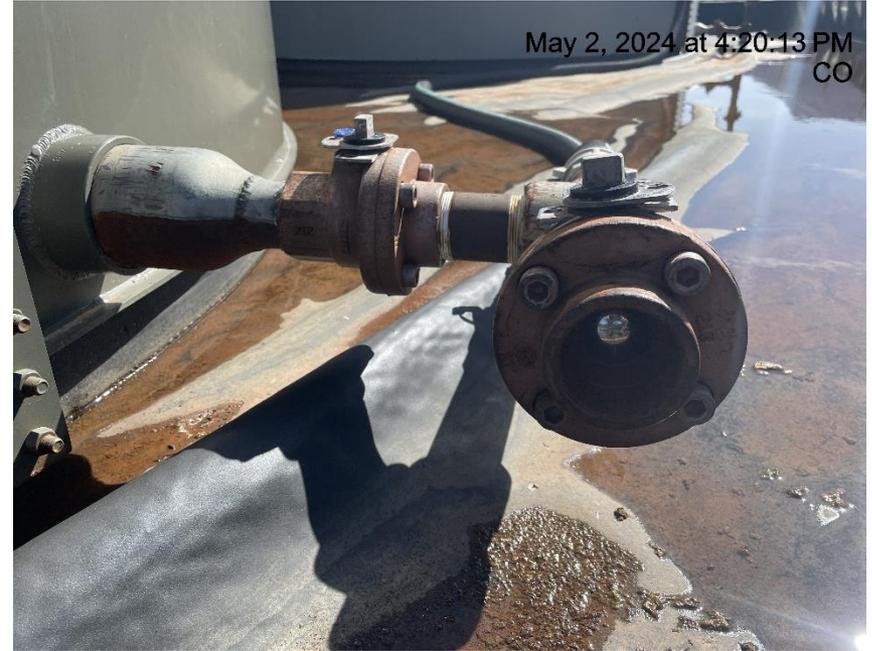
Photo # 5826 Open ended load line

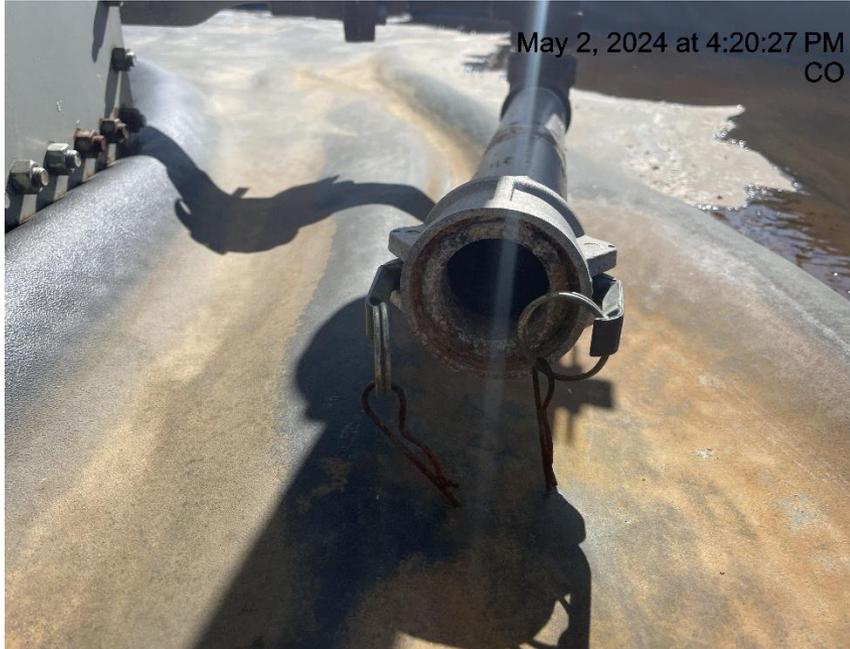
Photo # 5827 Open ended load line

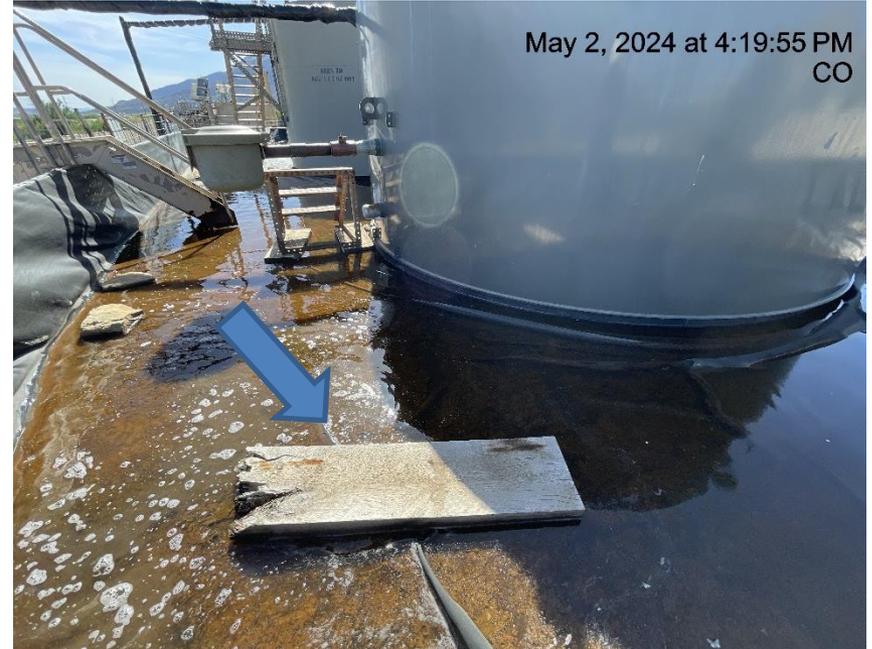
Photo # 5828 Debris

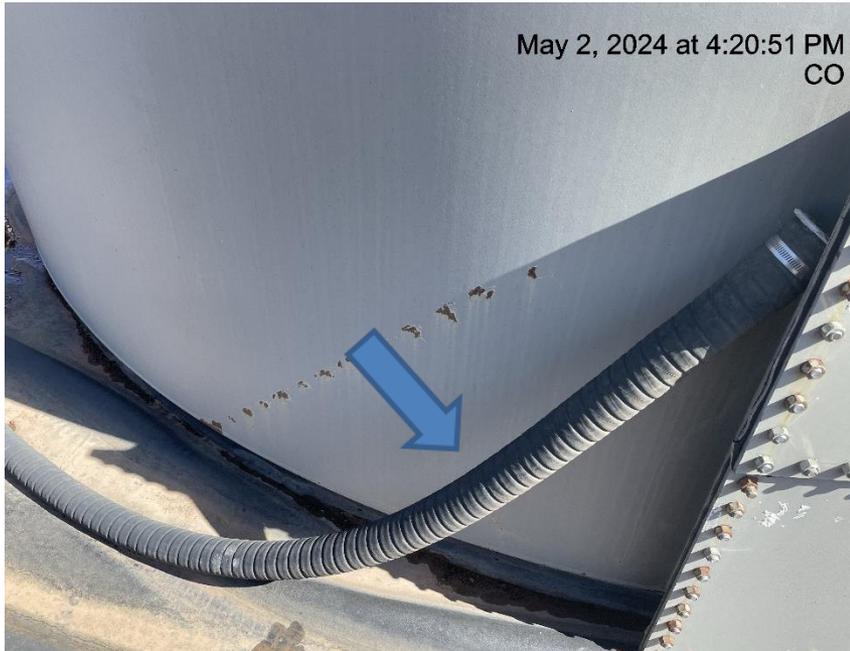
Photo # 5829 Debris

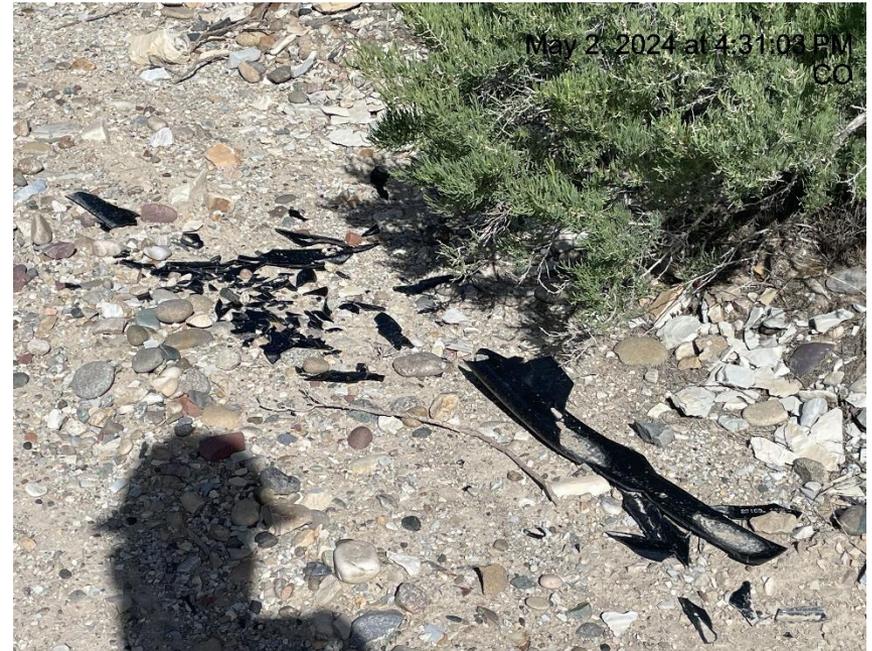
Photo # 5830 Debris

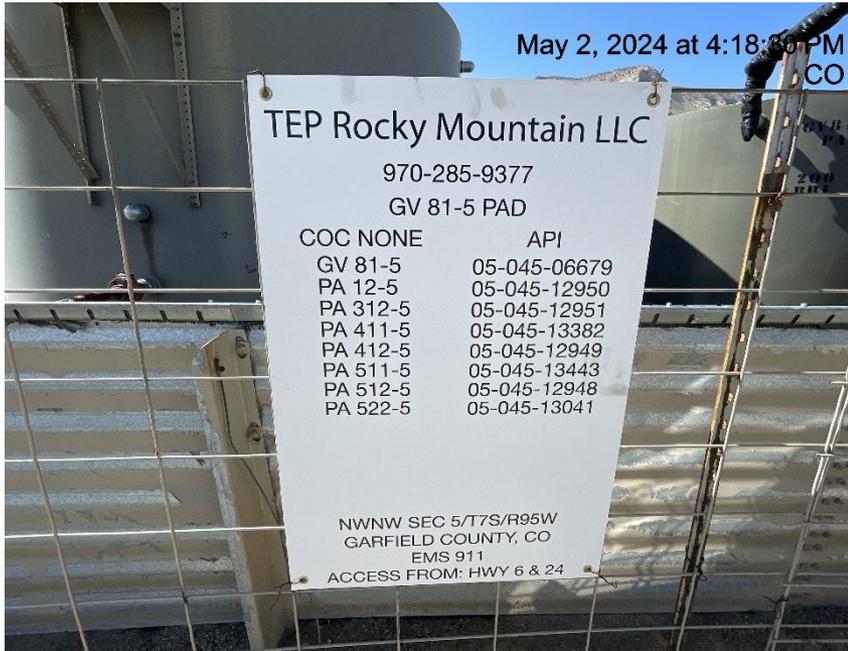
Photo # 5832 Battery sign does not list all wells associated with tank battery
