Fulcrum
Surprise unit 0680 S9
Location ID: 445005

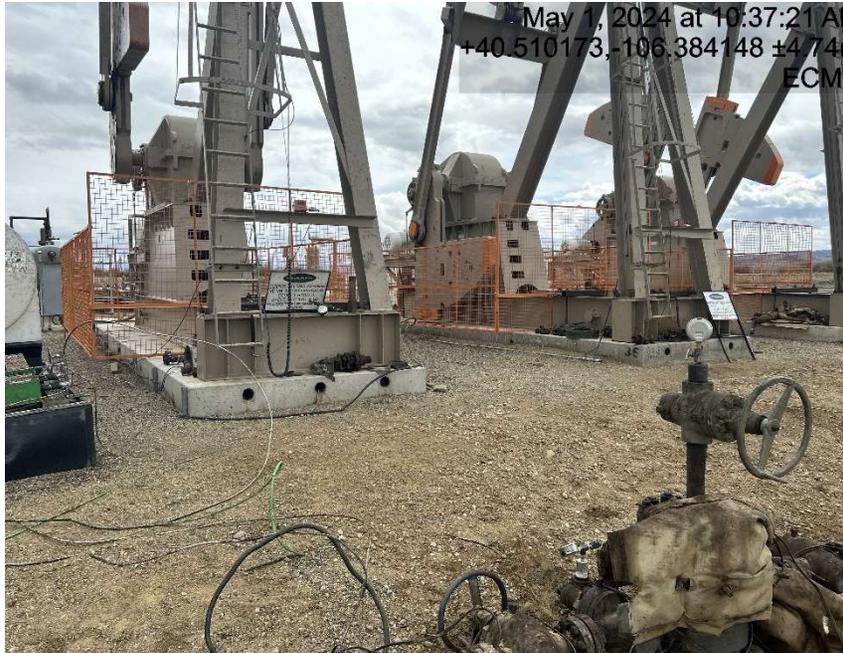
Old signage and debris

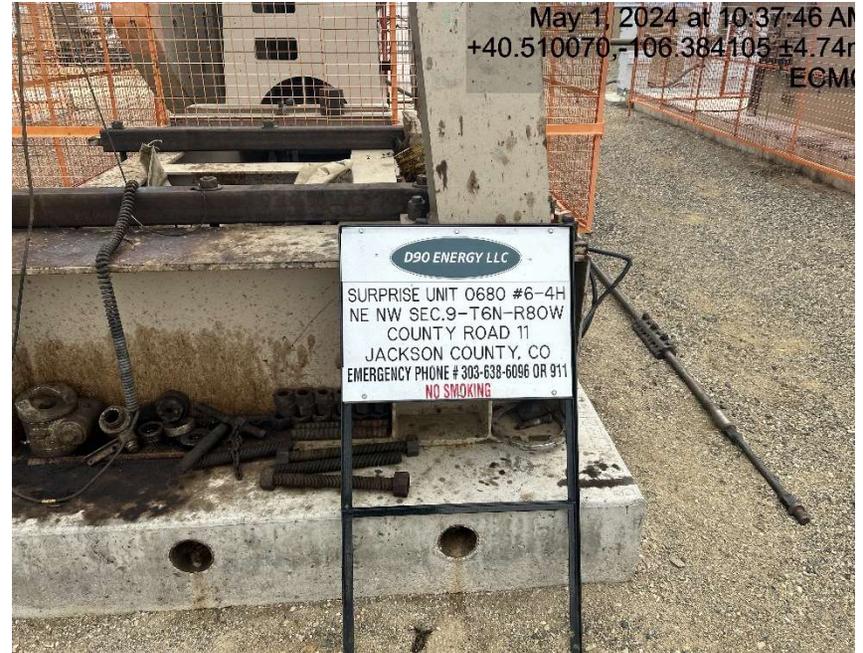
Old signage and debris

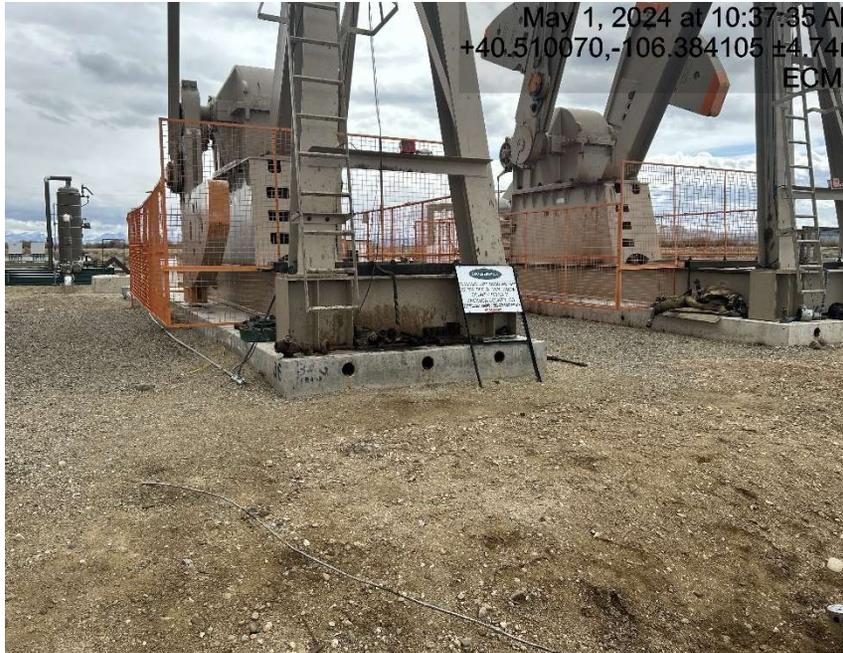
Old signage

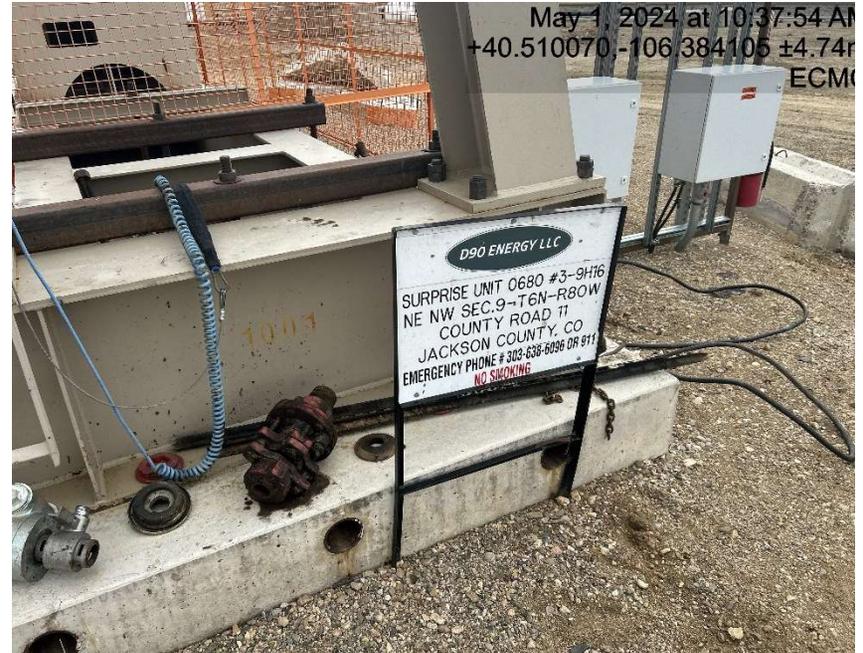
Old signage and debris

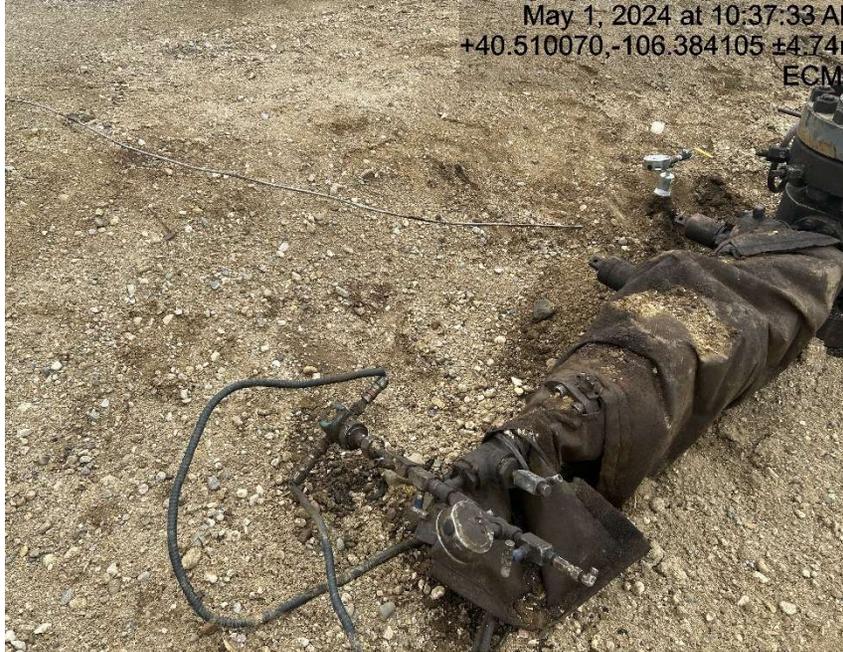
Staining

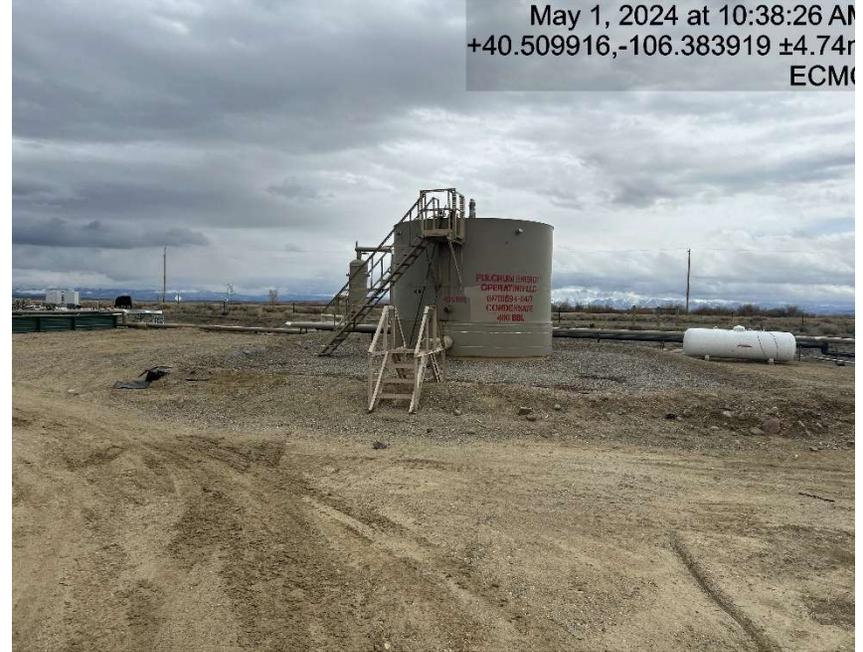
Tank battery lacking battery signage

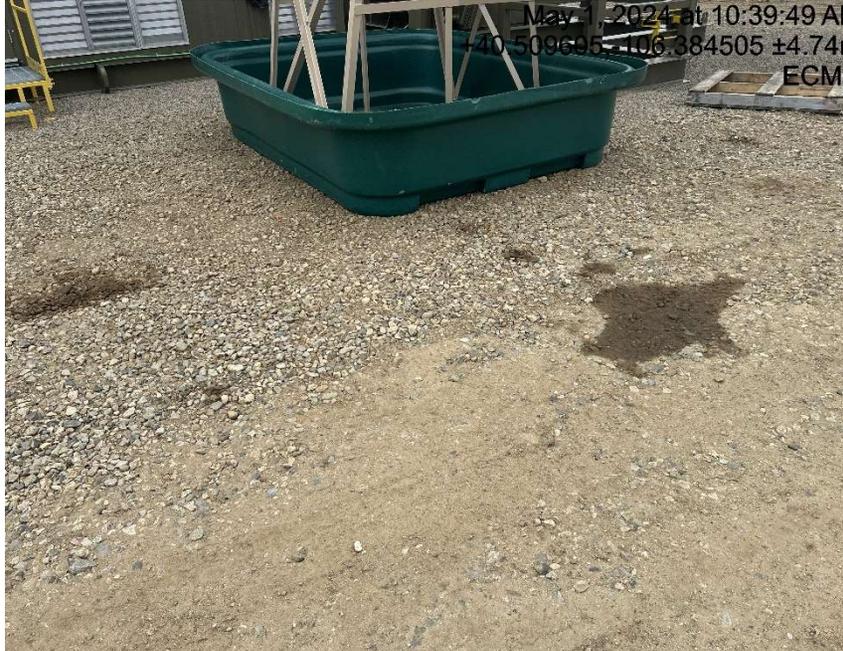
Staining

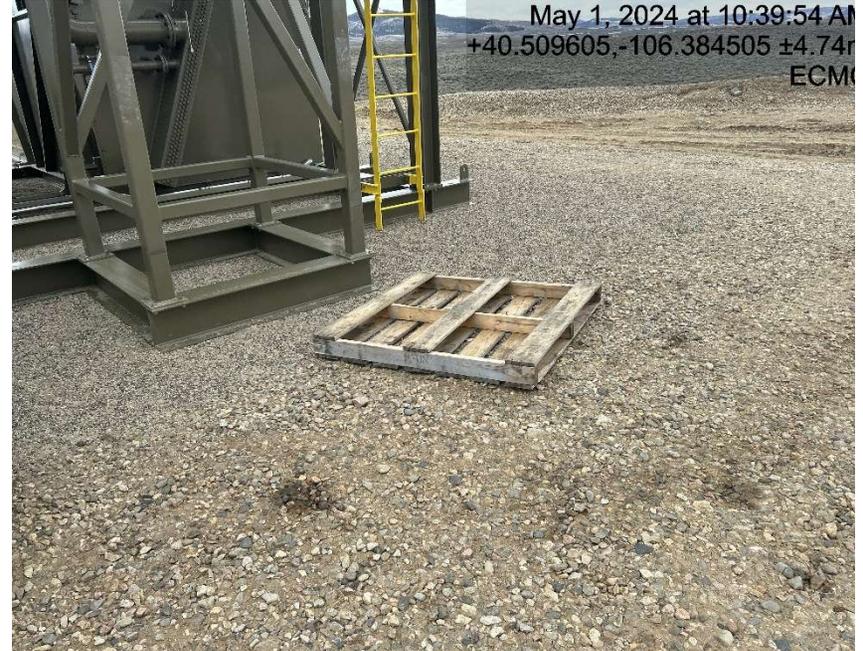
Debris

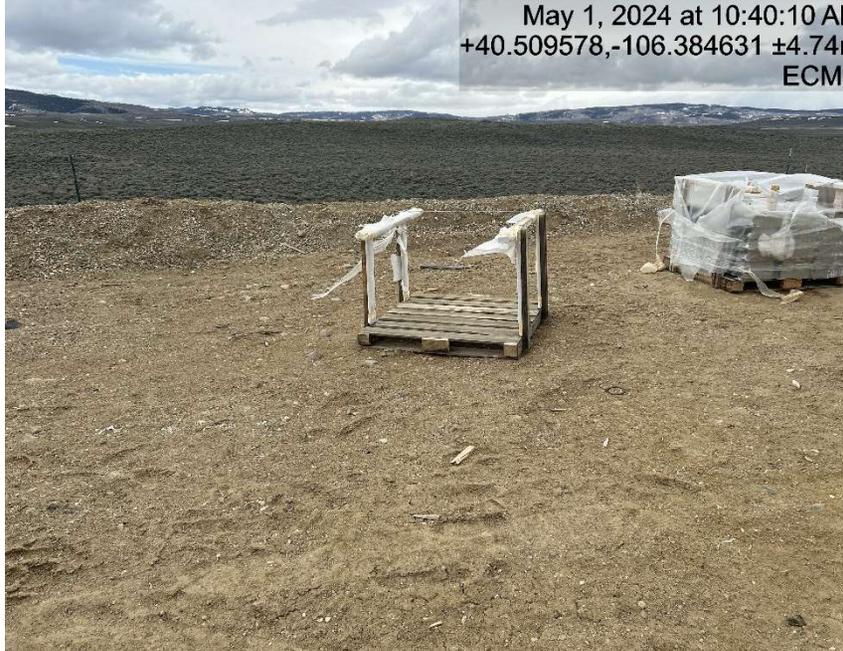
Debris

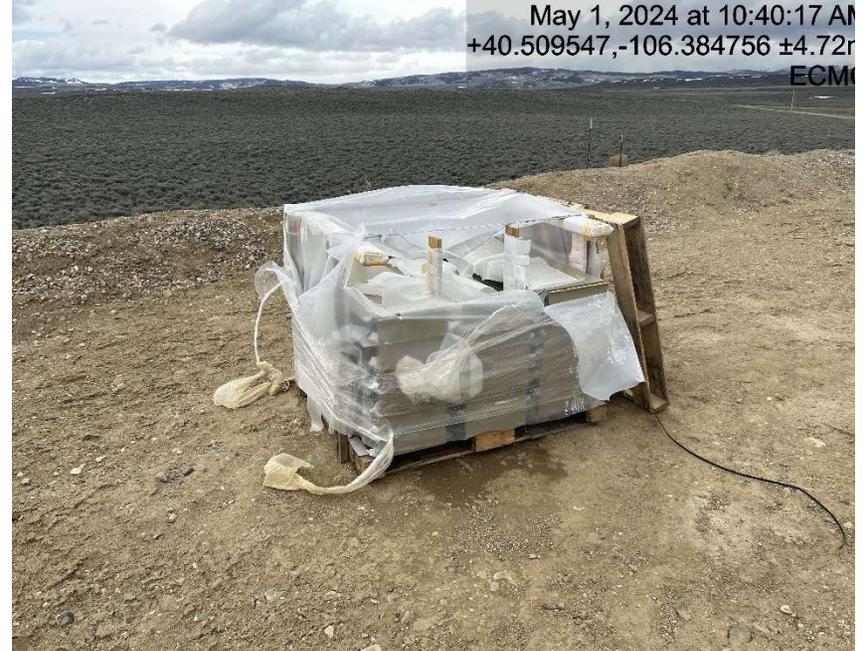
Debris

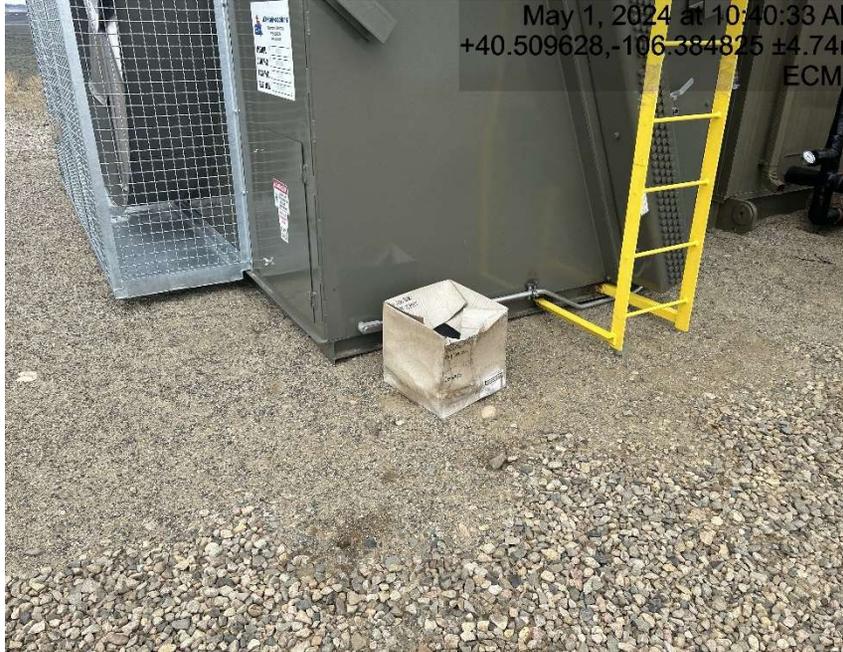
Debris

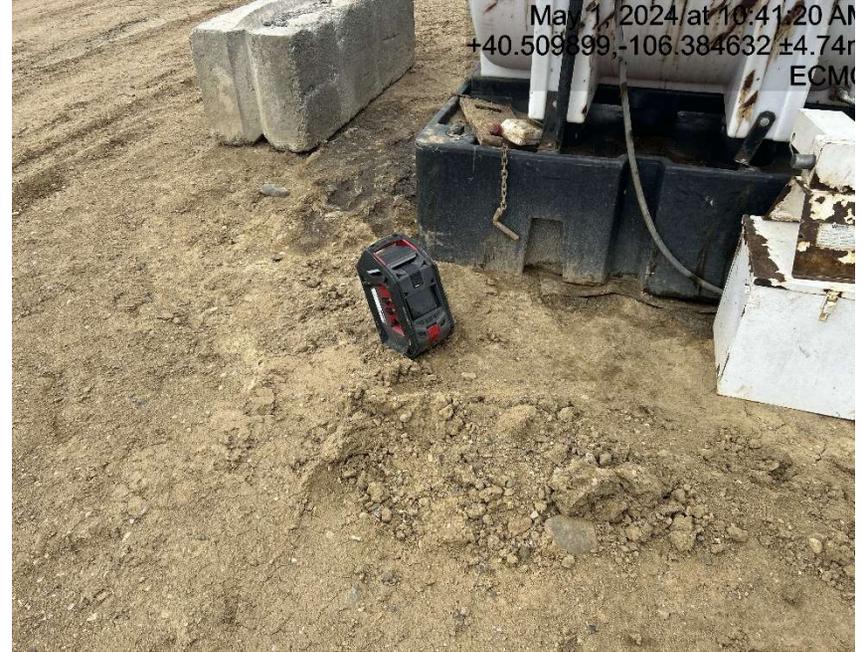
Black line safety monitor

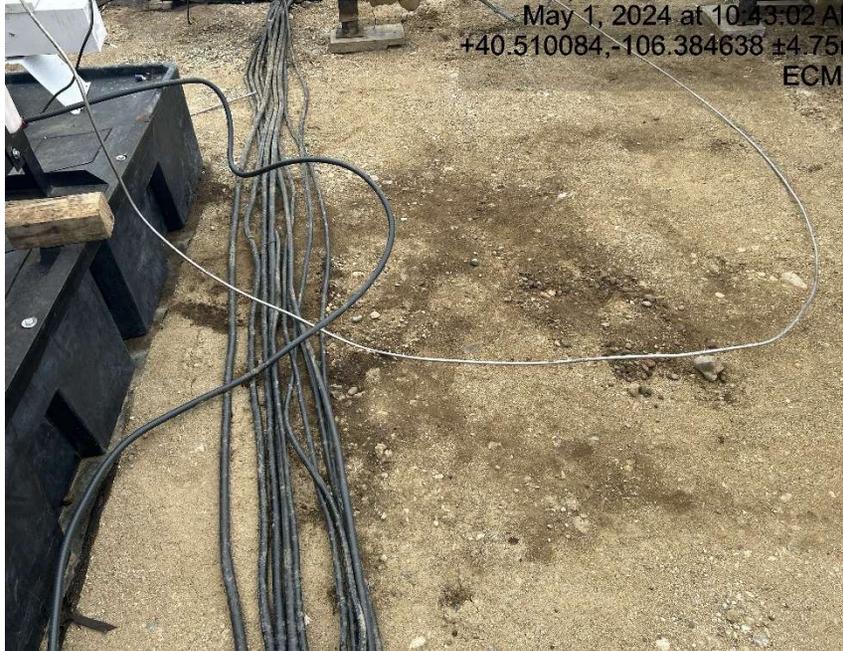
Staining

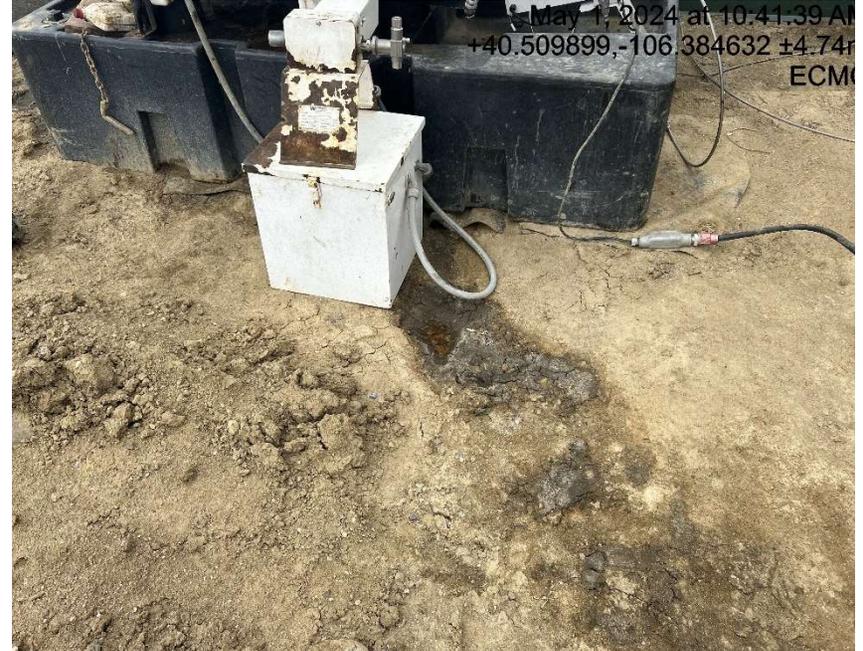
Staining coming from under chemical tank containment

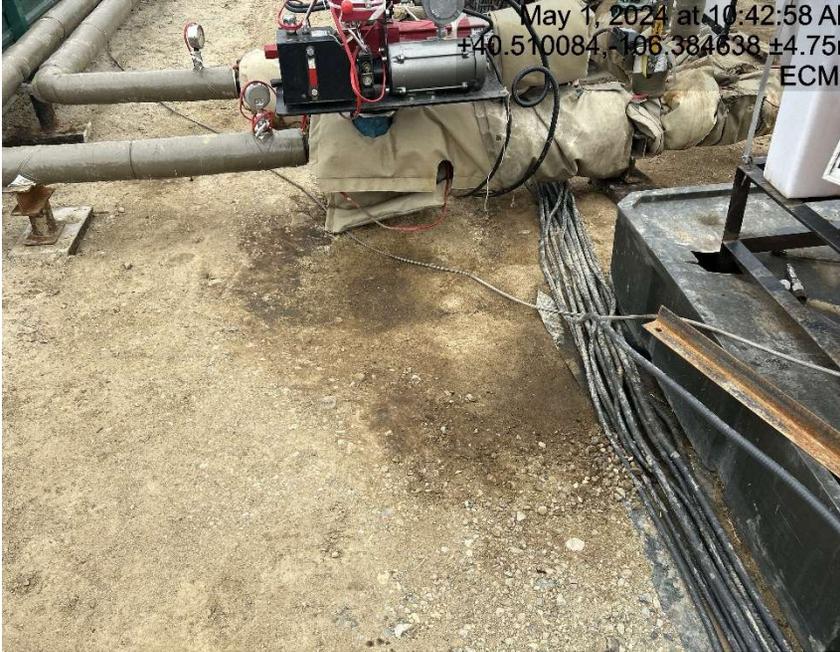
Staining

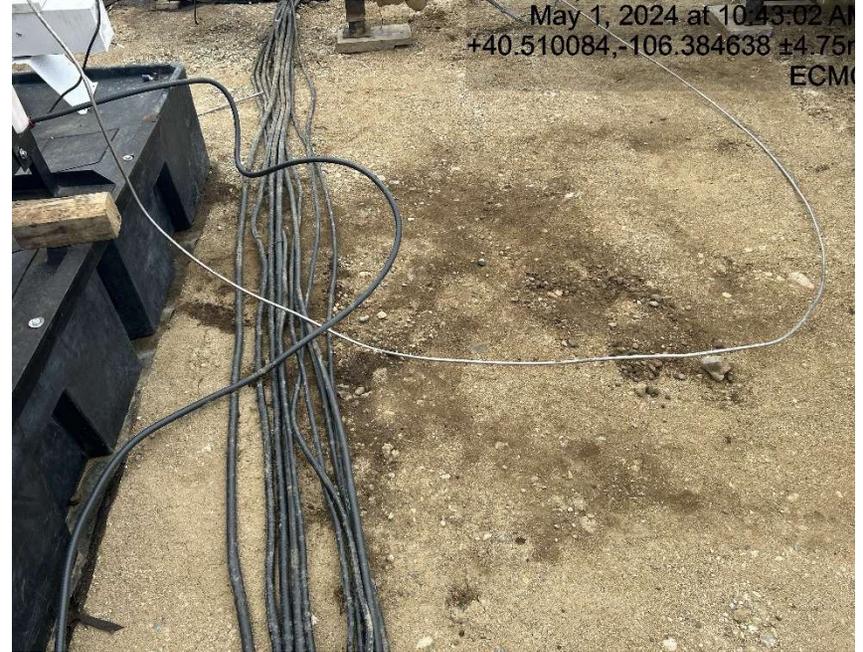
Staining

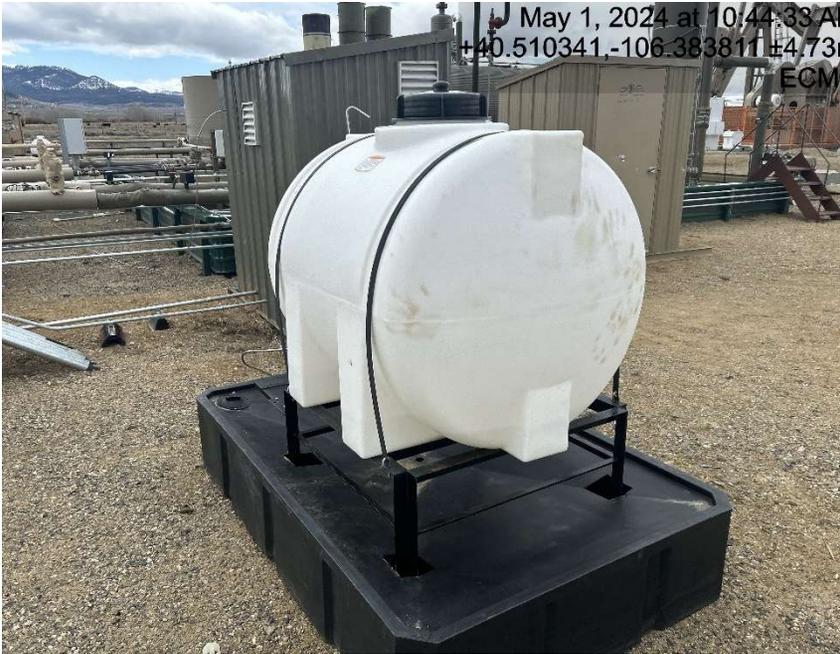
Unmarked container

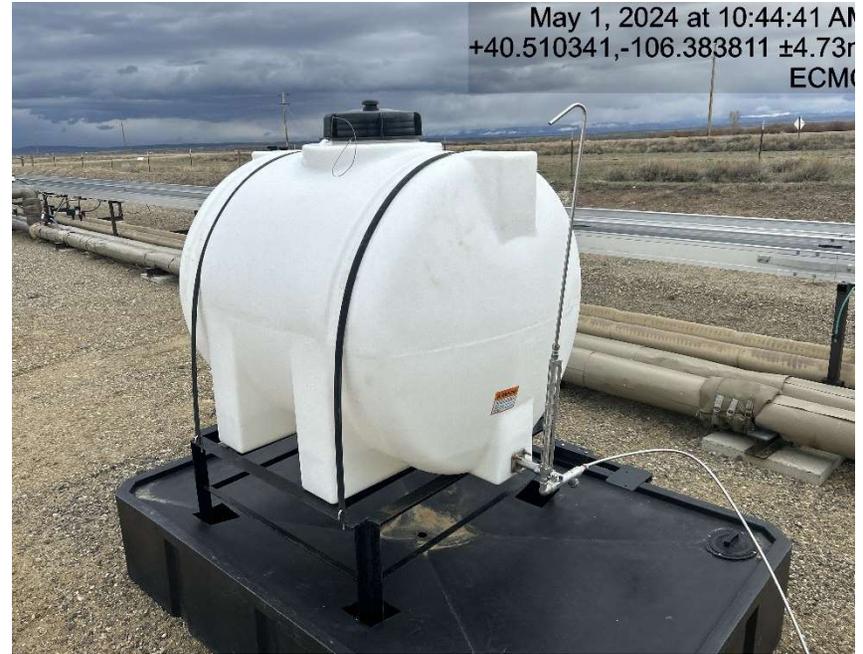
Unmarked container
