Inspection Photos

05/06/2024

Operator: TEP ROCKY MOUNTAIN LLC #96850

Location ID: 311852

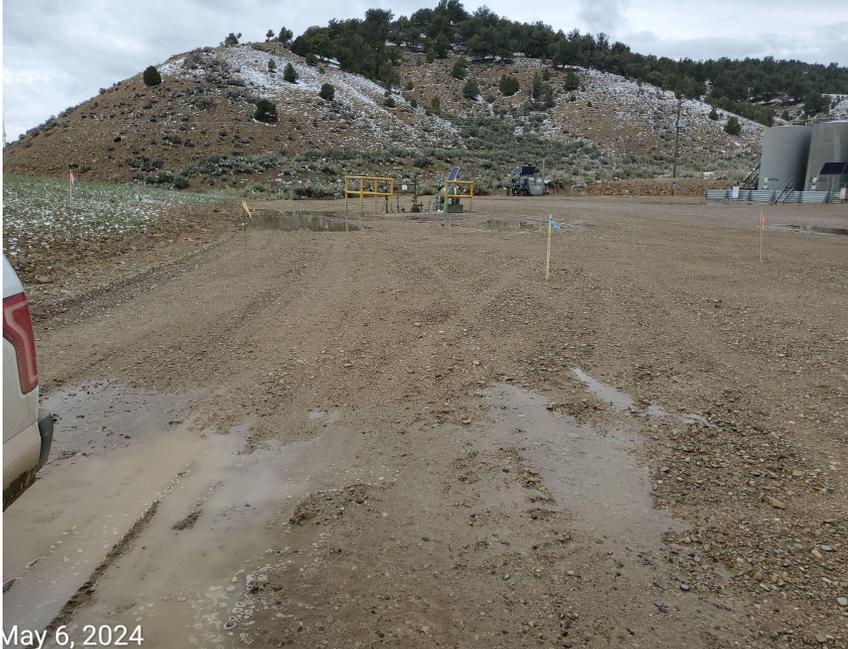
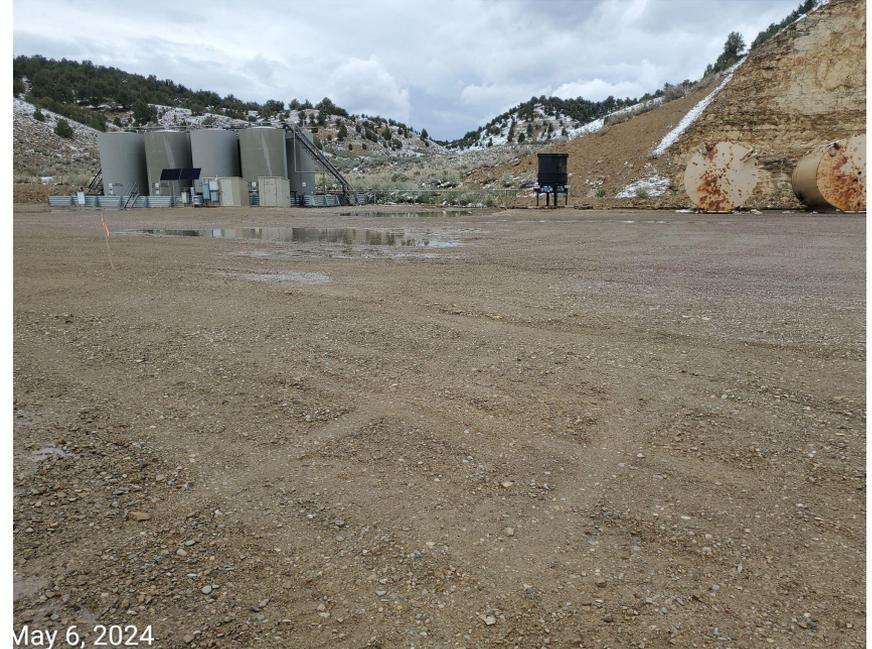
Photo 1: Photos 1-2 taken from the south end of the Location. Photo provides an overview of the Location from west, northwest, northeast to east. Photos also show the unused riser equipment associated with abandoned wells have been removed.

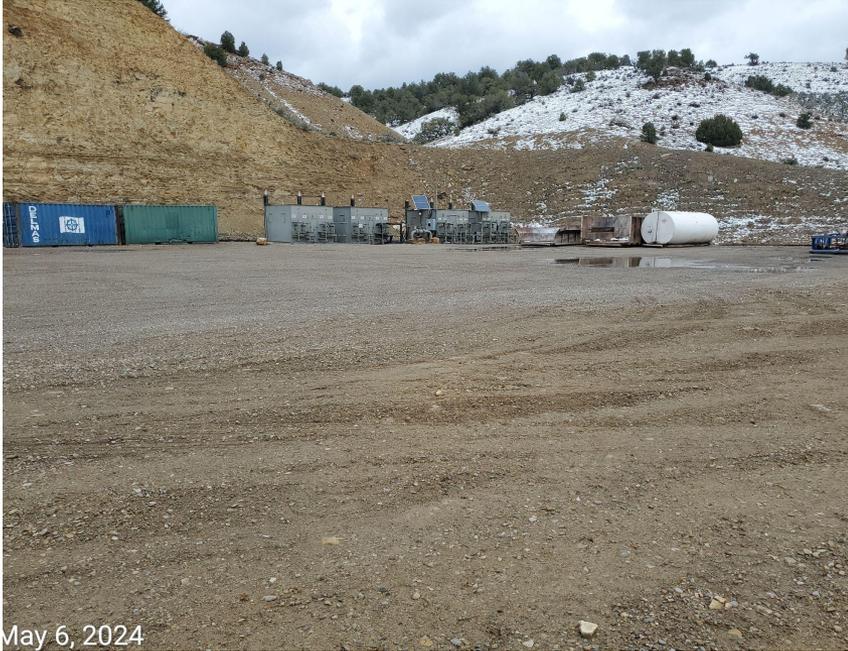
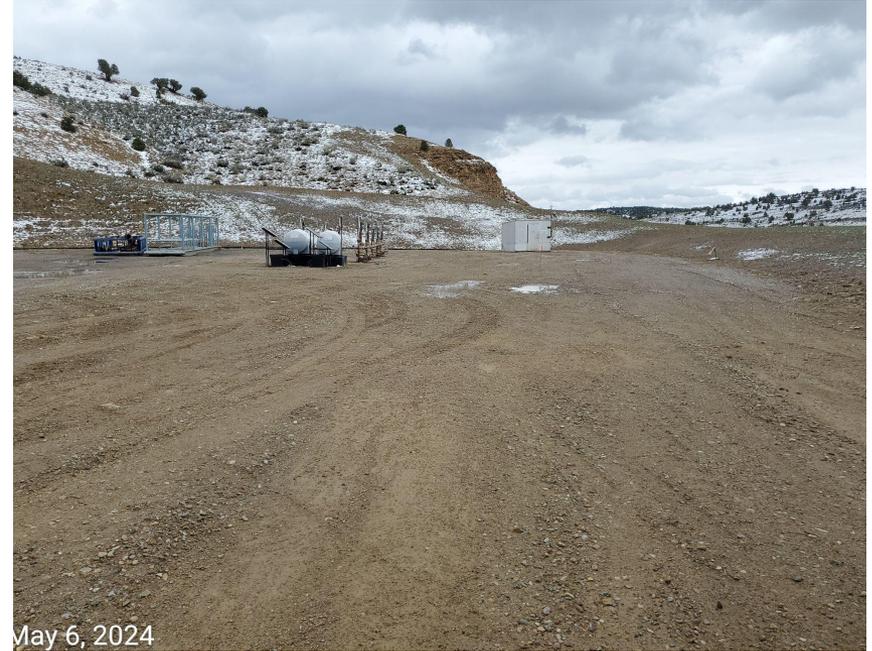
Photo 2: See comments under photo 1.

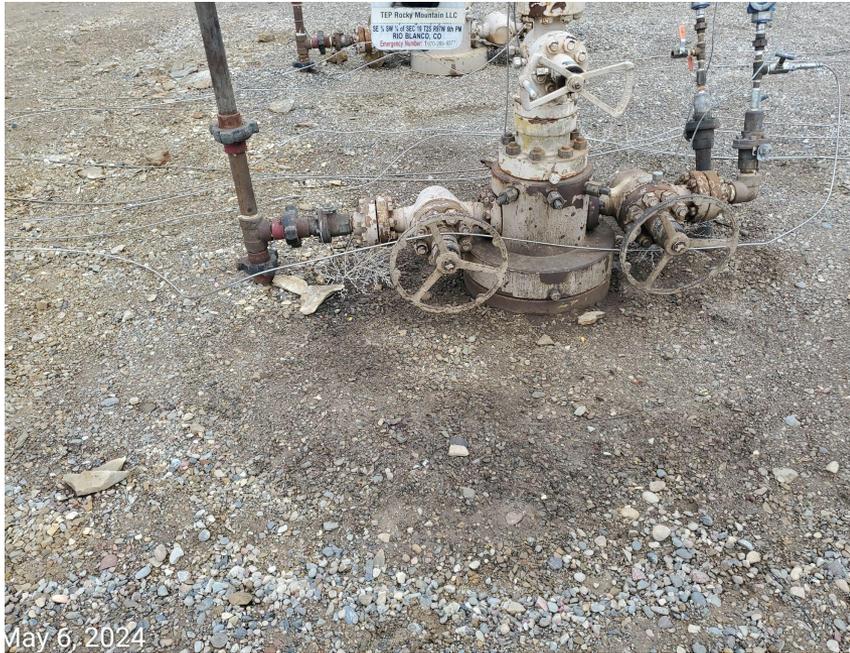
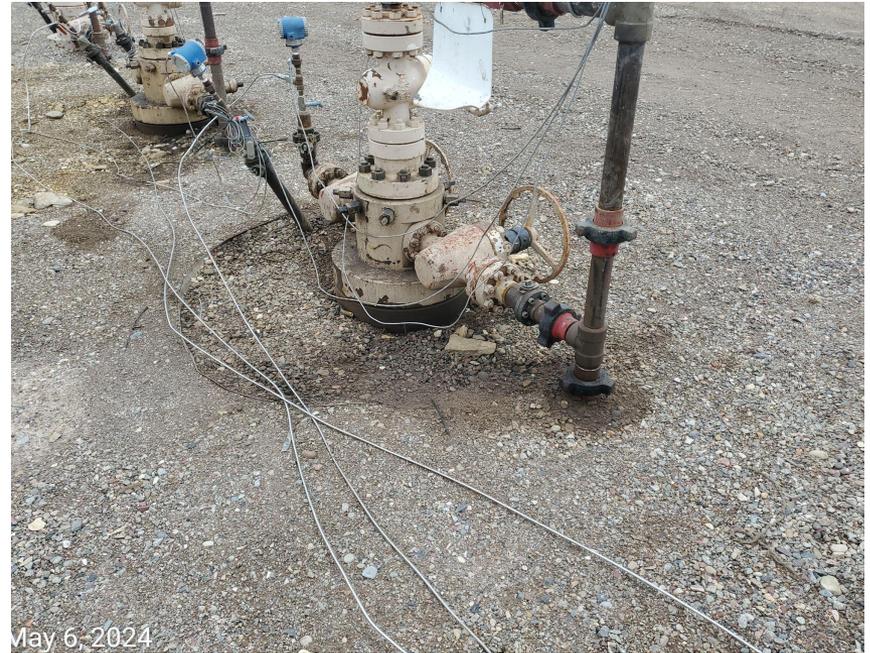
Photo 3: Stained soils due to spills at the wells remain evident.

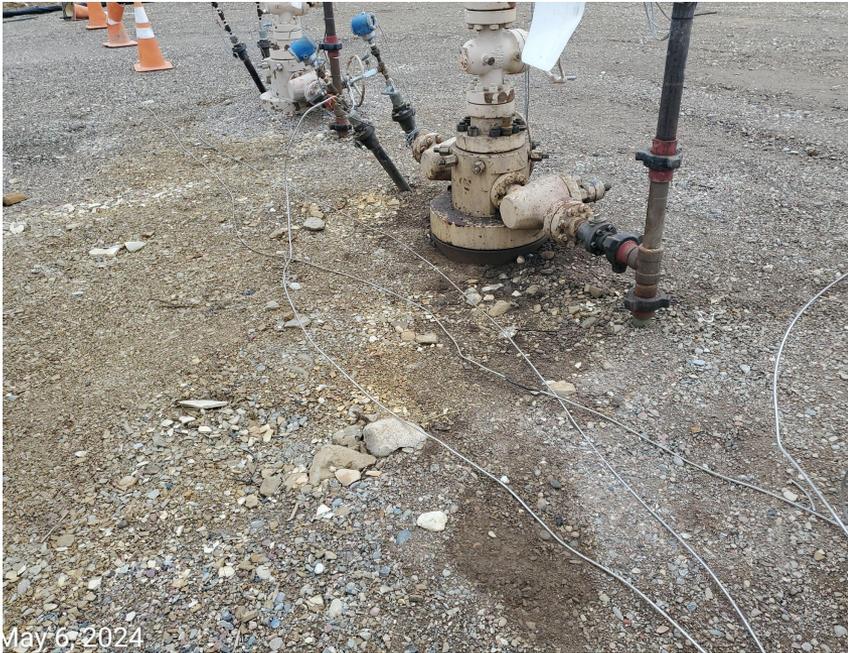
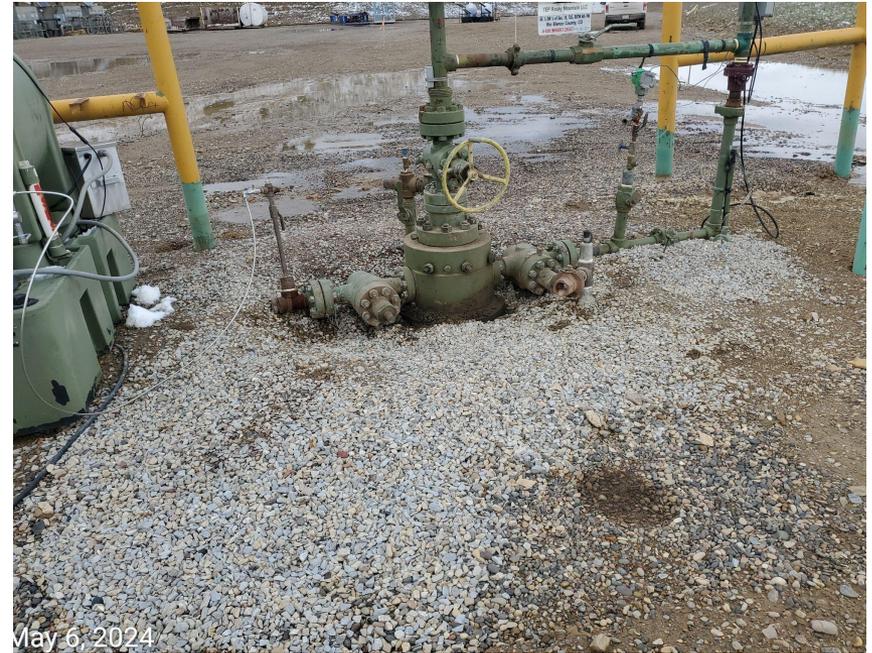
Photo 4: Stained soils due to spills at the wells remain evident.

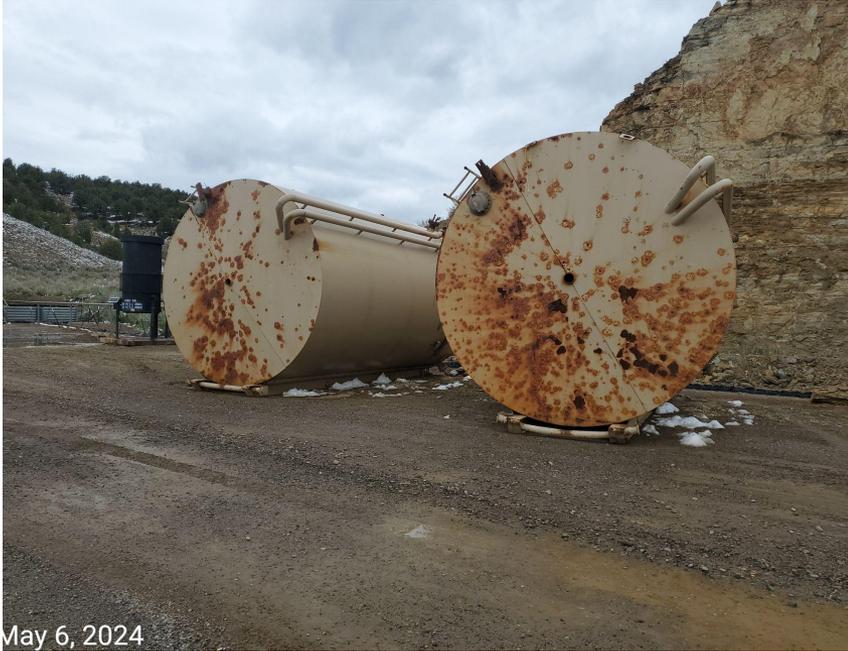
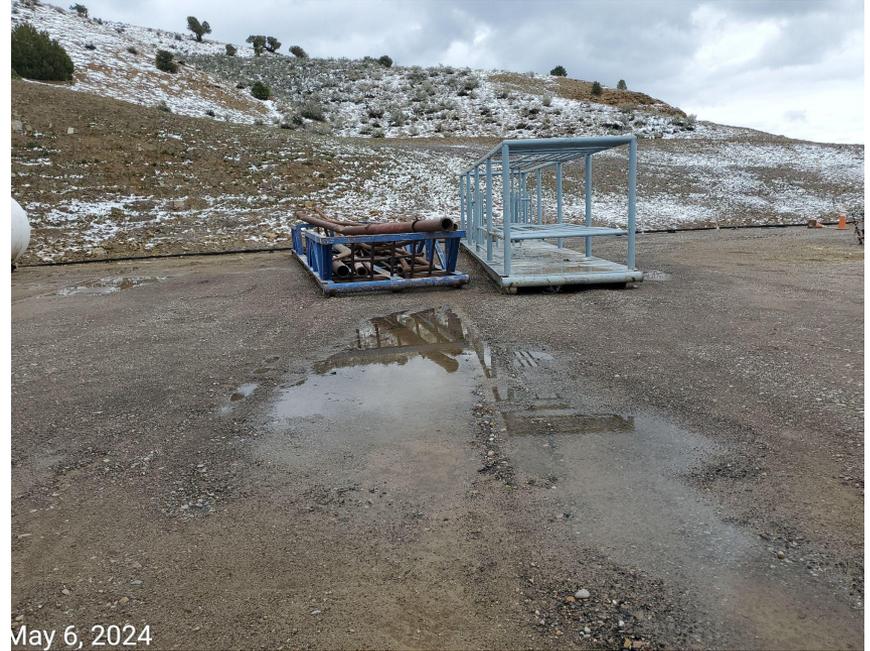
Photo 5: Unused equipment, or equipment not necessary for production remain stored on the Location.

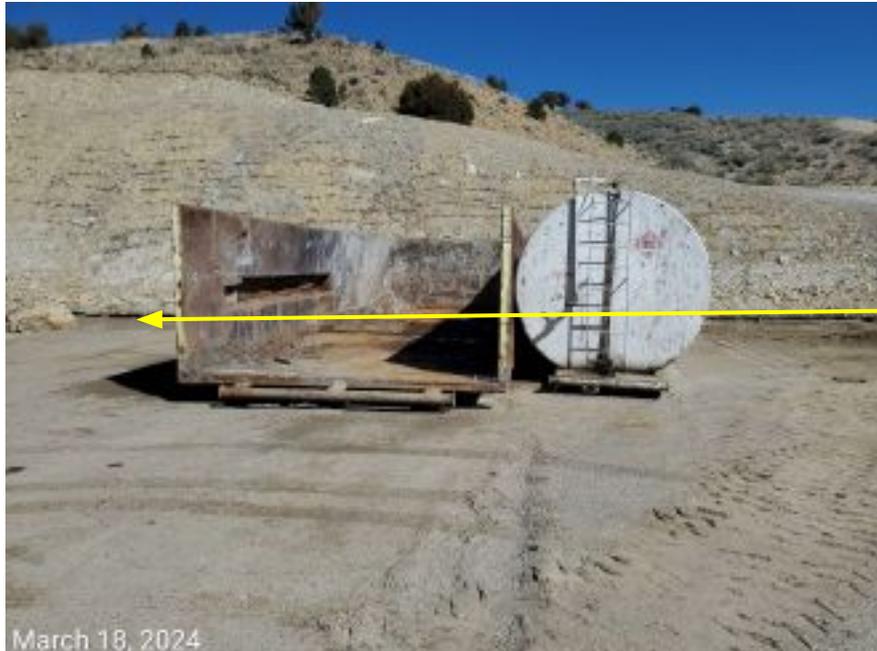
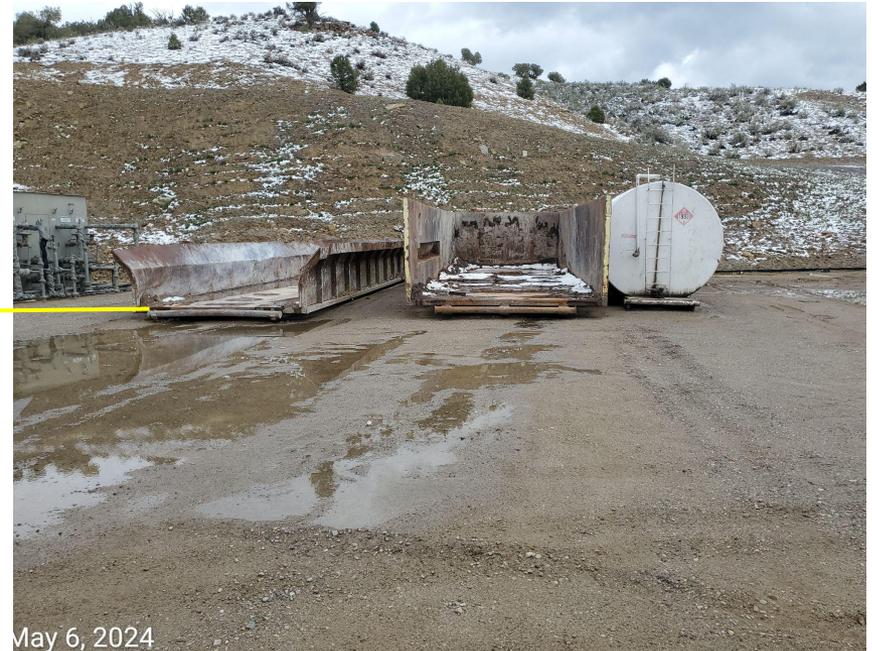
Photo 6: Unused equipment, or equipment not necessary for production remain stored on the Location. Photo left taken during the 3/18/2024 inspection. Photo right shows Operator has since brought on and stored additional unnecessary equipment on the Location.

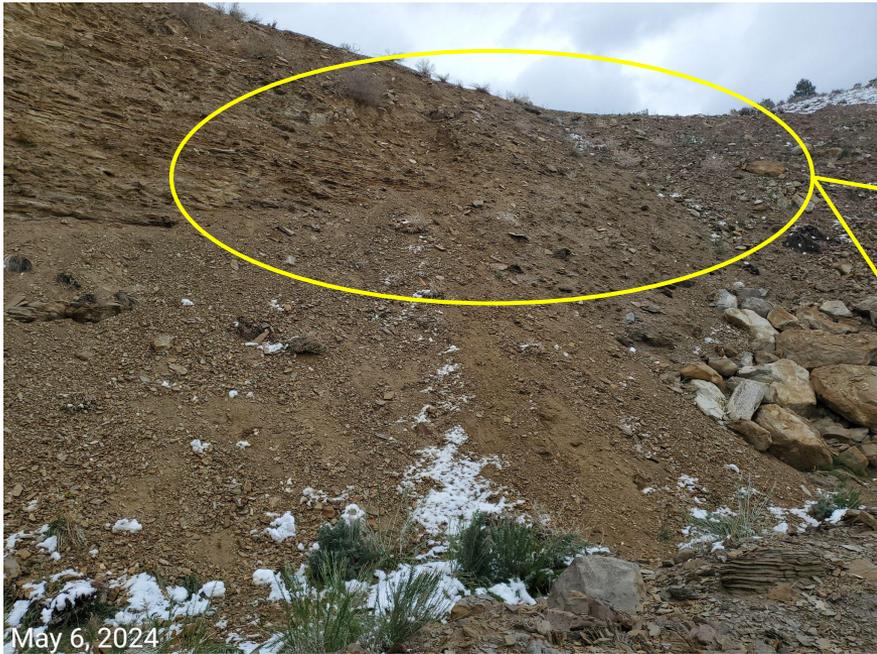
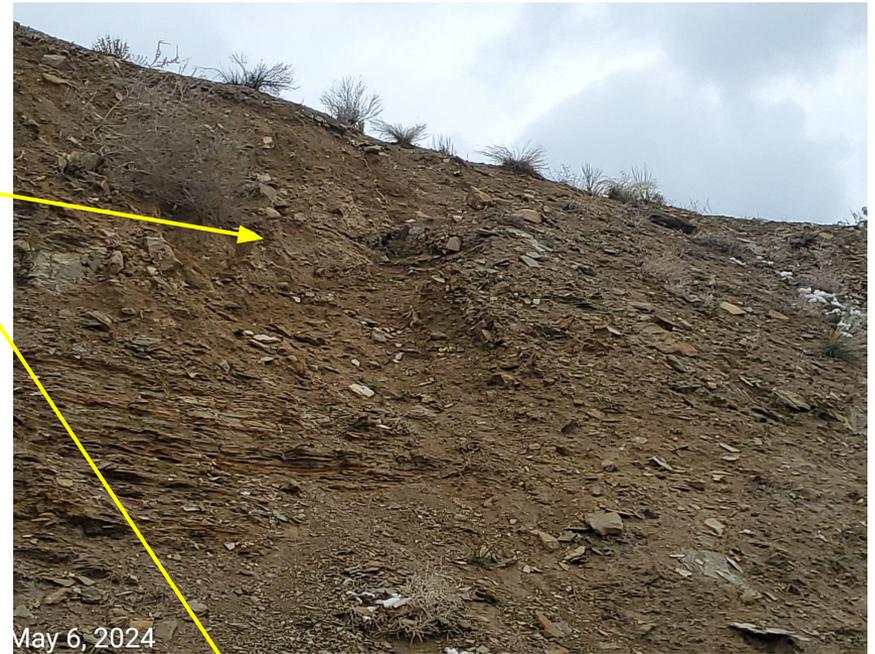
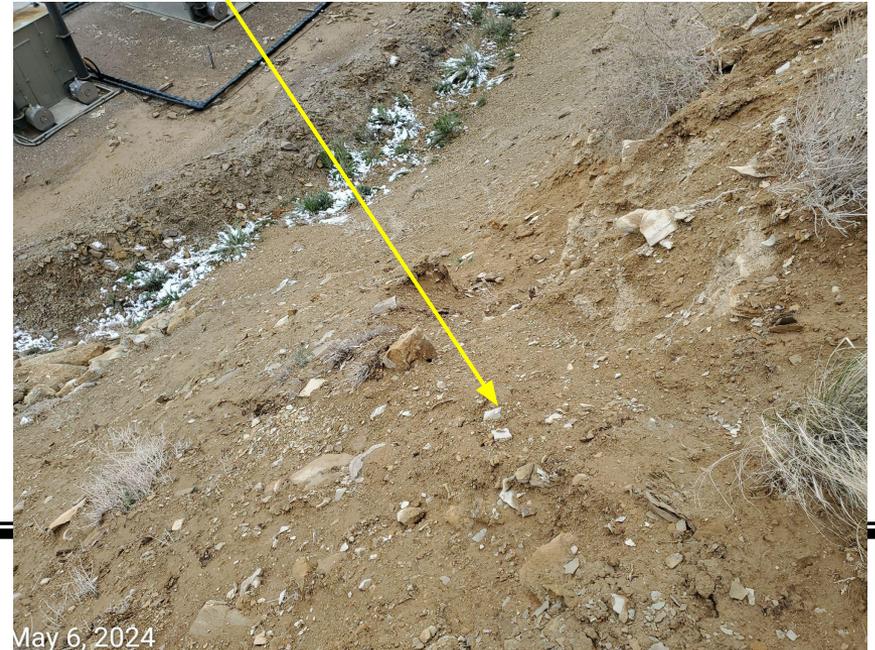
Photo 2: Photo taken from the cut slopes of the Location. Photo top left/right taken from the toe of the slopes looking up, photo bottom right taken from the top of the slope looking down. Photos examples showing stormwater and erosion control BMPs remain missing at cut slopes of the Location; erosion degradation has persisted.

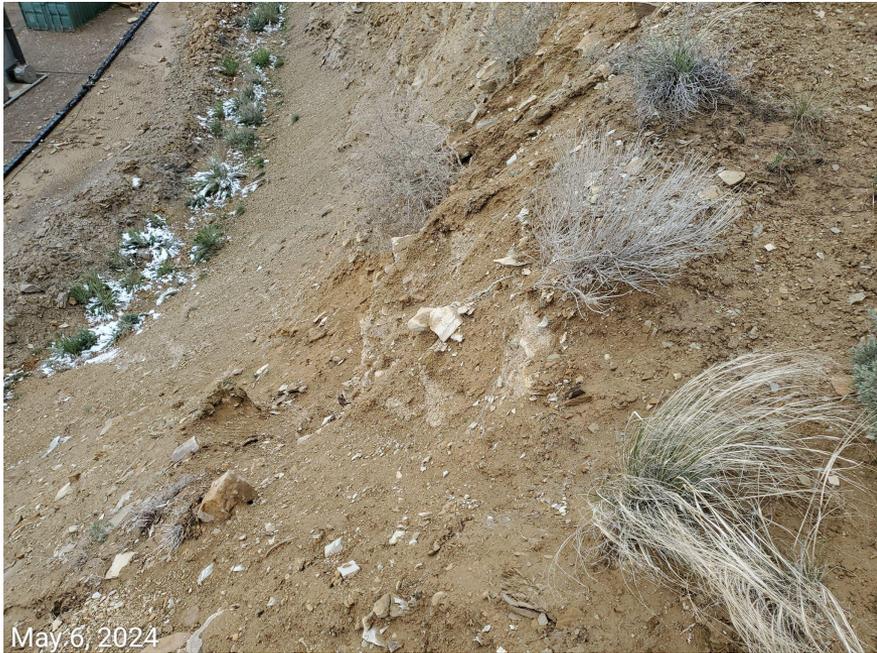
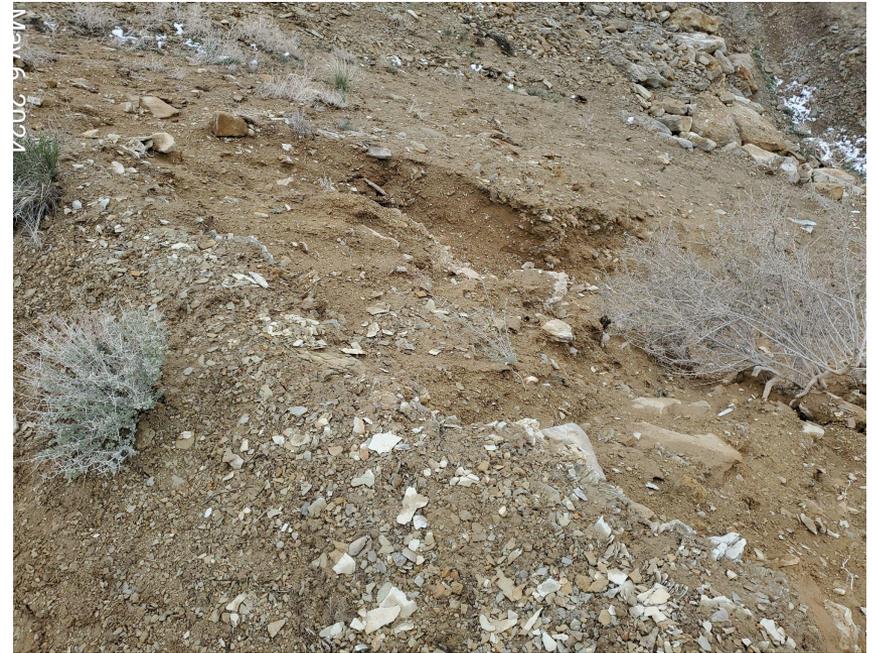
Photo 8: Photos 8-9 taken from the top of the cut slopes on the Location, facing down hill. Photos show erosion degradation occurring on the slopes. BMPs to minimize erosion, degradation and sediment transport remain missing or insufficient.

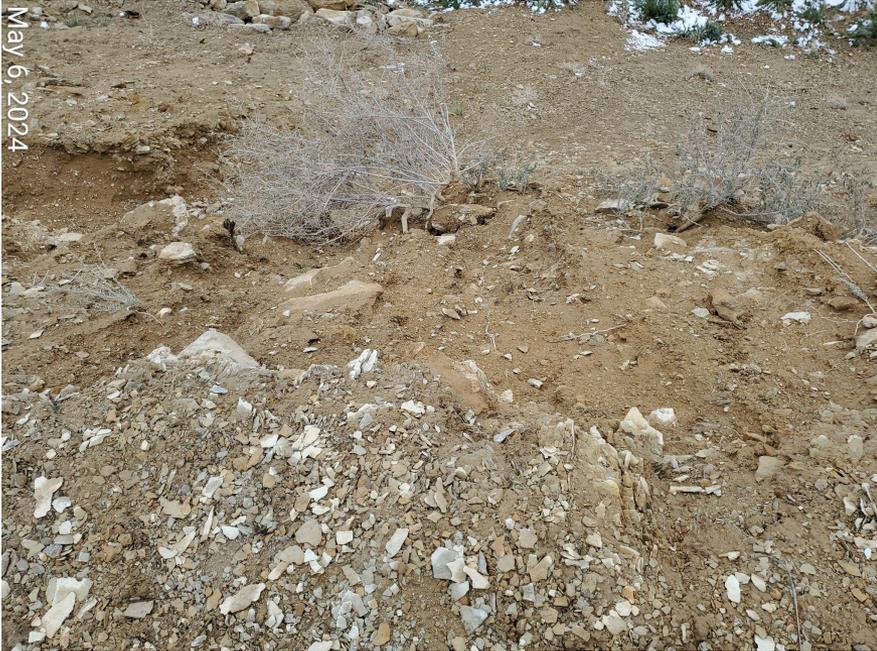
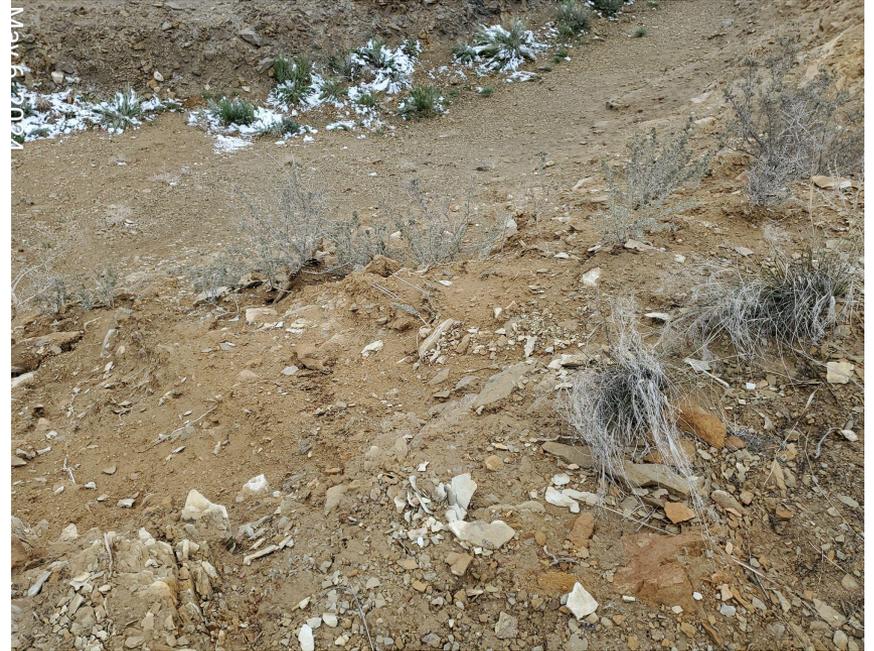
Photo 9: See comments under photo 8.

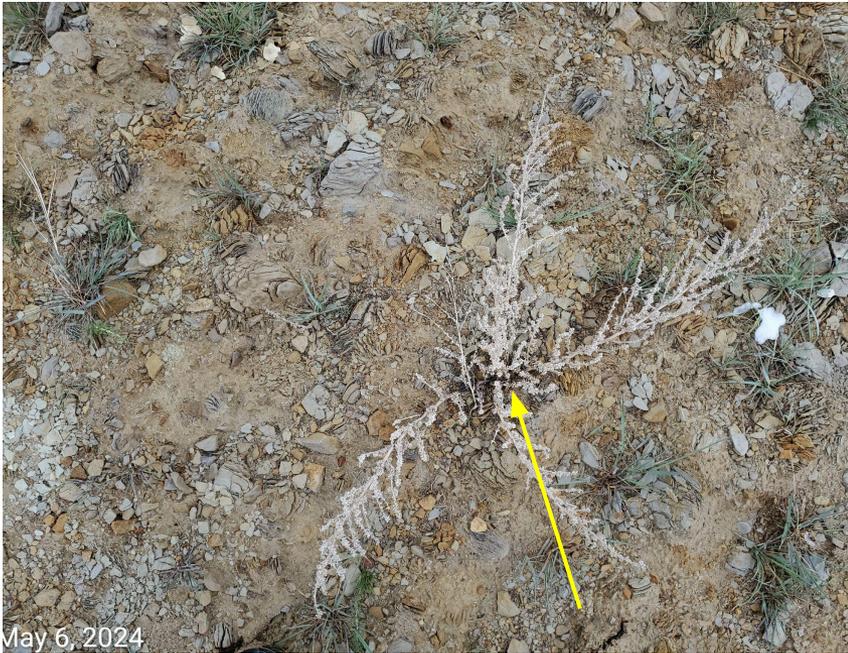
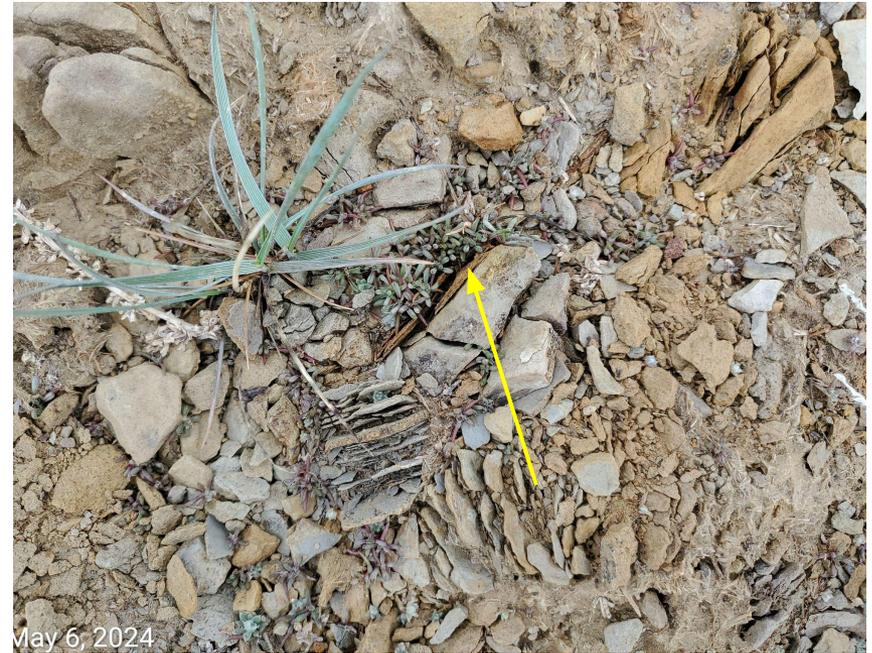
Photo 2: Photo left example of Halogeton observed on the interim areas established during the 2023 growing season. Photo right shows Halogeton germination.
