Hilcorp Energy Company
Duncan Vanschaick-612N100W 29SWNW
Location ID: 333337

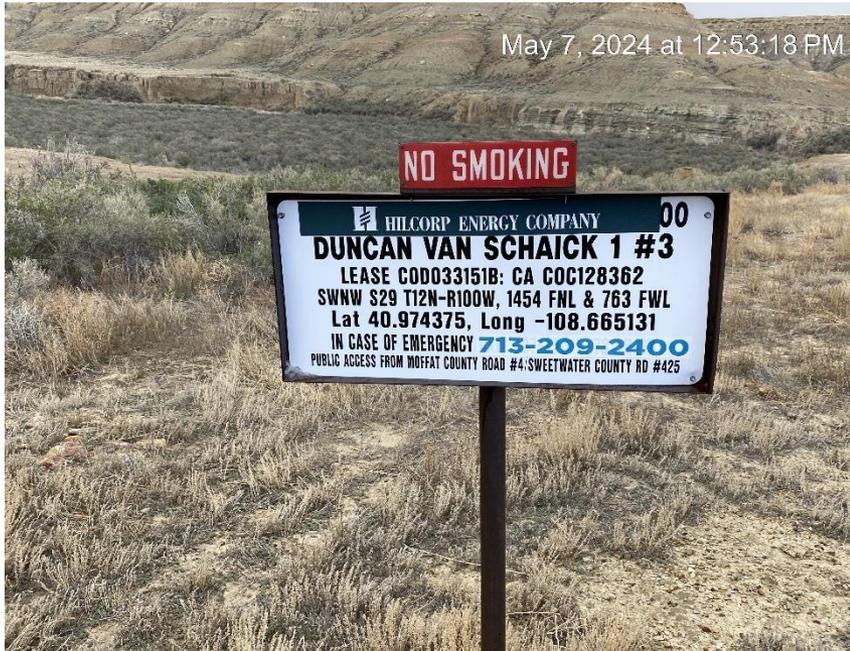
As signs are replaced additional information will be required

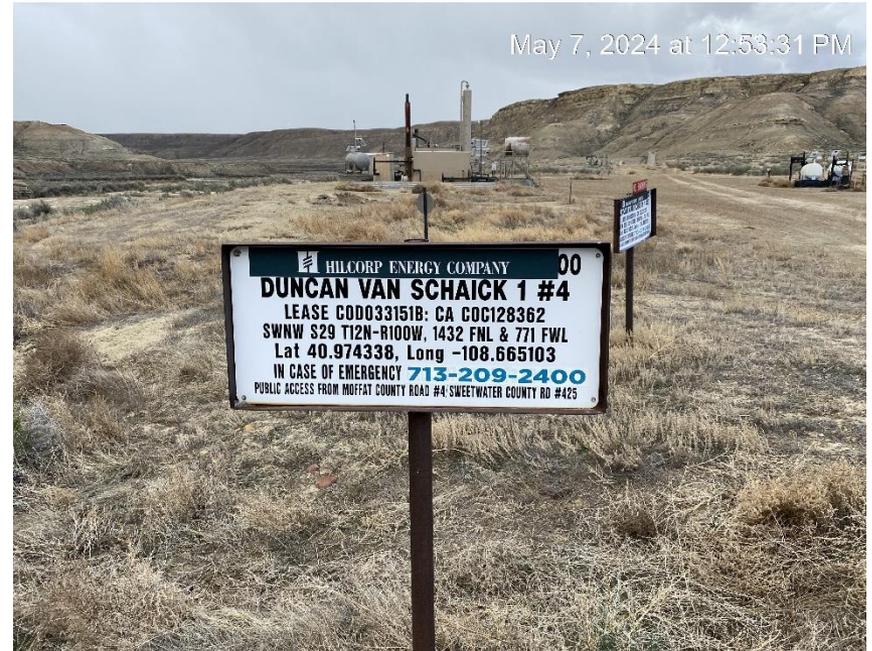
As signs are replaced additional information will be required

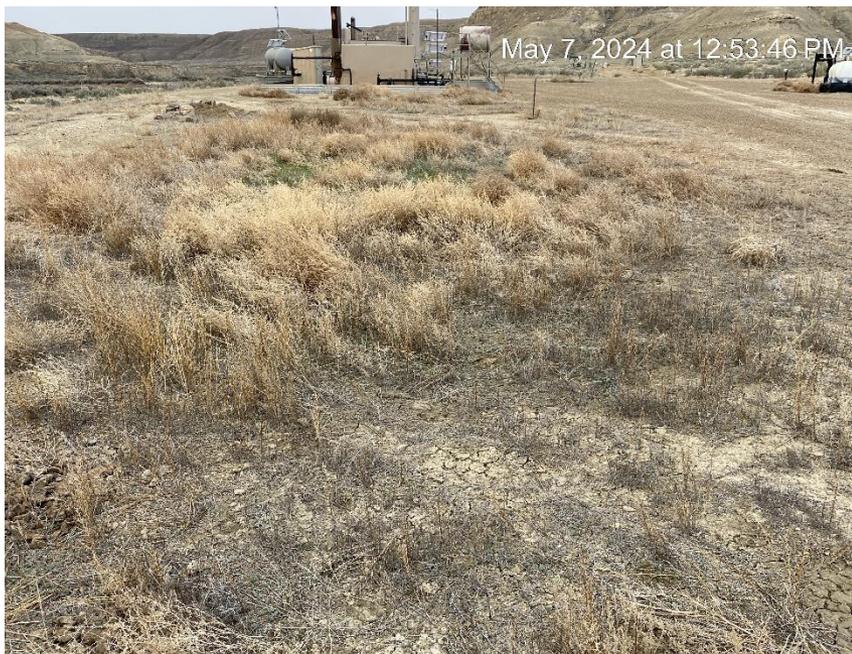
Weeds from last year

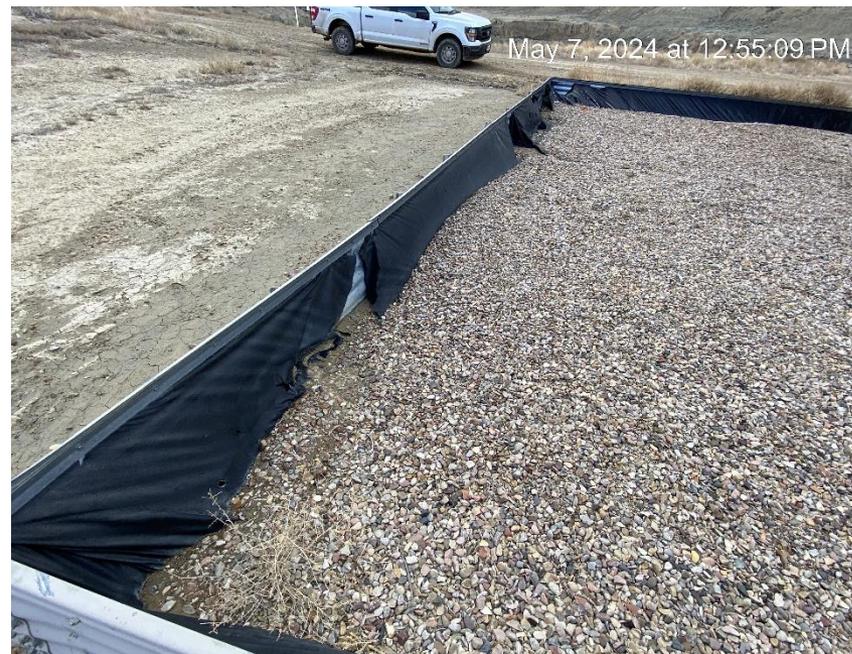
Liner no longer impervious to fluids

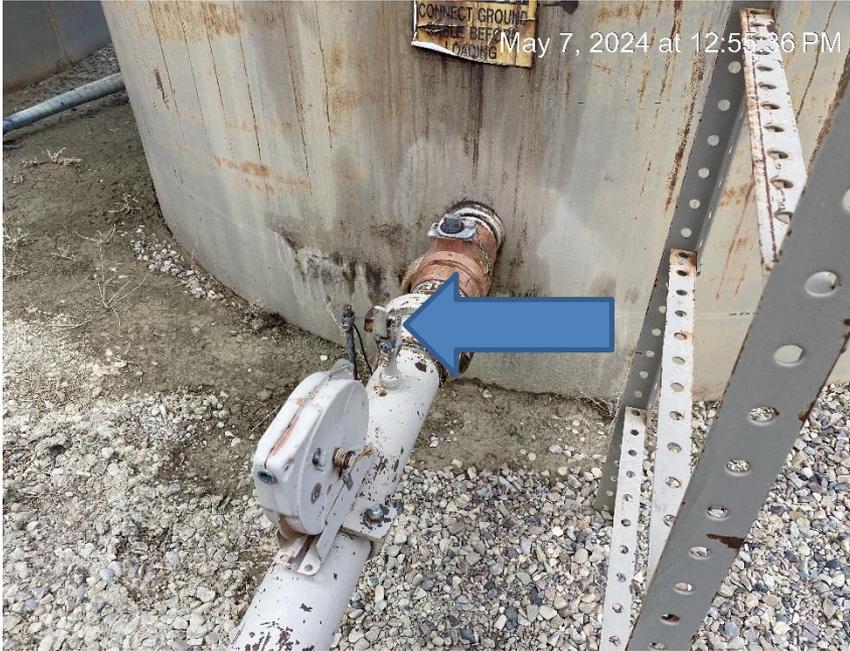
Open ended load line

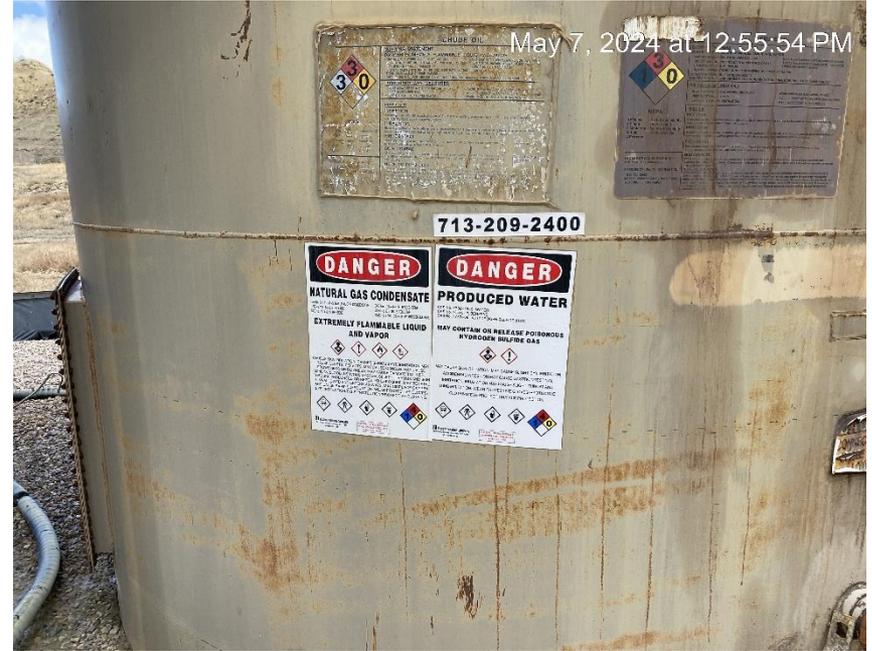
Tank label missing required information

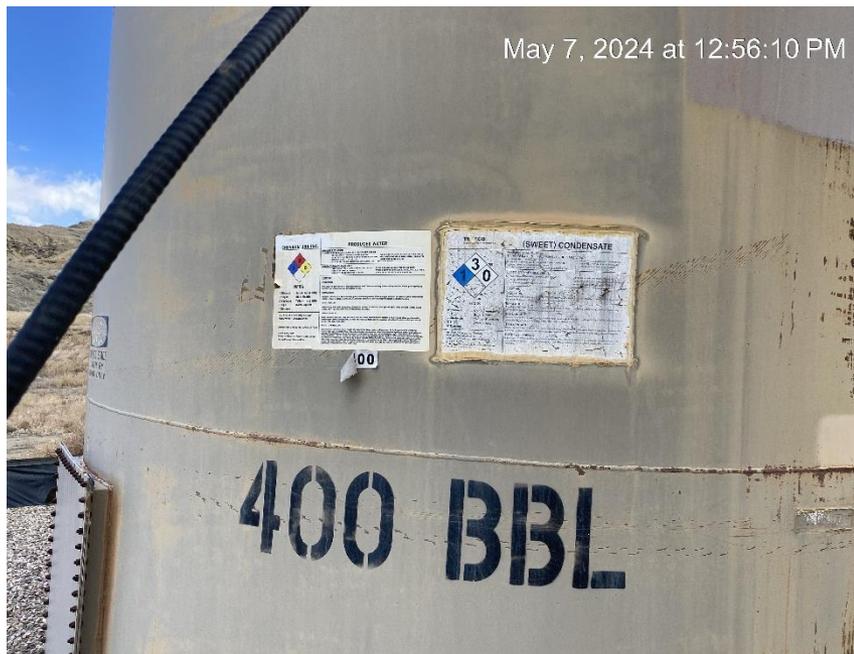
May 7, 2024 at 12:56:10 PM

Tank label missing required information

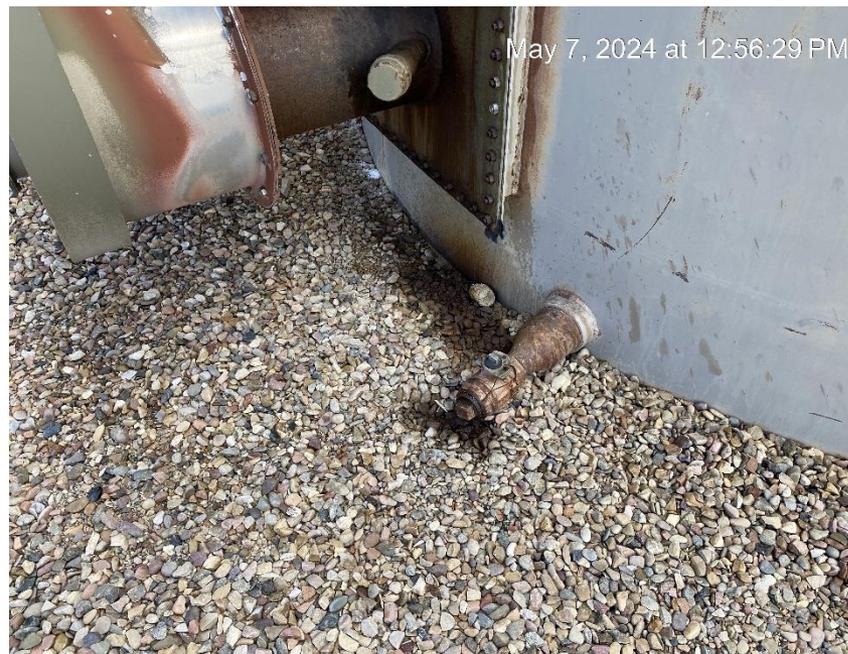
May 7, 2024 at 12:56:29 PM

Stained soil

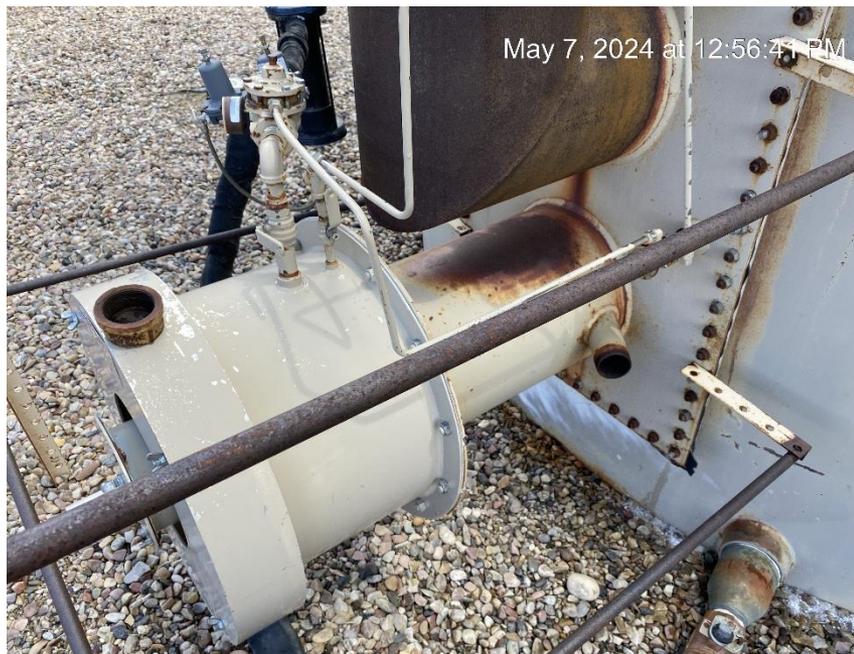
Open to wildlife

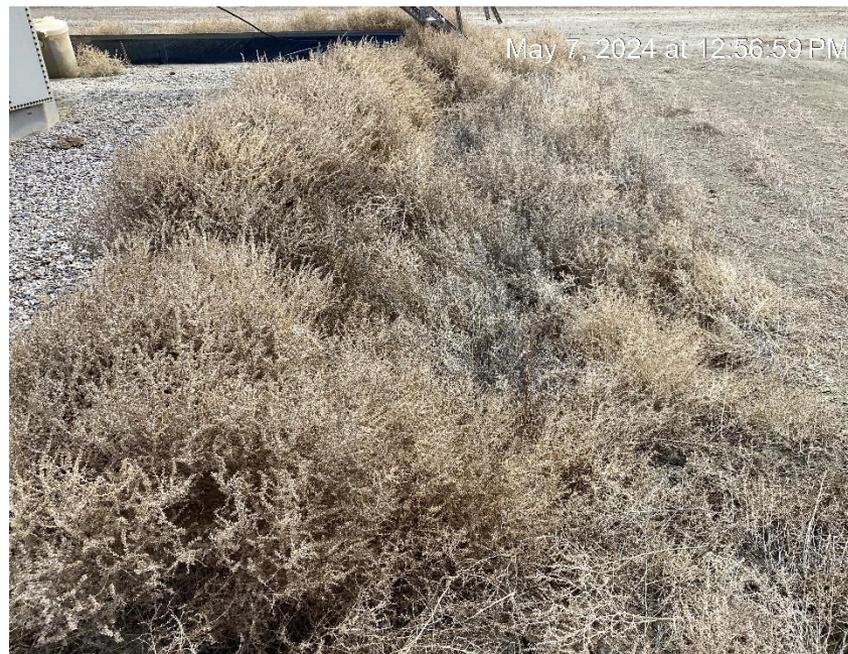
Weeds from last year

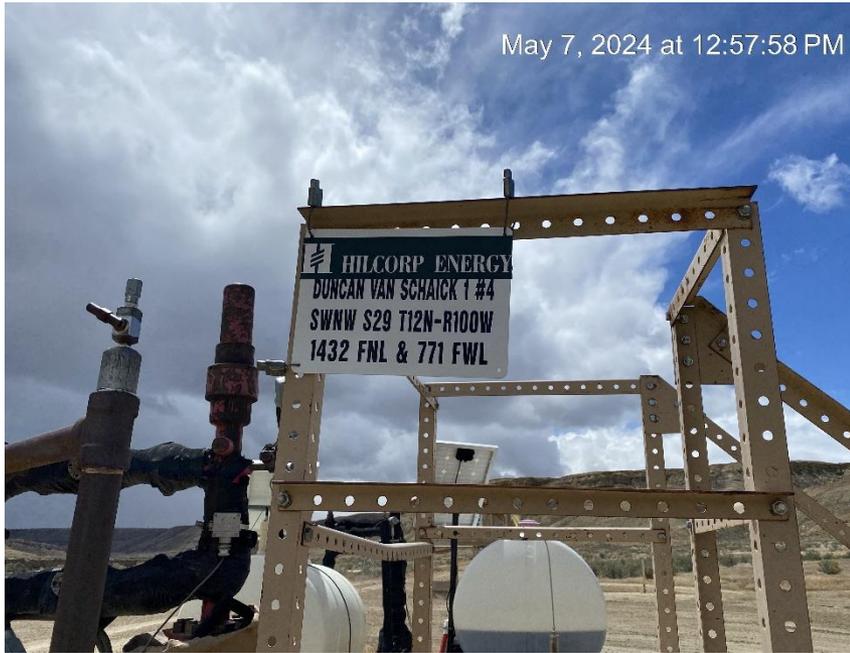
As signs are replaced additional information will be required

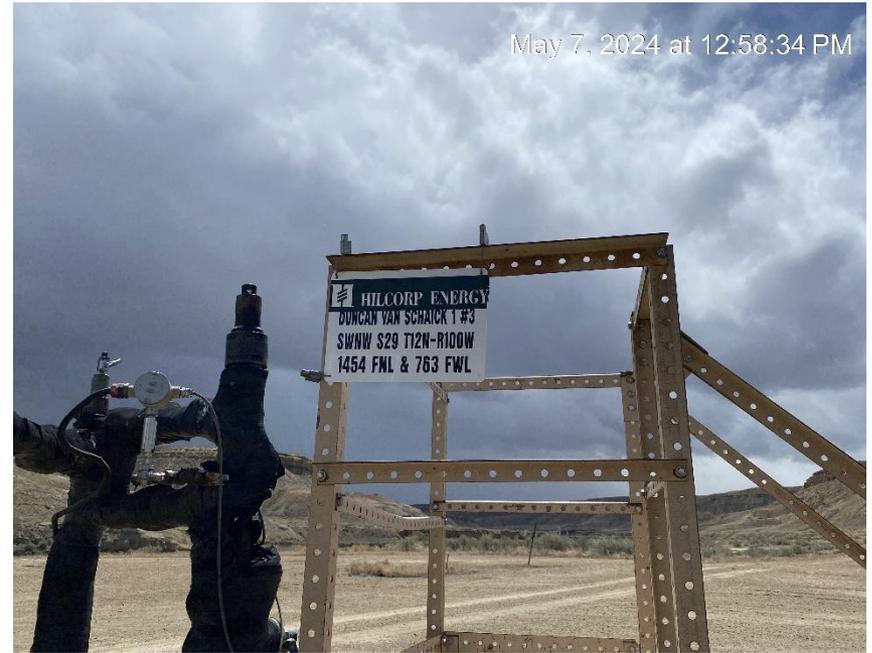
As signs are replaced additional information will be required

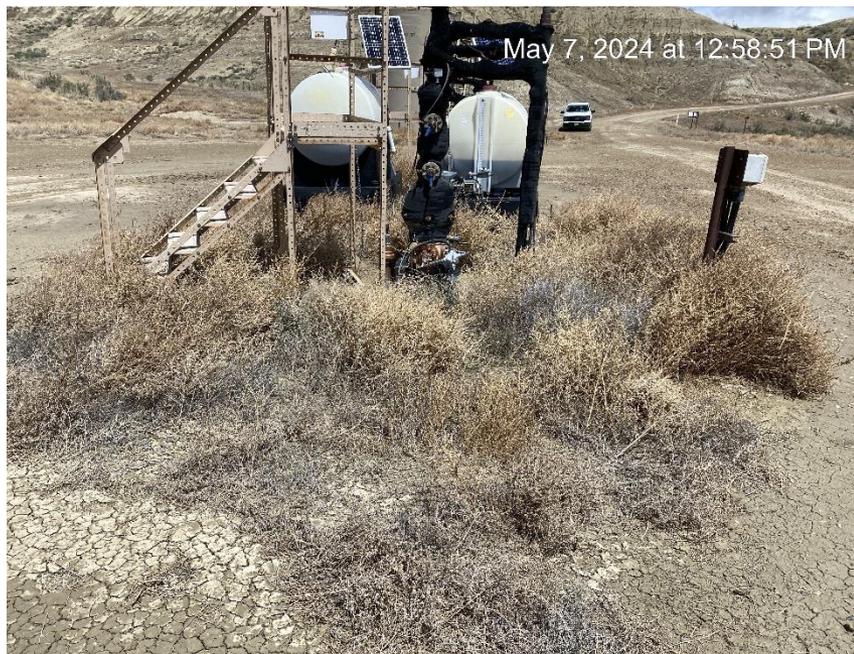
Weeds from last year

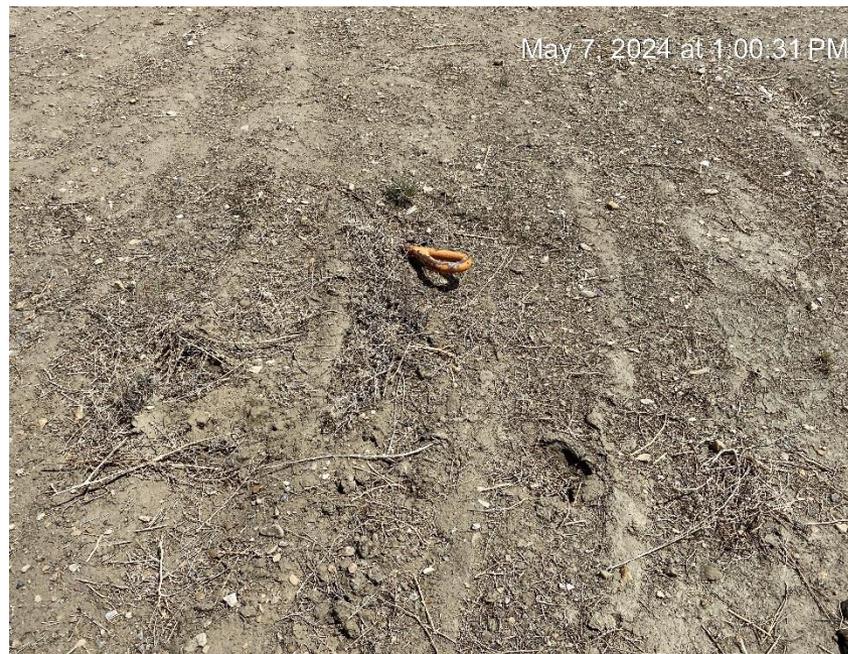
Unmarked anchor

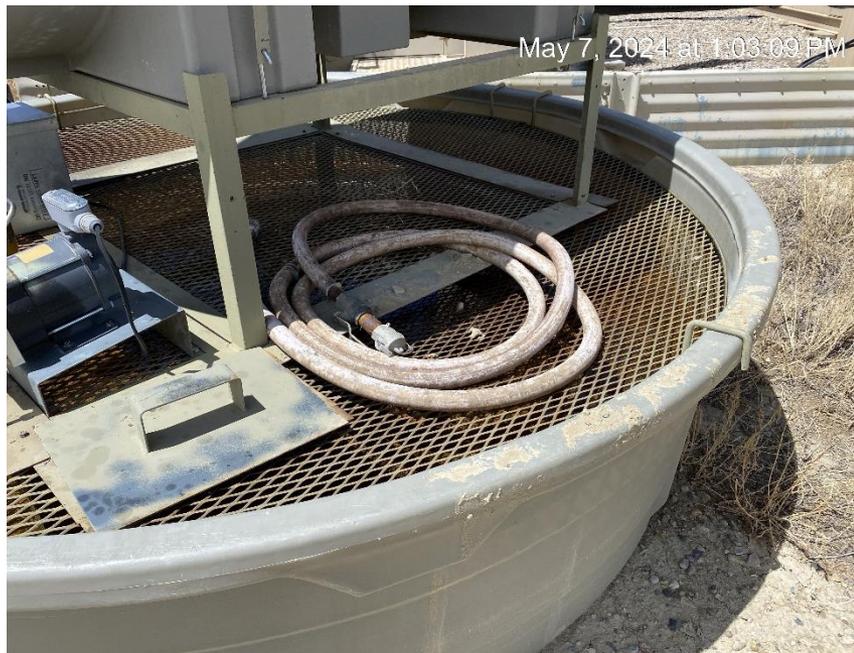
Debris

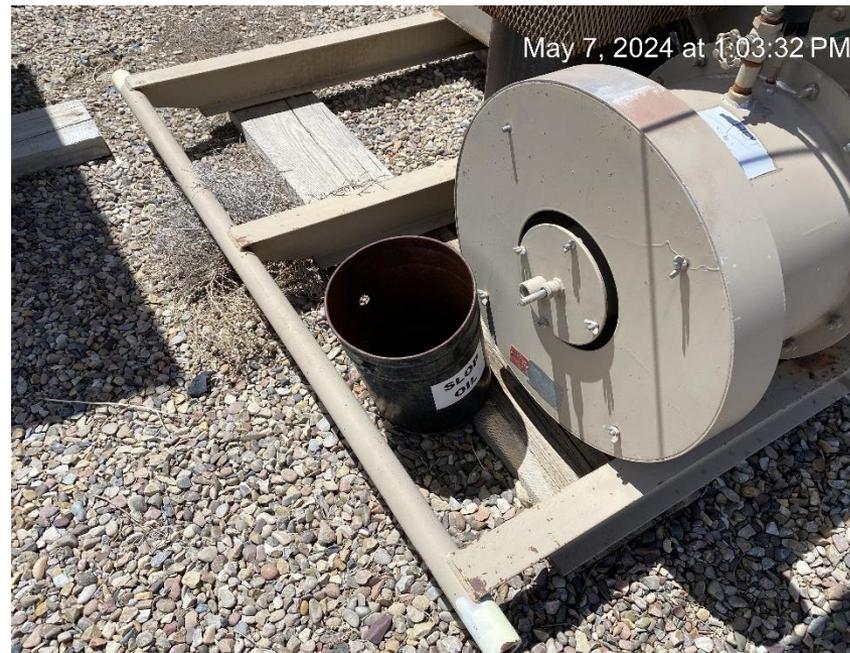
Debris

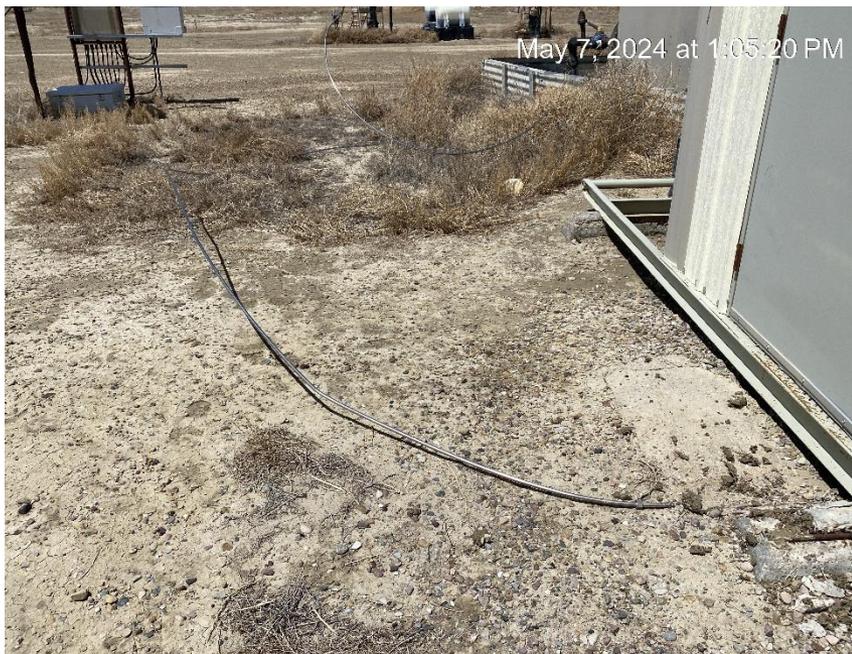
Debris

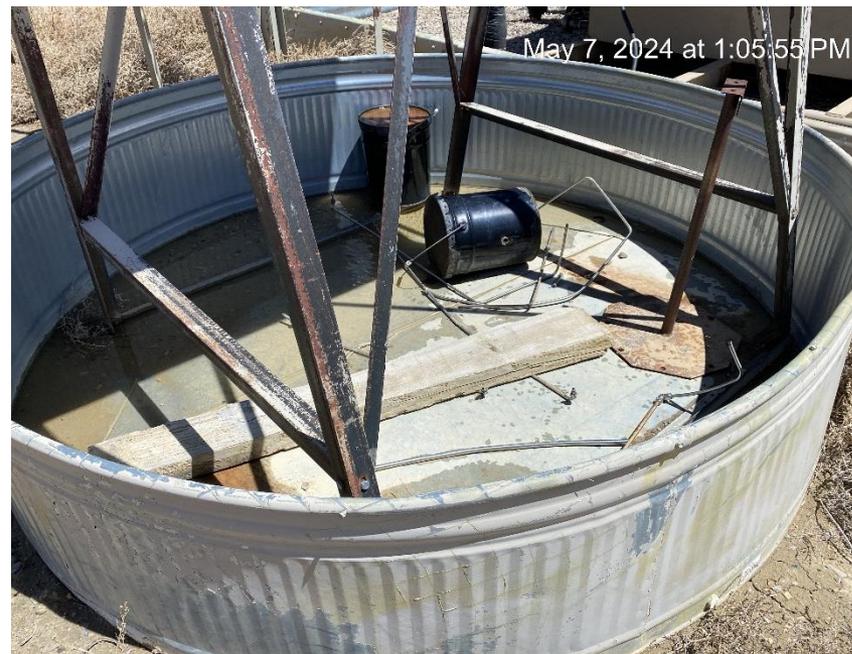
Debris. Unused equipment. Open to wildlife

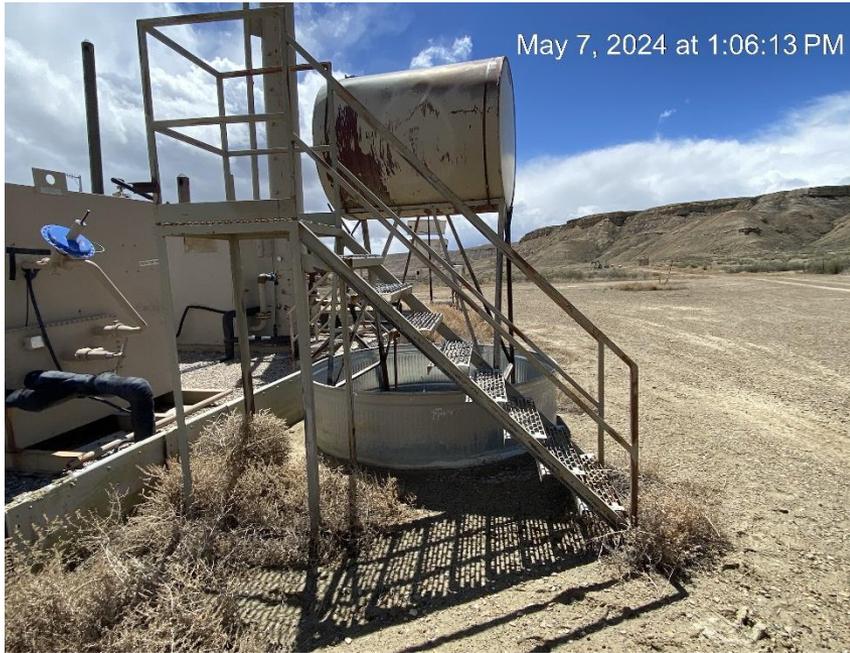
Unused equipment
