Inspection Photos

Location Name: CAERUS PICEANCE LLC Daybreak Federal 30-12 (PL30) Pad

Location #: 414077

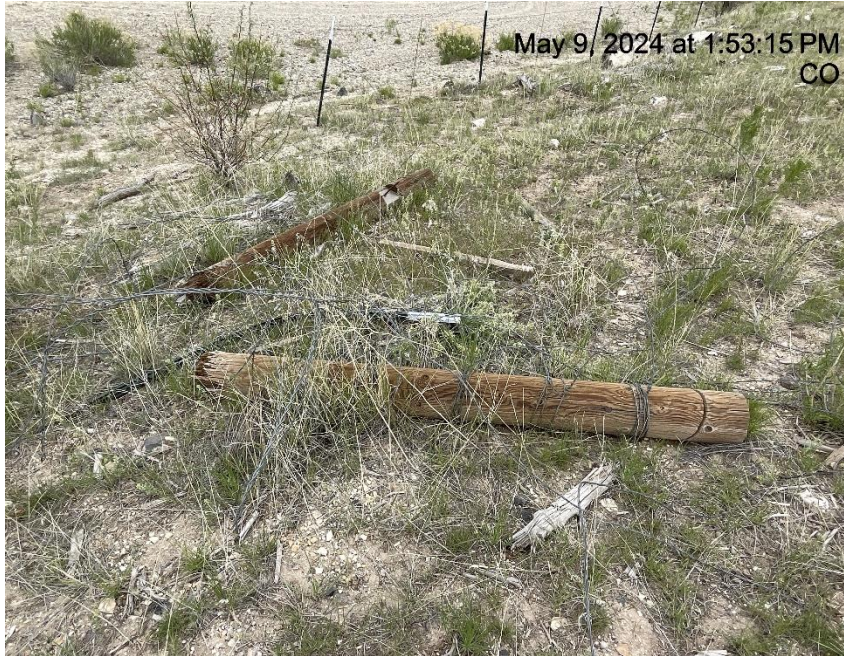
Photo # 6491 Barbed wire fence needs maintenance/wildlife hazard

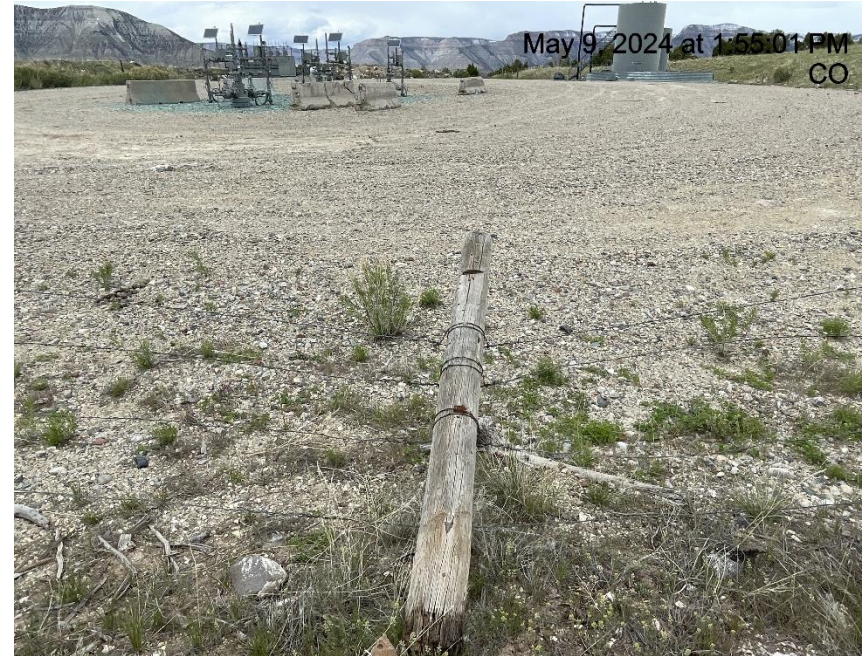
Photo # 6492 Barbed wire fence needs maintenance/wildlife hazard

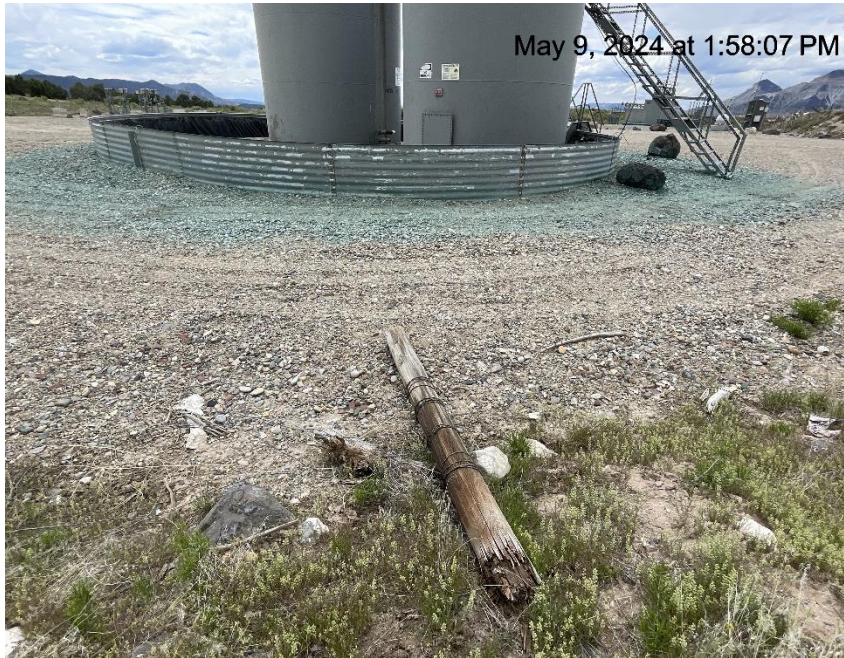
Photo # 6493 Barbed wire fence needs maintenance/wildlife hazard

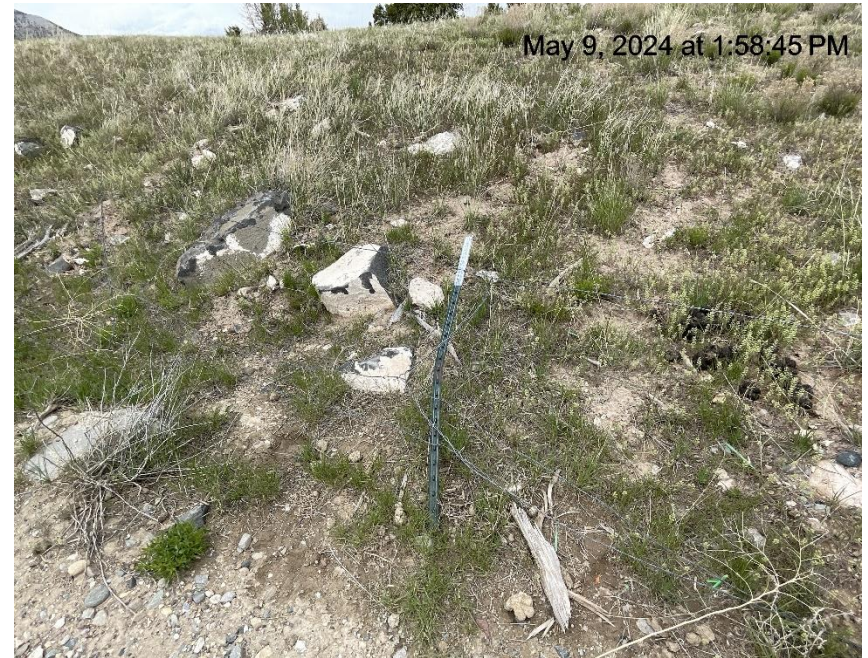
Photo # 6494 Barbed wire fence needs maintenance/wildlife hazard

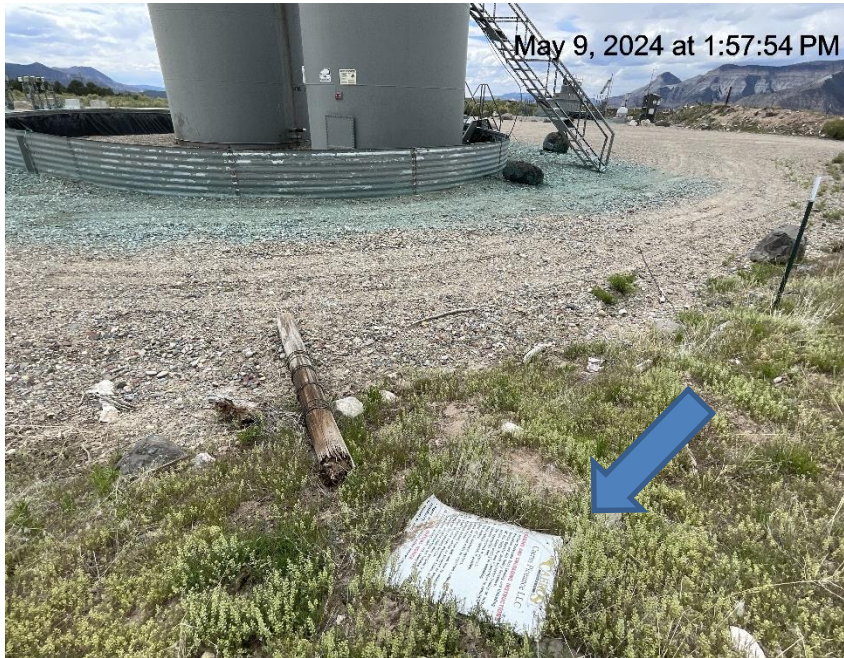
Photo # 6495 Debris

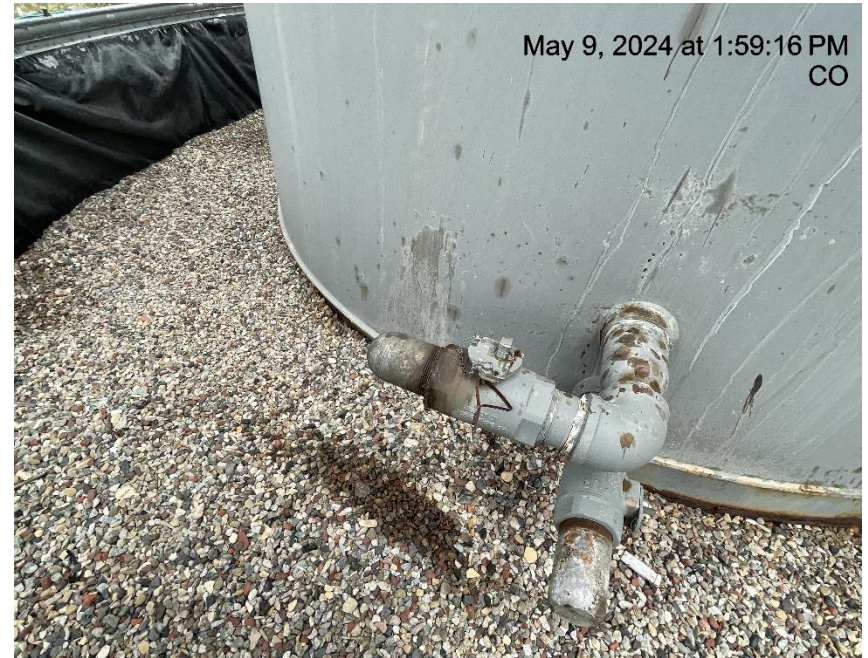
Photo # 6496 Stained gravel in secondary containment

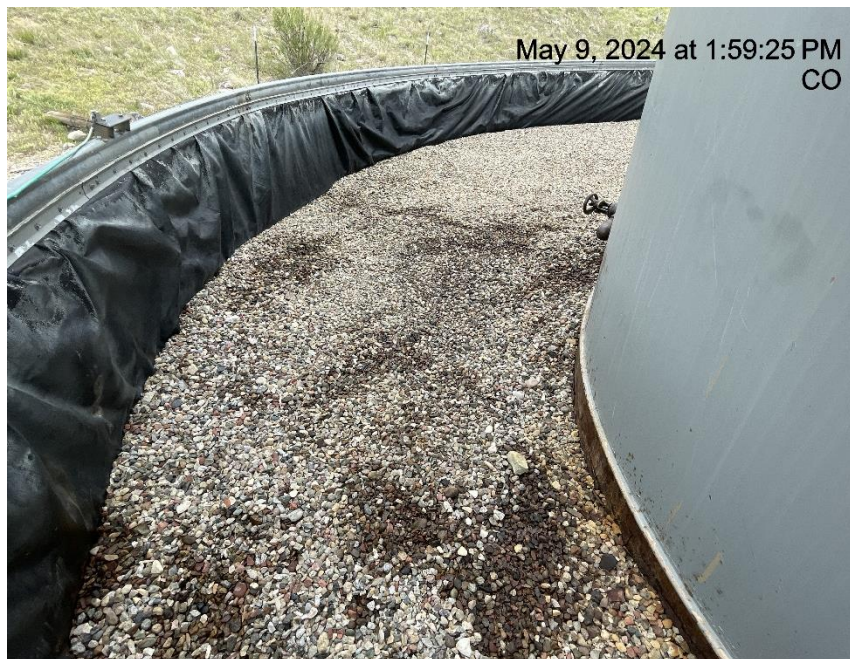
Photo # 6497 Stained gravel in secondary containment

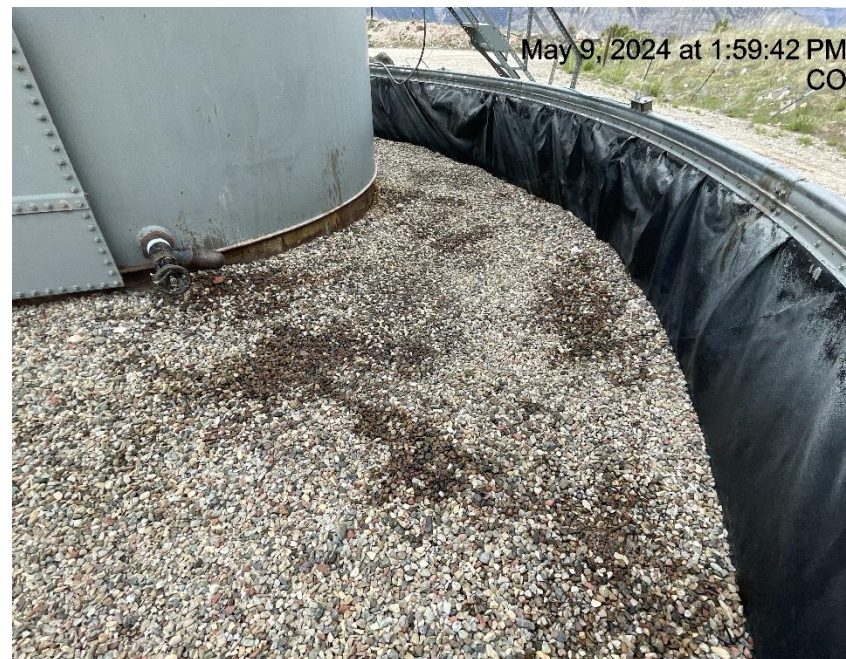
Photo # 6498 Stained gravel in secondary containment

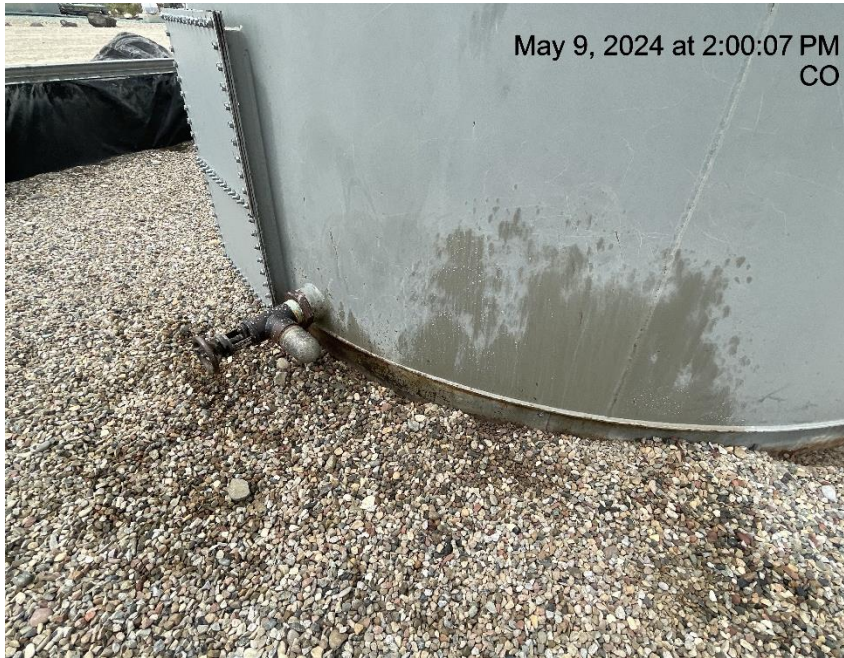
Photo # 6499 Stained gravel in secondary containment

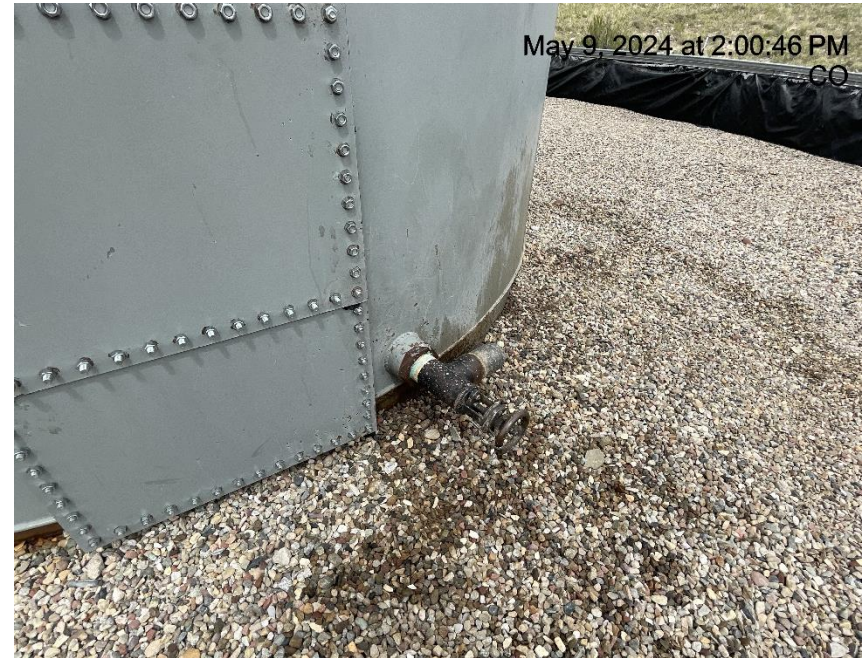
Photo # 6500 Stained gravel in secondary containment

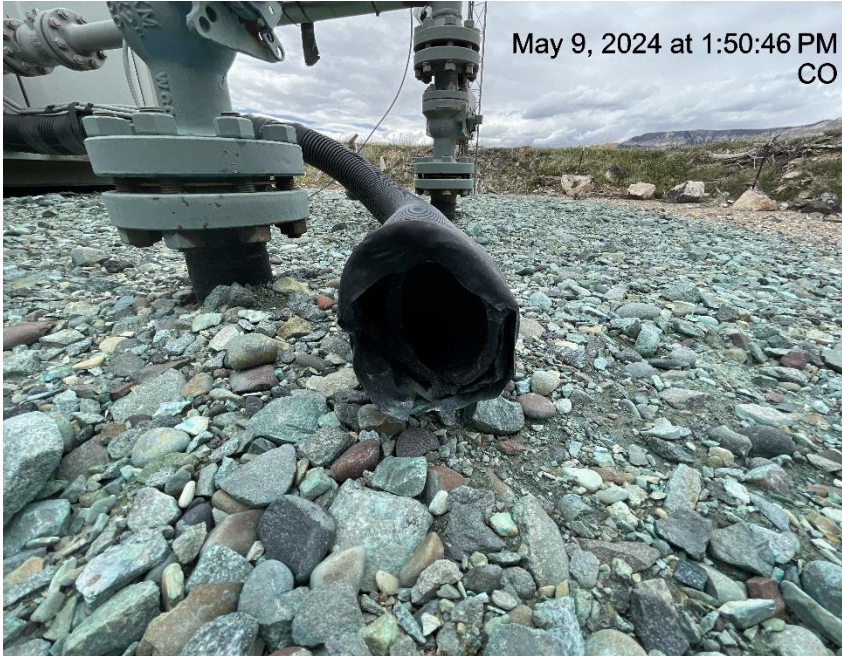
**Photo # 6501 Flowline heating insulation open ended
/wildlife hazard/available for entry by wildlife**

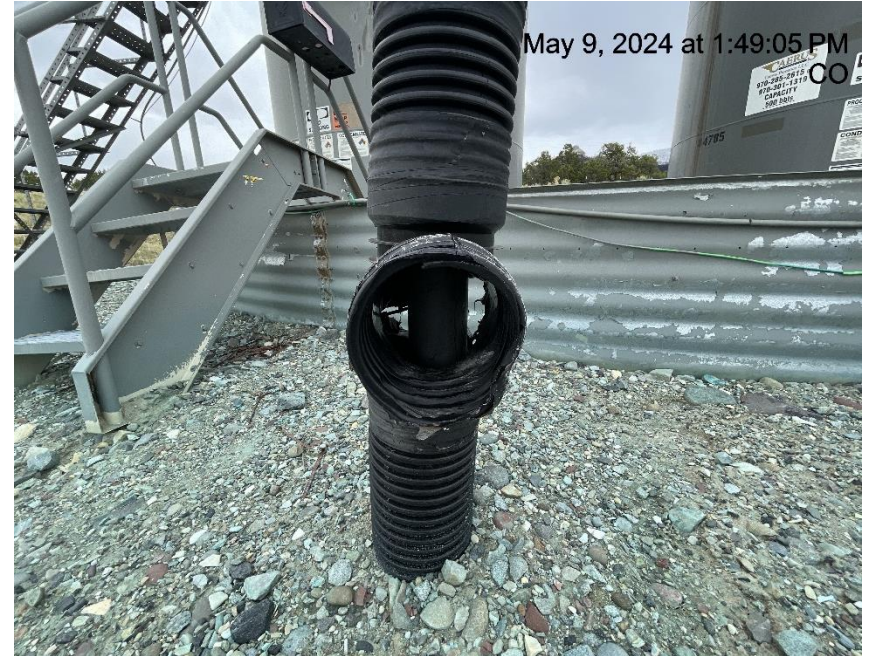
**Photo # 6502 Flowline heating insulation open ended
/wildlife hazard/available for entry by wildlife**
