Inspection Photos

Operator: TEP ROCKY MOUNTAIN LLC #96850

Location ID: 335678

Inspection Doc: 696205818

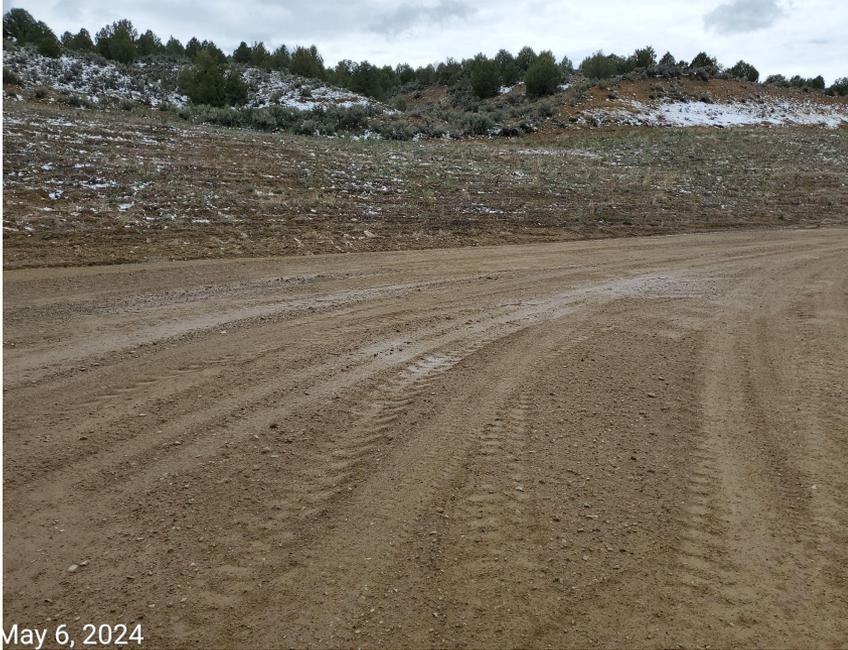
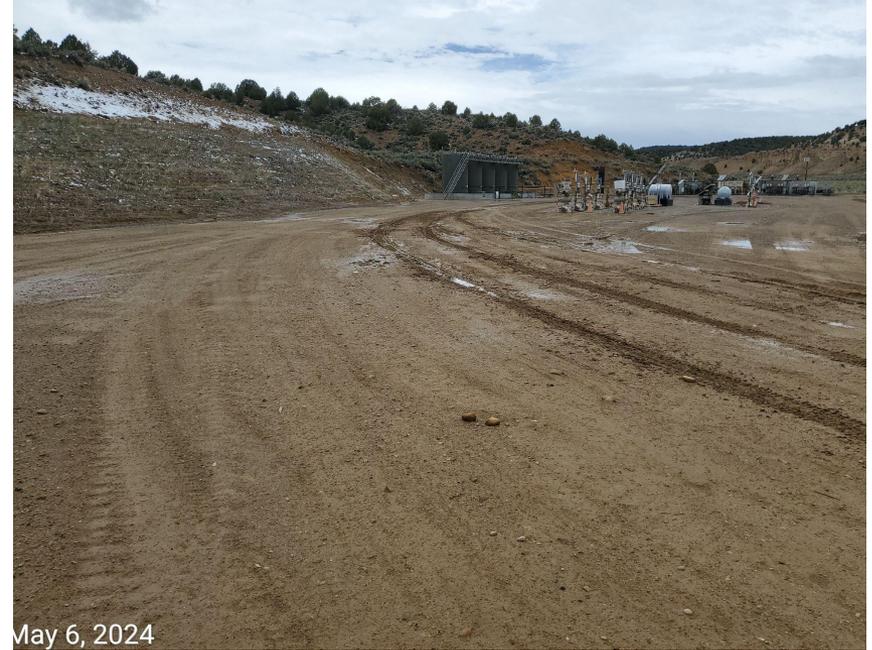
Photo 1: Photos 1-2 taken from the east end of the working pad surface. Photos provide an overview of the Location from south, southwest, northwest to north.

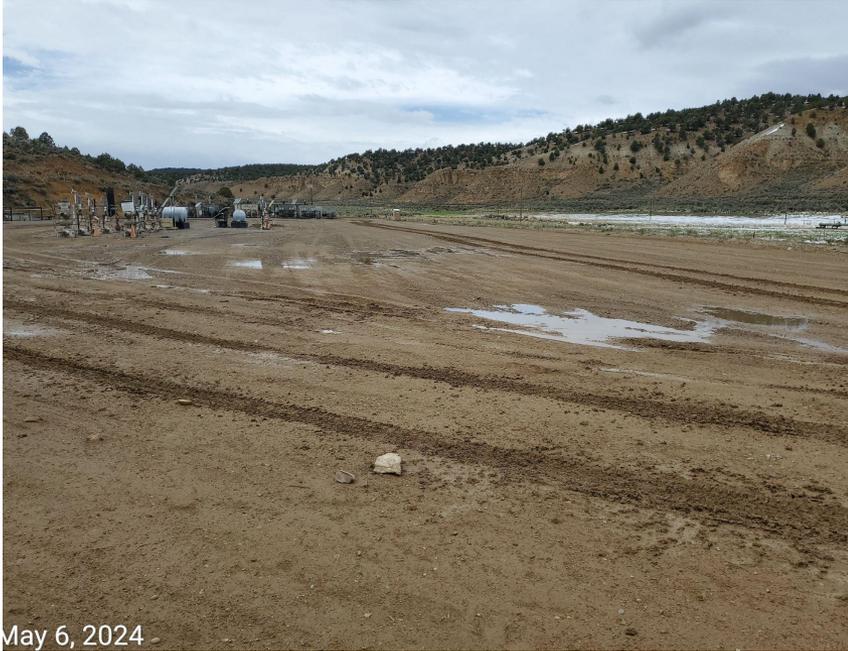
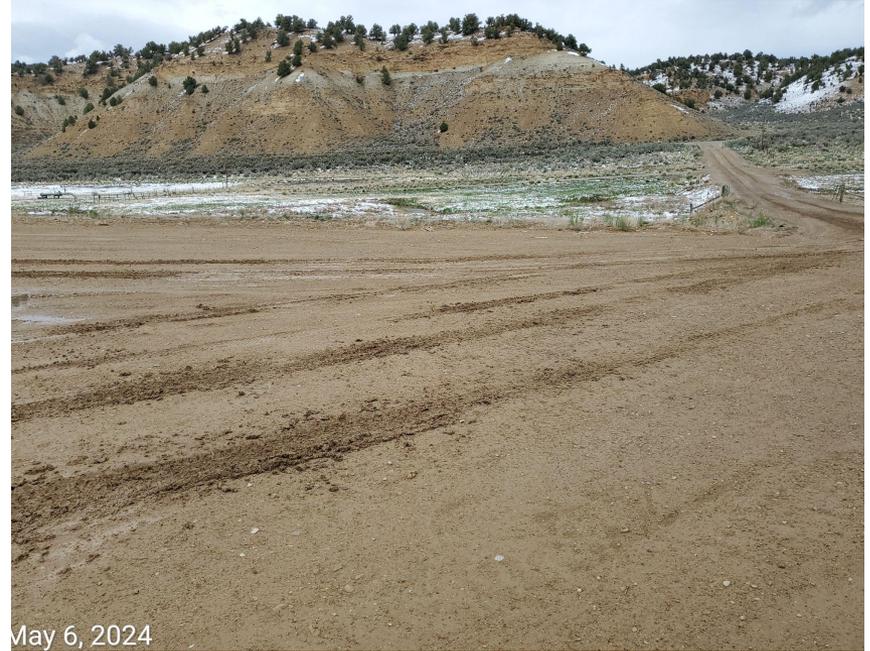
Photo 2: See comments under photo 1.

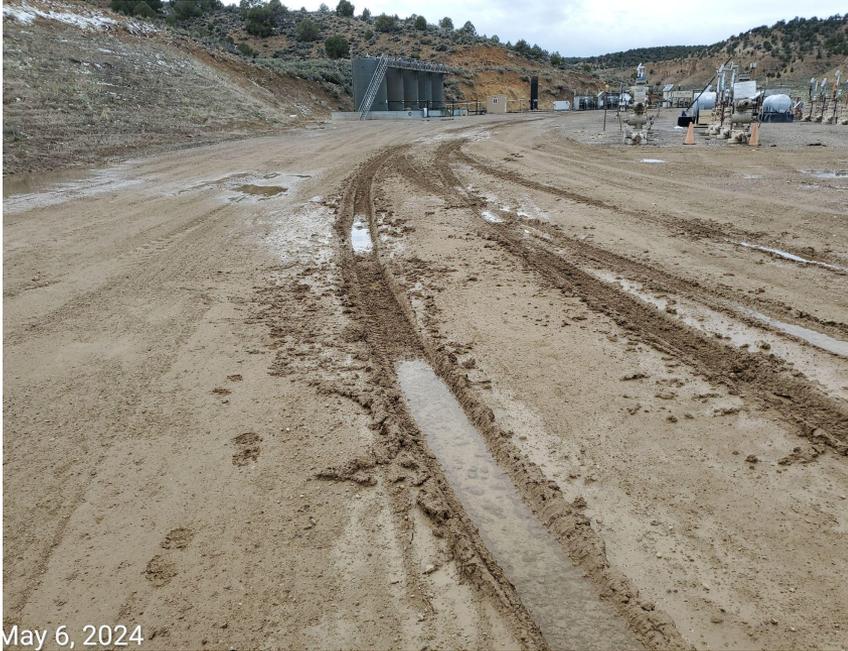
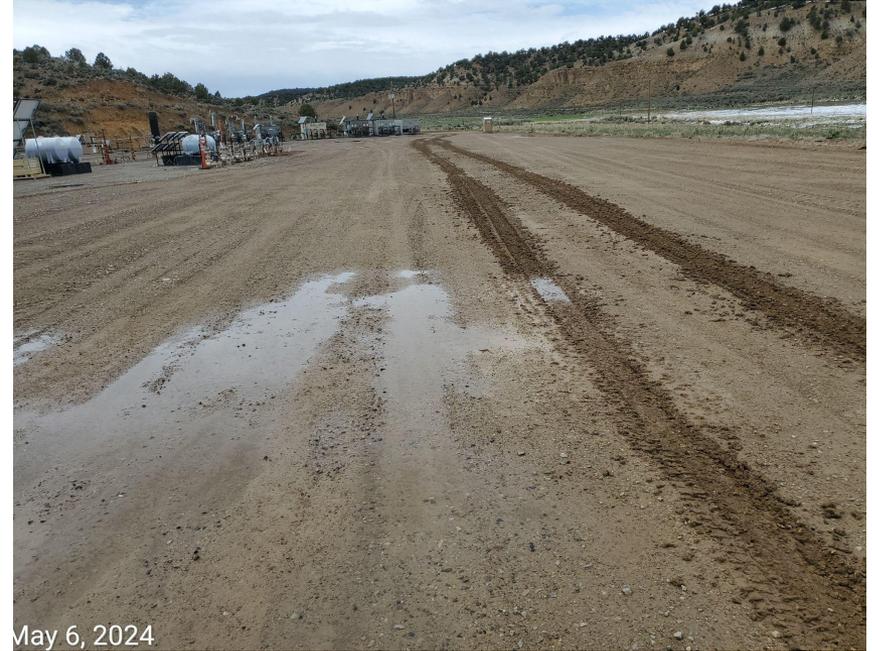
Photo 3: Photos taken from the working pad surface. Work to address the tracking and pad stabilization issues evident, though insufficient; tracking/degradation issues are recurring; Operator appears to have only graded the working pad surface; no other BMPs to stabilize the WPS in a manner that minimizes erosion, degradation and sediment transport during wet conditions appear to have been implemented.

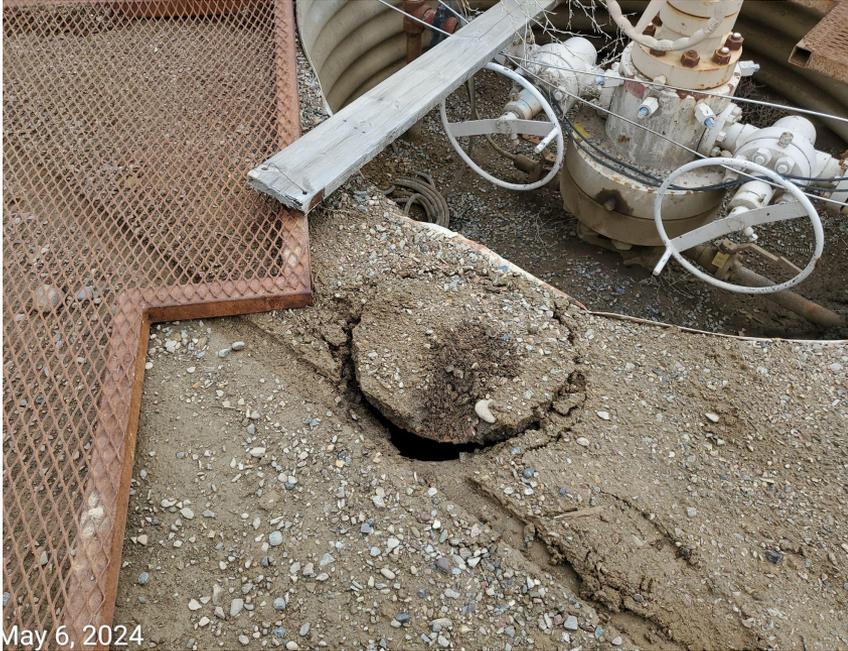
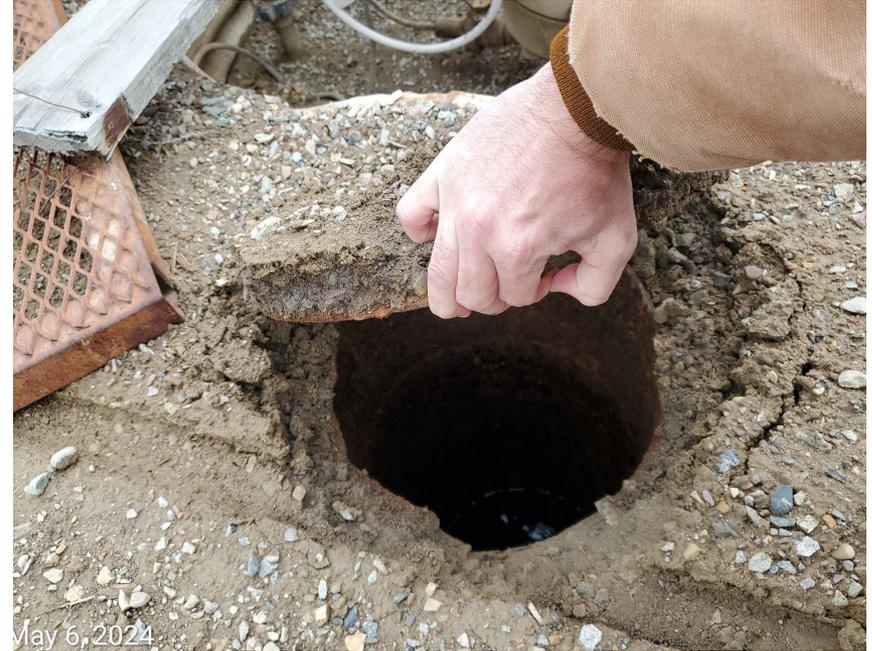
Photo 4: Photo example showing mouseholes, or other boreholes at the wells on Location have not been properly backfilled and/or closed.

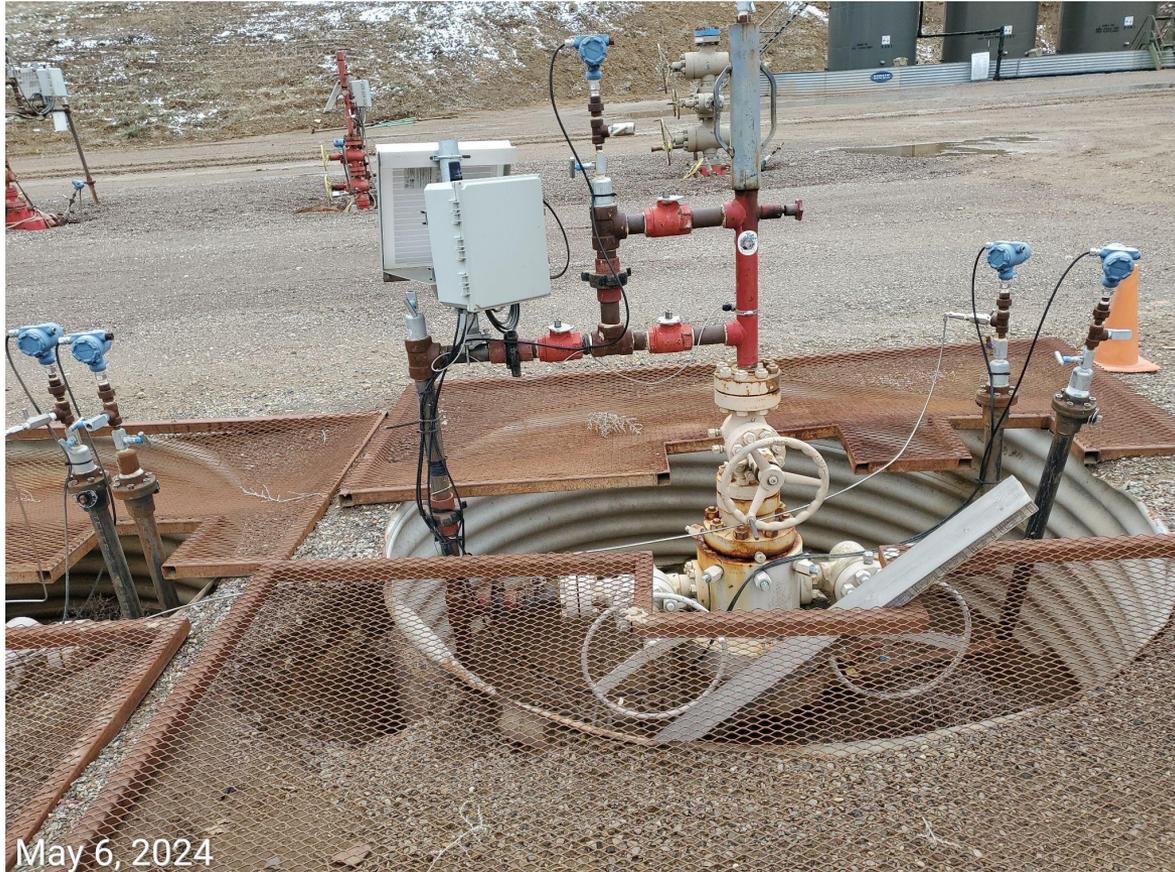
Photo 5: Signage missing at well.

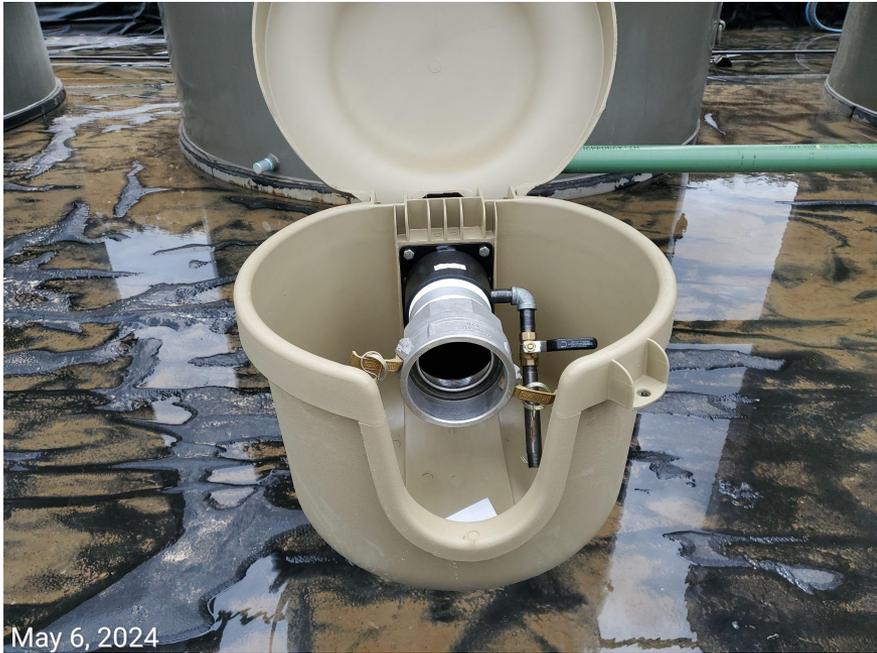
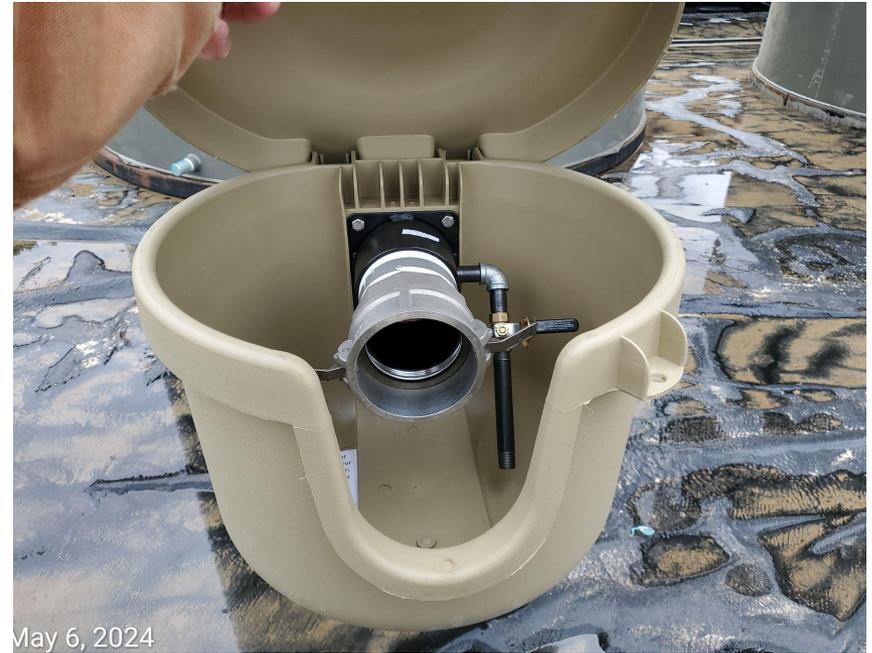
Photo 6: Photo examples showing lines at tanks missing cap/plug.

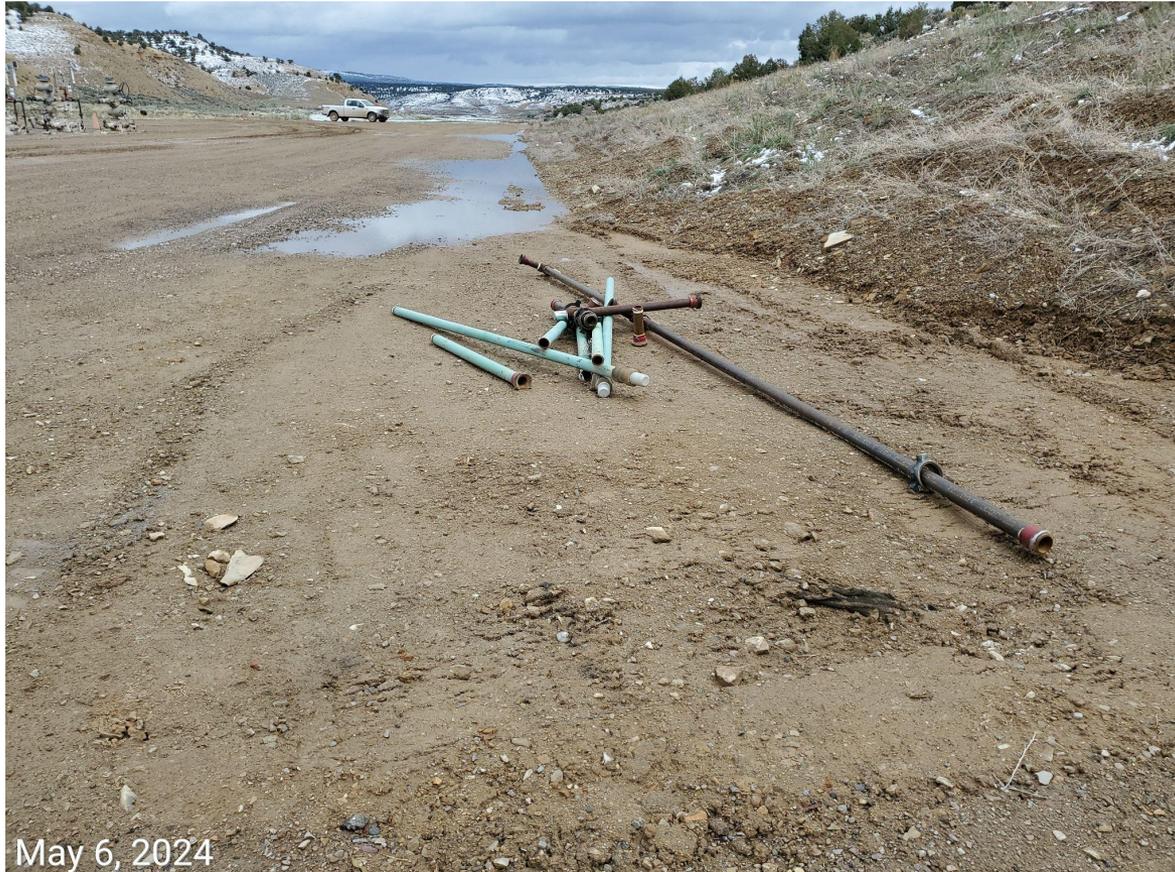
Photo 7: Unused pipe equipment.

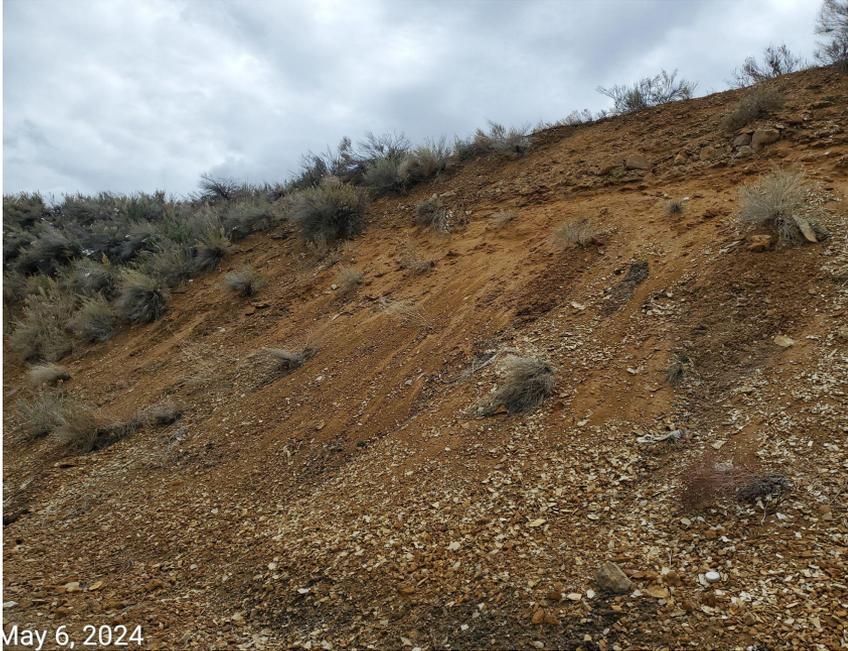
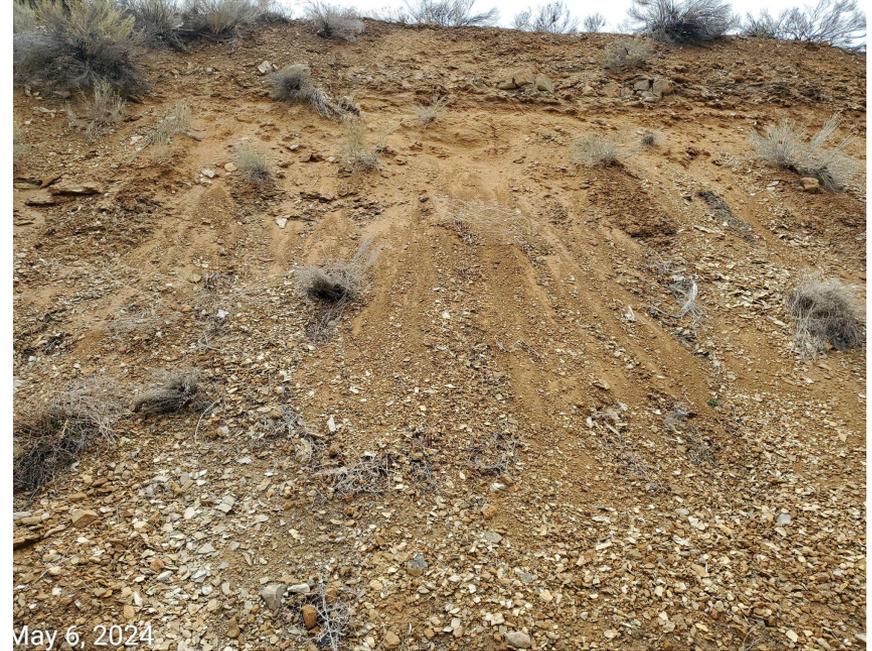
Photo 8: Photos 8-13 example showing BMPs to minimize erosion, degradation and sediment transport remain missing or insufficient at the slopes of the Location (Cut/Fill, and interim area slopes). Erosion has persisted. Photos specifically show cut slopes of Location.

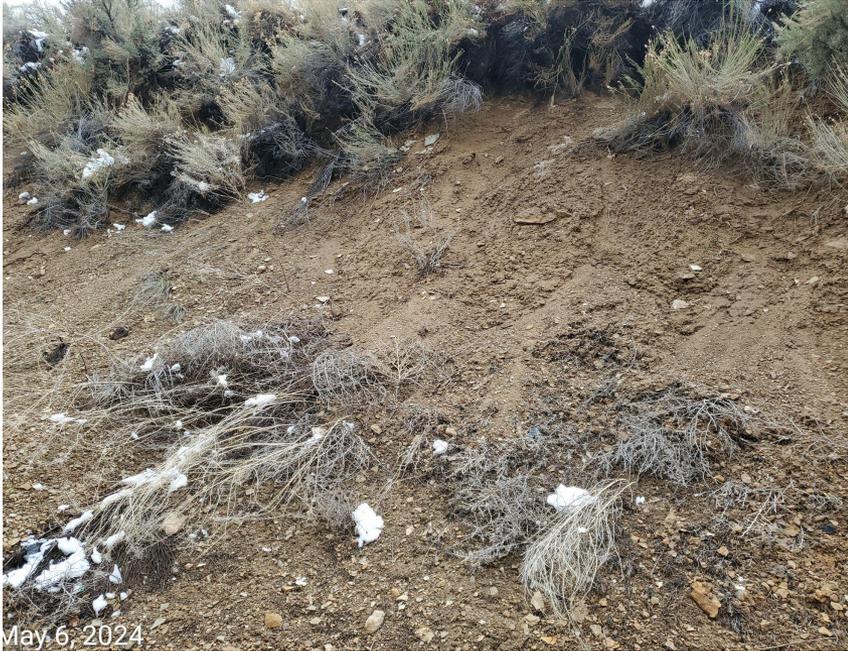
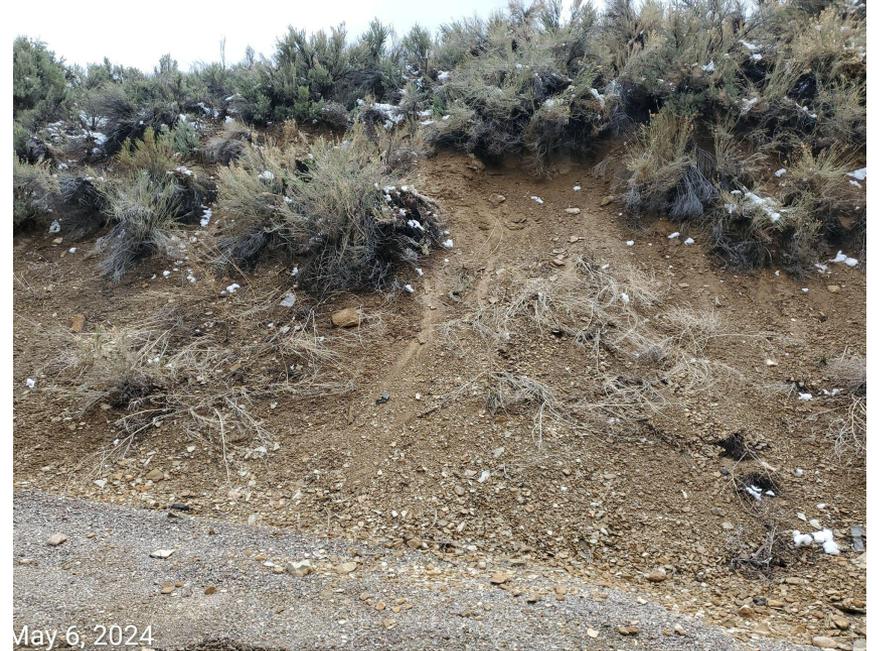
Photo 9: See comments under photo 8. Cut slopes.

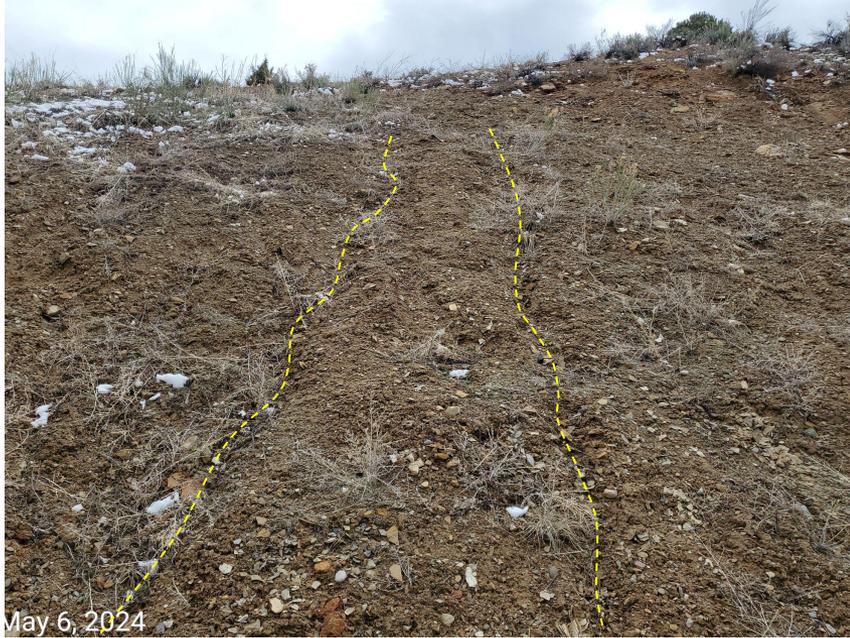
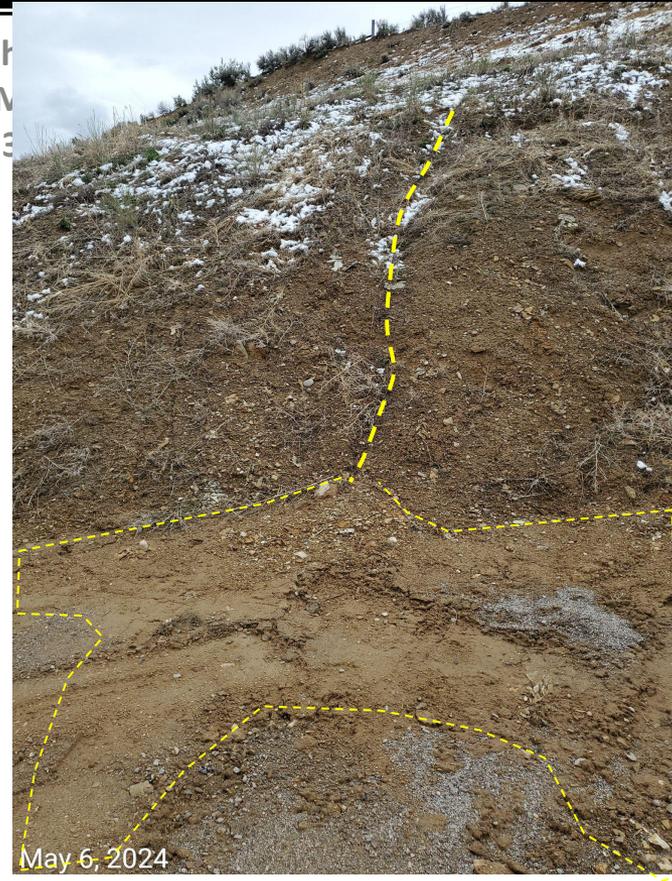
Photo 10: See comments under photo 8. Photo example showing erosion issues within the interim areas of the Location. Yellow lines examples showing areas of erosion and sediment deposition.

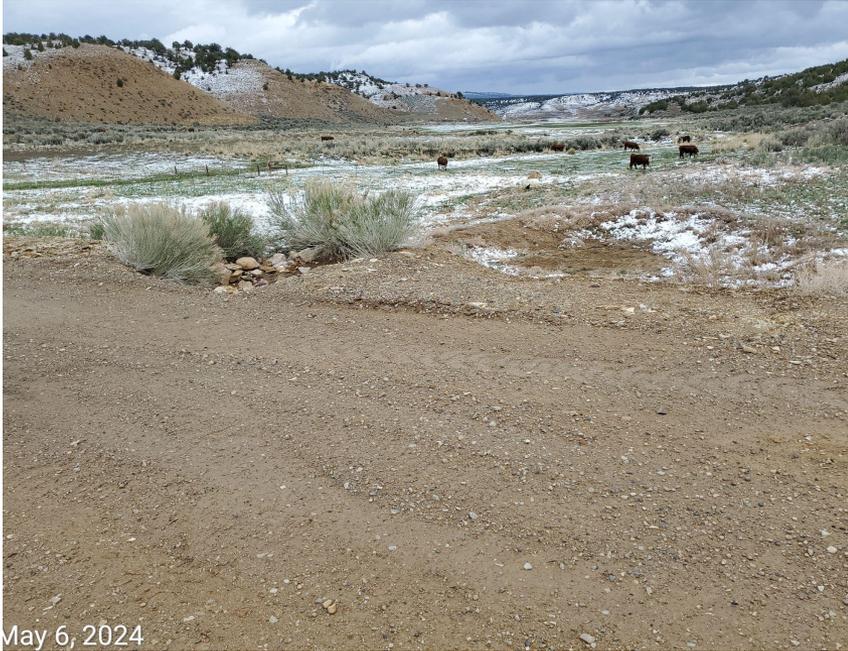
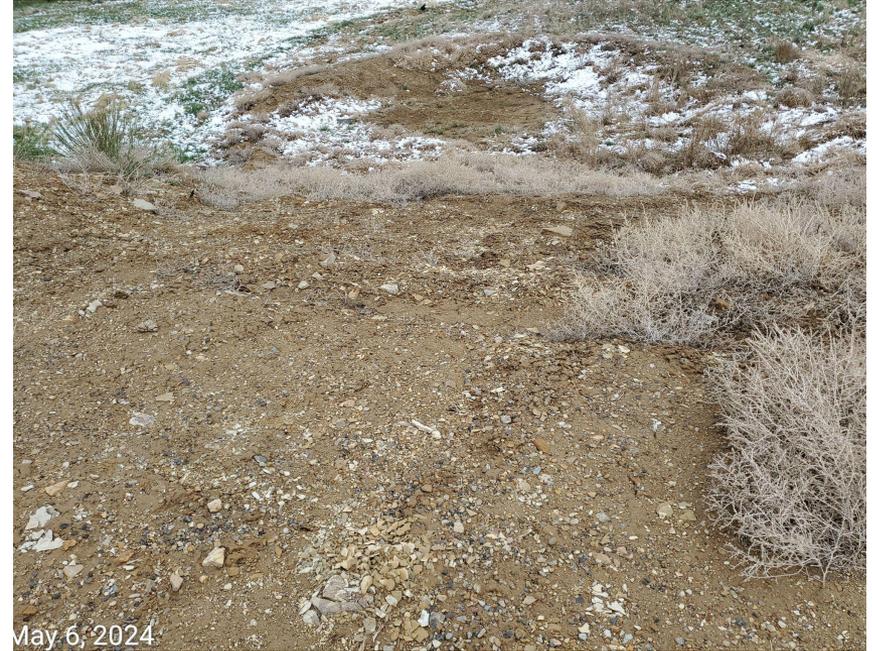
Photo 11: Photos taken from the east end of the Location, facing east. Photo left shows sediment trap at edge of working pad surface. Stormwater appears to be traveling down the slopes next to the BMP. Slopes bare and lack BMPs to stabilize, as well as to minimize erosion and degradation. Photo right taken from the top of the fill slope next to the sediment trap, facing downslope. See comments under photo 8.

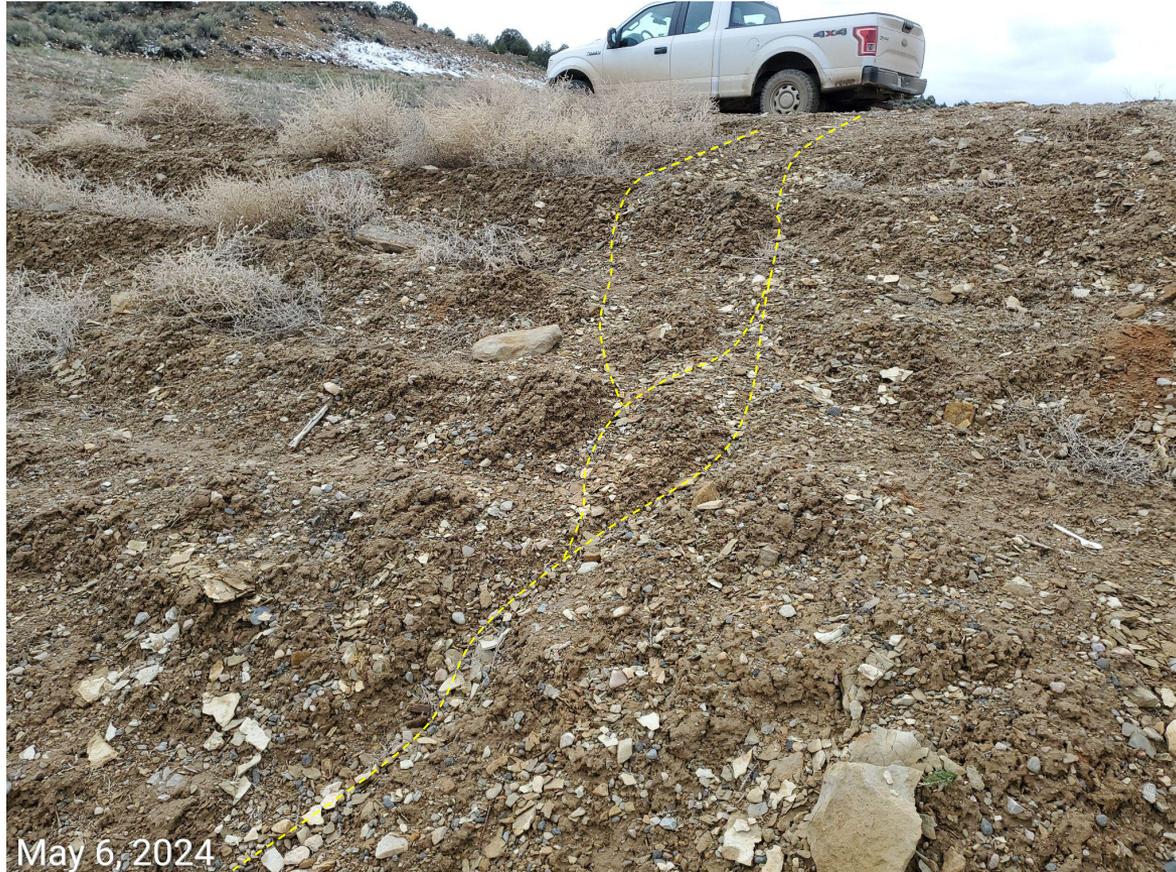
Photo 12: Continued from photo 11. Photo taken down slope of the working pad surface, facing west. Slopes bare and lack BMPs to stabilize, as well as to minimize erosion and degradation.
