Inspection Photos

API: 011-05055

Operator: RENEGADE OIL & GAS COMPANY LLC

Inspection Date: 5/8/2024

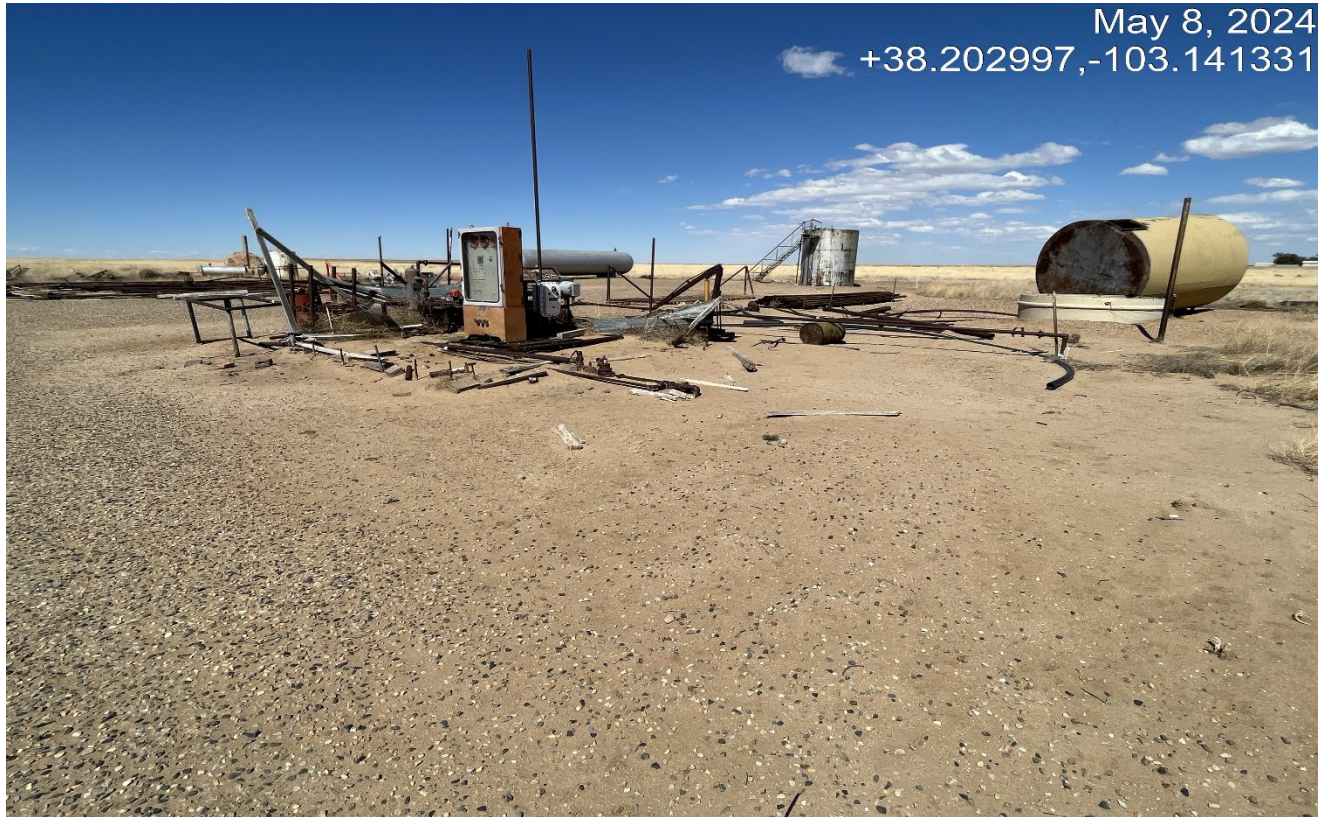
Photo 3. Facing northeast at the location. There is various unused equipment, supplies and tanks stored at the location that will need to be removed.

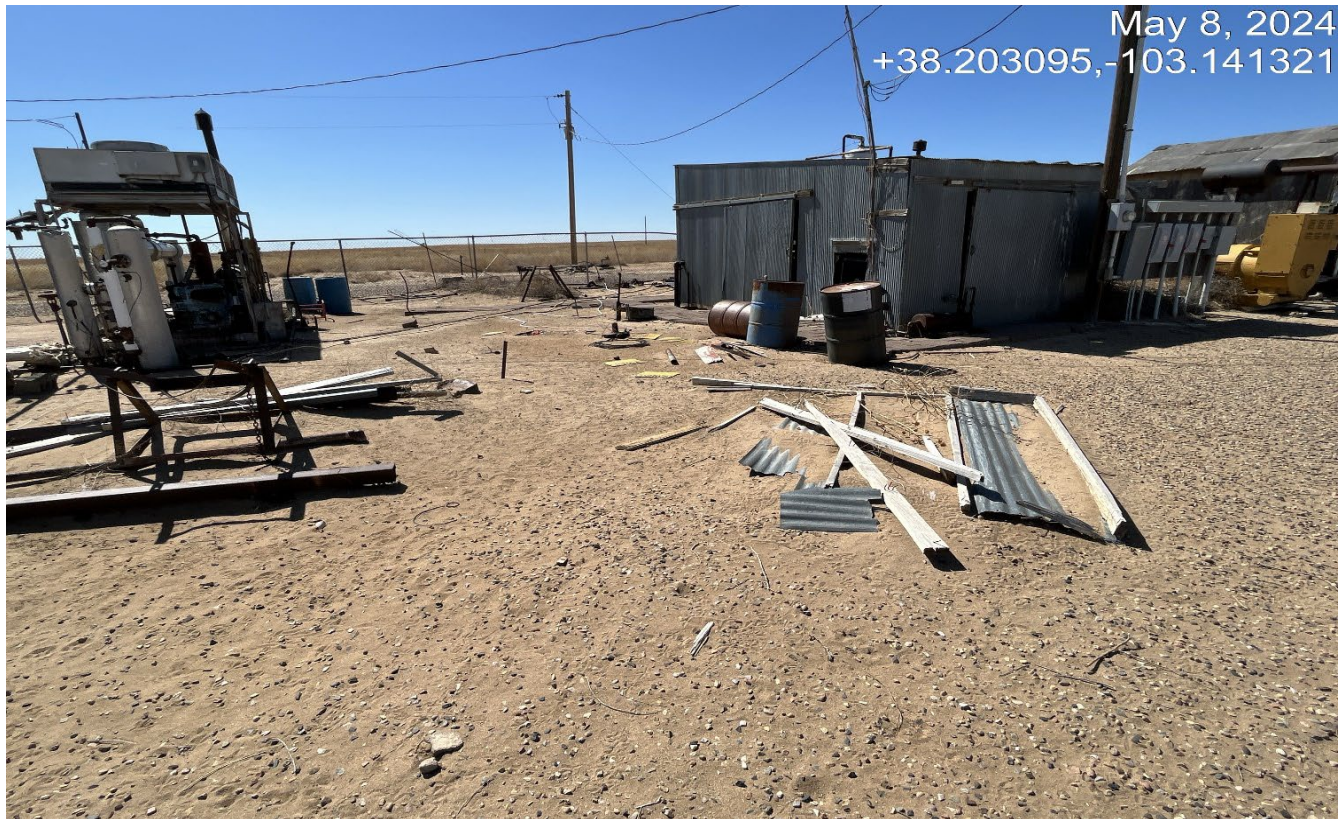
Photo 5. Facing northwest at the sheds and various equipment which are in disrepair. There is chemical barrels with no containment and various debris laying on the ground.

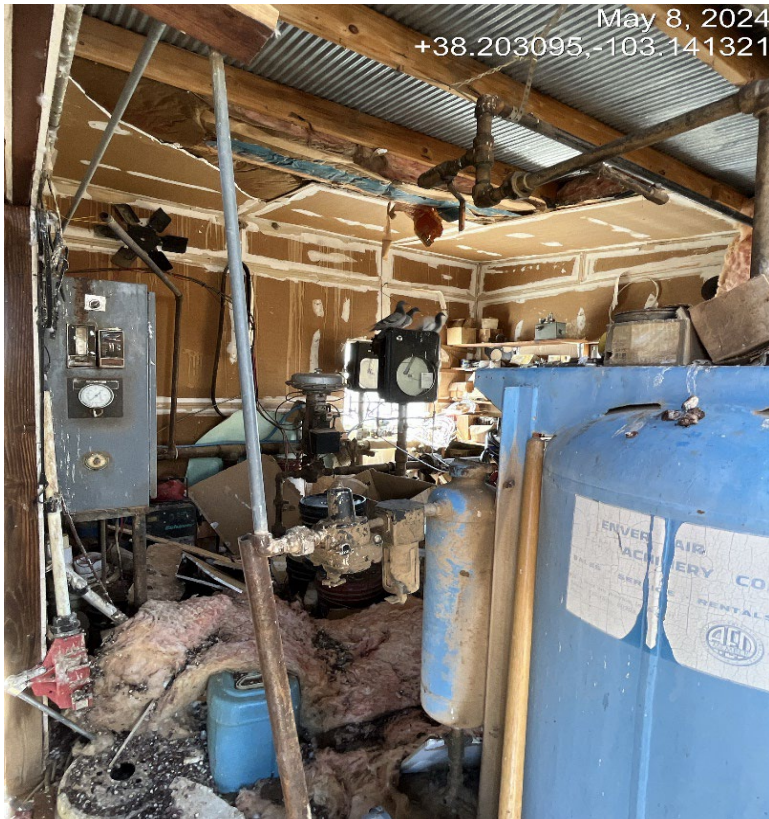
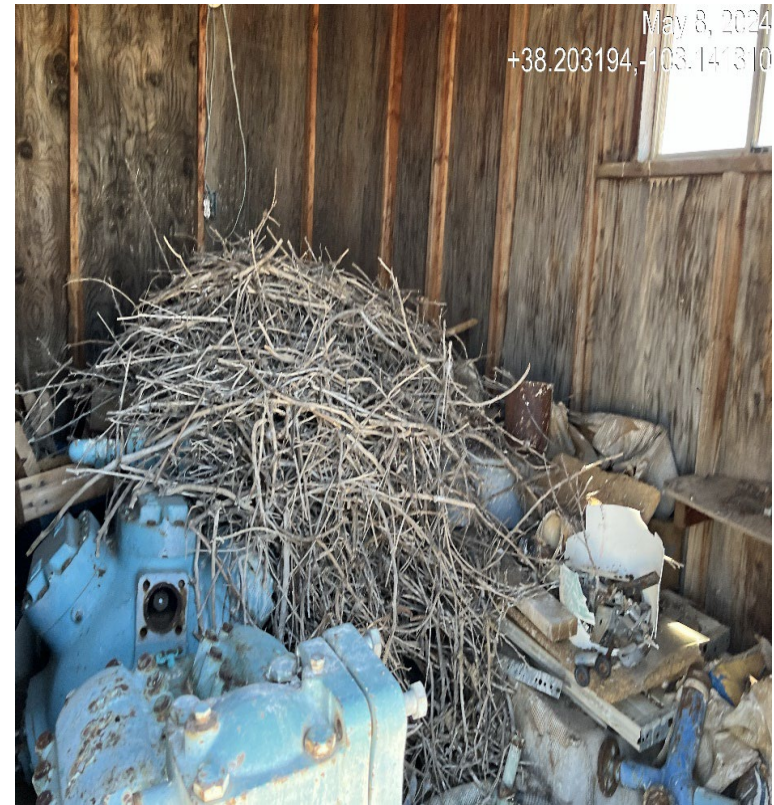
Photo 6&7. There are other sheds with large bird nests. Operator will need to consult with USFS and CPW regarding time restrictions and relocation.

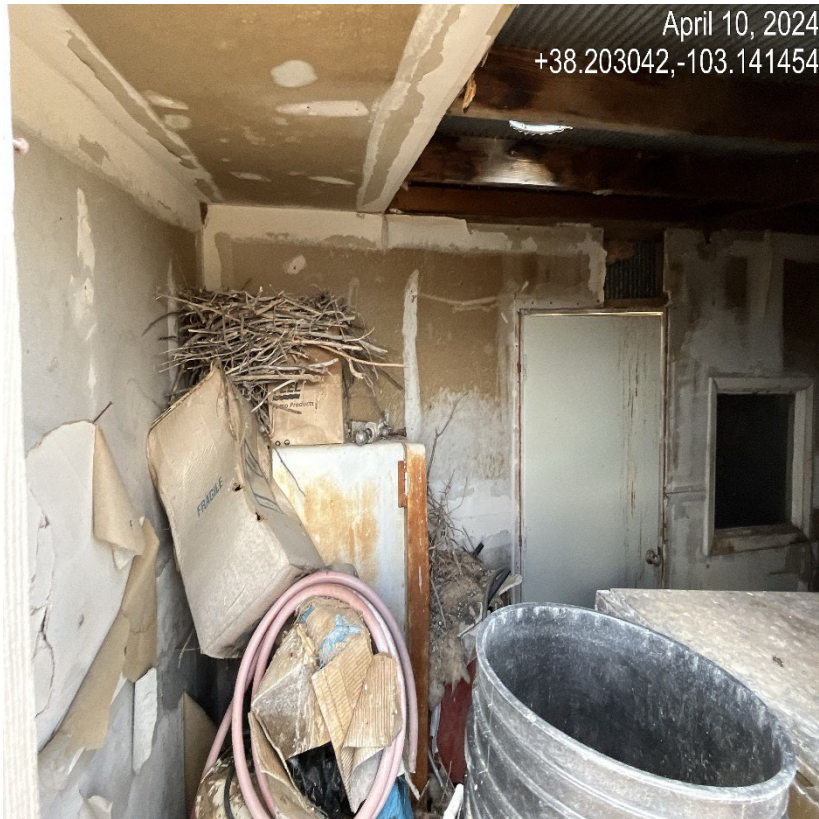
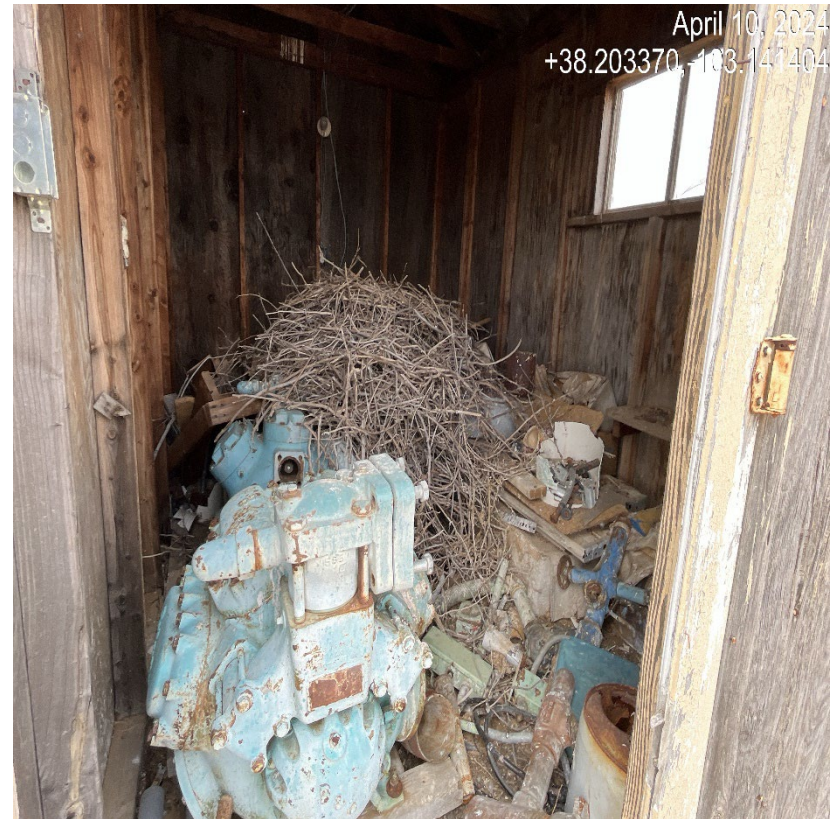
Photo 8&9. There are other sheds with large bird nests. Operator will need to consult with USFS and CPW regarding time restrictions and relocation.

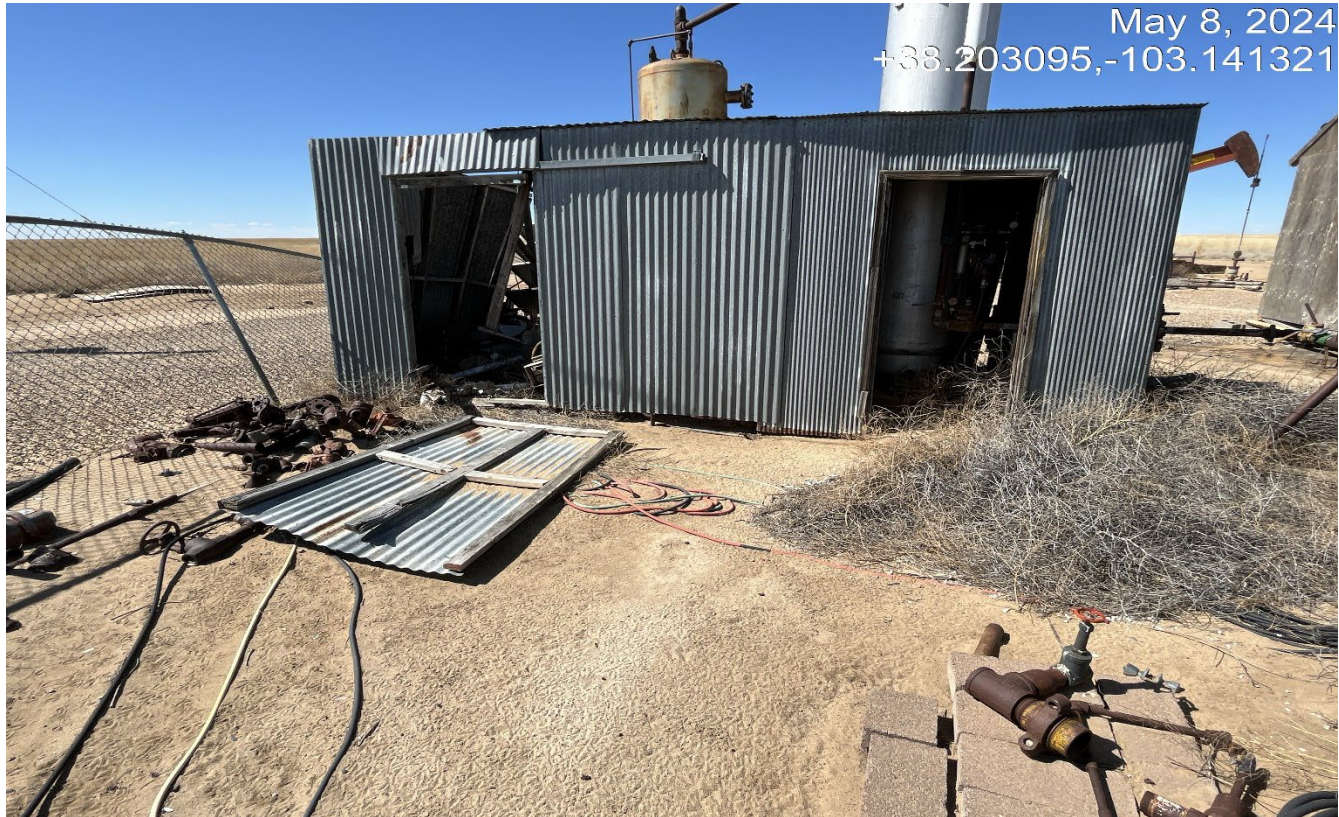
Photo 10. Facing northwest at the sheds and equipment which are in disrepair..

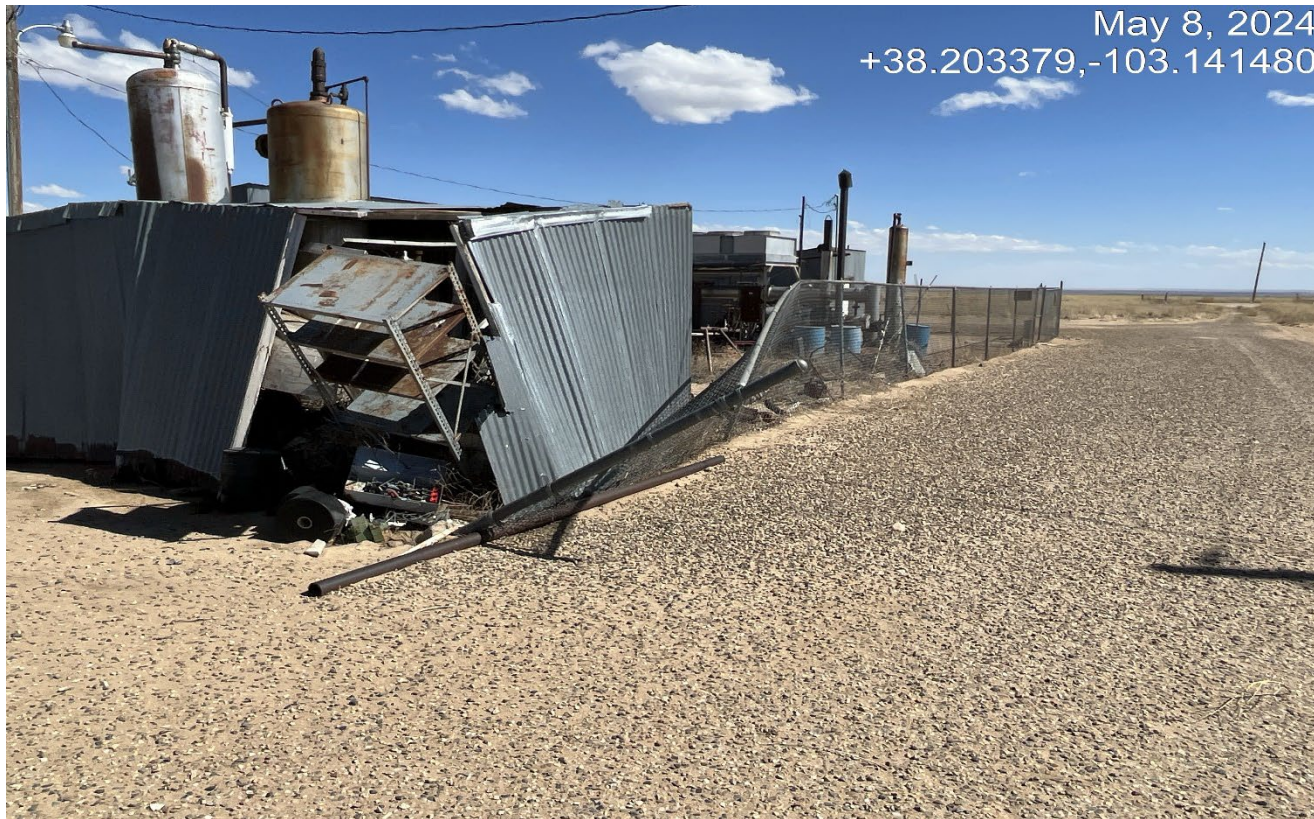
Photo 11. Facing southeast at the west side of the location. This shed and fence are in disrepair with various unused unneeded supplies.

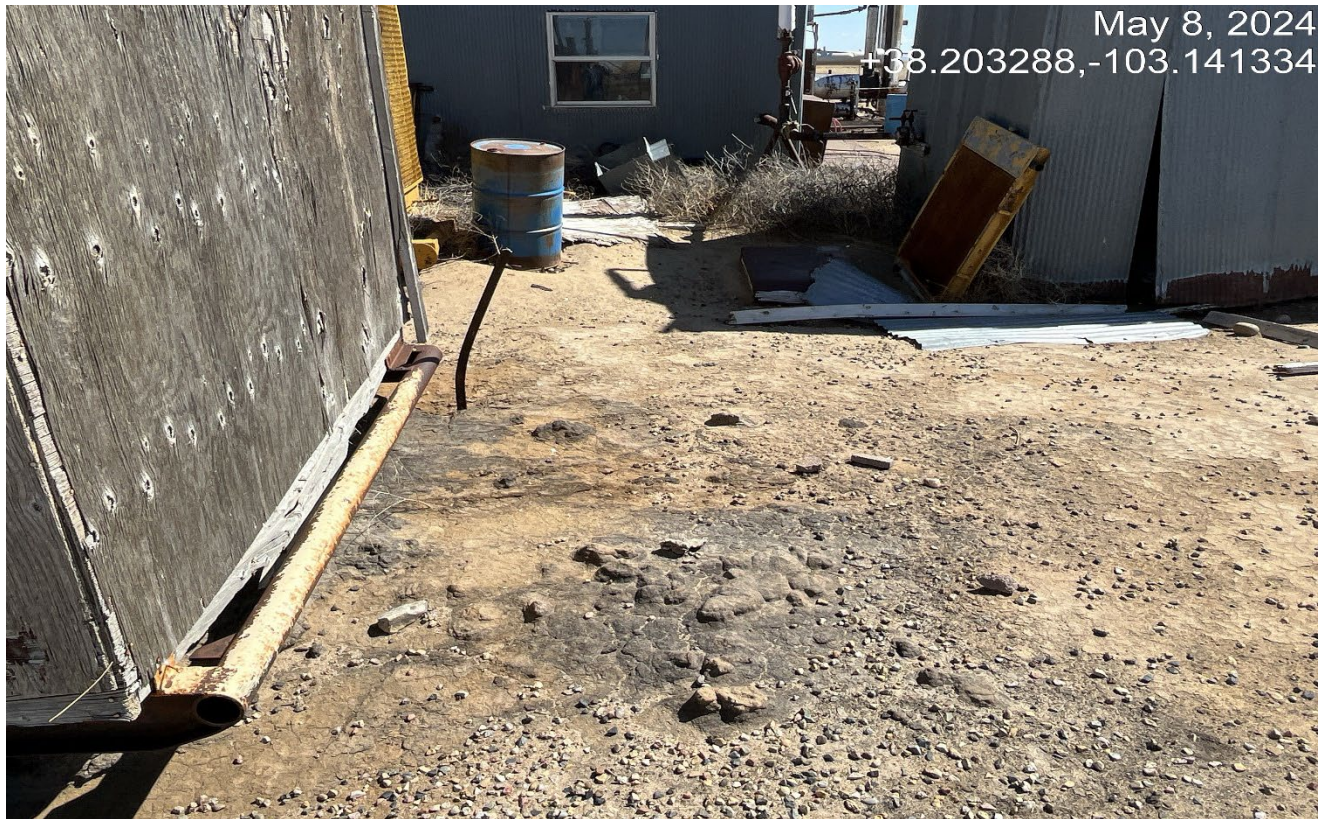
Photo 12. There are stained soils near this shed and engine compressor. There is chemical barrels with no containment and various debris laying on the ground.

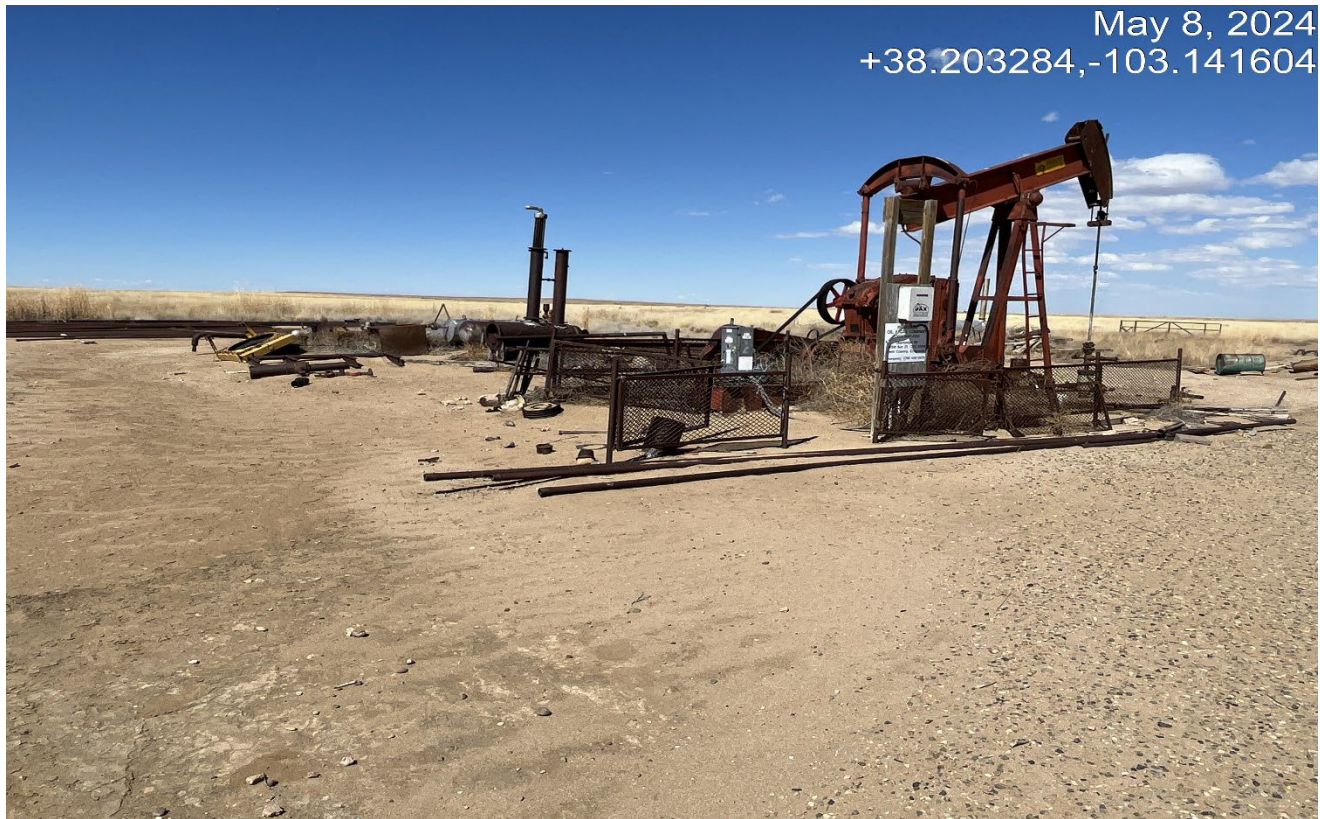
Photo 13. Facing northeast toward the well. The fence around the pumpjack is in disrepair and there is unused equipment stored near the well.

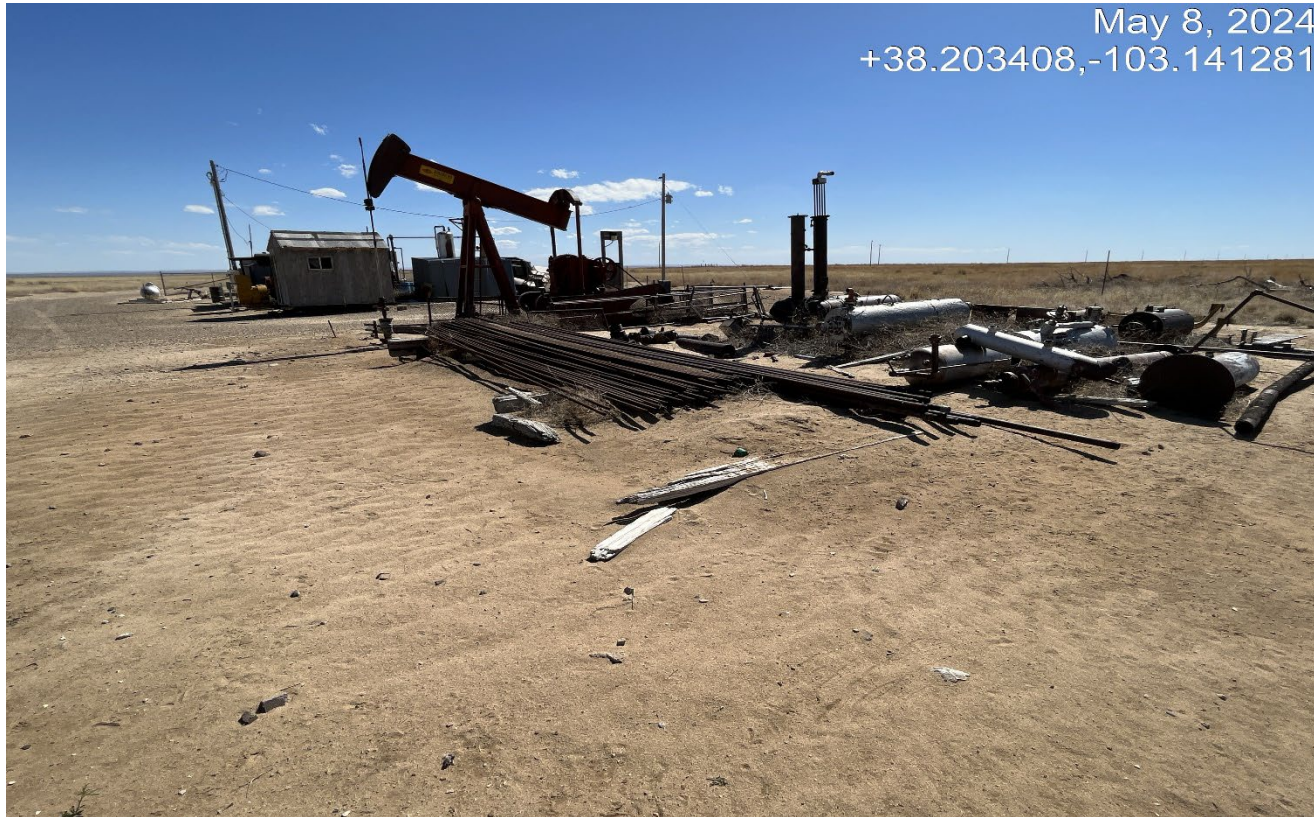
Photo 14. North side of the location facing southwest. There is unused pipe stored on location that needs to be removed.

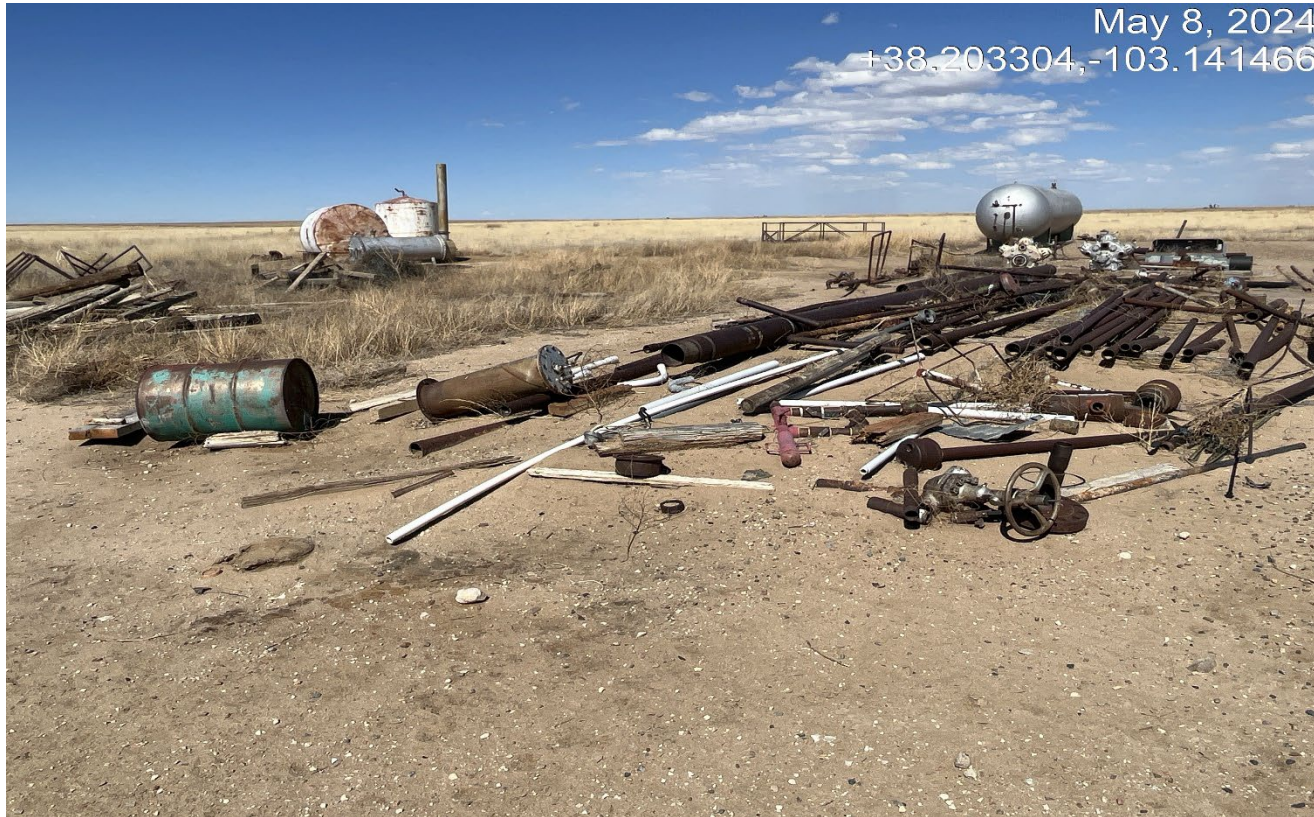
Photo 15. Facing northeast. There are various unused equipment and supplies stored on location that needs to be removed.

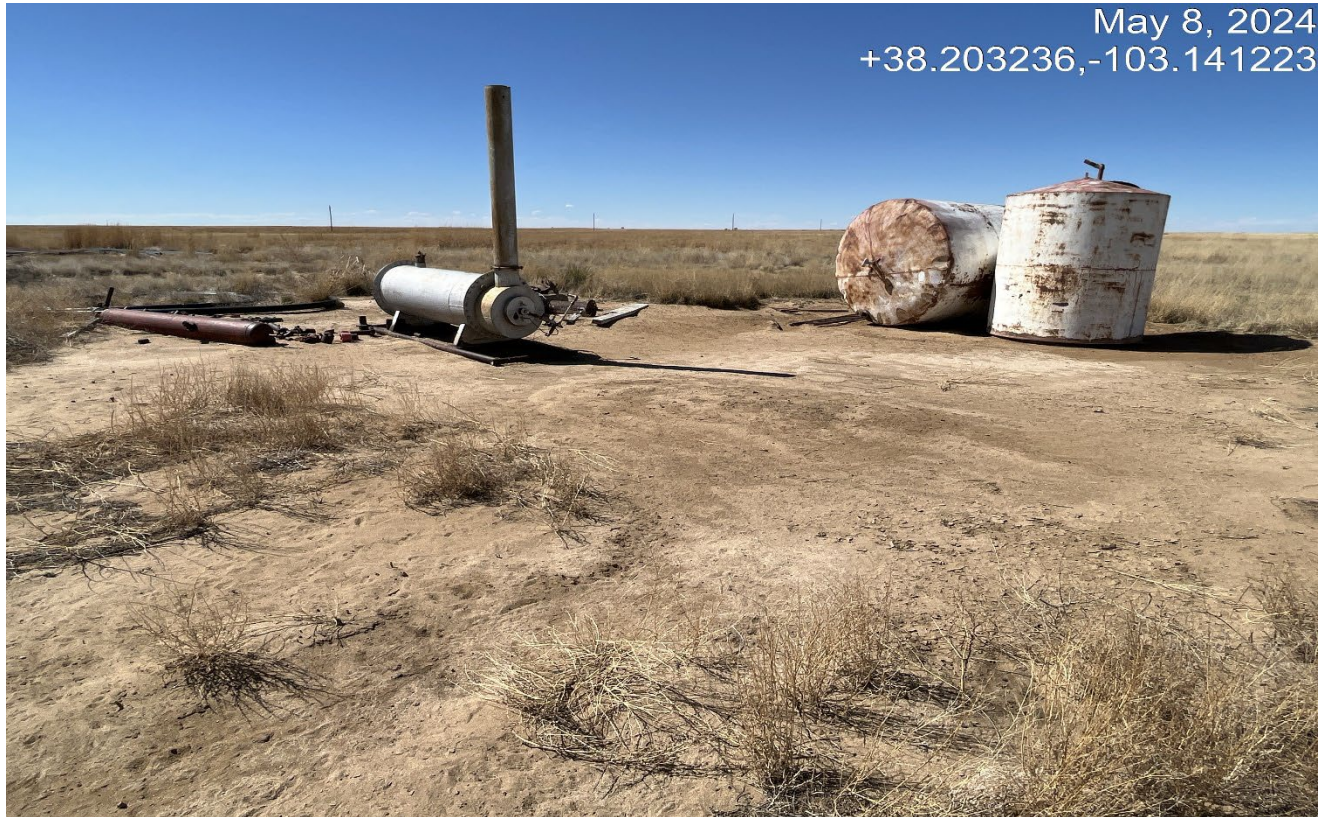
Photo 16. North side of the location facing northwest. There are unused tanks stored on location which is impacting vegetation in this area.

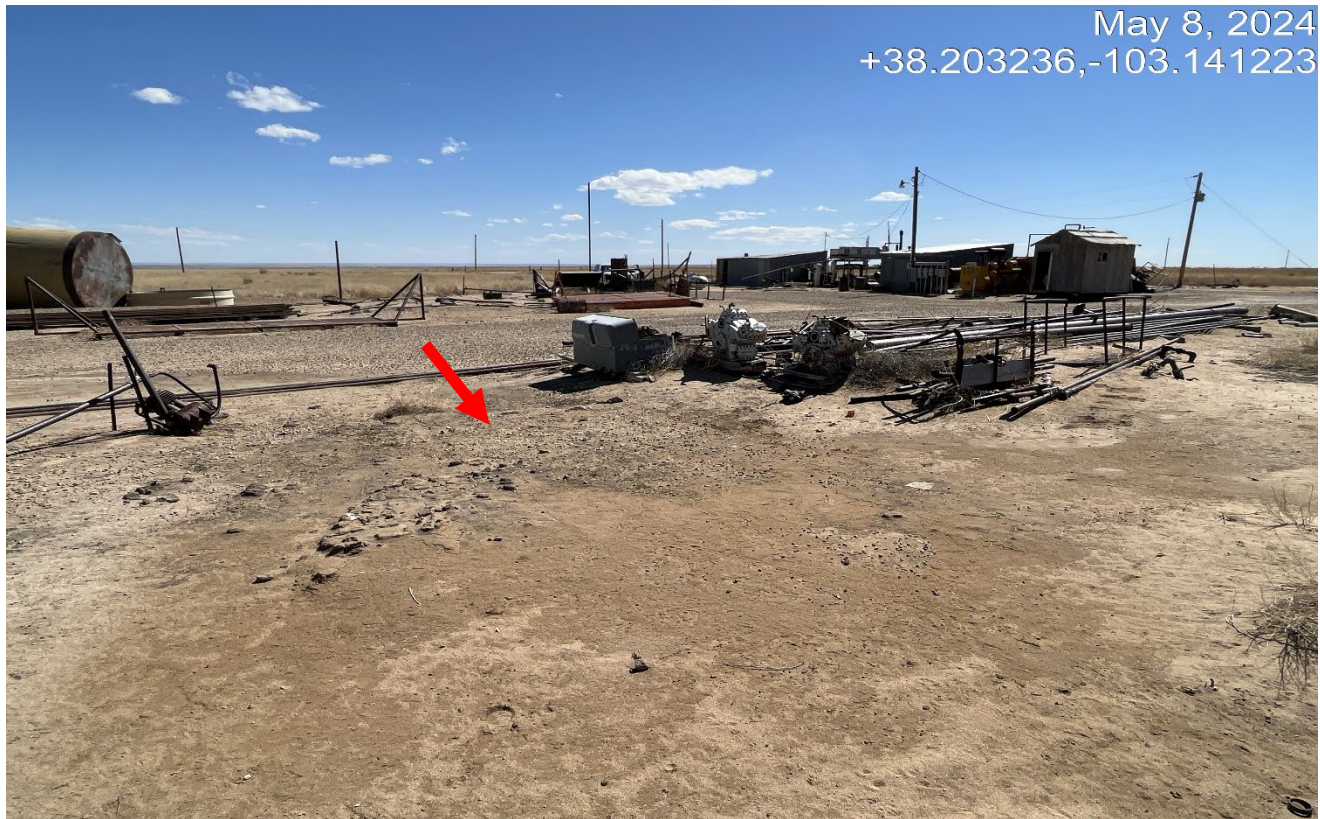
Photo 17. Facing southwest at the location. There appears to be impacted stained soil shown at red arrow.

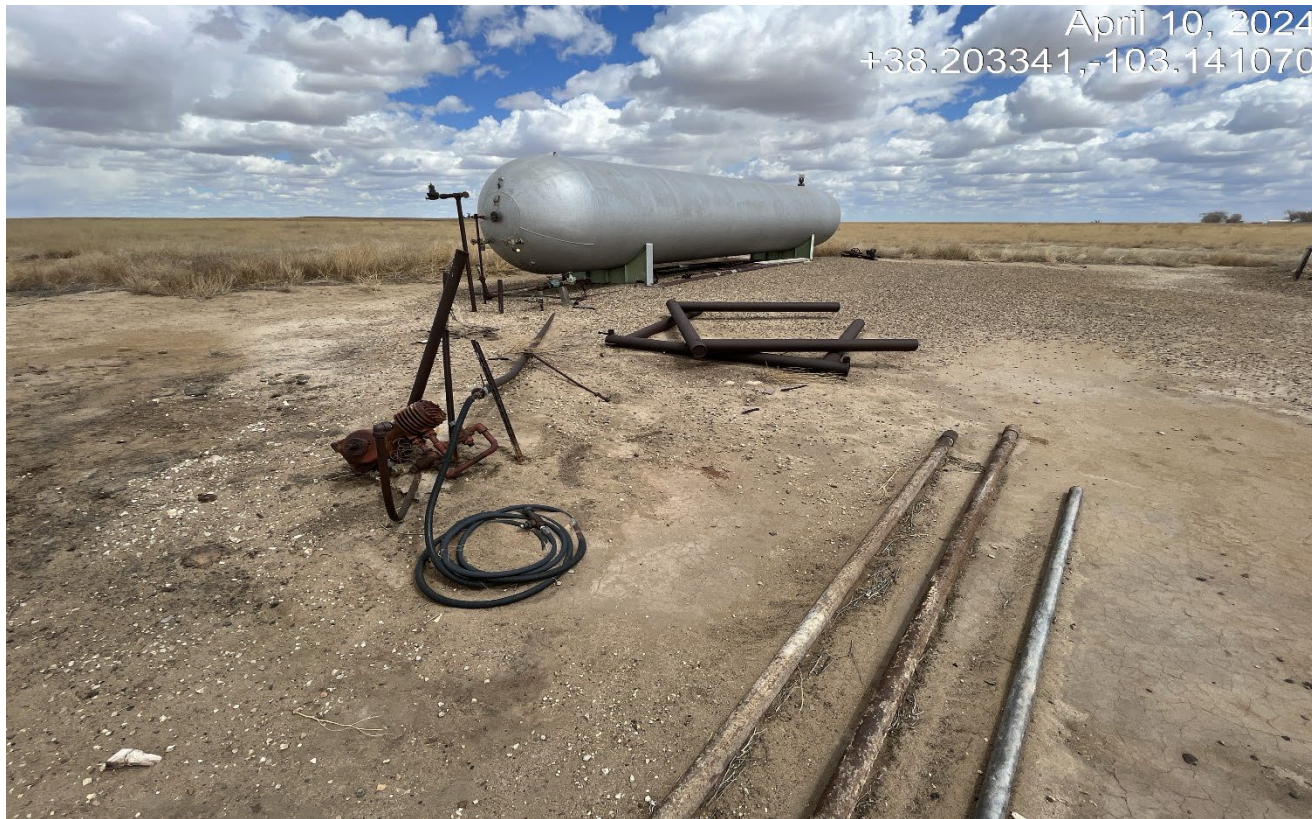
Photo 18. Facing toward the west side of the location There is a large volume tank with no labeling and appear to be unused.

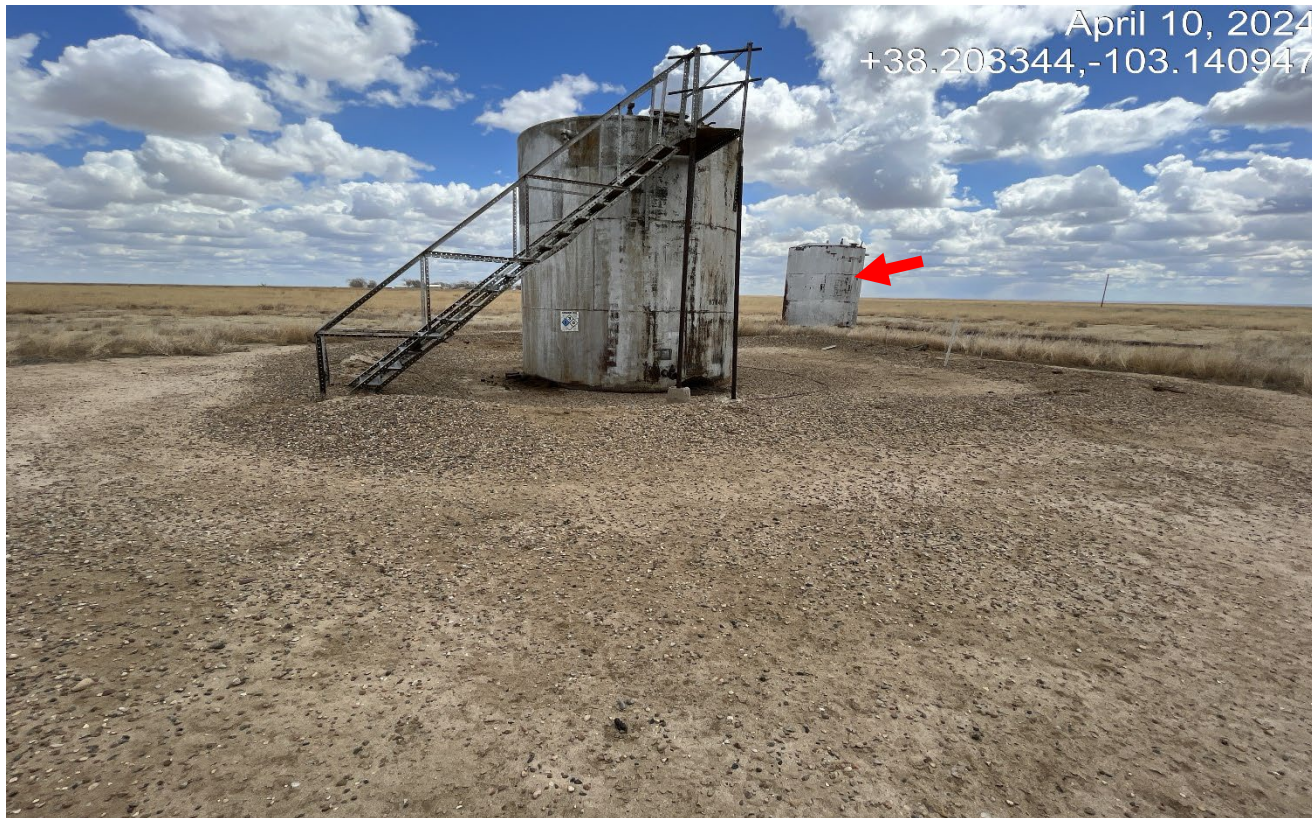
Photo 19. Facing toward the east side of the location. There is an tank with berm installed around the tank. The tank at red arrow is unused equipment.

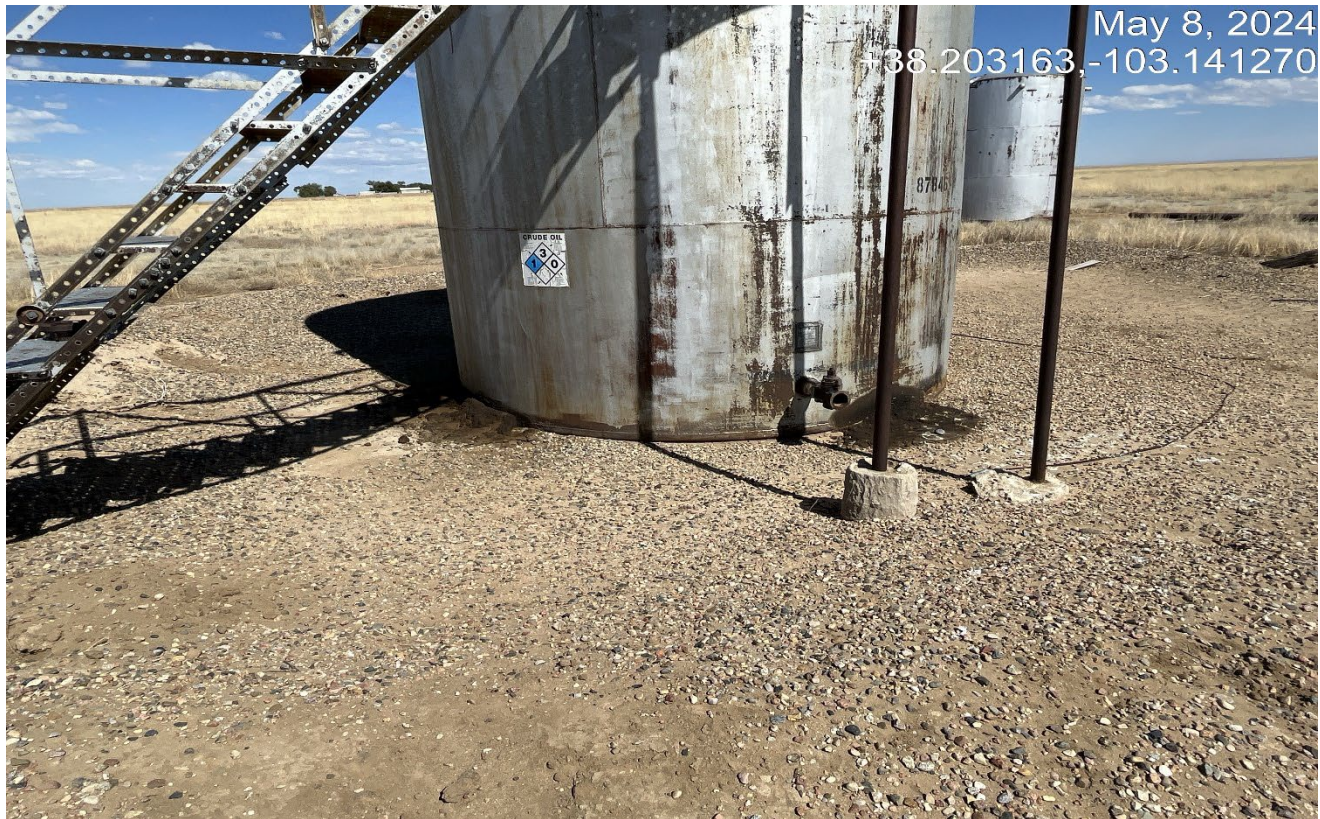
Photo 20. There is oily sludge at the base of the tank that needs to be cleaned up and properly disposed.

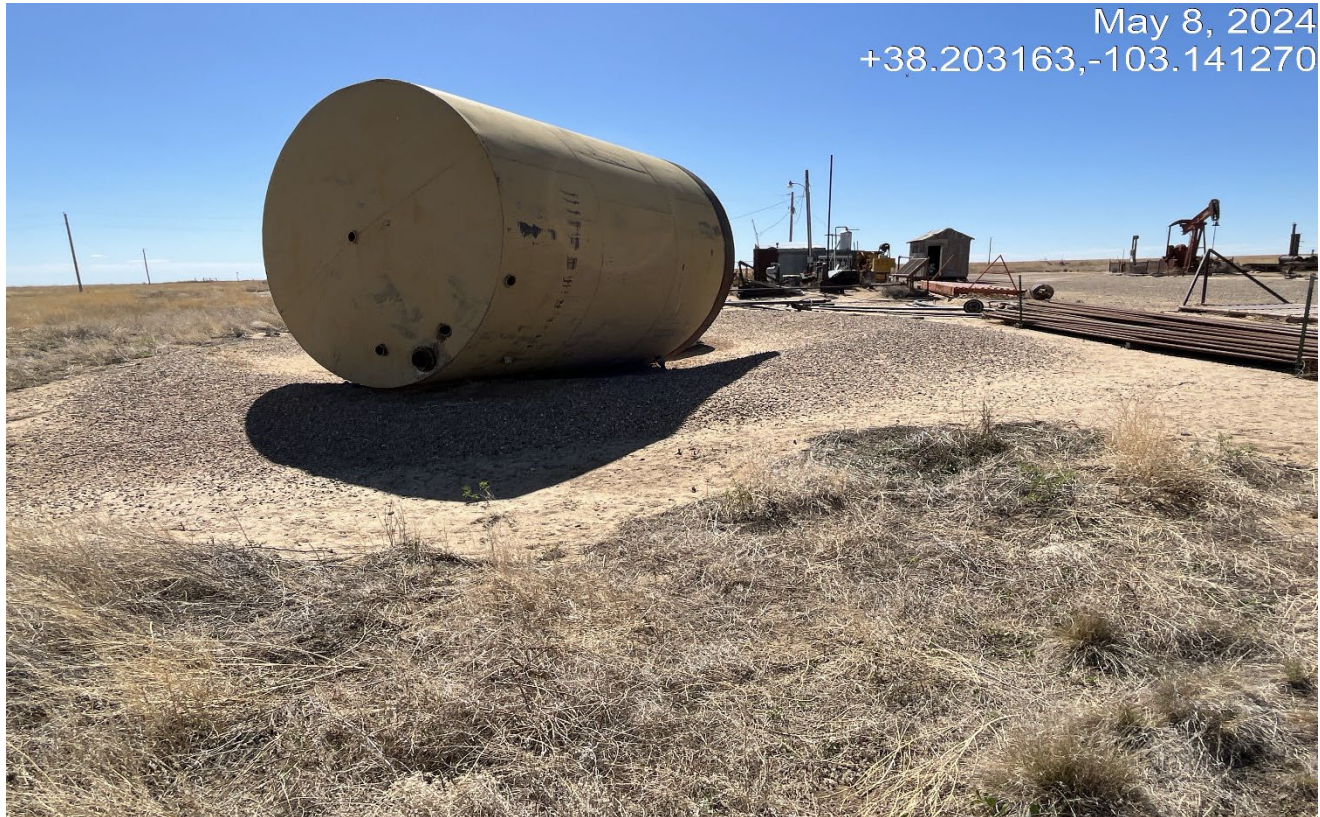
Photo 21. East side of the location facing west. There is unused pipe stored on location and a tank that is tipped over.
