**COLORADO**  
Energy & Carbon Management  
Commission  
Department of Natural Resources

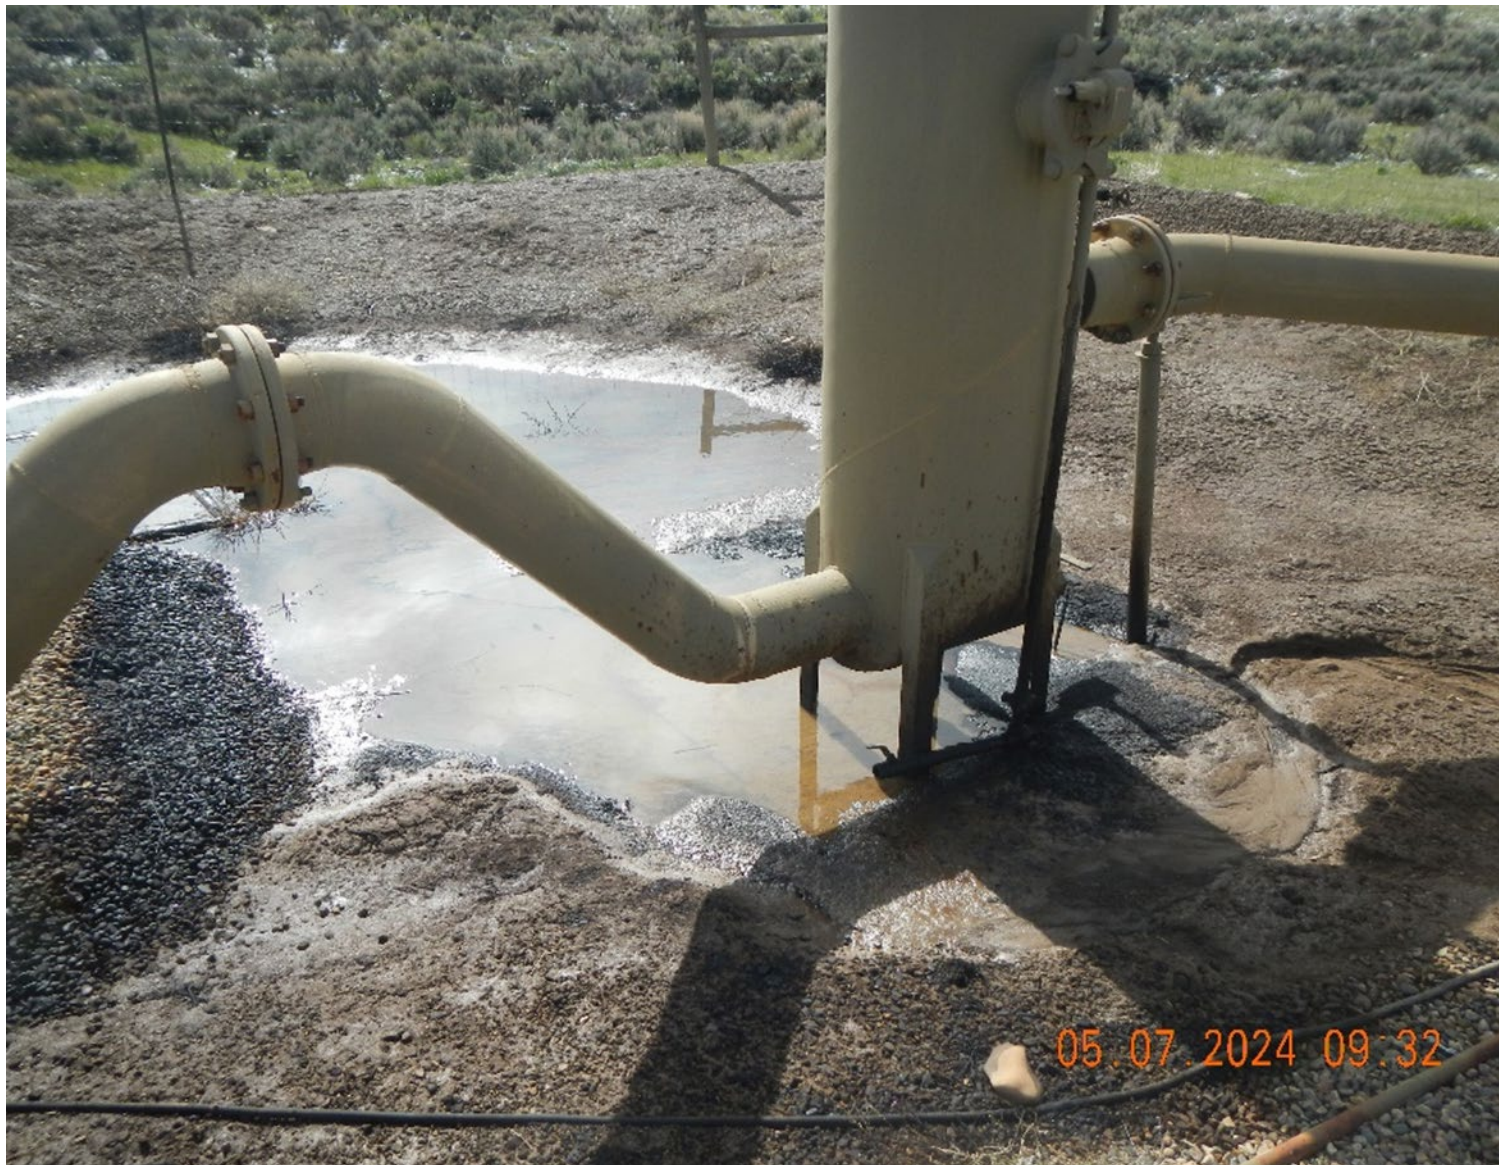
**Facility #480890 Photo #3 Gas knockout equipment on the south east corner of the tank battery. A steady drip was observed leaking oil out of this vessel. POC was notified via email on 5/8/2024.**

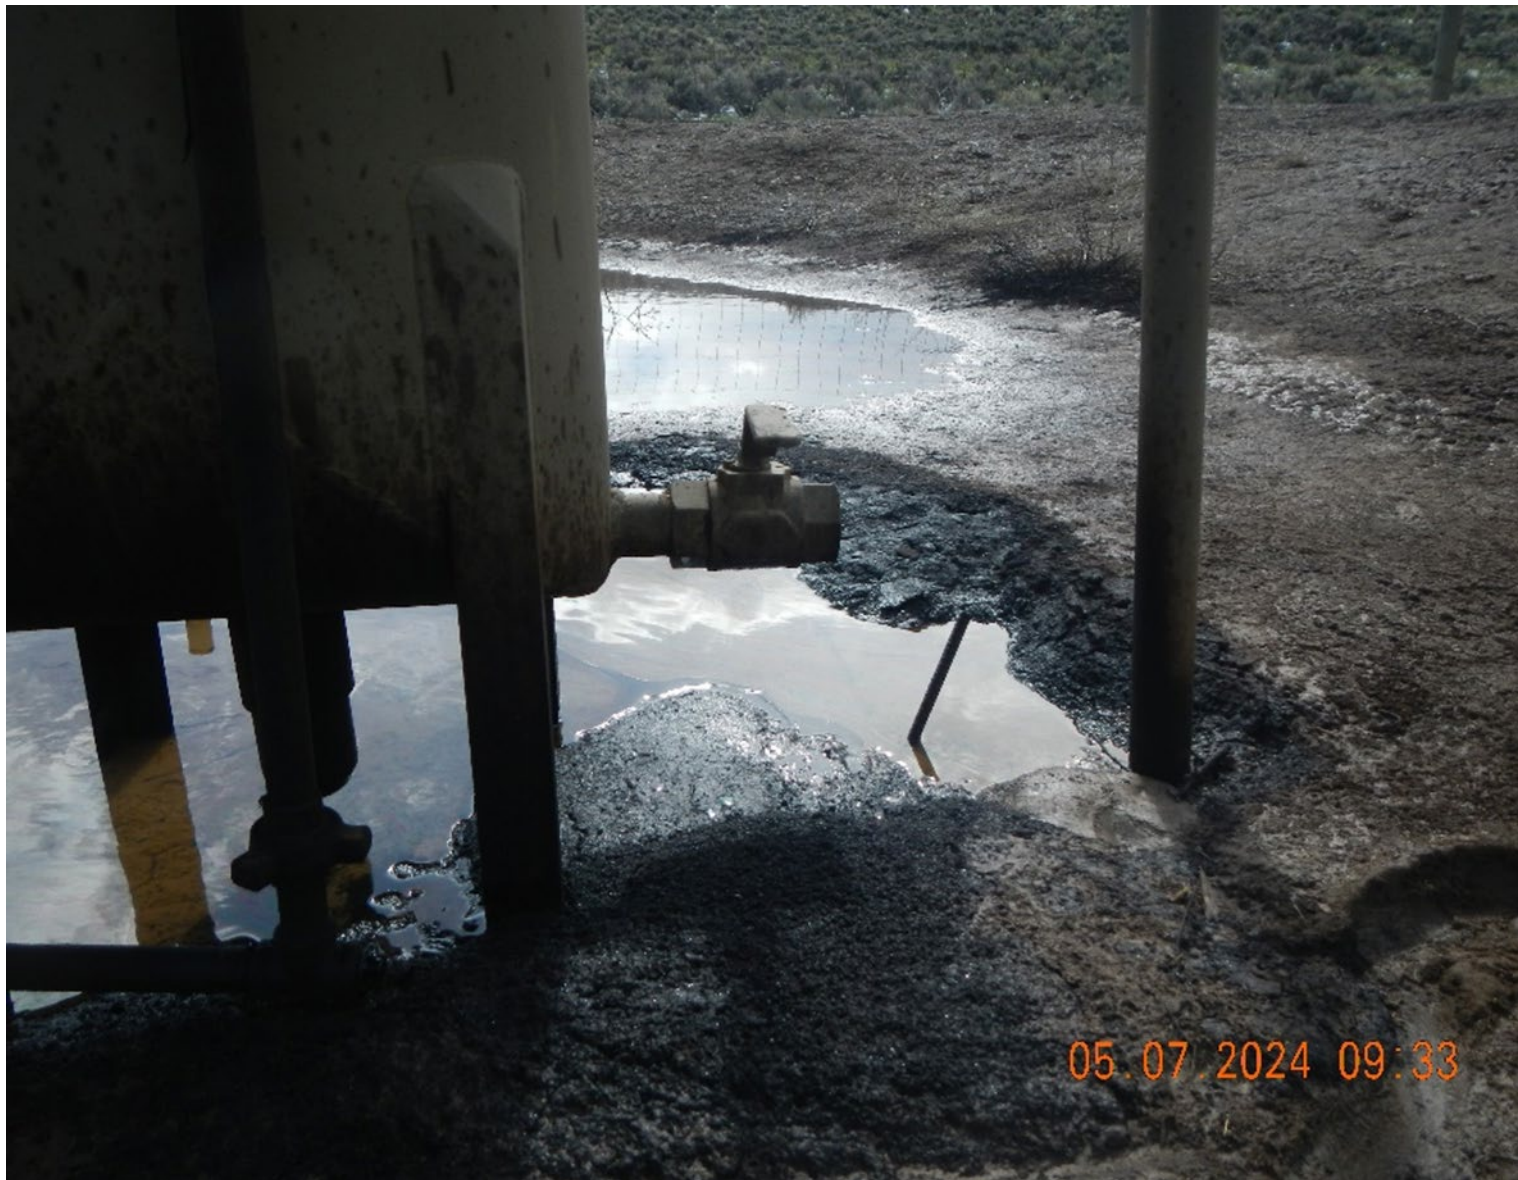
**Facility #480890 Photo #4 Gas knockout equipment on the south east corner of the tank battery. A steady drip was observed leaking oil out of this vessel. POC was notified via email on 5/8/2024.**

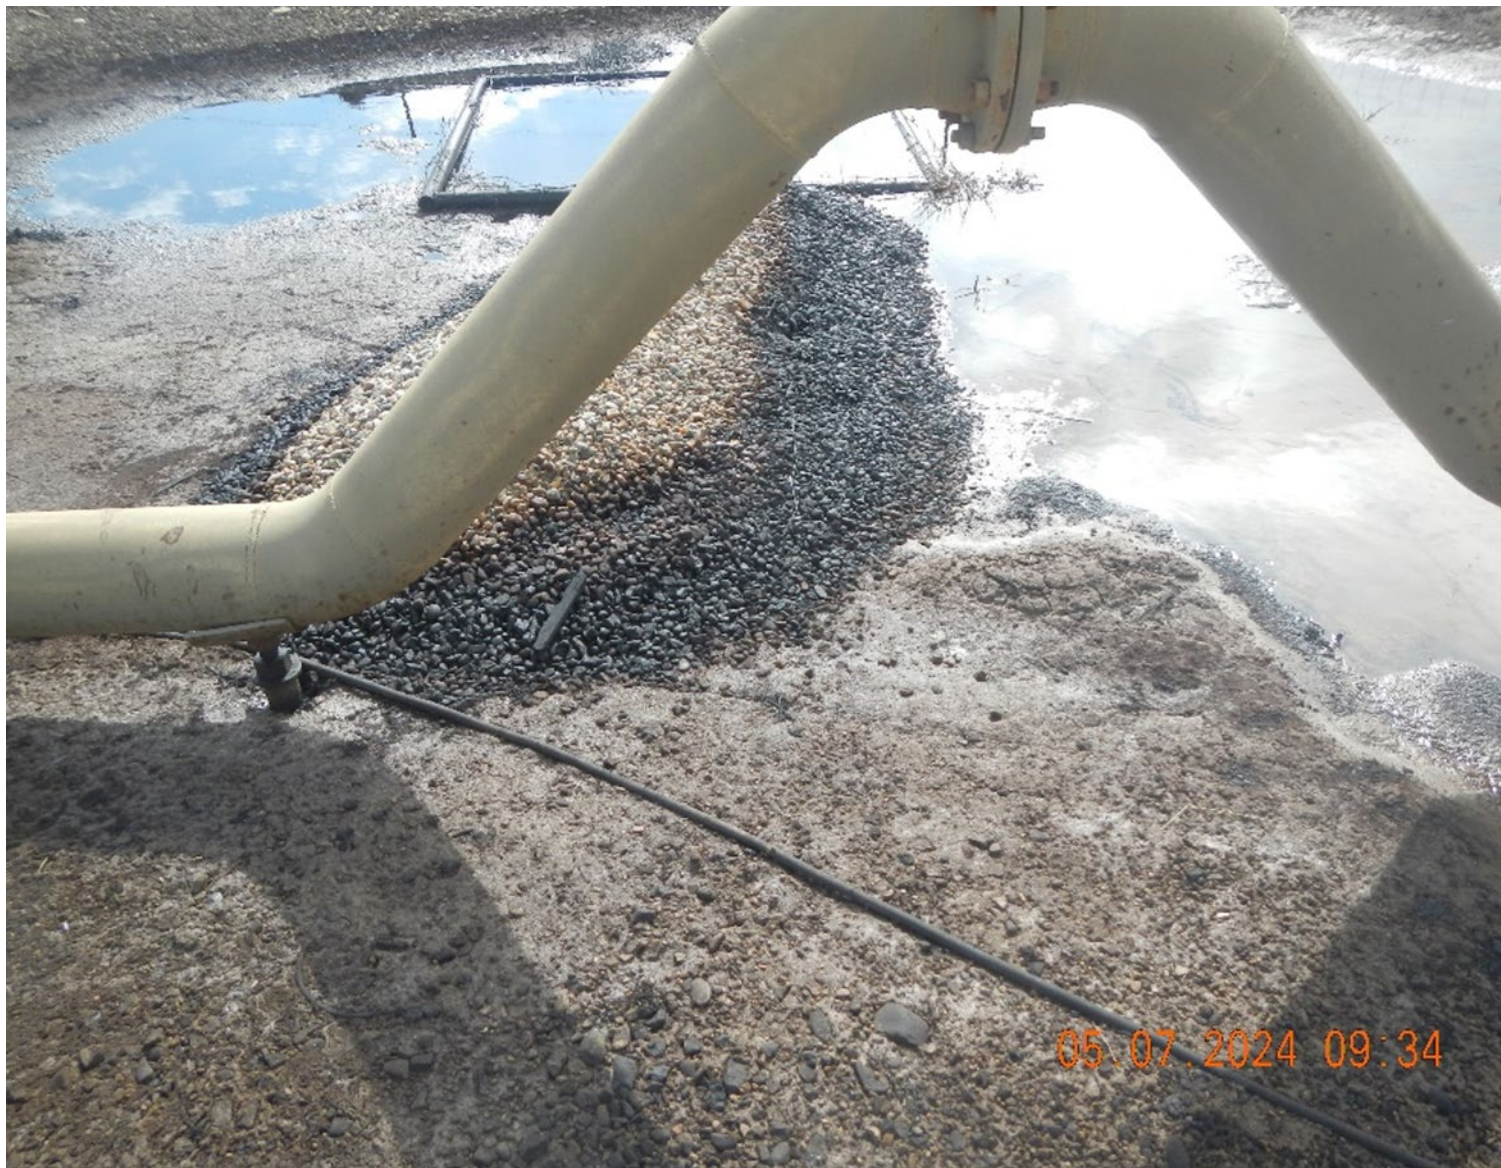
**Facility #480890 Photo #6 Gas knockout equipment on the south east corner of the tank battery. A steady drip was observed leaking oil out of this vessel. POC was notified via email on 5/8/2024.**

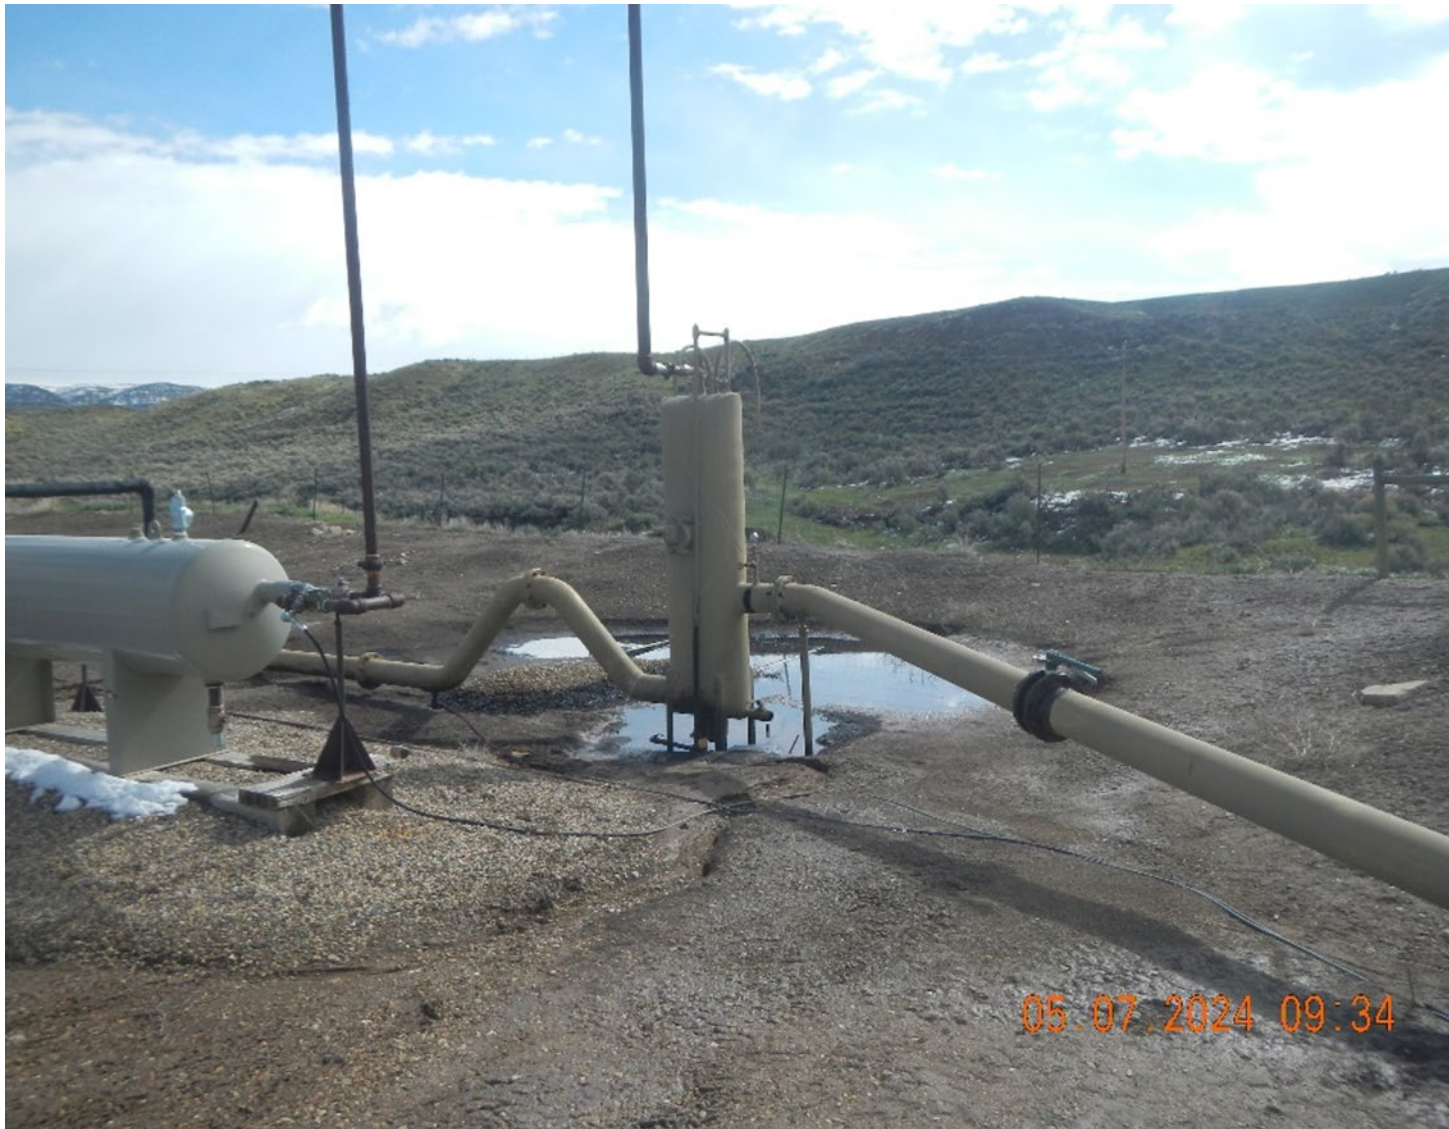
**Facility #480890 Photo #7 Gas knockout equipment on the south east corner of the tank battery. A steady drip was observed leaking oil out of this vessel. POC was notified via email on 5/8/2024.**

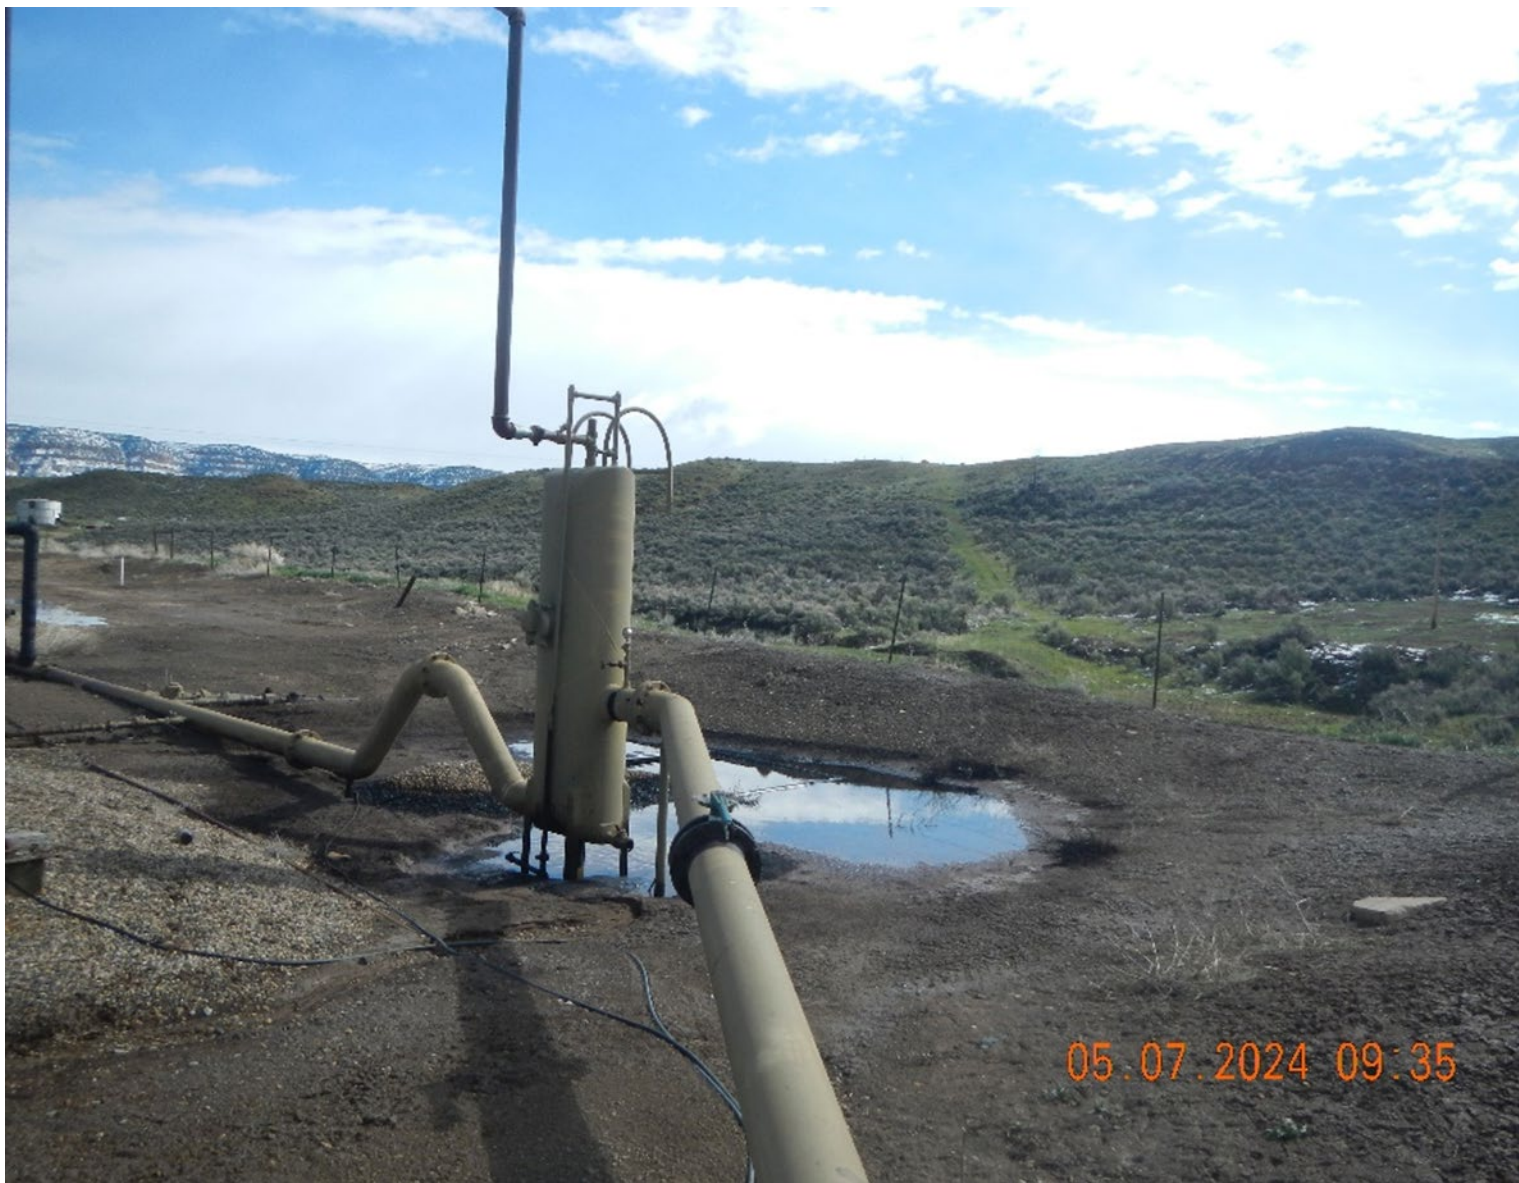
**Facility #480890 Photo #8 Gas knockout equipment on the south east corner of the tank battery. A steady drip was observed leaking oil out of this vessel. POC was notified via email on 5/8/2024.**

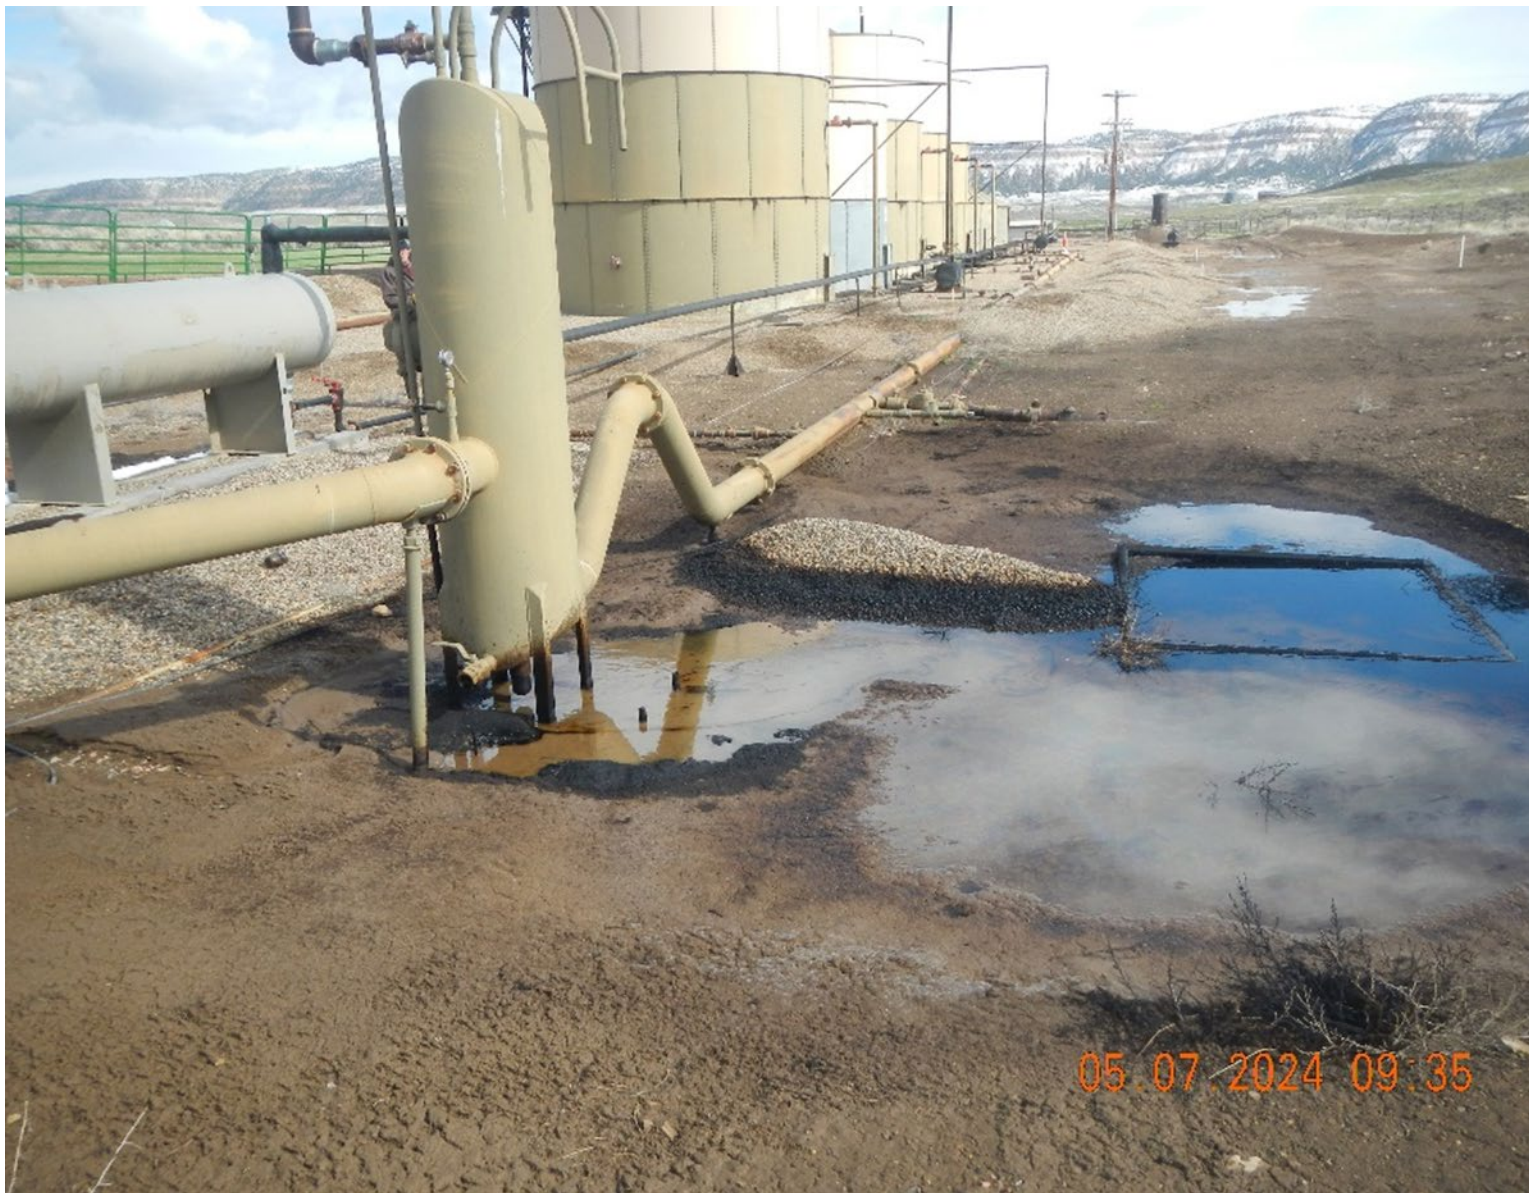
**Facility #480890 Photo #9 Gas knockout equipment on the south east corner of the tank battery. A steady drip was observed leaking oil out of this vessel. POC was notified via email on 5/8/2024.**

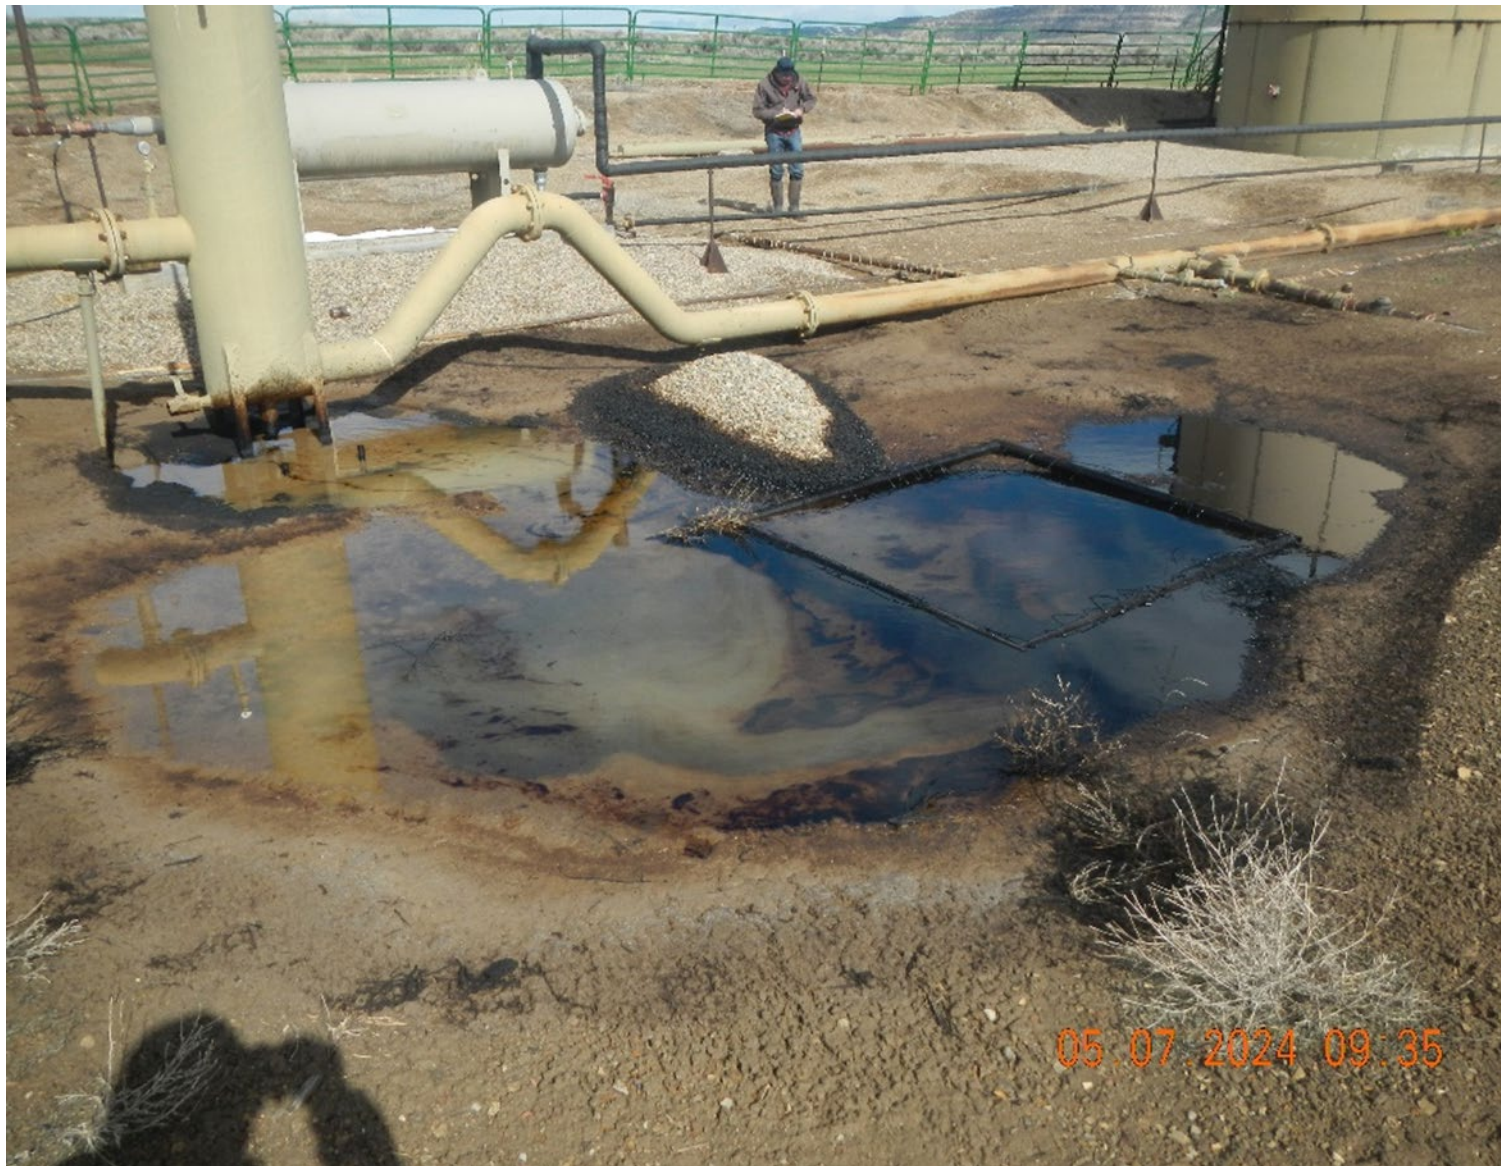
**Facility #480890 Photo #10 Gas knockout equipment on the south east corner of the tank battery. A steady drip was observed leaking oil out of this vessel. POC was notified via email on 5/8/2024.**

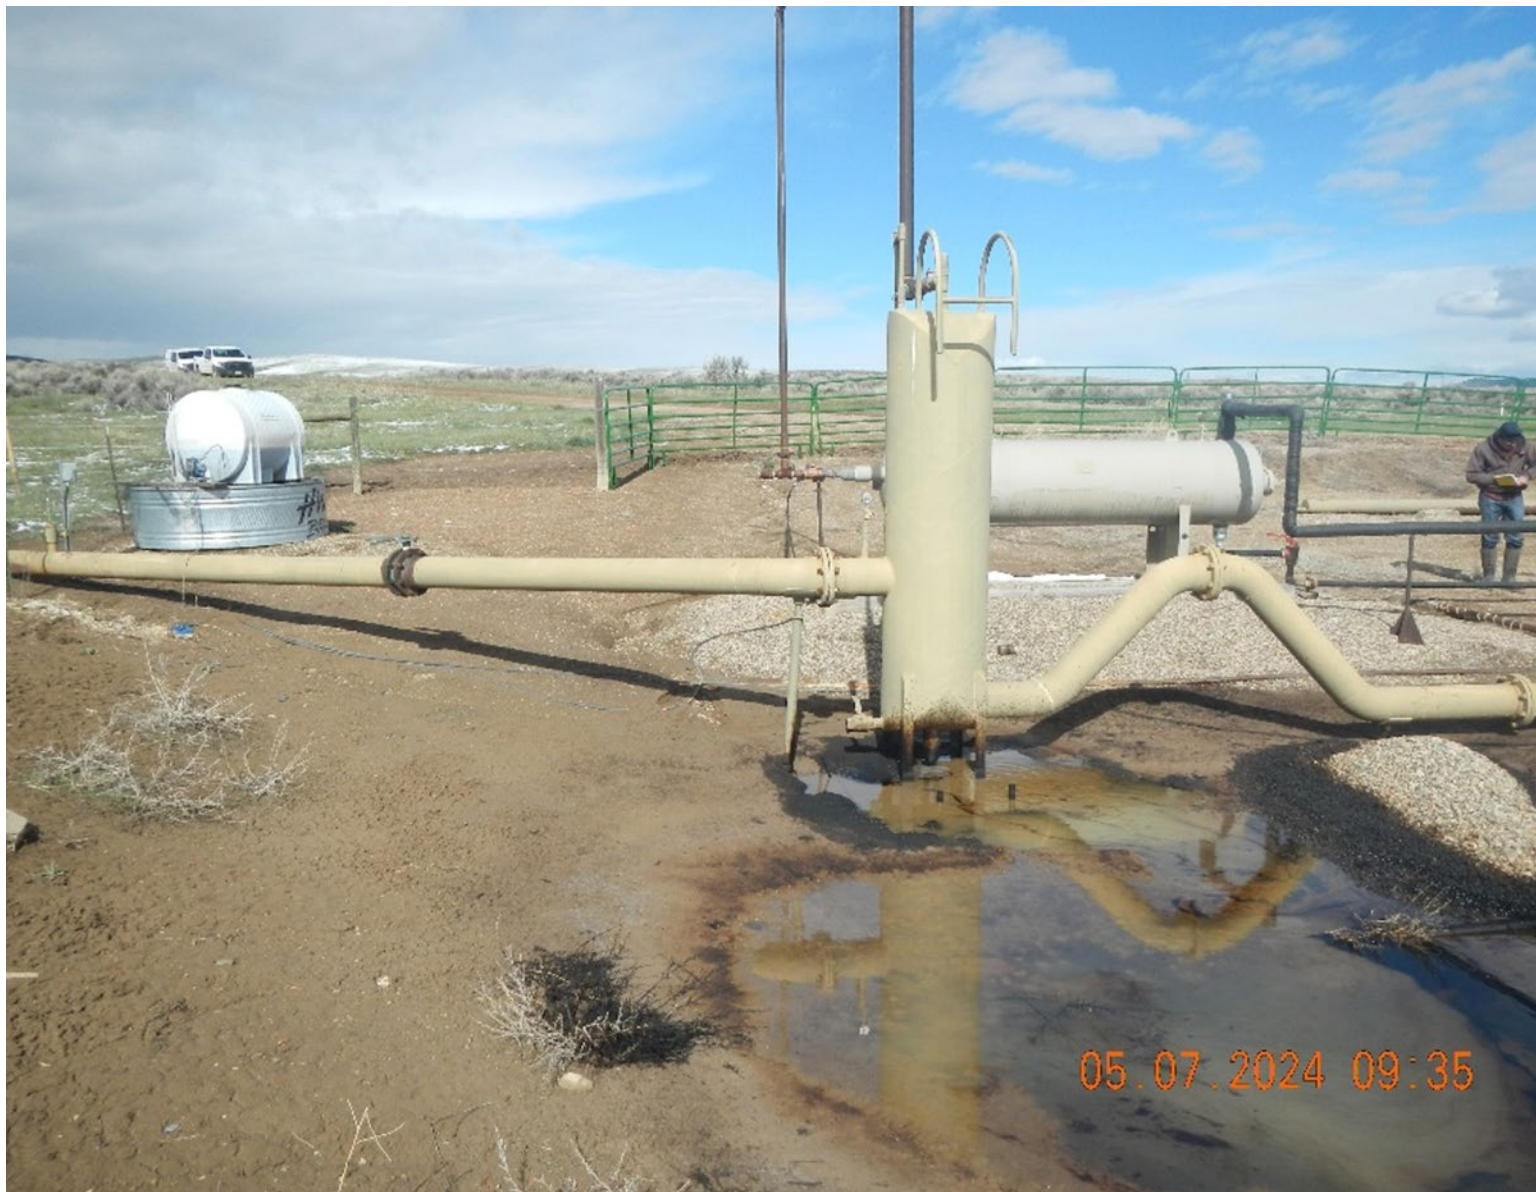
**Facility #480890 Photo #11 Gas knockout equipment on the south east corner of the tank battery. A steady drip was observed leaking oil out of this vessel. POC was notified via email on 5/8/2024.**

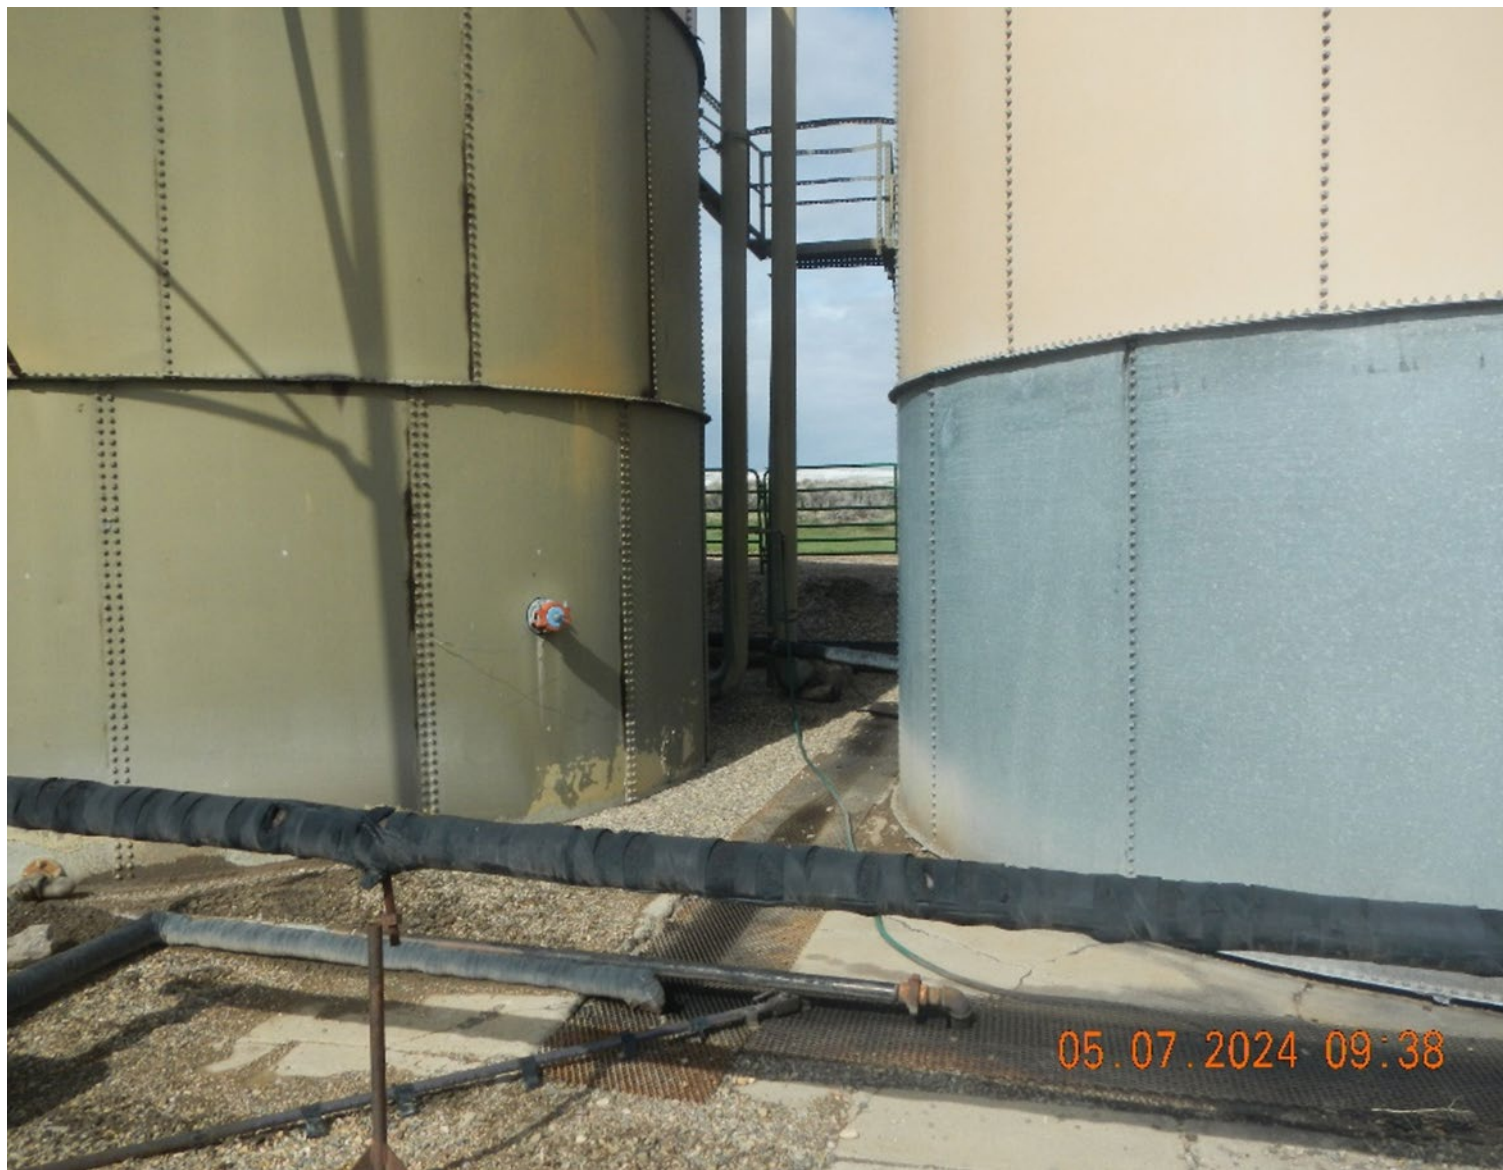
Facility #480890 Photo #13 AGT's, Oil on ground inside bermed area.

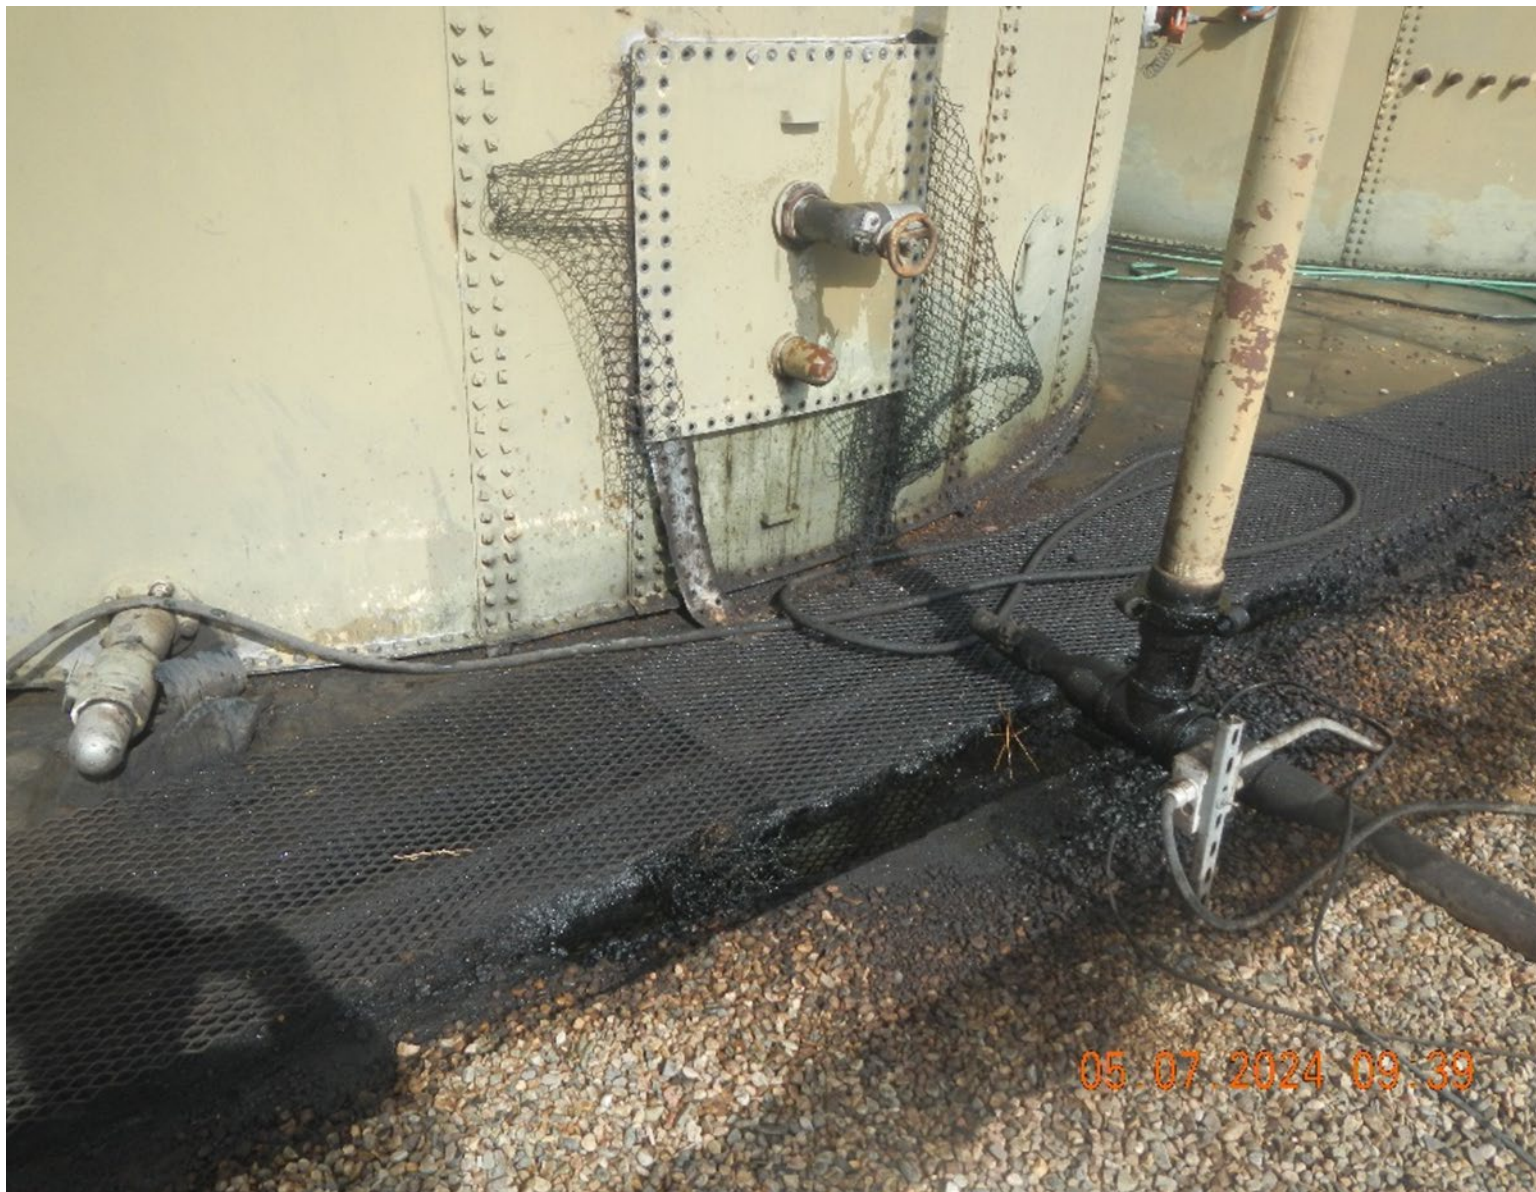
Facility #480890 Photo #15 Tank #4, oil on the ground inside tank berm. Note: Bolts on hatch removed.

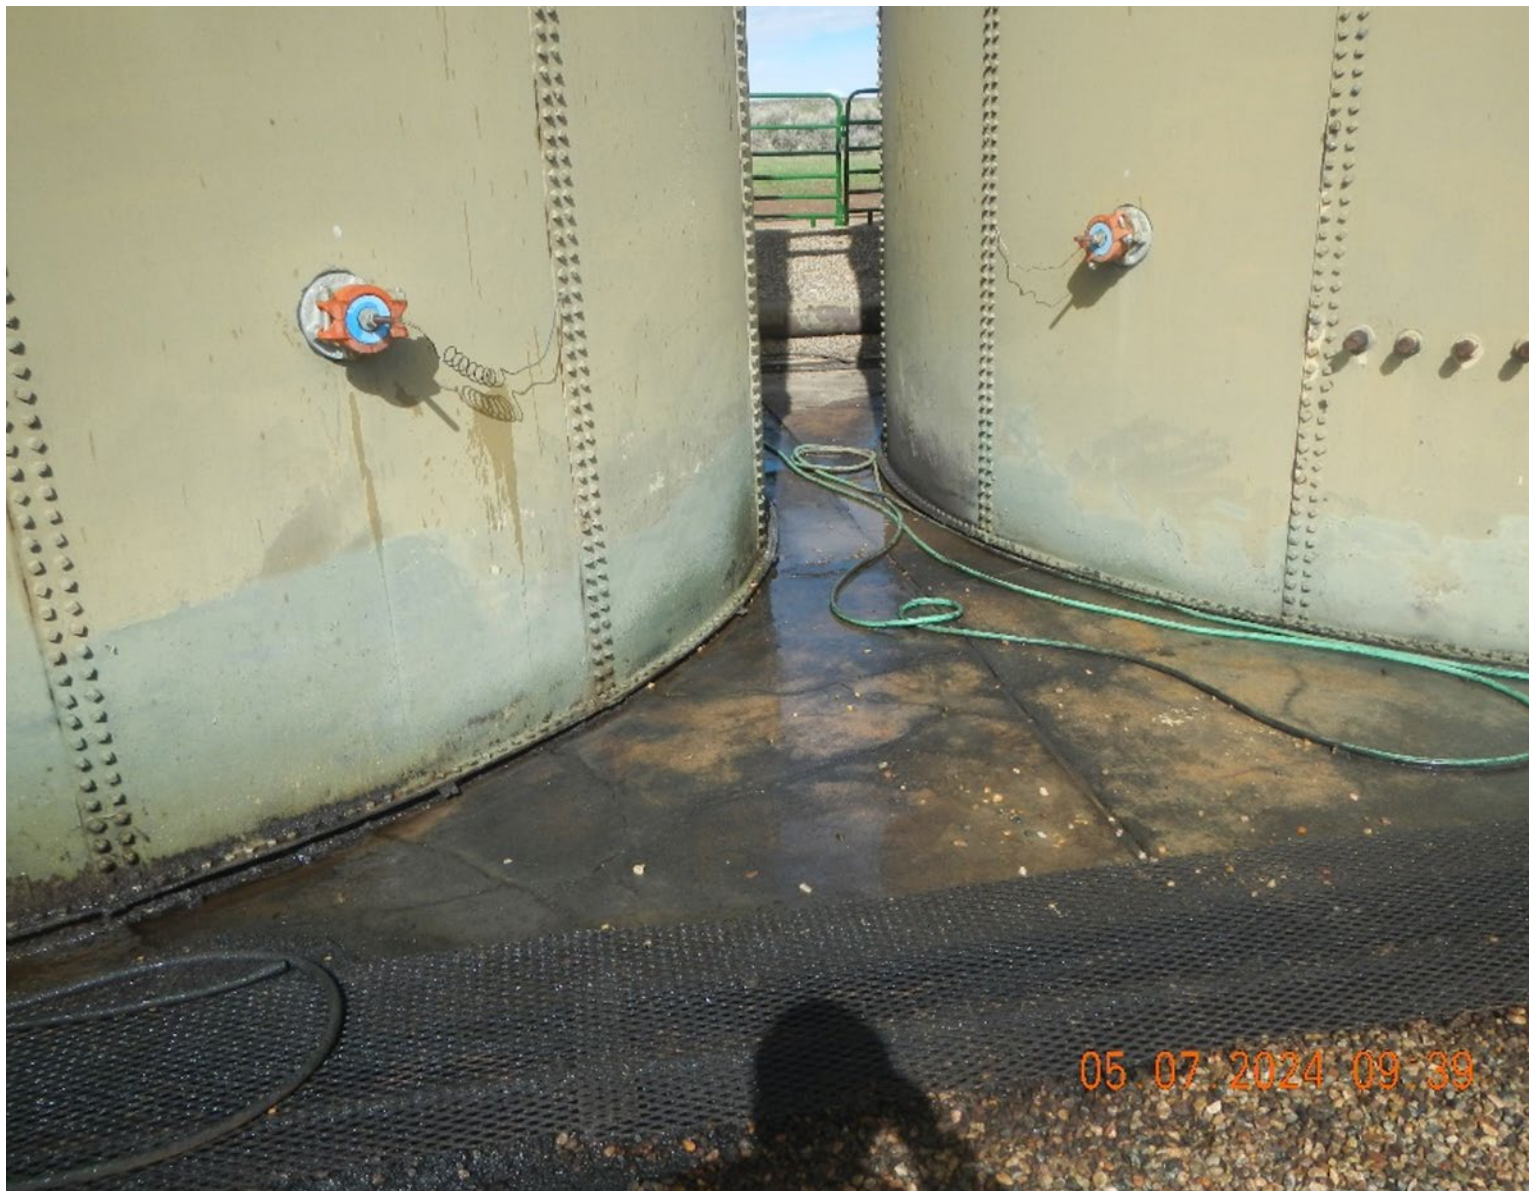
Facility #480890 Photo #16 note staining on ground.

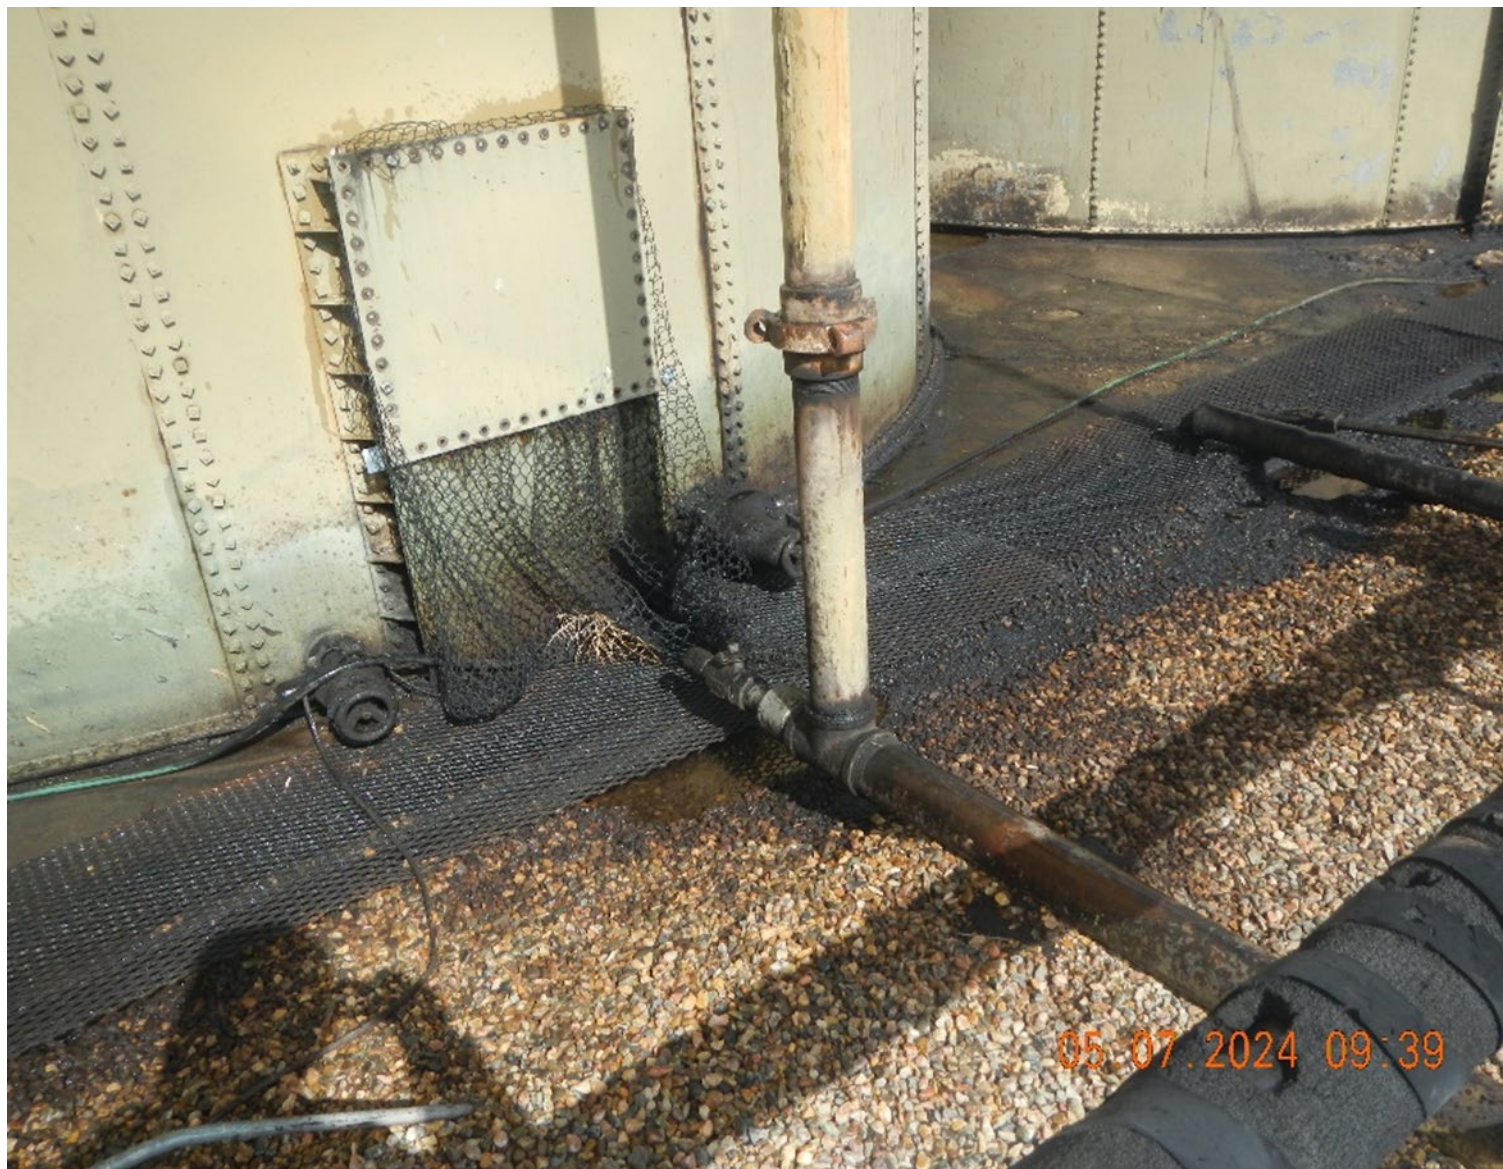
Facility #480890 Photo #17 Tank #5 bolts removed from hatch. Note: oil on ground.
