**COLORADO**  
Energy & Carbon Management  
Commission  
Department of Natural Resources

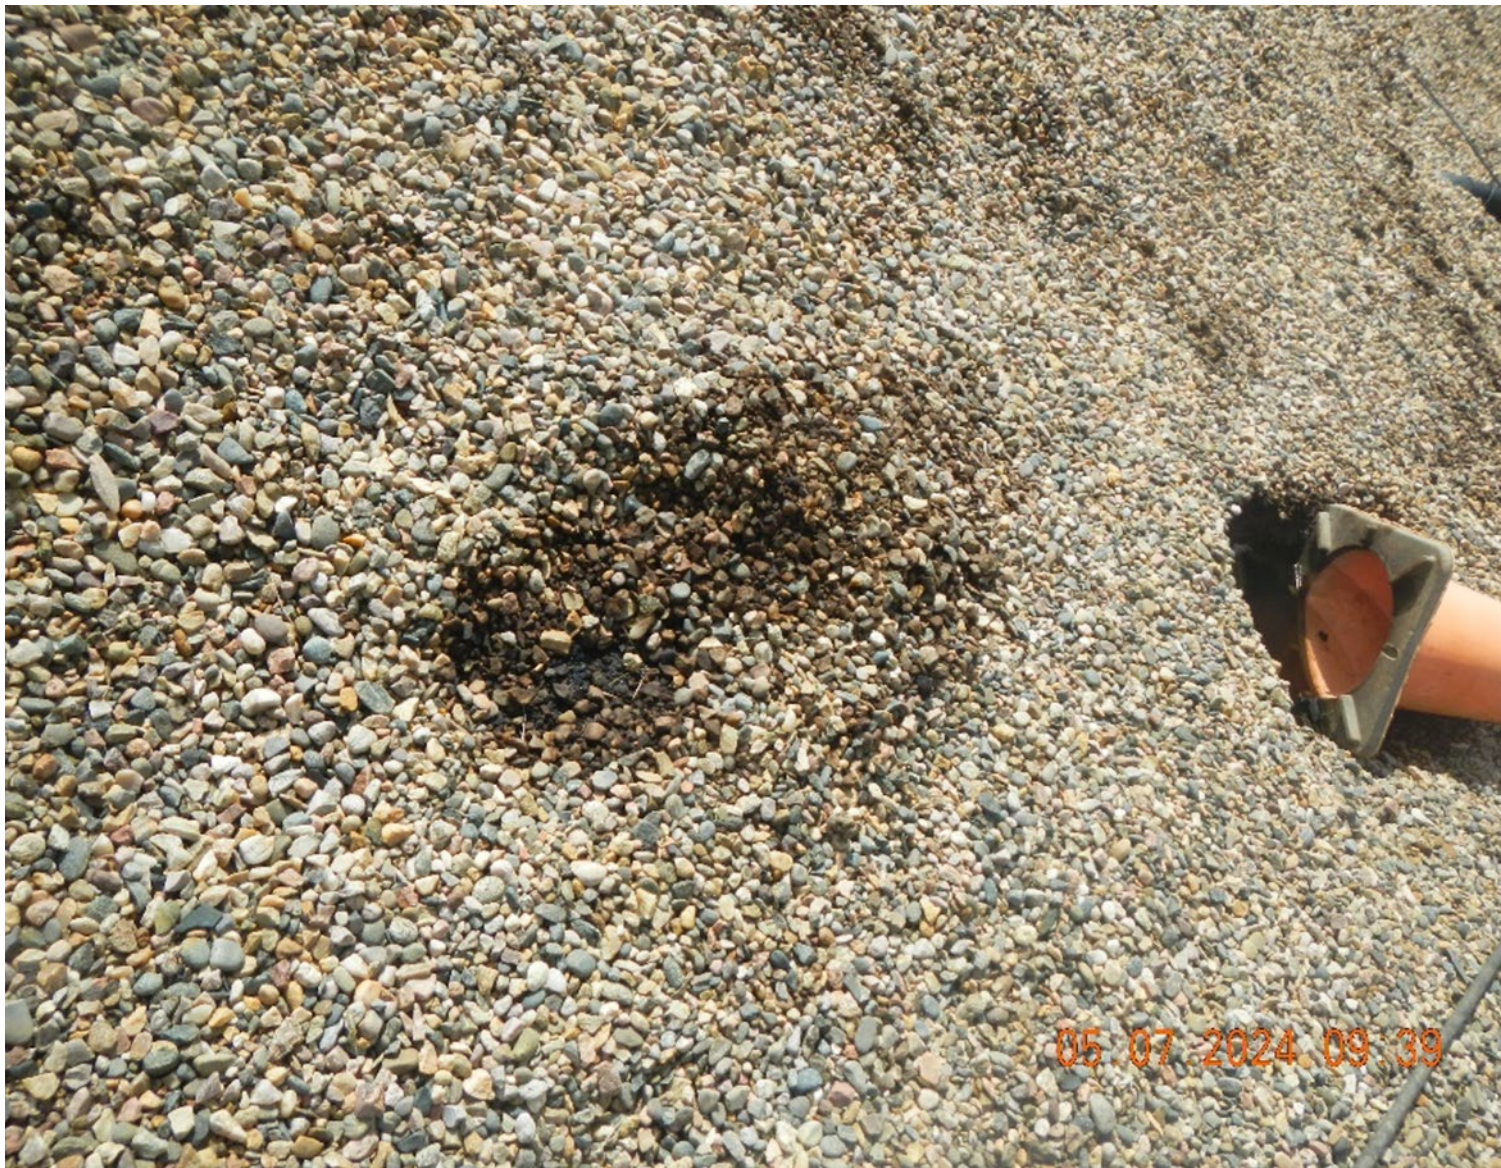
Facility #480890 Photo #18 pot hole. It is unknown what this pothole is for.

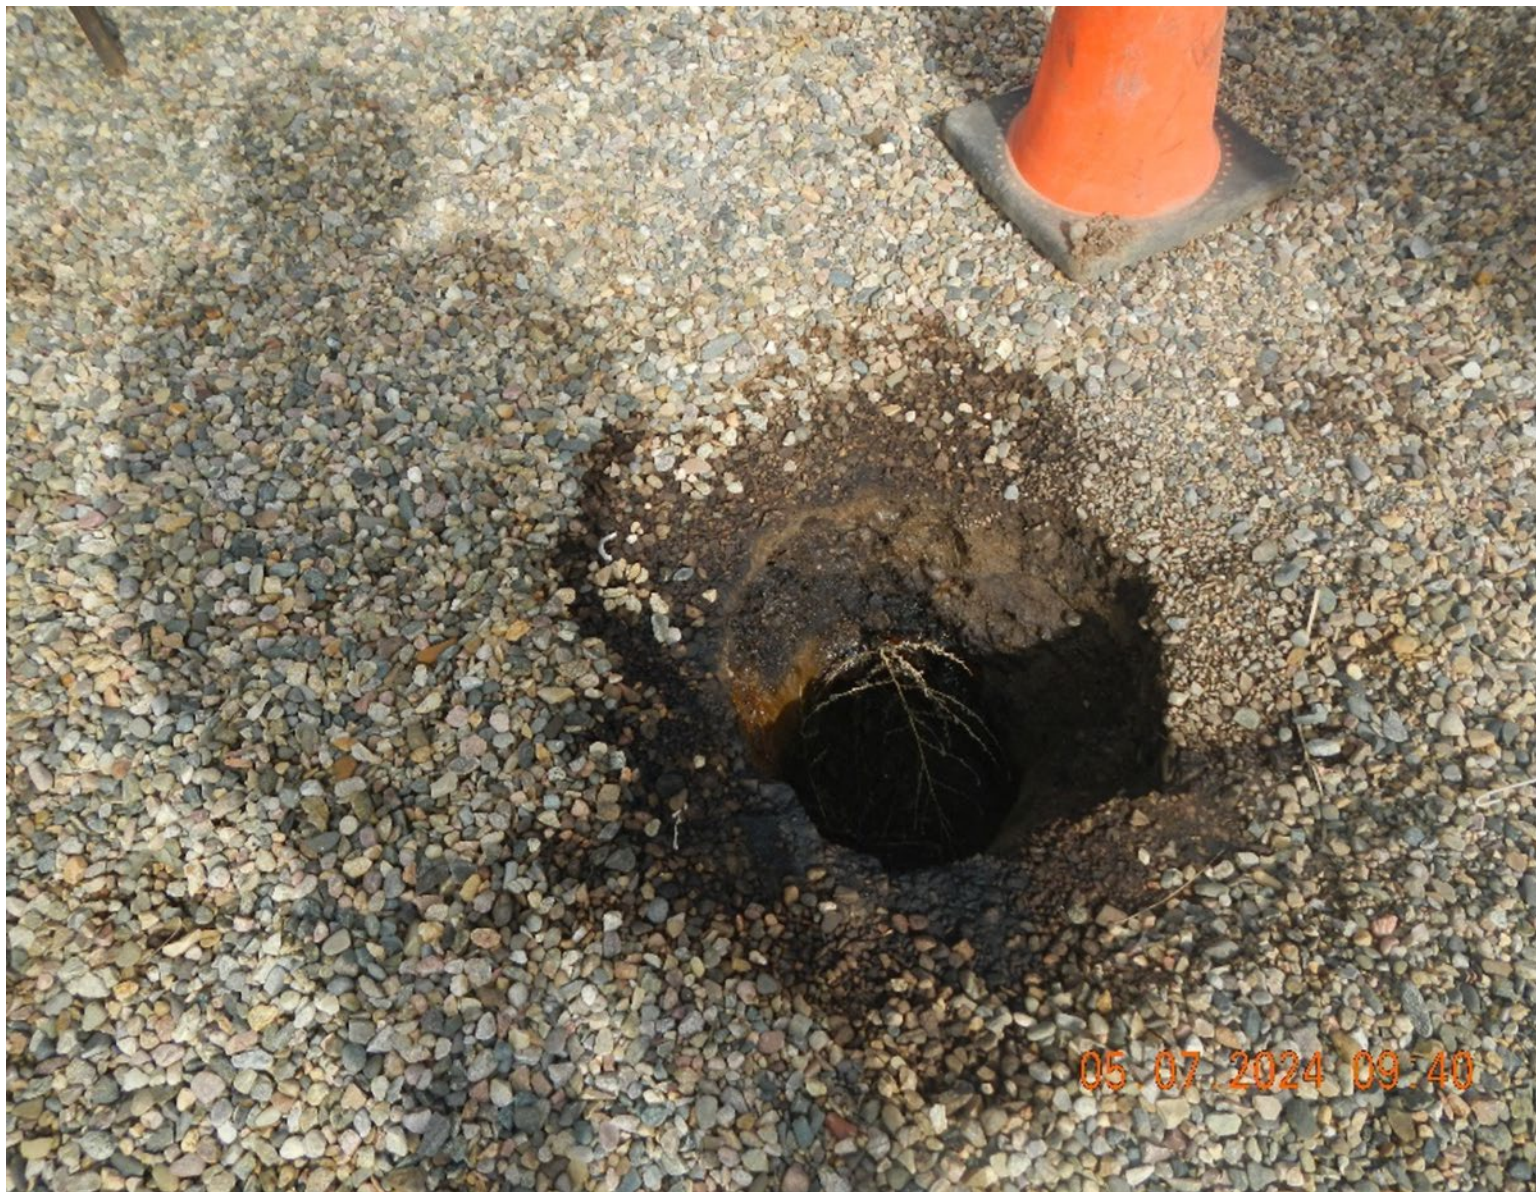
**Facility #480890 Photo #20 Inside tank battery bermed area, open pot hole, oil stained soil observed inside pothole.**

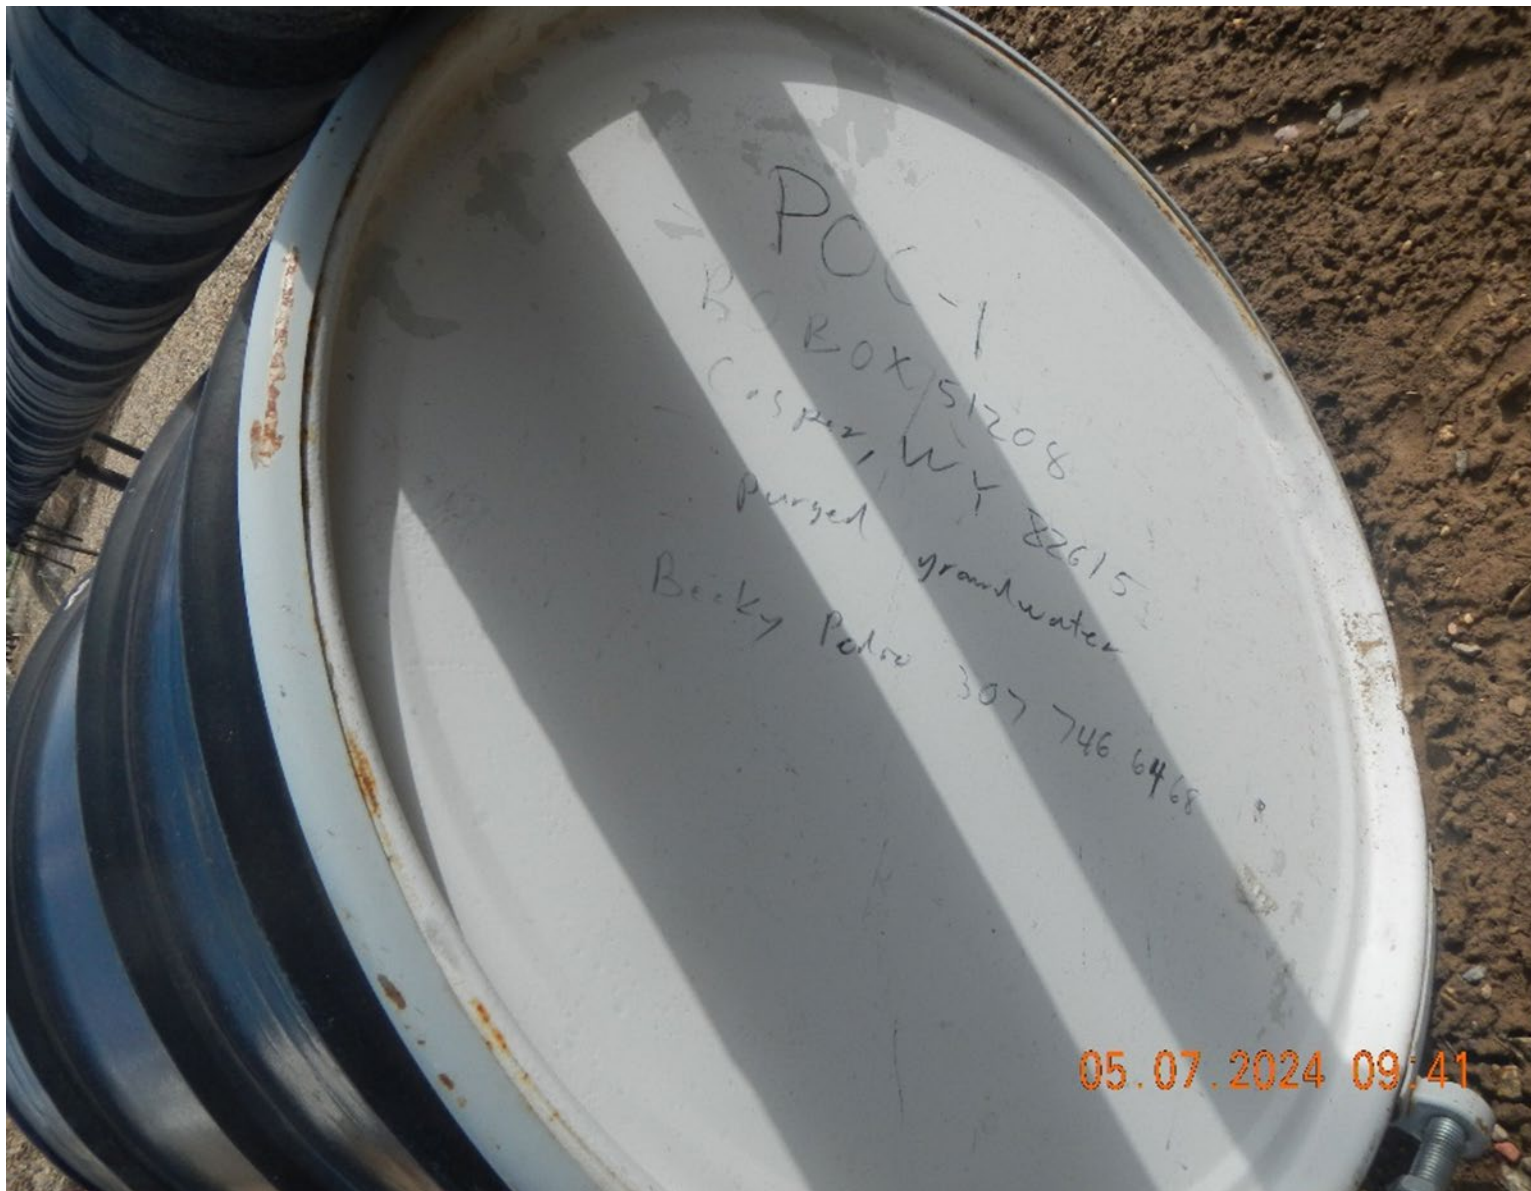
Facility #480890 Photo #21 drum on it's side inside berm. Drum was empty. IT is labeled as "purged groundwater"

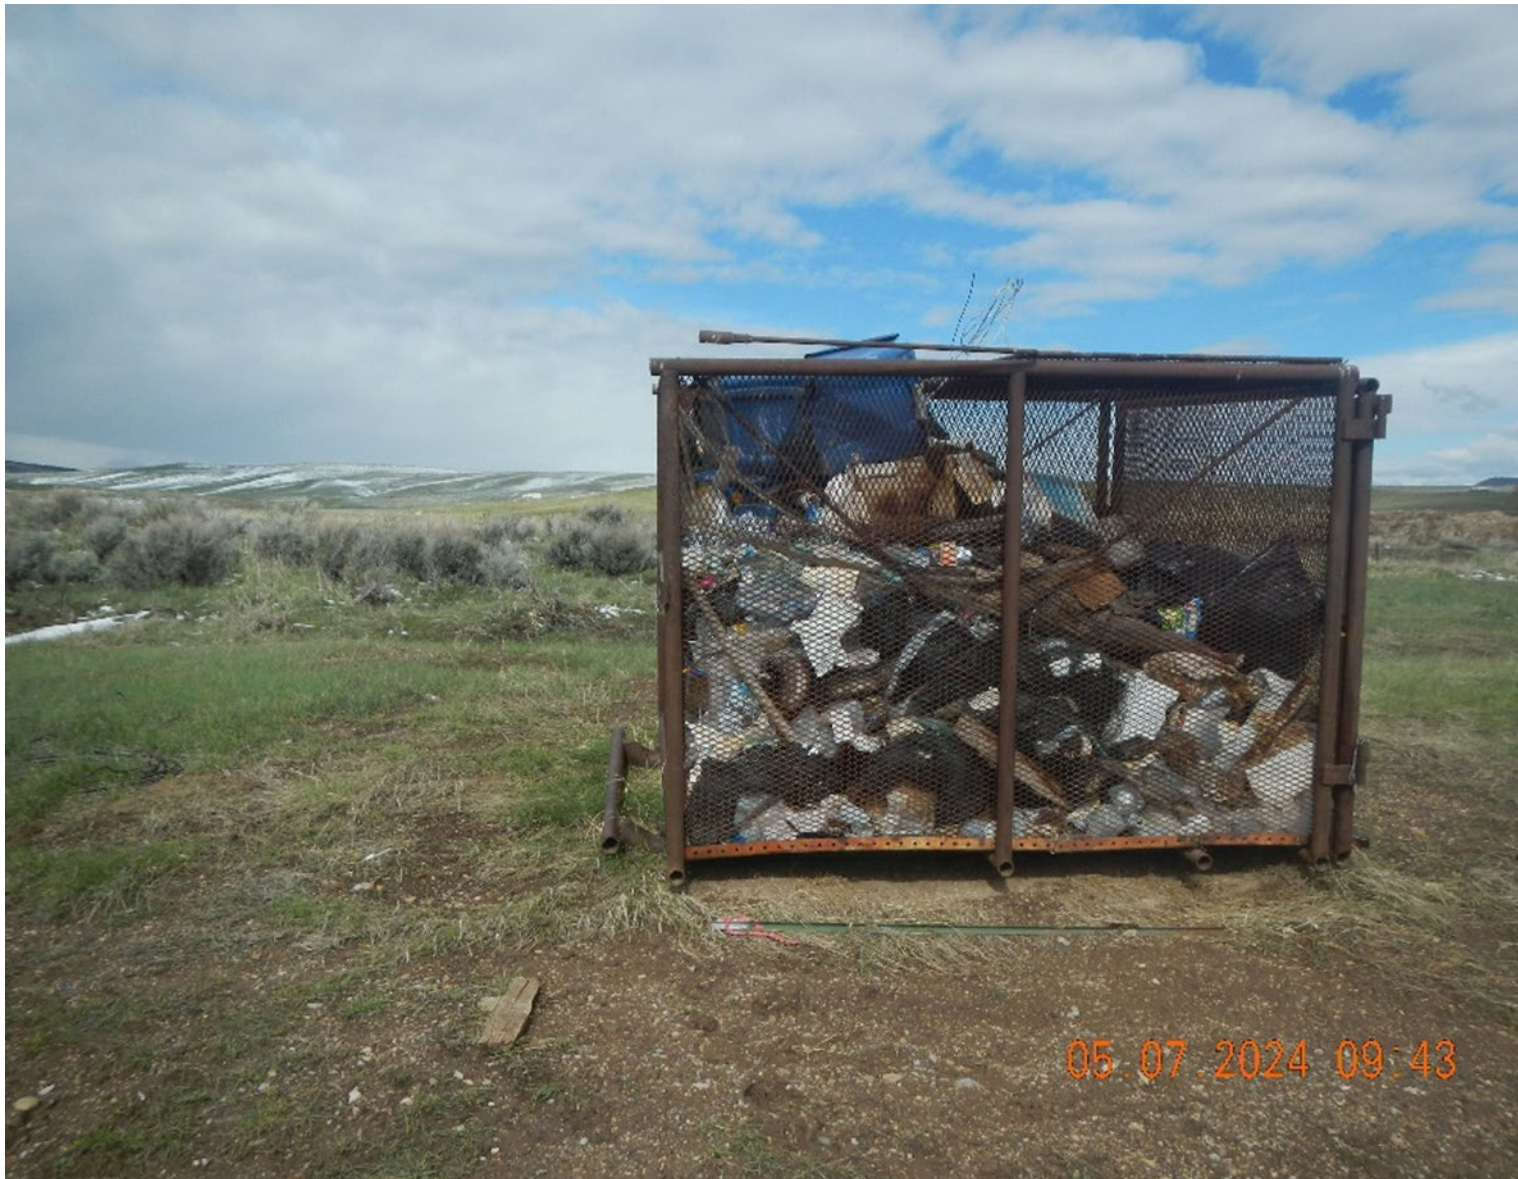
Facility #480890 Photo #23 trash bin on location, note: the top of the bin is open.

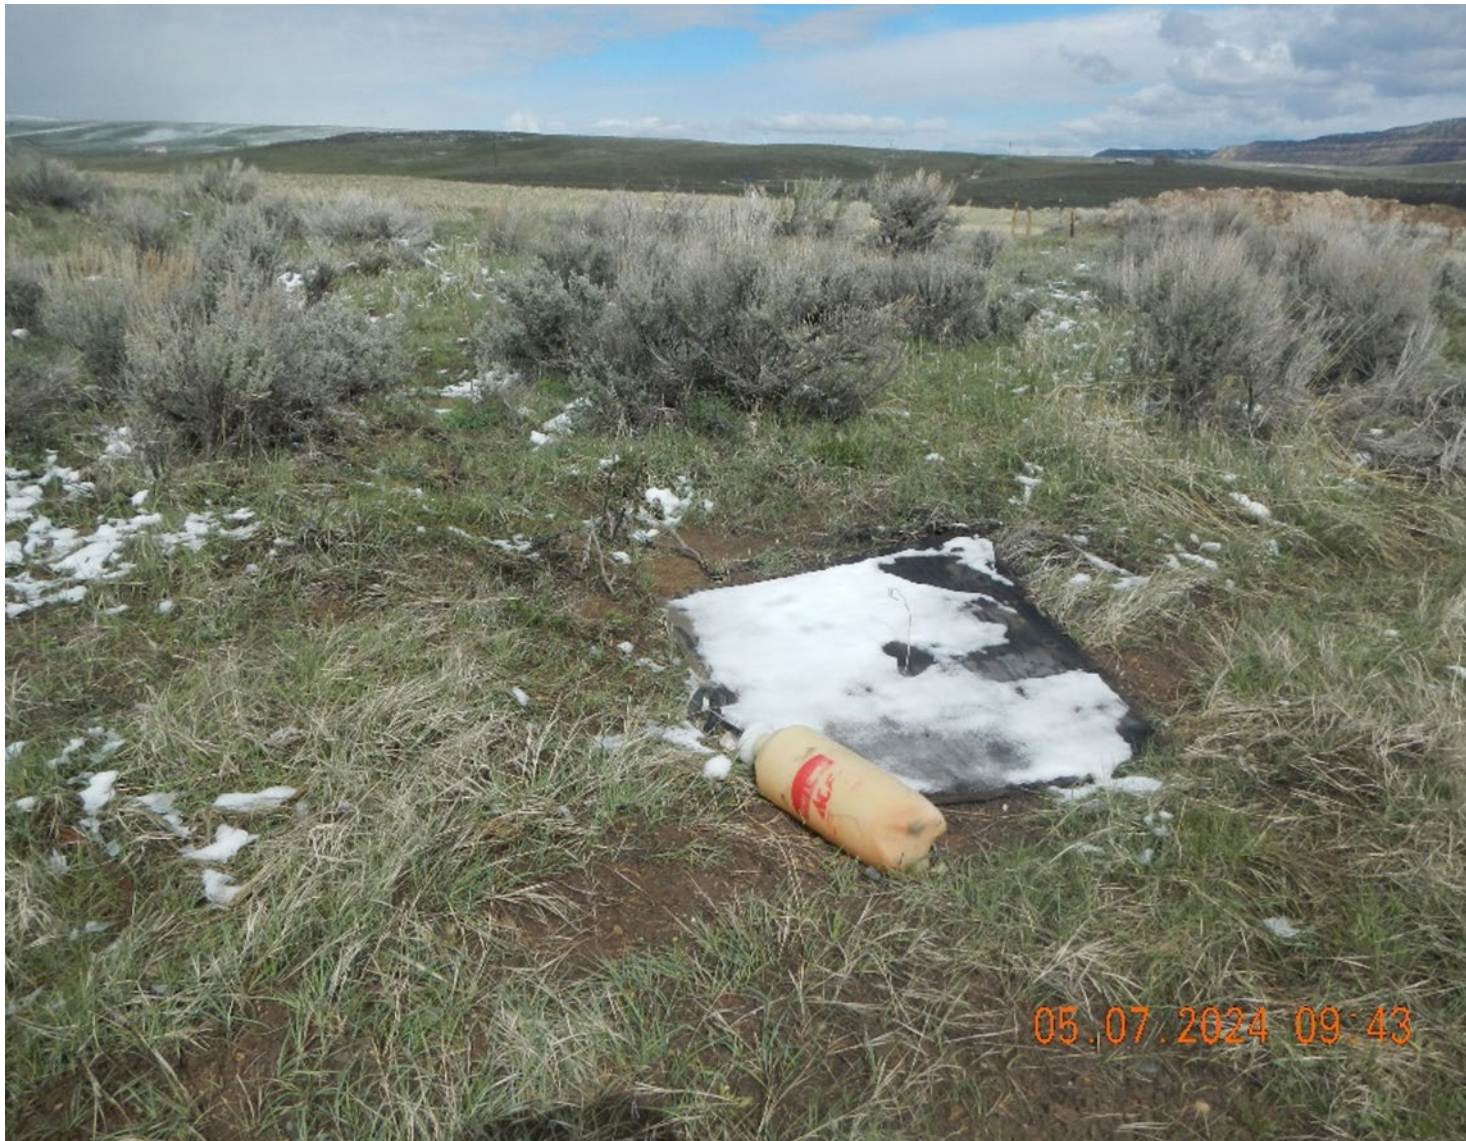
Facility #480890 Photo #24 trash on ground near trash bin.
