Inspection Photos

API: 061-06838

Operator: INVESTMENT EQUIPMENT LLC

Inspection Date: 5/8/2024

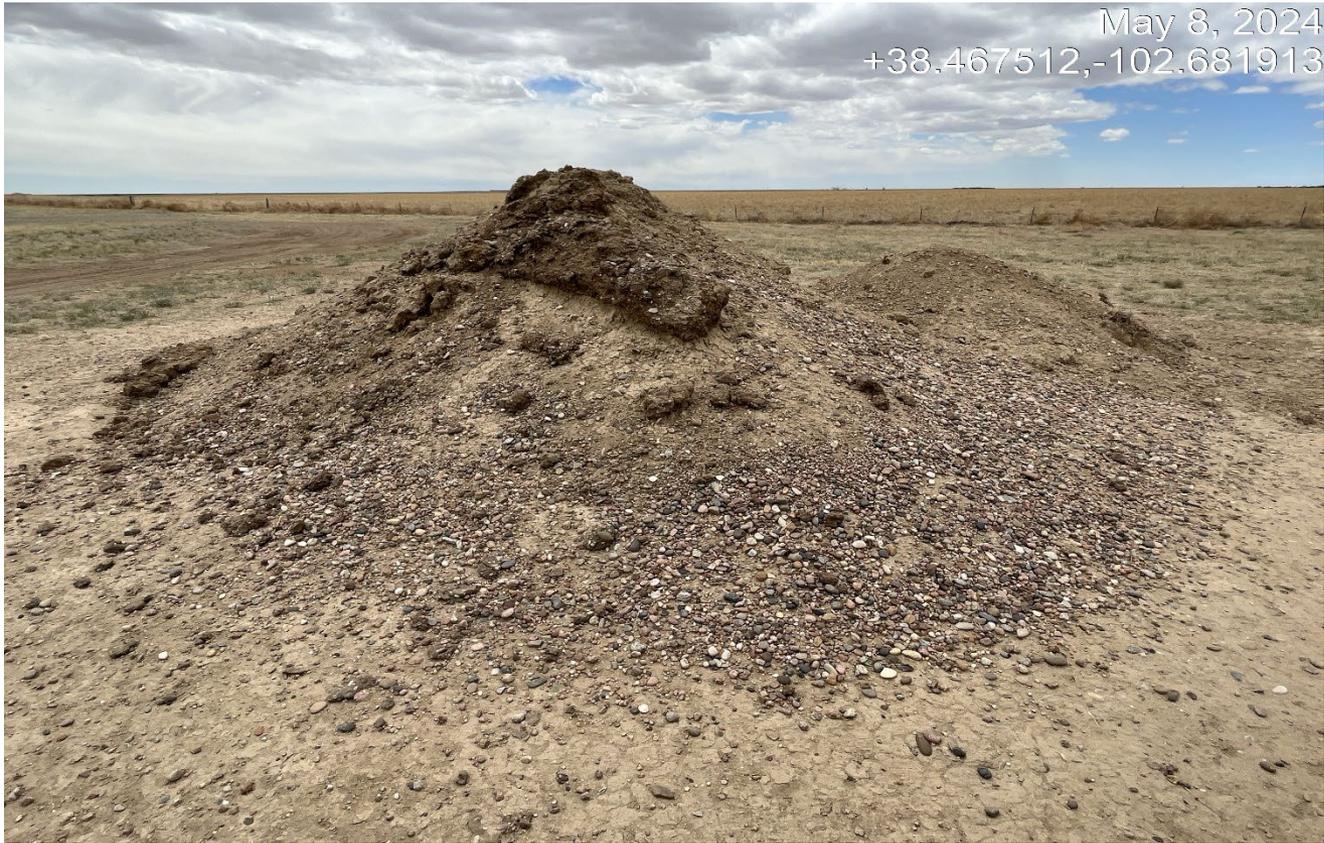
Photo 2. There is a pile of oily gravel material stored on location that must be removed and properly disposed.

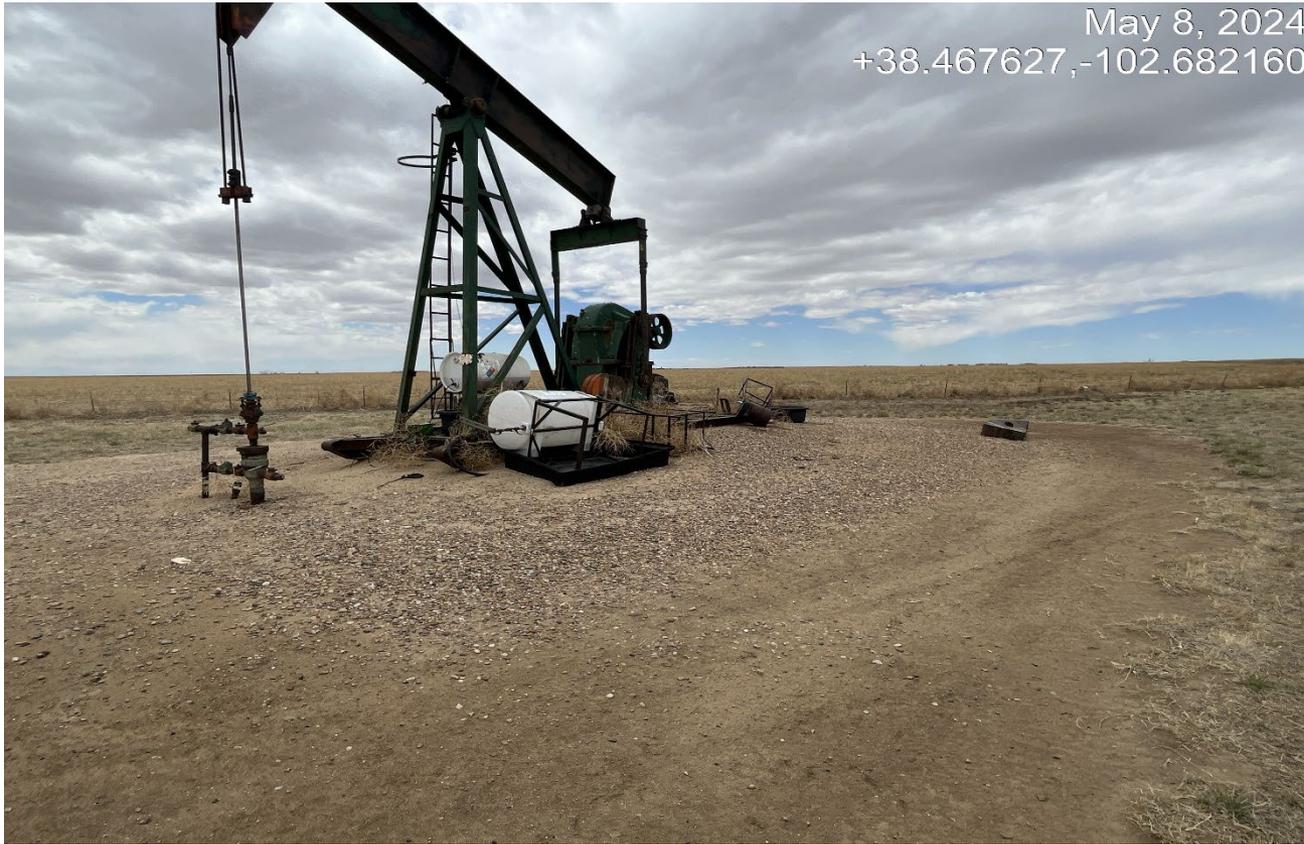
Photo 3. Facing toward the wellsite. The chemical container has tipped over.

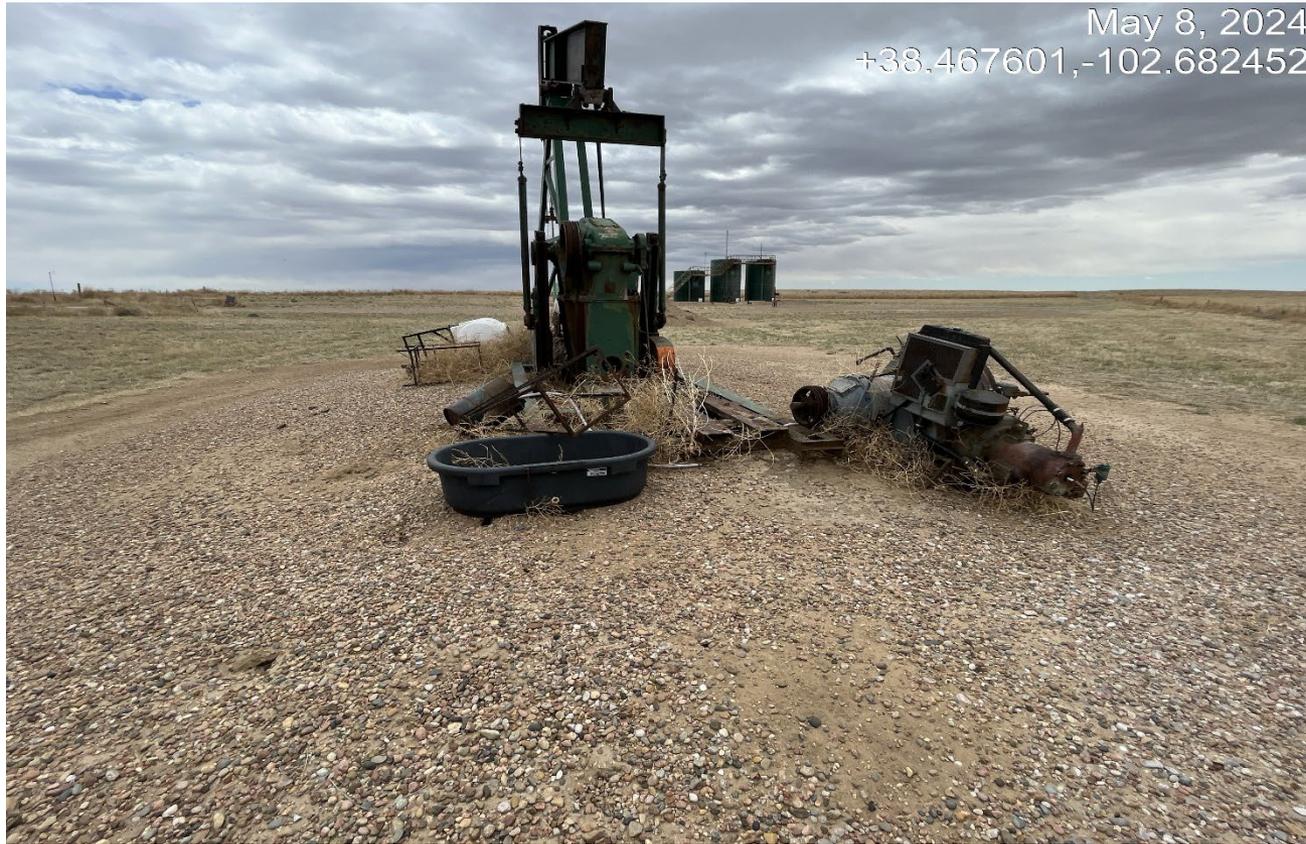
Photo 4. The chemical container at the backside has also tipped over.

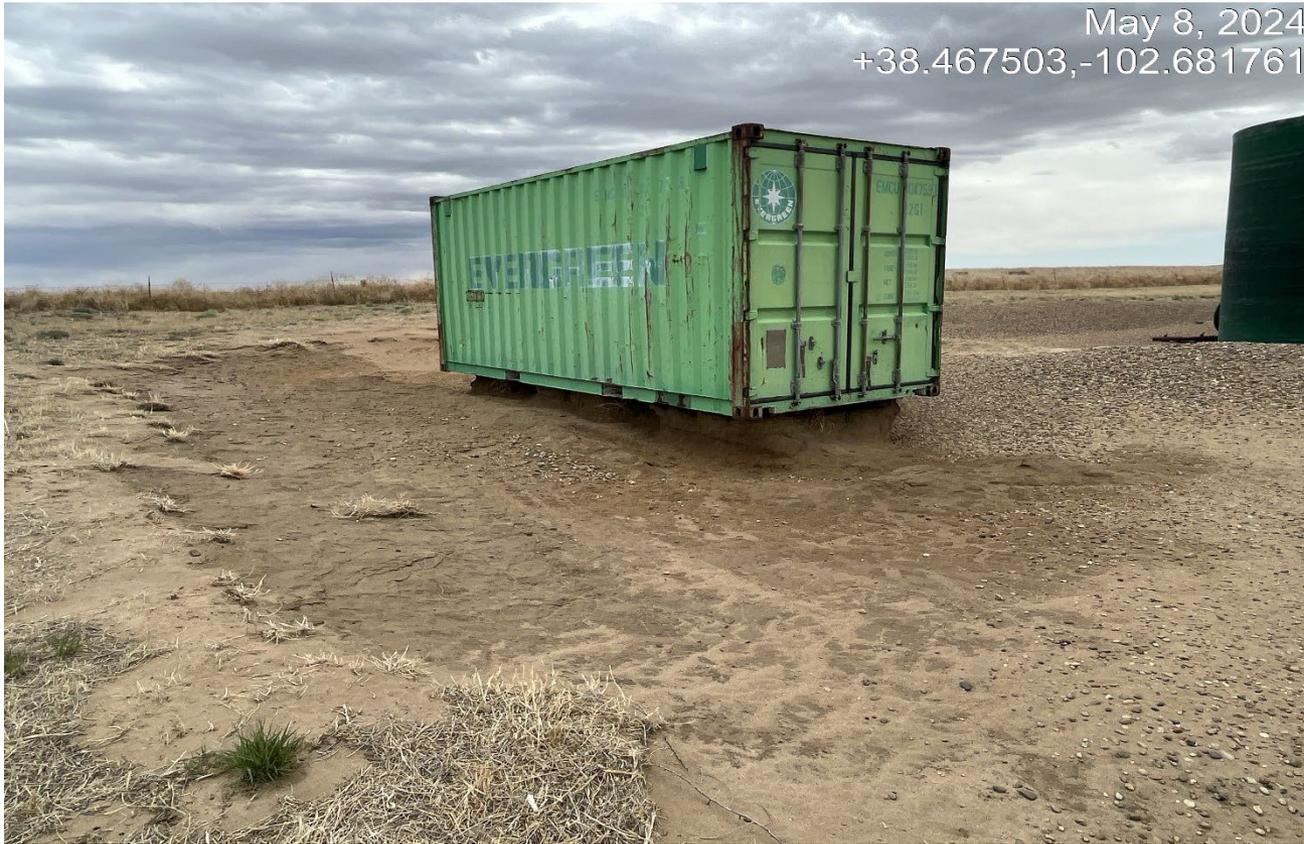
Photo 5. There is a conex at the east side of the location which must be removed. Erosion has occurred underneath the conex. The soils need to be stabilized once conex has been removed..

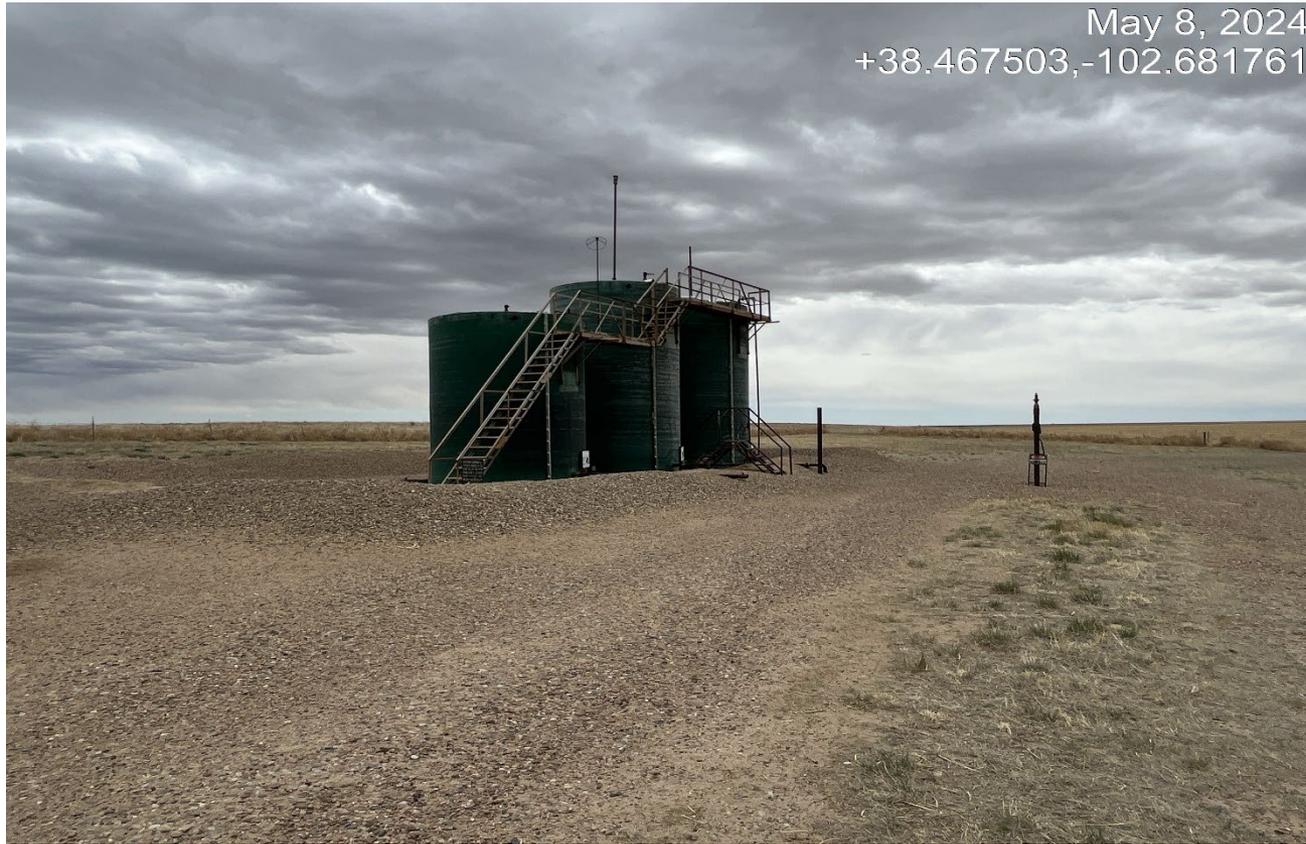
Photo 6. Facing toward the tank battery. The H₂S wind sock is missing.

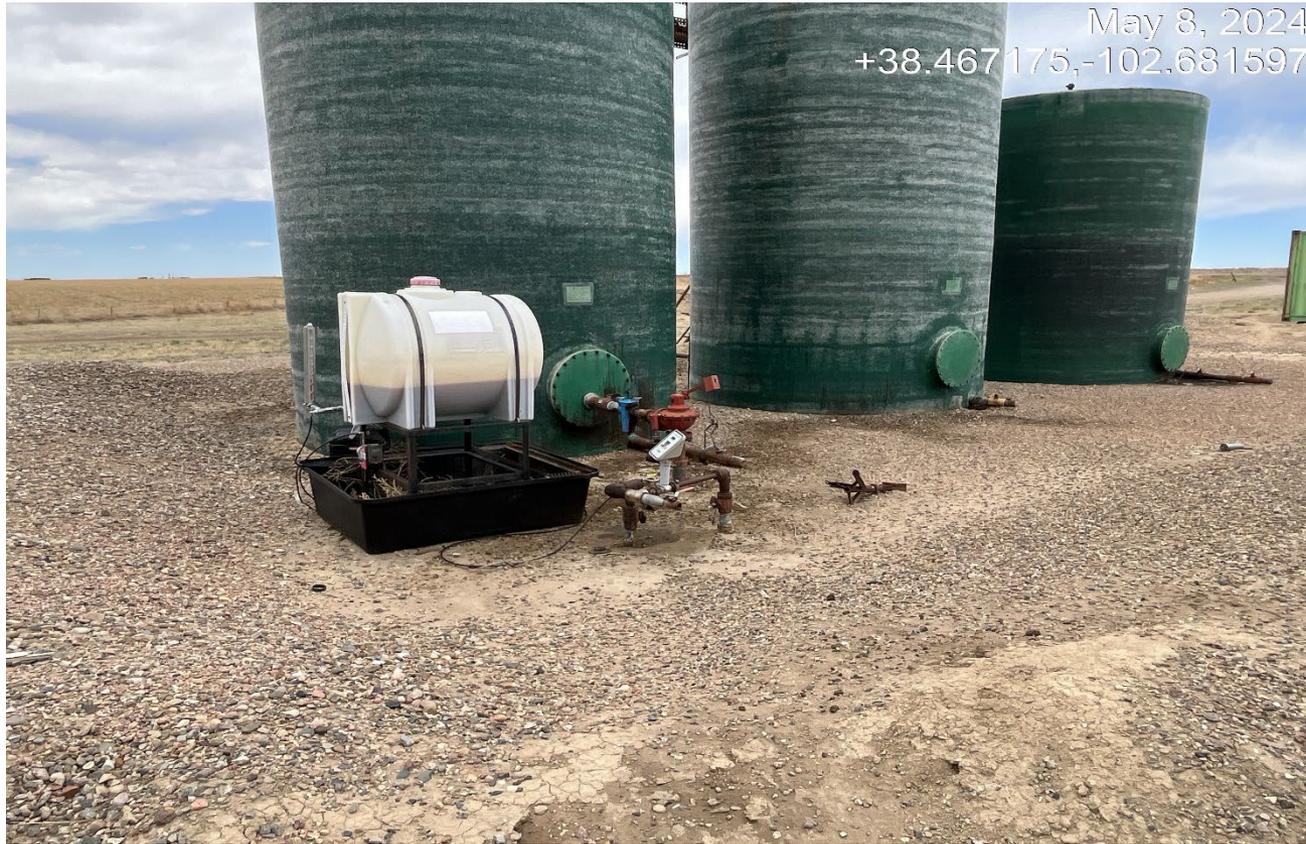
Photo 7. There are stained soils at the back side of the tank battery that must be cleaned up.
