Inspection Photos

Location Name: CAERUS PICEANCE LLC FEDERAL 30-15BB (PN30) Pad

Location #: 334060

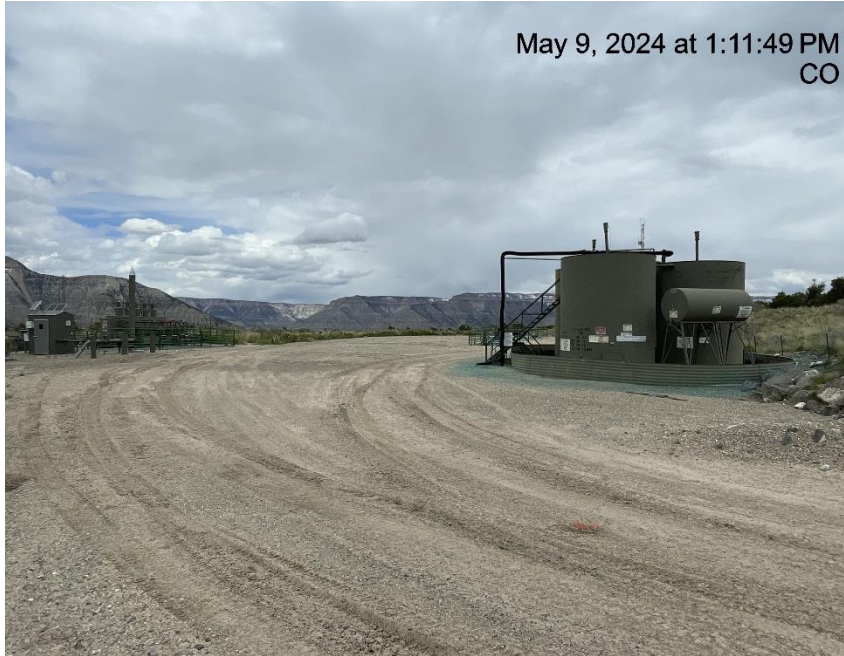
Photo # 6450 From entrance to location

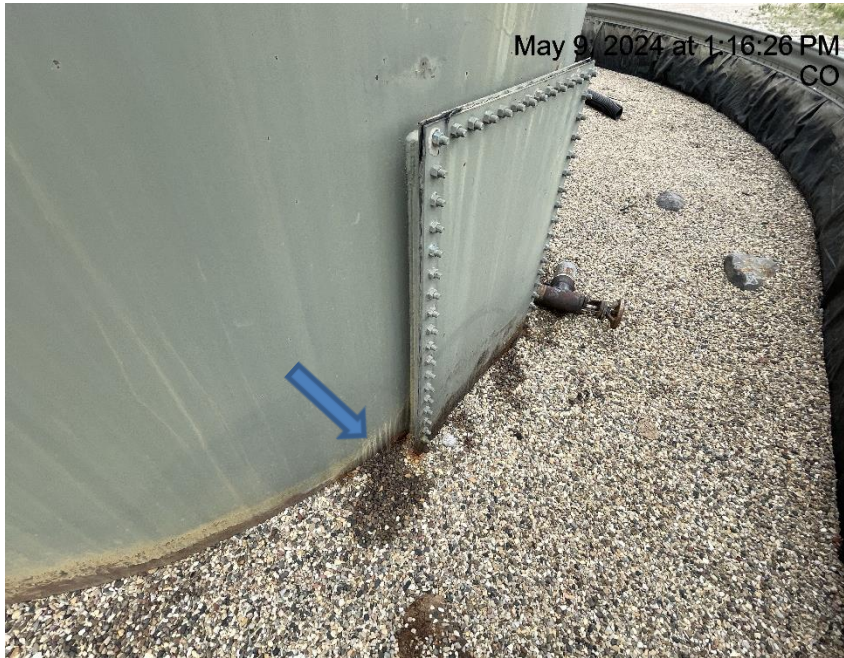
Photo # 6456 Suspected tank leak/tank appears to lack integrity (Tank # 81735)

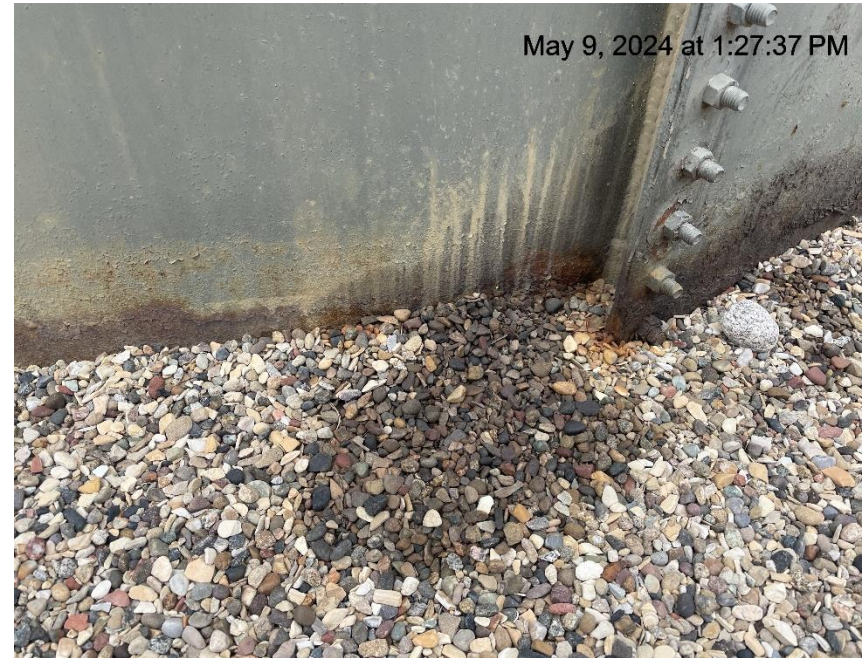
Photo # 6457 Suspected tank leak/tank appears to lack integrity (Tank # 81735)

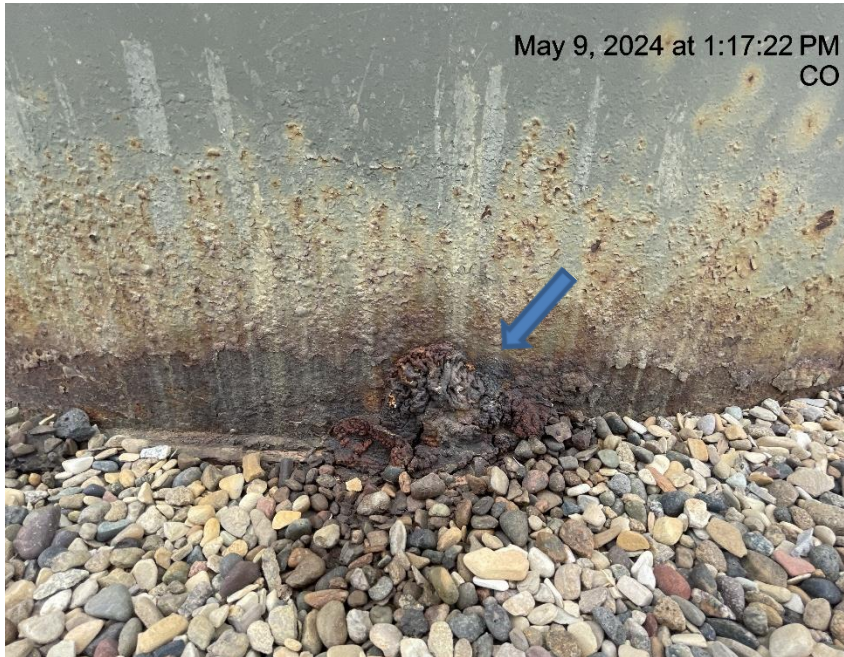
Photo # 6458 Suspected tank leak/tank appears to lack integrity (Tank # 81735)

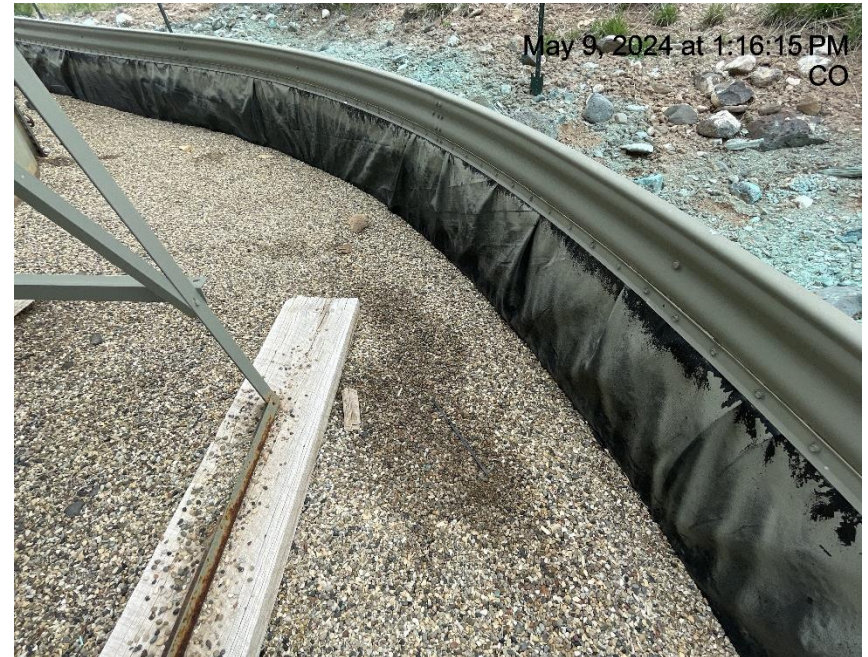
Photo # 6459 Stained gravel in secondary containment

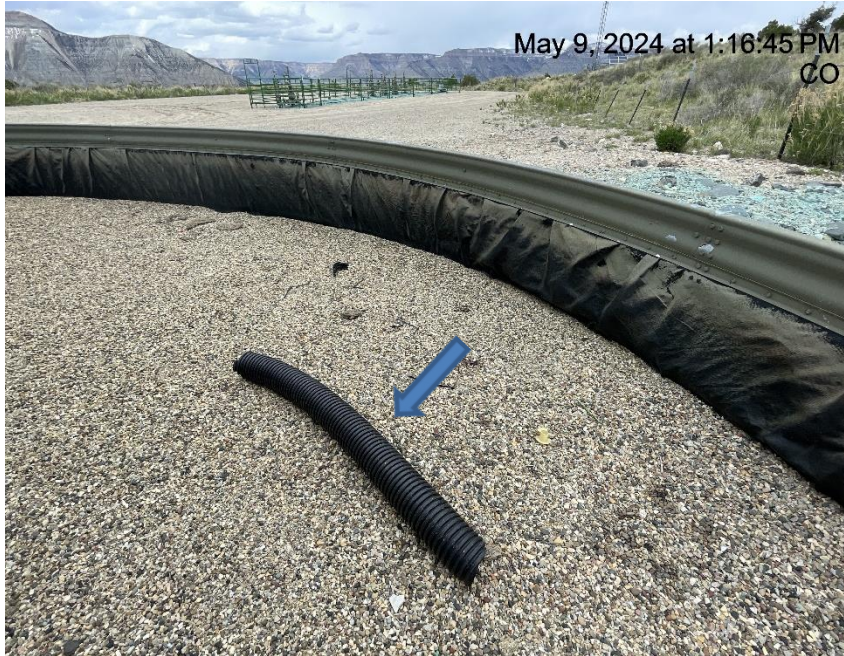
Photo # 6460 Debris
