# Inspection Photos

Location Name: CAERUS PICEANCE LLC DAYBREAK FEDERAL 19-2 (PJ19) Pad

Location #: 417538

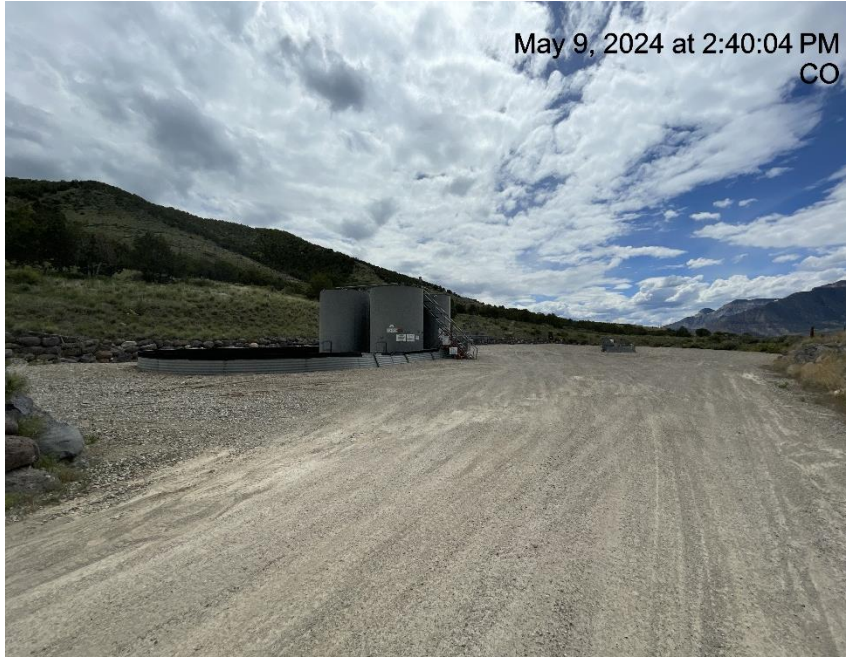
Photo # 6526 From entrance to location

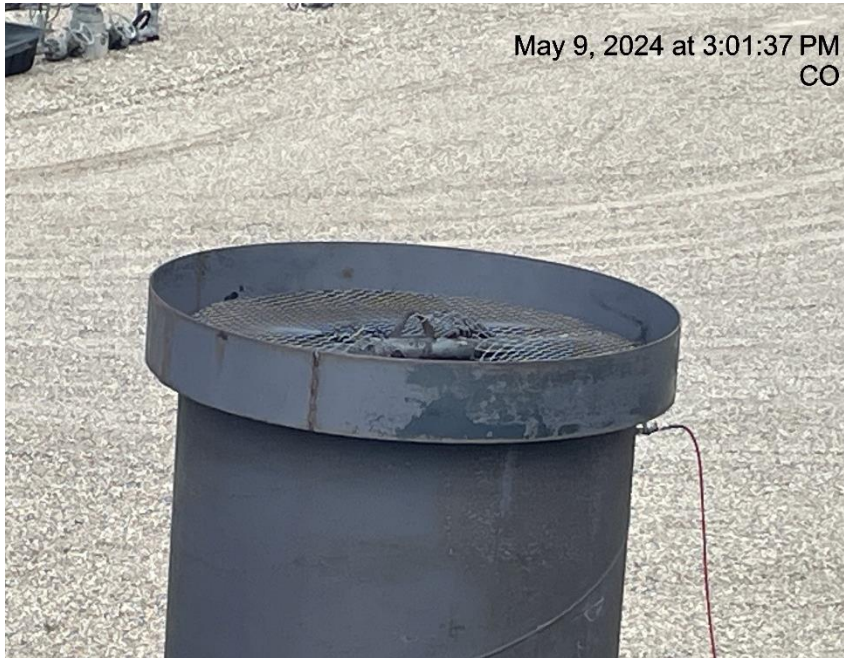
**Photo # 6536 Bird protection on ECD damaged & needs maintenance/wildlife hazard/available for entry by wildlife**

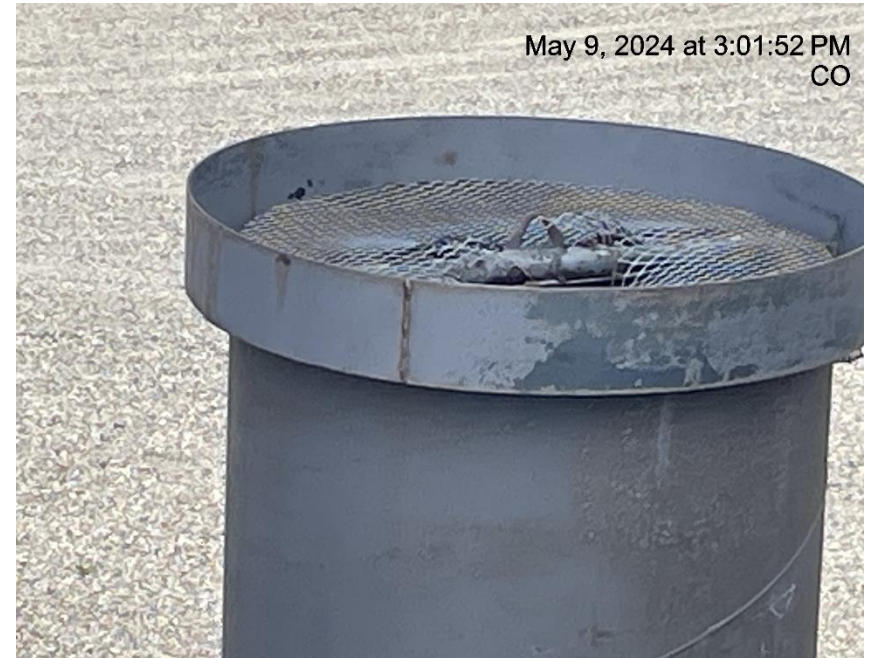
**Photo # 6537 Bird protection on ECD damaged & needs maintenance/wildlife hazard/available for entry by wildlife**

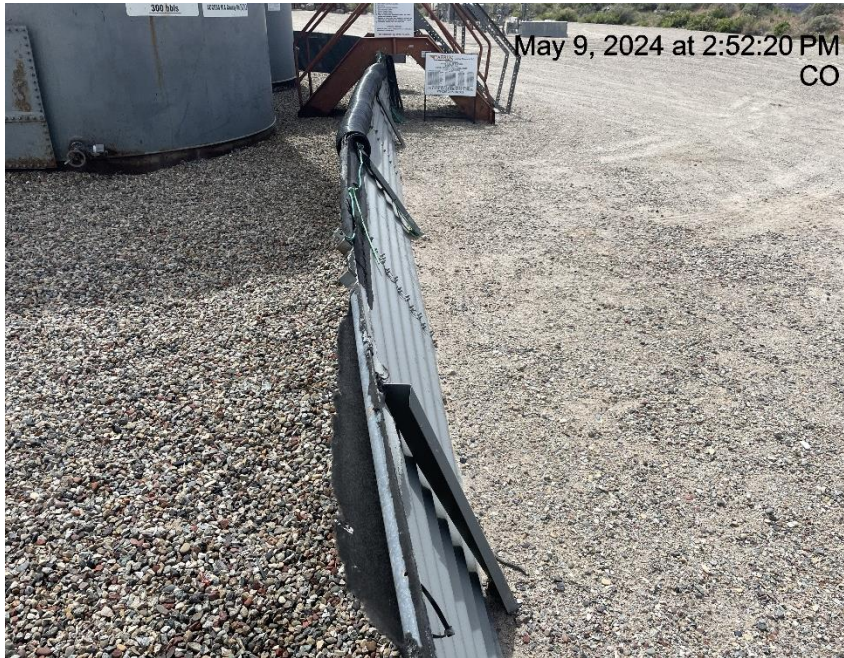
Photo # 6538 Tank containment damaged/buckling

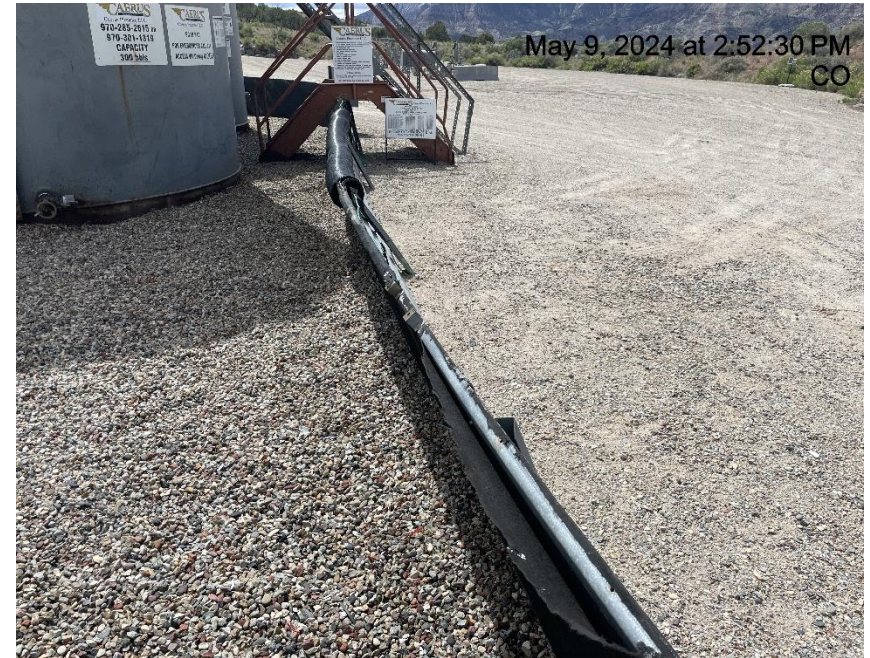
Photo # 6539 Tank containment damaged/buckling

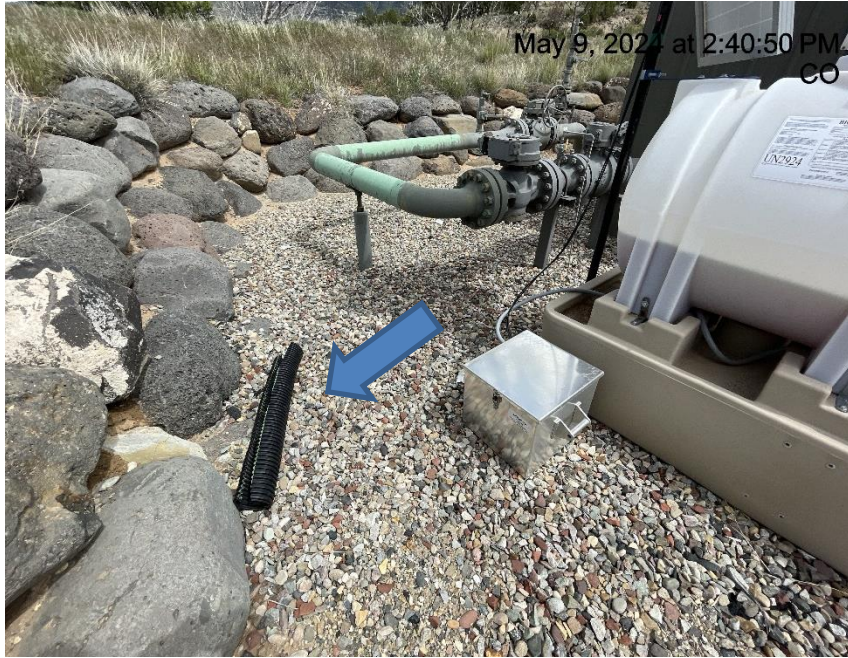
Photo # 6540 Debris
