Inspection Photos

Location Name: TEP ROCKY MOUNTAIN LLC Domestic Tap 34NENW

Location # 323790

Facility # 456910

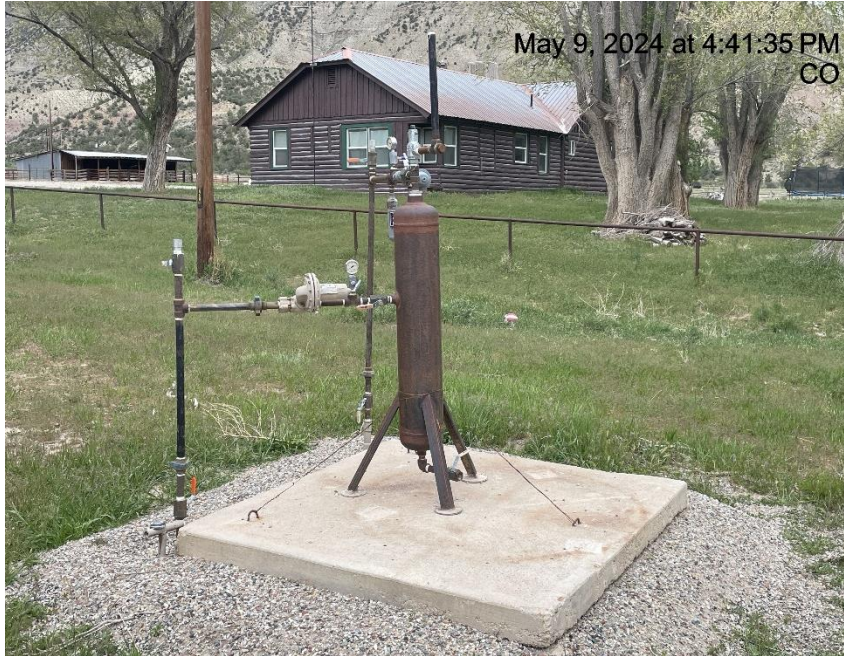
Photo # 6604 Domestic tap

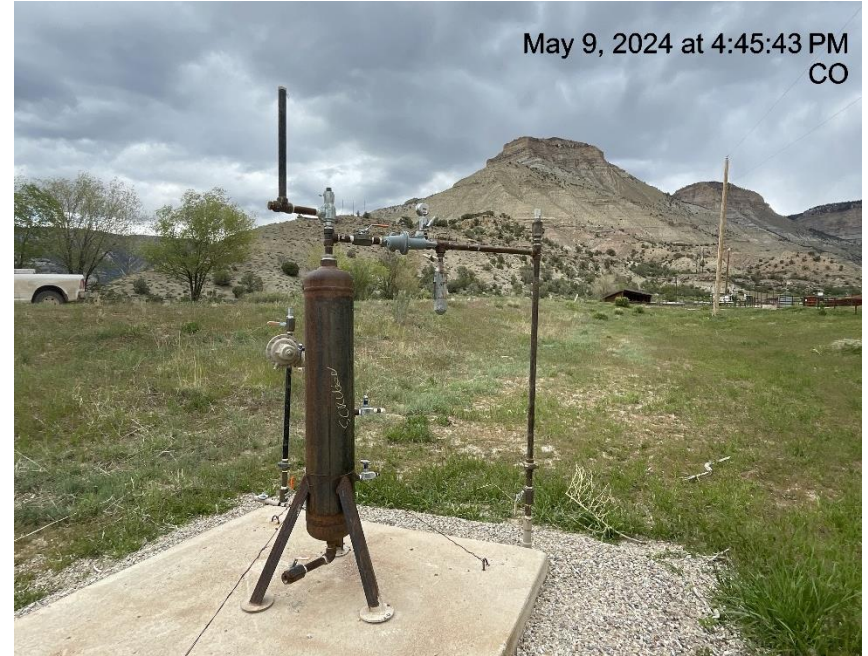
Photo # 6605 Domestic tap

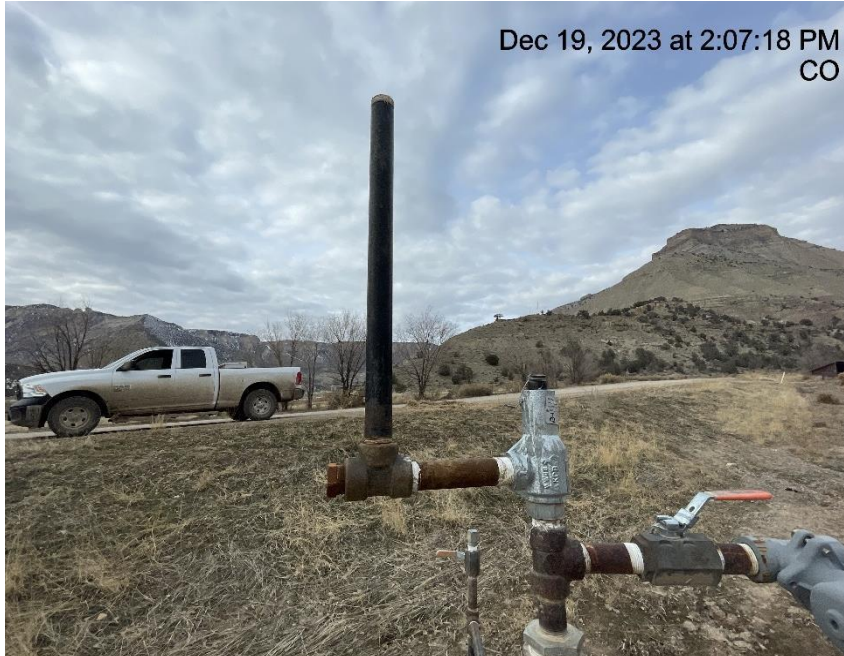
Photo # 384 From inspection 708902565 conducted on 12/19/2023 PRV vent line lacks cap

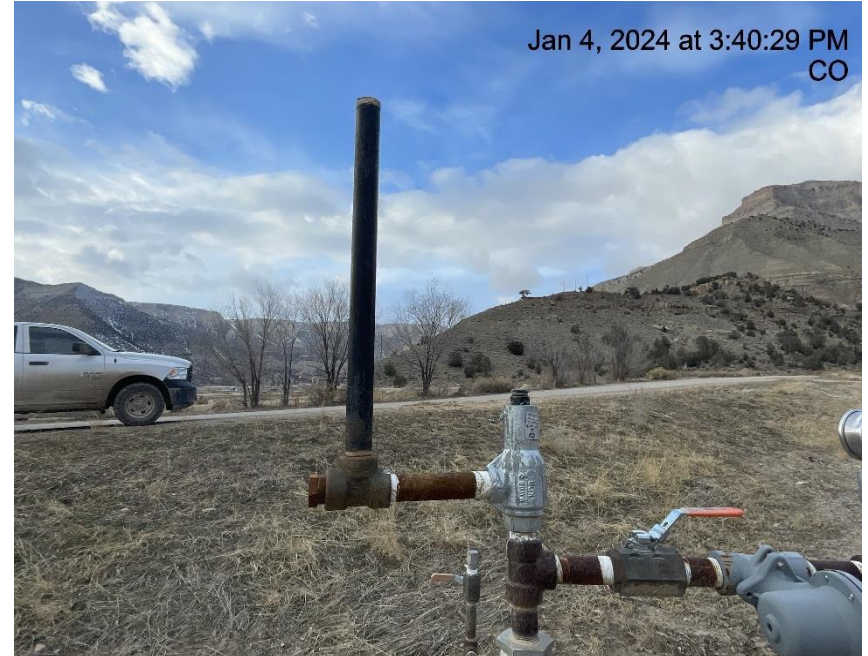
Photo # 1909 From inspection 708902696 conducted on 01/04/2024 PRV vent line lacks cap

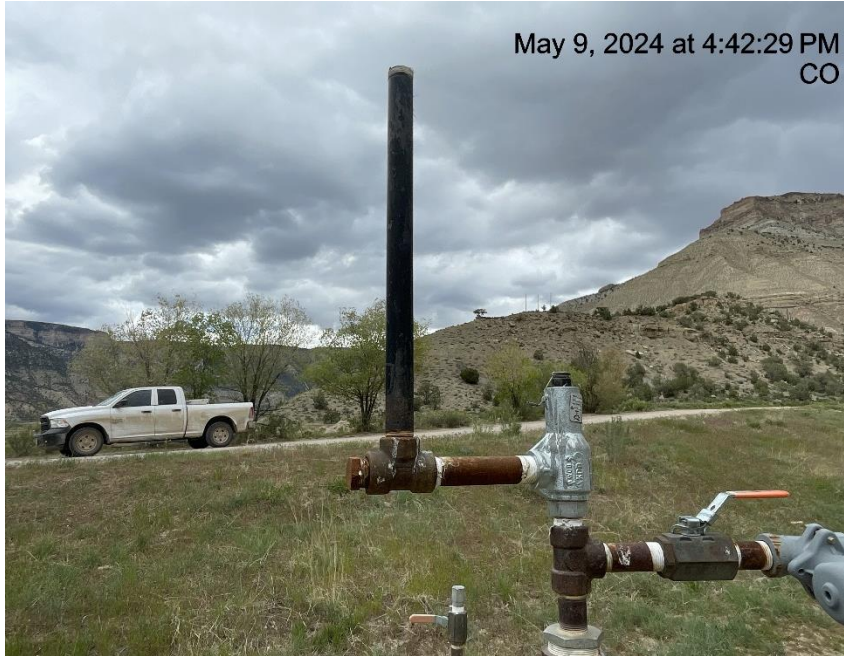
Photo # 6606 PRV vent line lacks cap/does not comply CECMC pressure safety device rules

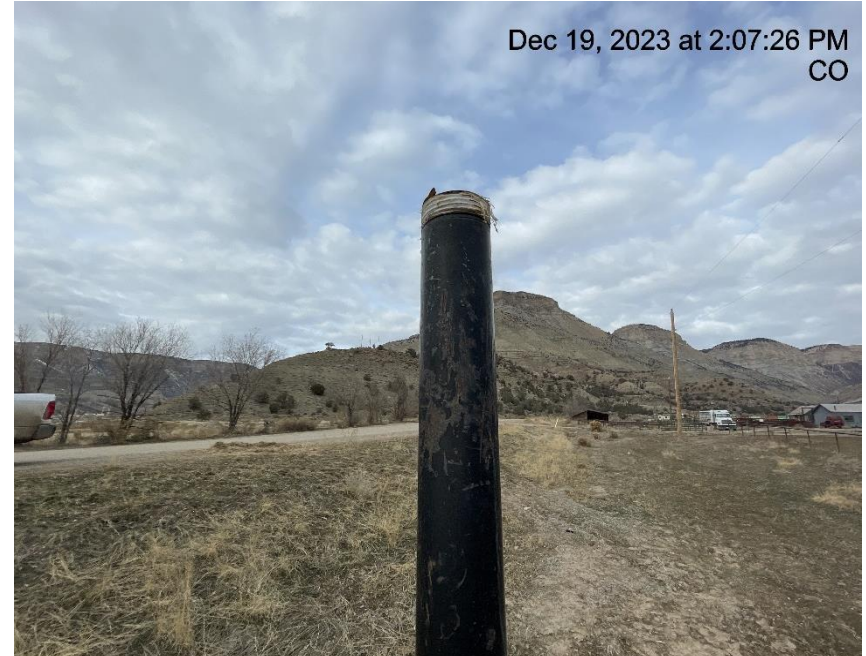
Photo # 385 From inspection 708902565 conducted on 12/19/2023 PRV vent line lacks cap

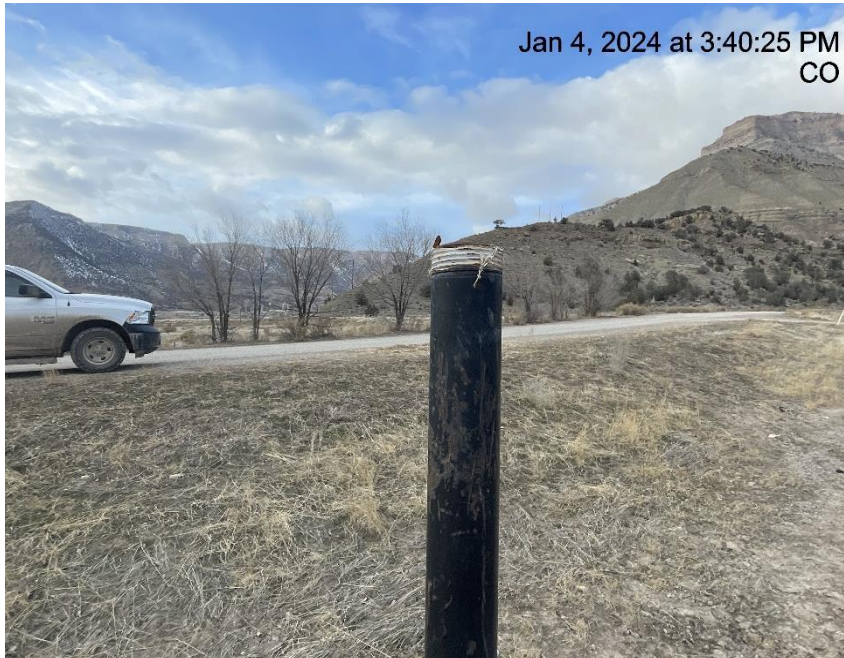
Photo # 1910 From inspection 708902696 conducted on 01/04/2024 PRV vent line lacks cap

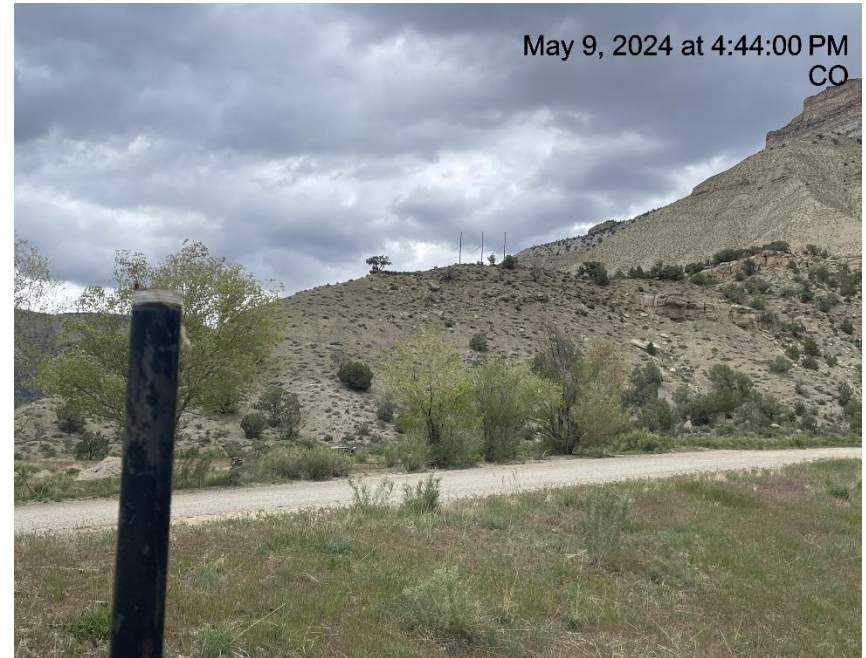
Photo # 6607 PRV vent line lacks cap/does not comply CECMC pressure safety device rules

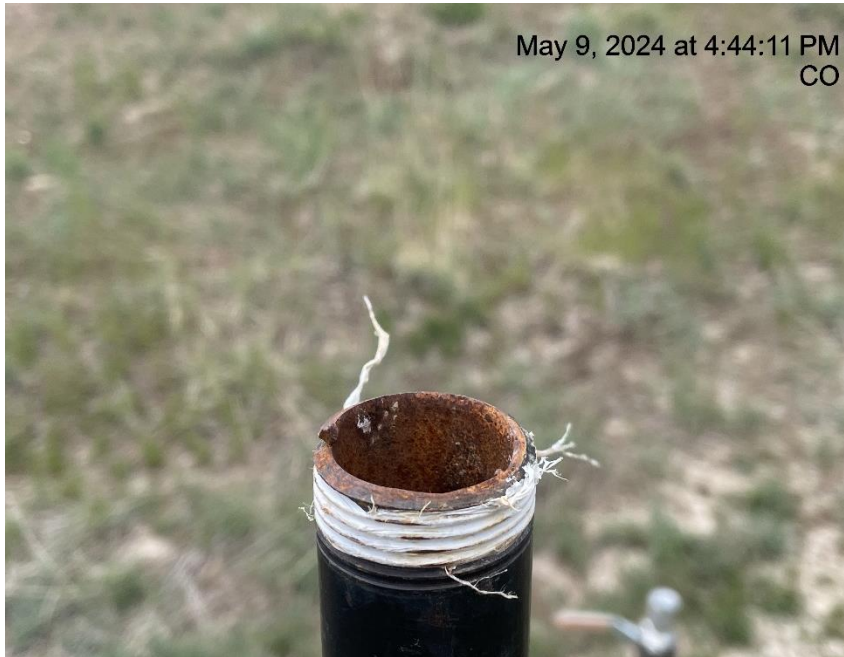
**Photo # 6608 PRV vent line lacks cap/does not comply
CECMC pressure safety device rules**

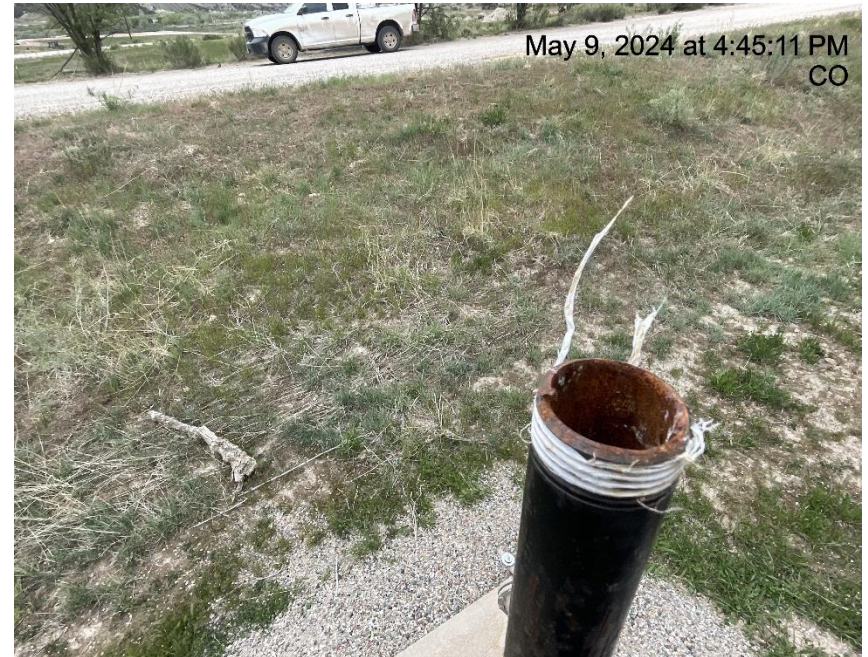
**Photo # 6609 PRV vent line lacks cap/does not comply
CECMC pressure safety device rules**
