Inspection Photos
Location: Baughman # 6
Facility ID: 324843

Surface Location API# 05-061-06452	Well Classification: OW	Status: SI - 8/2/2022
--	--------------------------------	------------------------------

[Operator:](#) [CHEMCO INC - 16520](#) Federal Or State Lease #:
(Click Operator Name for Company Detail Report)

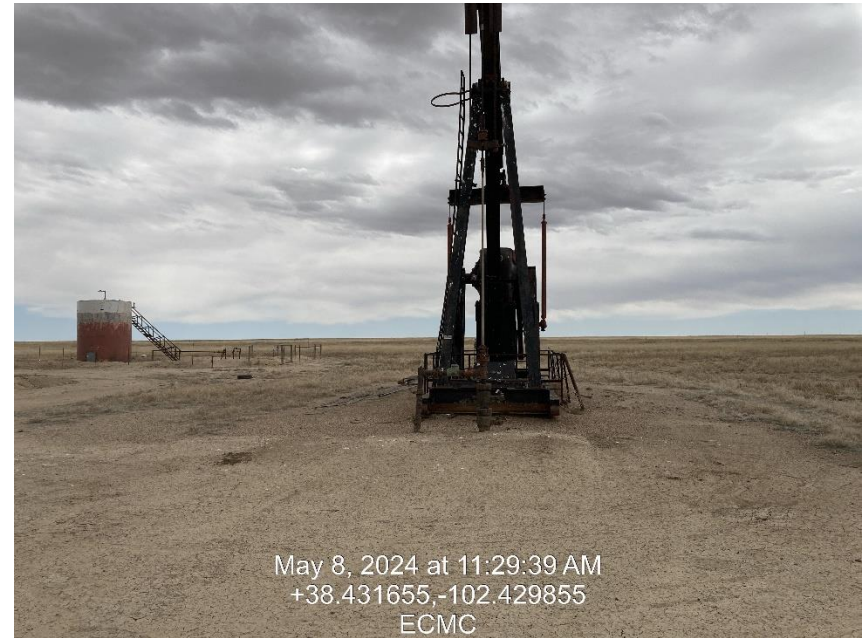
Photo 1 –Scout Card, no well placard present

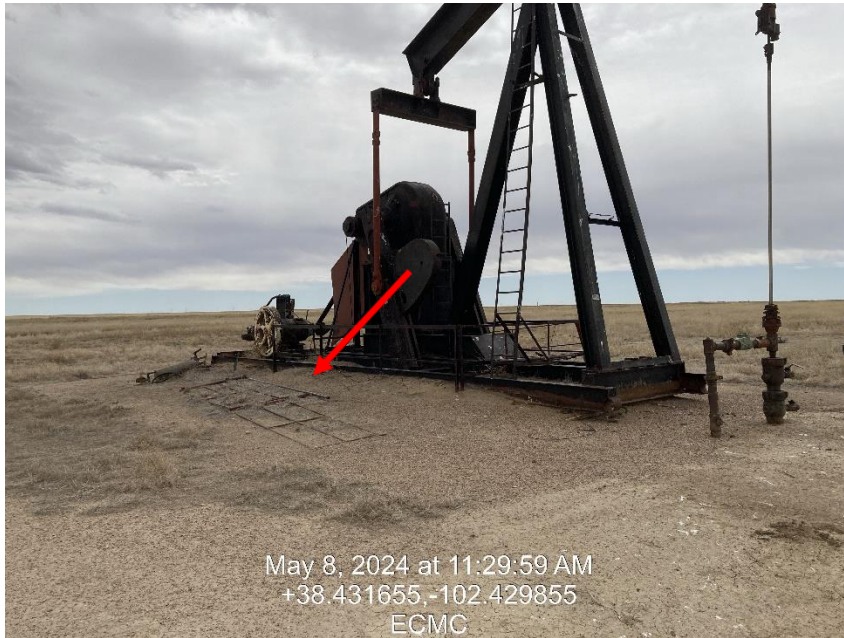
Photo 3 – Unused equipment

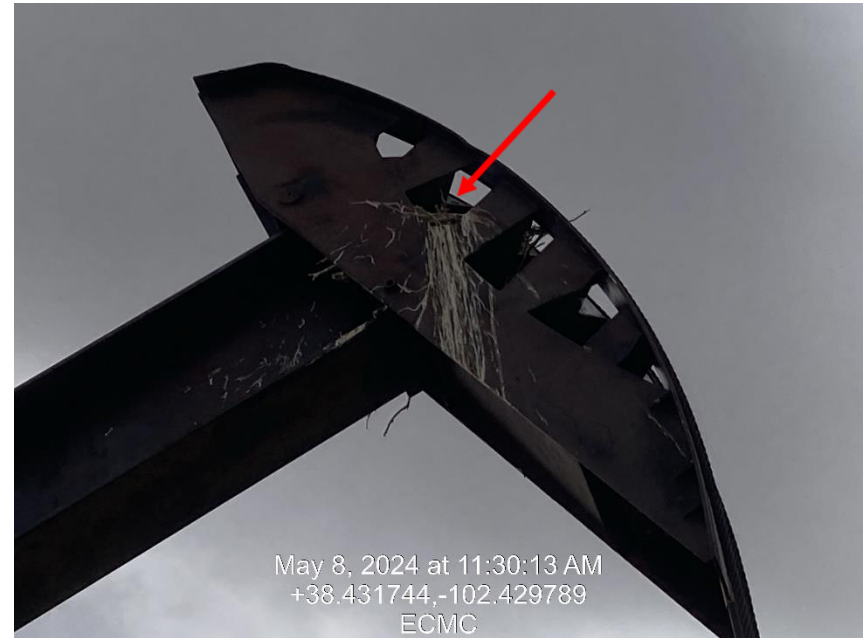
Photo 4 – Crow/Bird nest

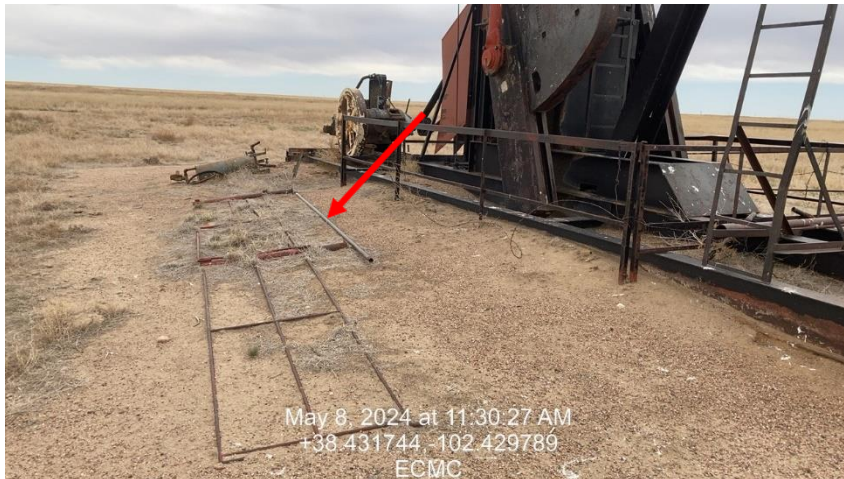
Photo 5 – Unused equipment

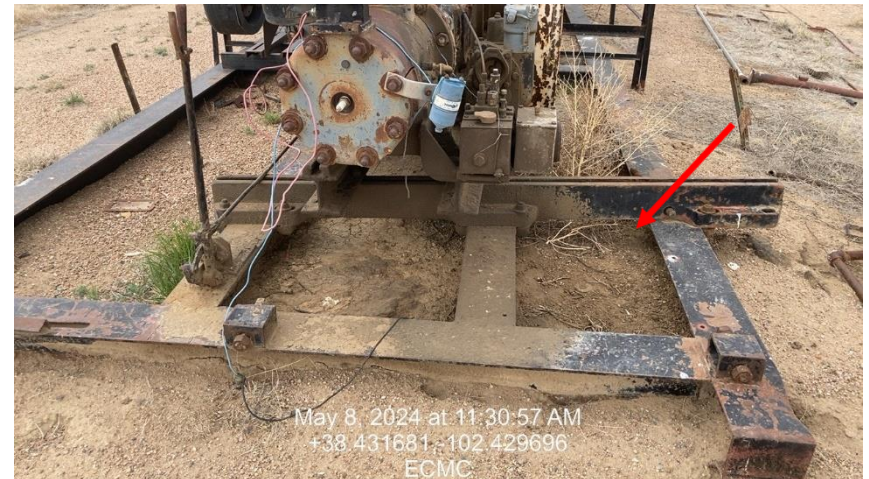
Photo 6 – Stained soils

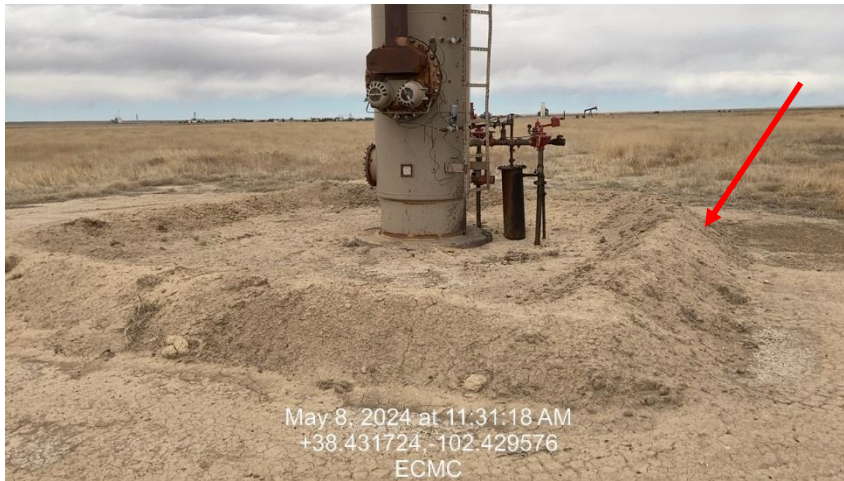
Photo 7 – Heater Treater new dirt berm.
