Inspection Photos
 Location: Wear 3
 Facility ID: 324847

Surface Location		Well Classification: OW	Status: PR - 9/1/2023
Well Name/No:	WEAR #3	Click Here for Transporter Gatherer Info	
<small>(Click Well Name for Production Data)</small>			
Operator:	CHEMCO INC - 16520	Federal Or State Lease #:	
<small>(Click Operator Name for Company Detail Report)</small>			
Facility Status:	PR	Status Date	9/1/2023
FacilityID:	213124	LocationID:	324847
County:	KIOWA #061	Location:	SESE 3 19S45W 6
Field:	BRANDON - #7500	Elevation:	3918 ft.
Planned Location:	660FSL 660 FEL	Lat/Long:	38.427872 / -102.438824
As Drilled Location:	Footages Not Available	Lat/Long:	38.427852 / -102.438838
		Source:	Field Measured
Sample Site Data

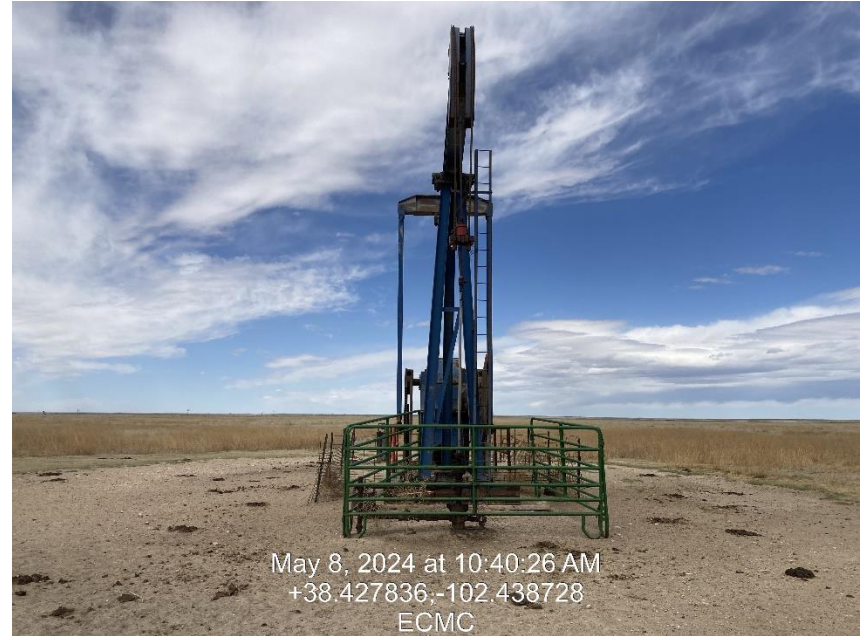
Photo 2 – Pump Jack

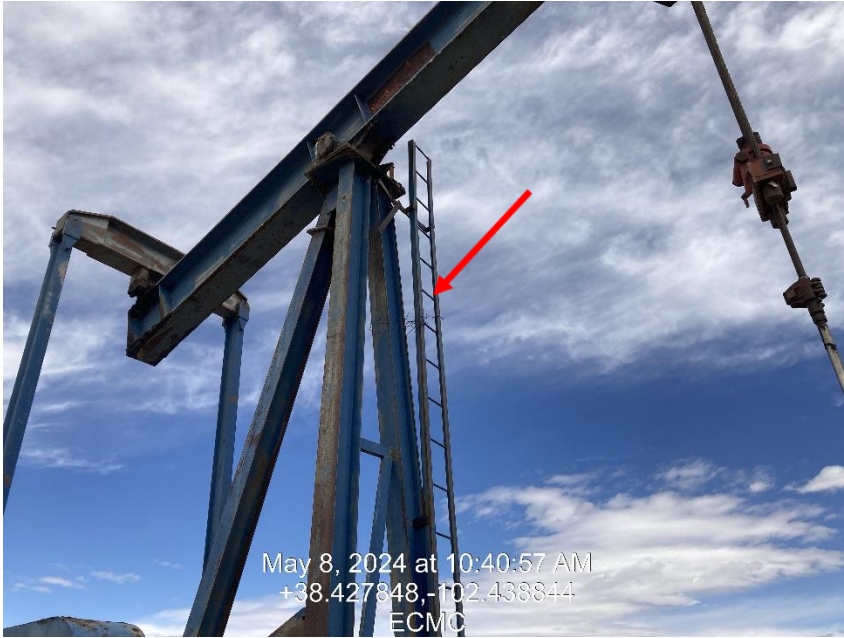
Photo 3 – Ladder with mechanic wire

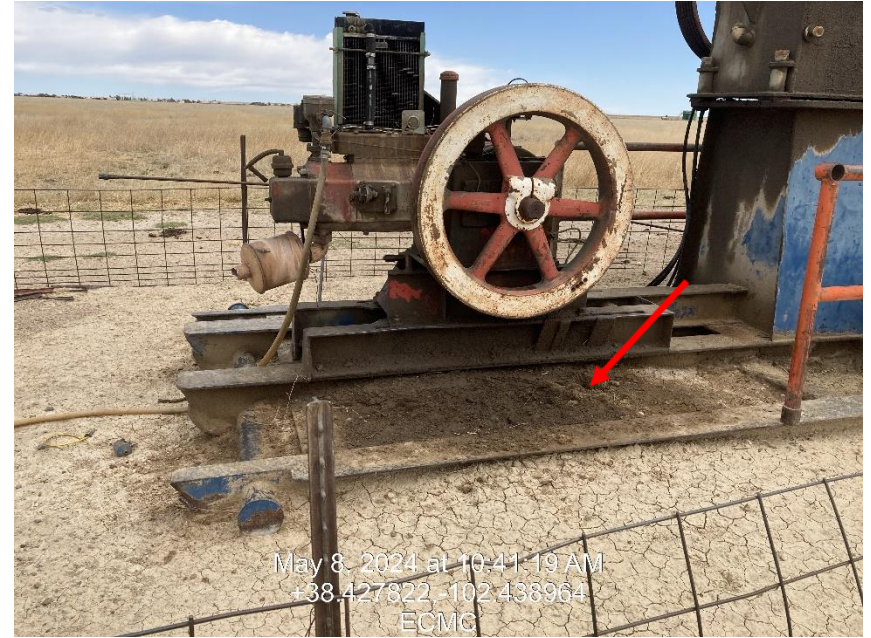
Photo 4 – Oil stained soils

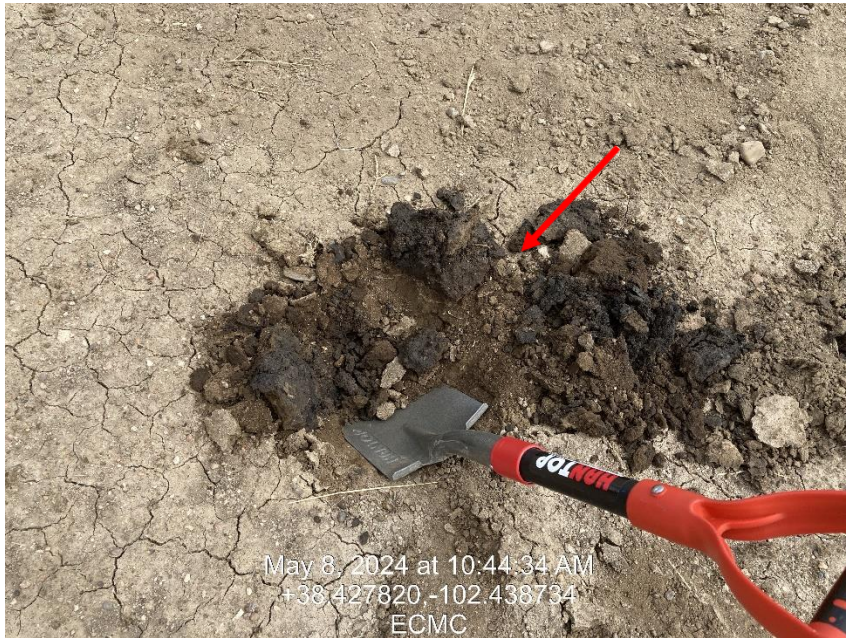
Photo 5 – Impacted soils adjacent to wellhead

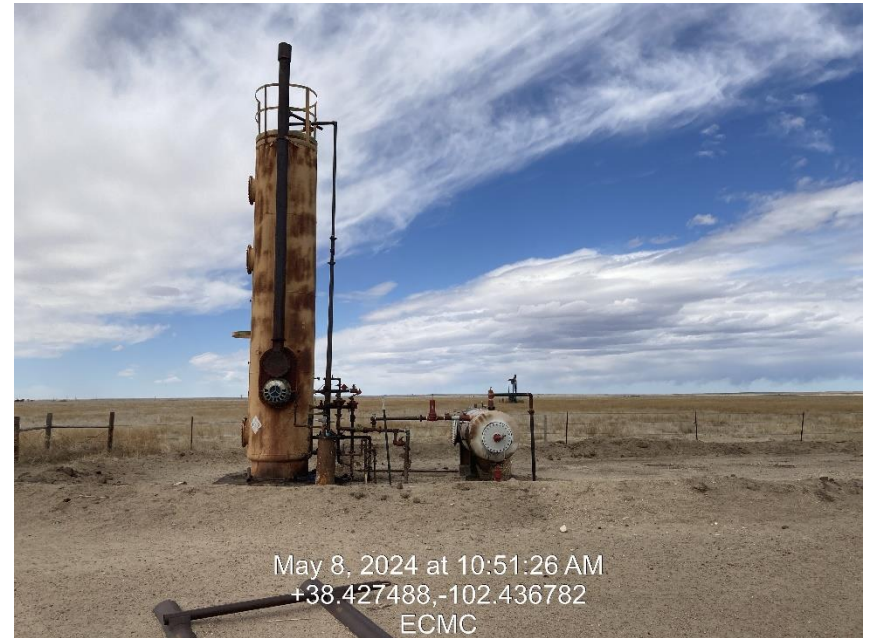
Photo 6 – Tank Battery / Treater

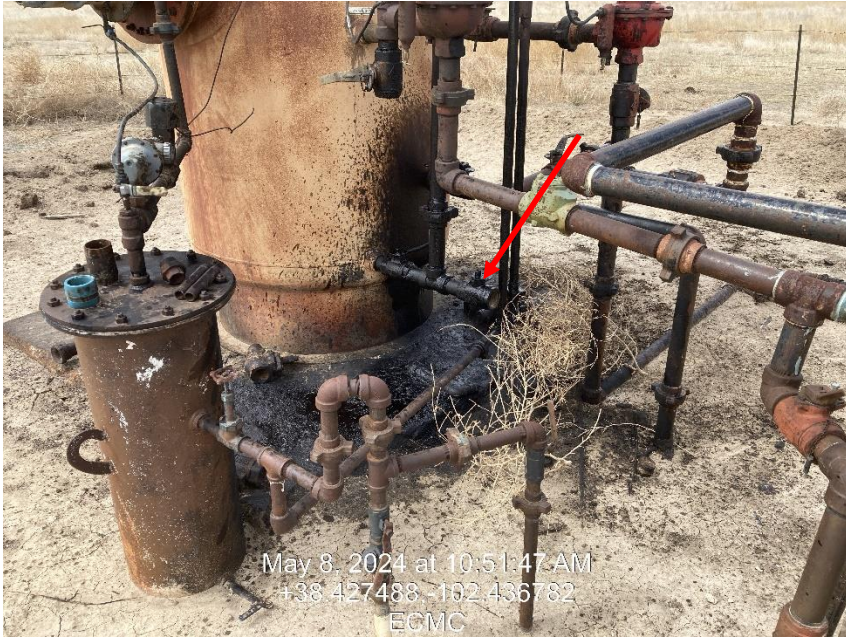
Photo 7 – Leaking piping at Treater.

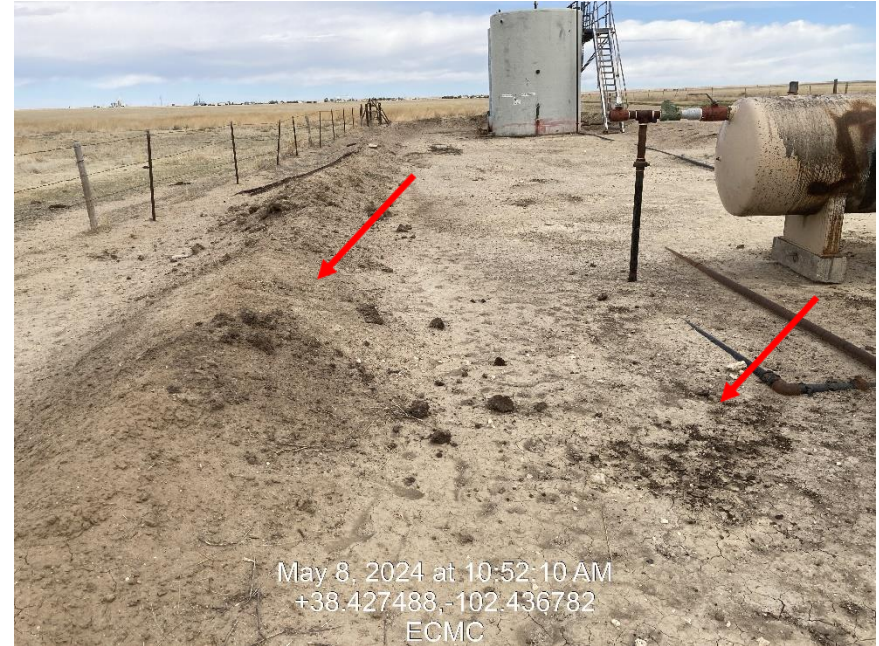
Photo 8 – Impacted soils in Secondary Containment

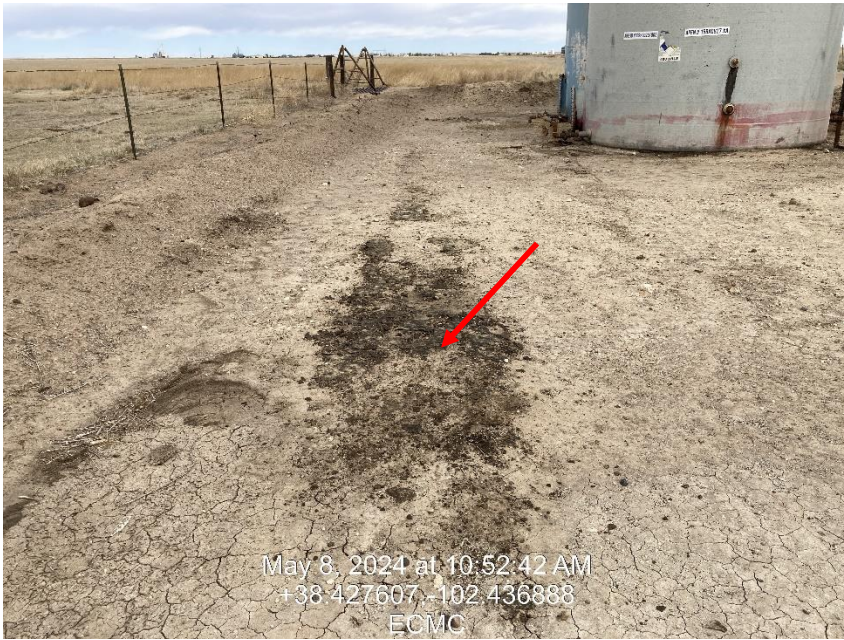
Photo 9 – Impacted soils in Secondary Containment

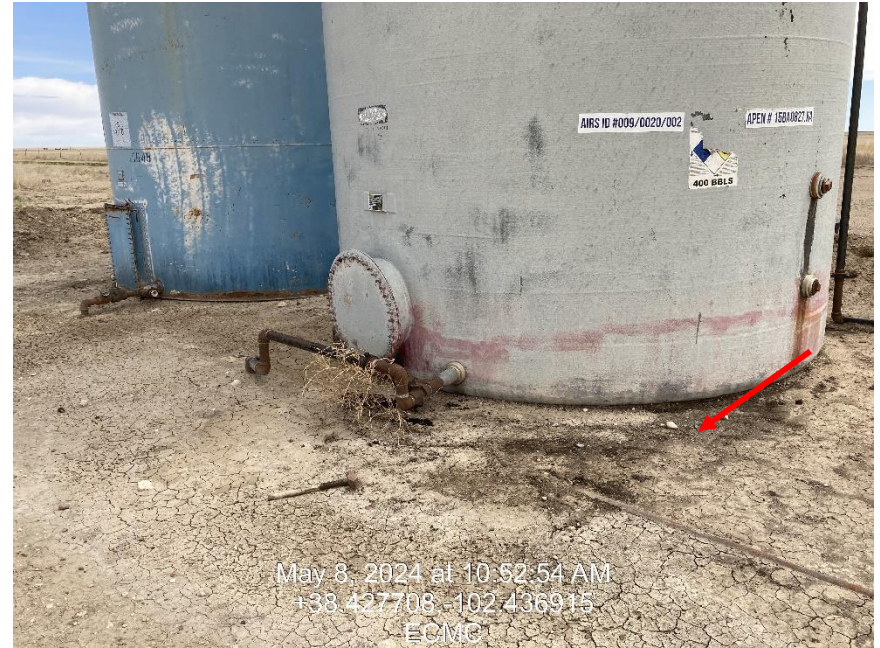
Photo 10 – Impacted soils in Secondary Containment
