Inspection Photos  
Location: Donohoe 4A-2  
Facility ID: 384662

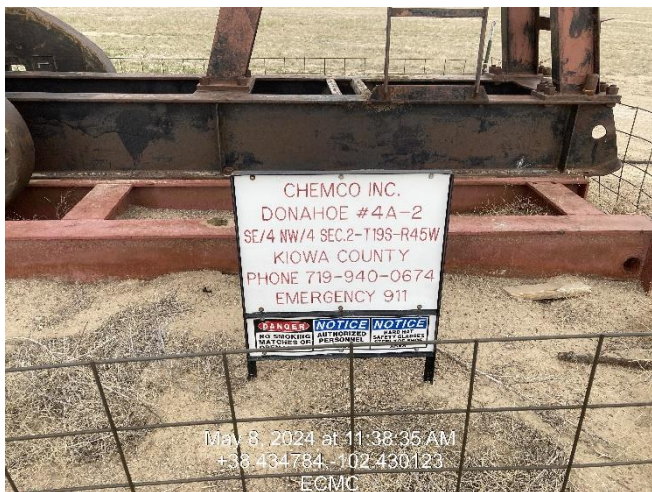
Photo 1 –Well Placard

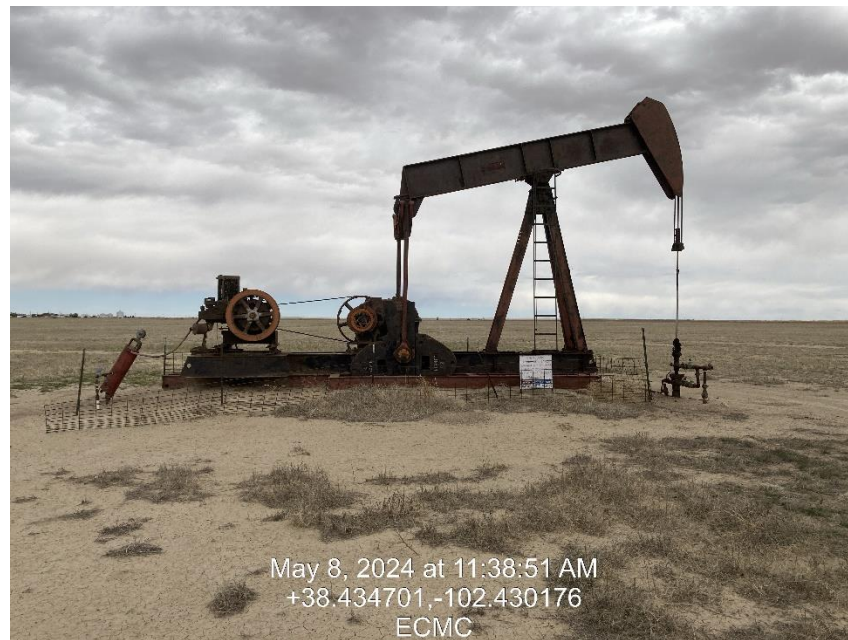
Photo 2 – Pump Jack

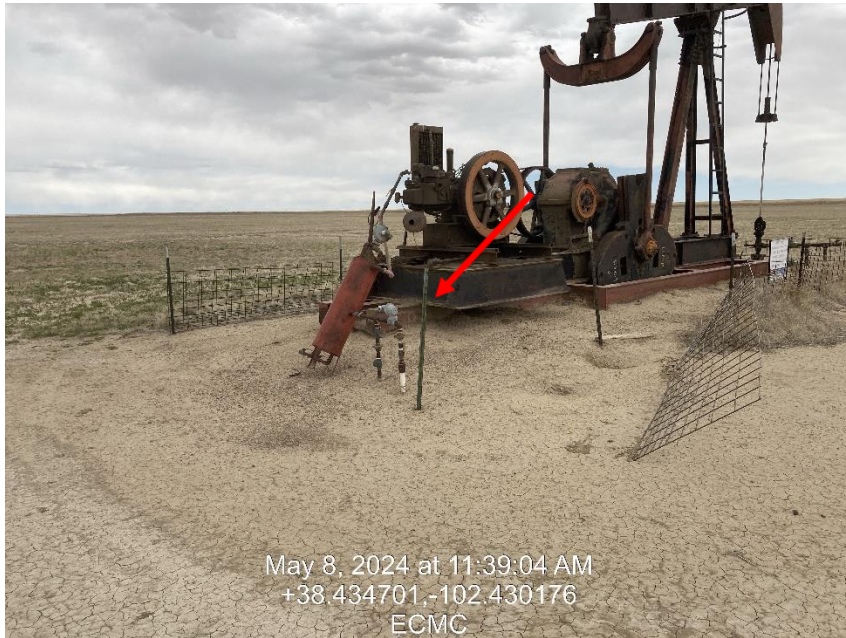
**Photo 3 – Machine Guarding not maintained**

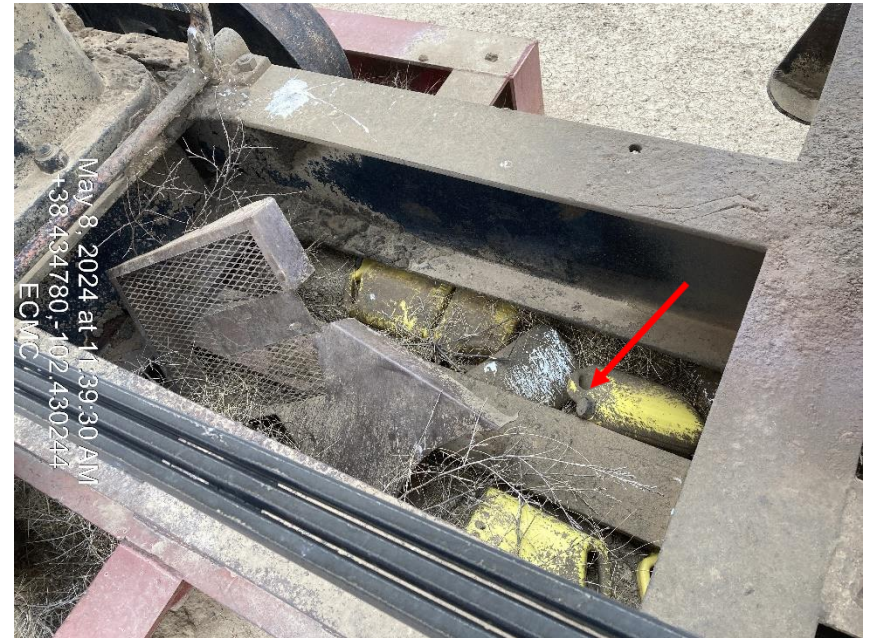
**Photo 4 – Oil and Coolant bottles stored in pump jack frame**

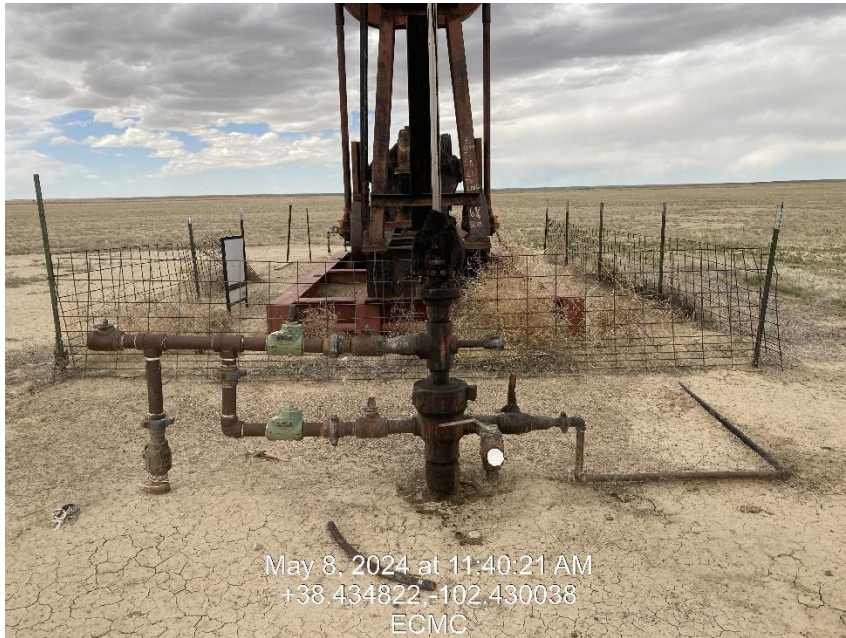
**Photo 5 – Well head with rag on stuffing box**

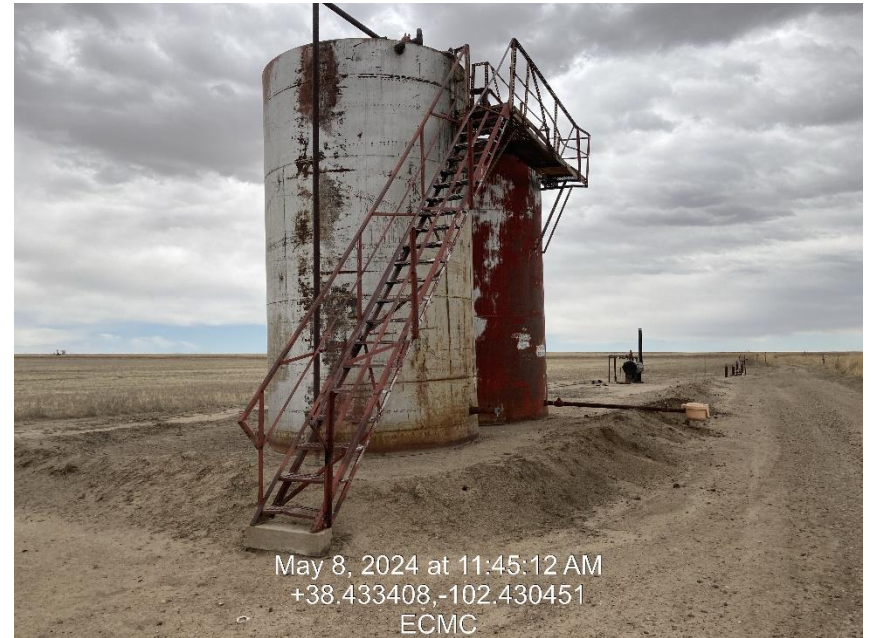
**Photo 6 – Tank Battery, Secondary containment not adequate**

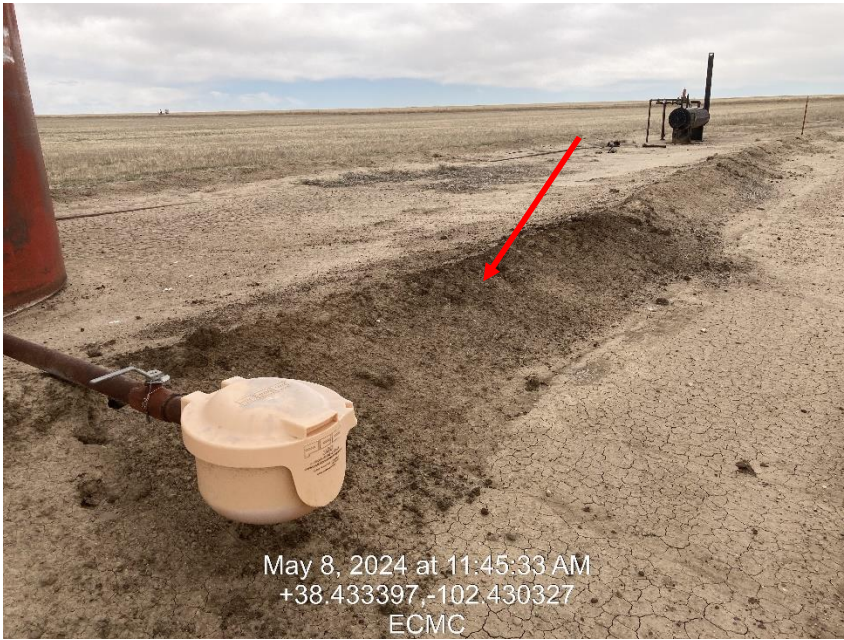
**Photo 7 – Impacted soils along berm**

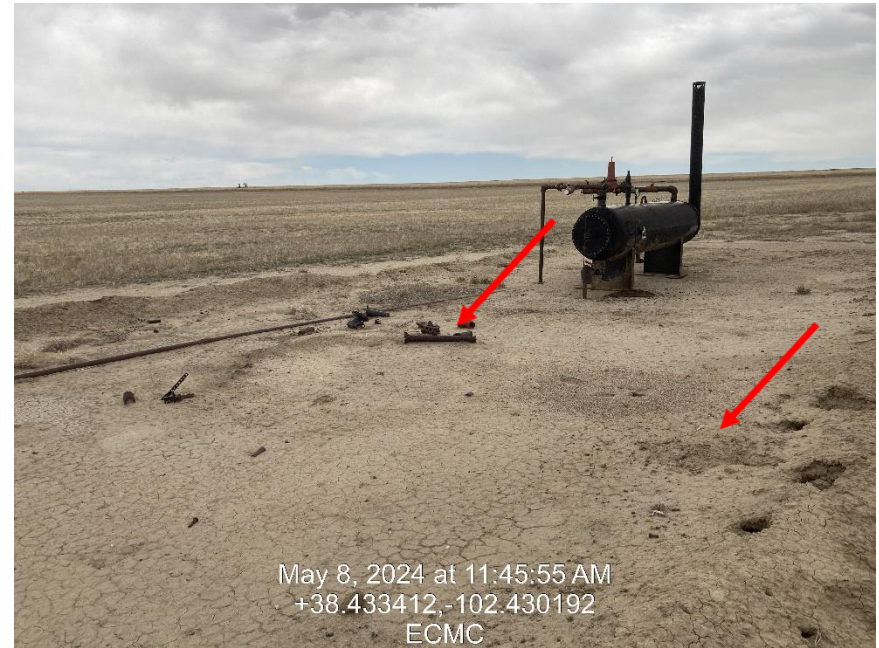
**Photo 8 – Unused equipment and stained soils**

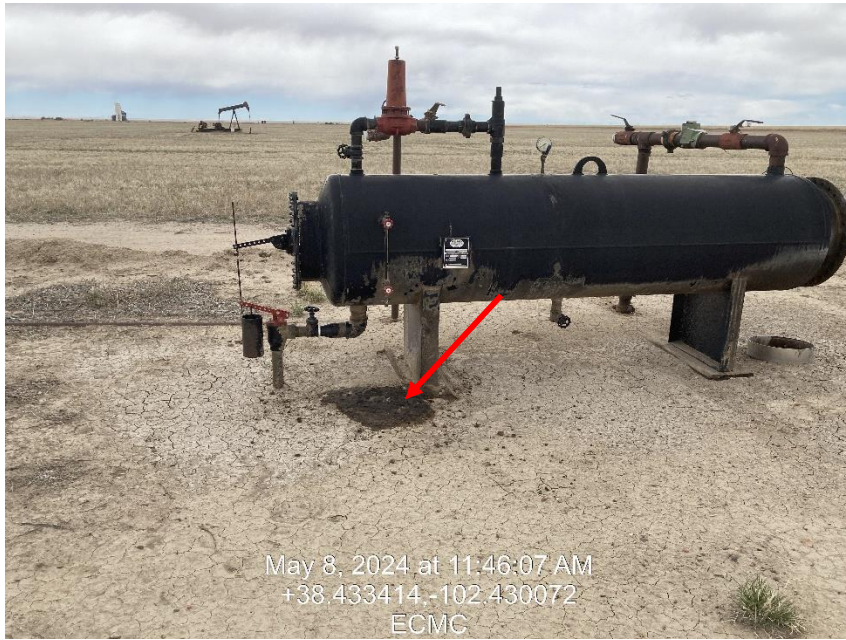
**Photo 9 – Impacted soils at Heater Treater**

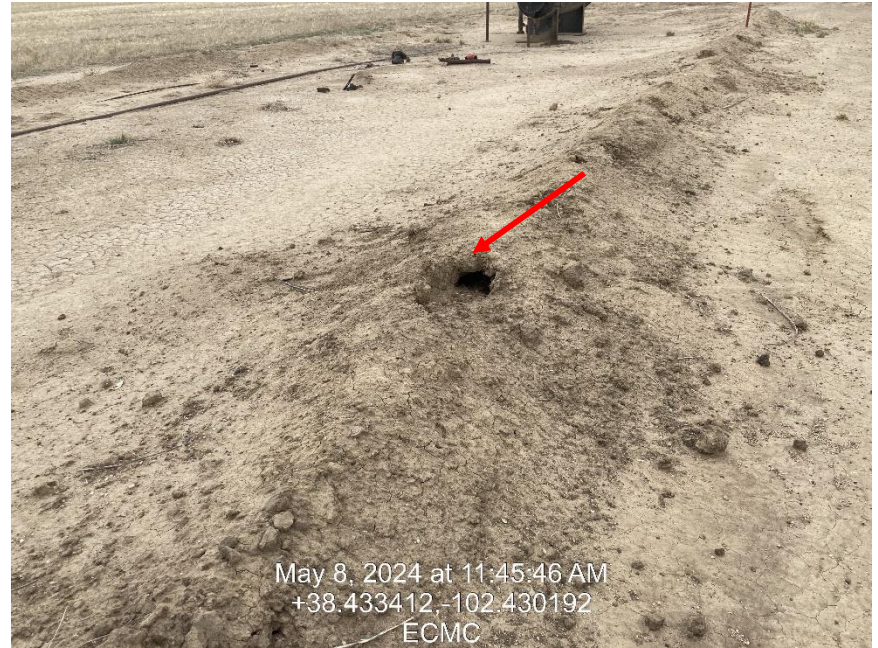
**Photo 10 – Hole in berm**
