Storm Water Management and Erosion control

Location Name: TEP ROCKY MOUNTAIN LLC BATTLEMENT MESA PARTNERS GV 82-5 Pad

Location ID: 334825

COLORADO
Energy & Carbon Management
Commission
Department of Natural Resources

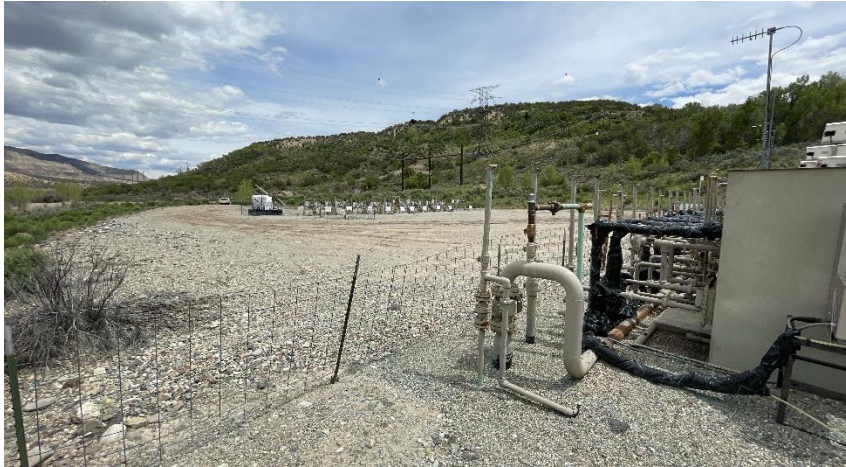
North West corner of location.

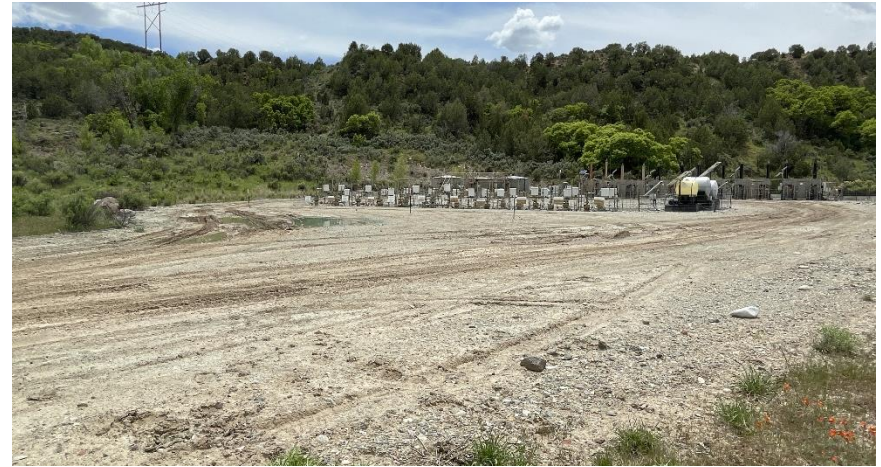
North East corner of location.

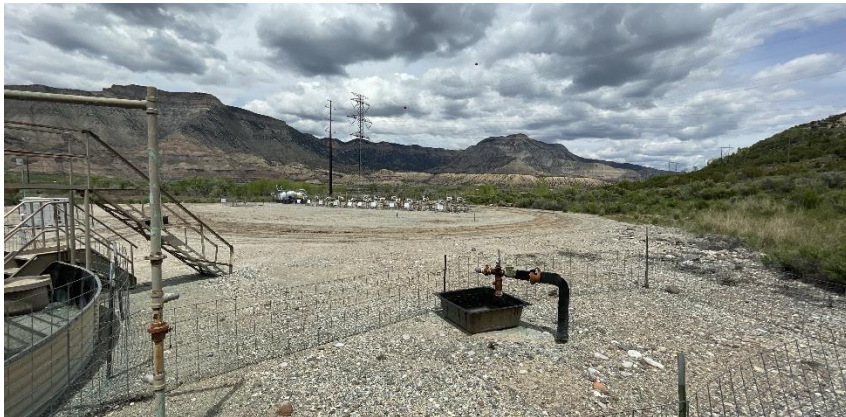
South West corner of location.

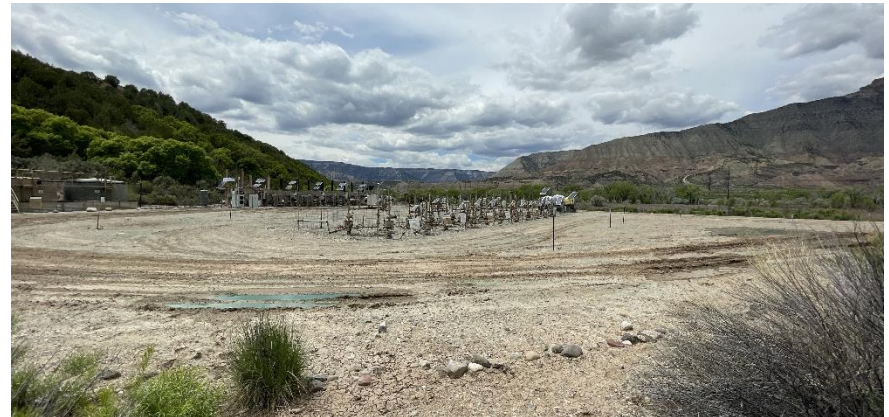
South East corner of location.

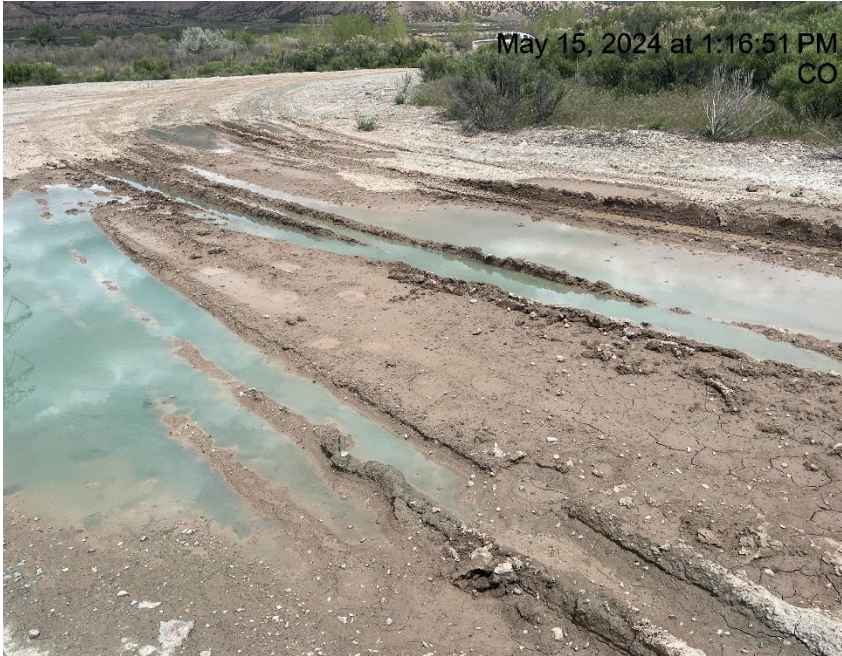
Photo # 7073 Location surface lacks stabilization/compaction with insufficient vehicle tracking BMPs in place to minimize transportation of sediment

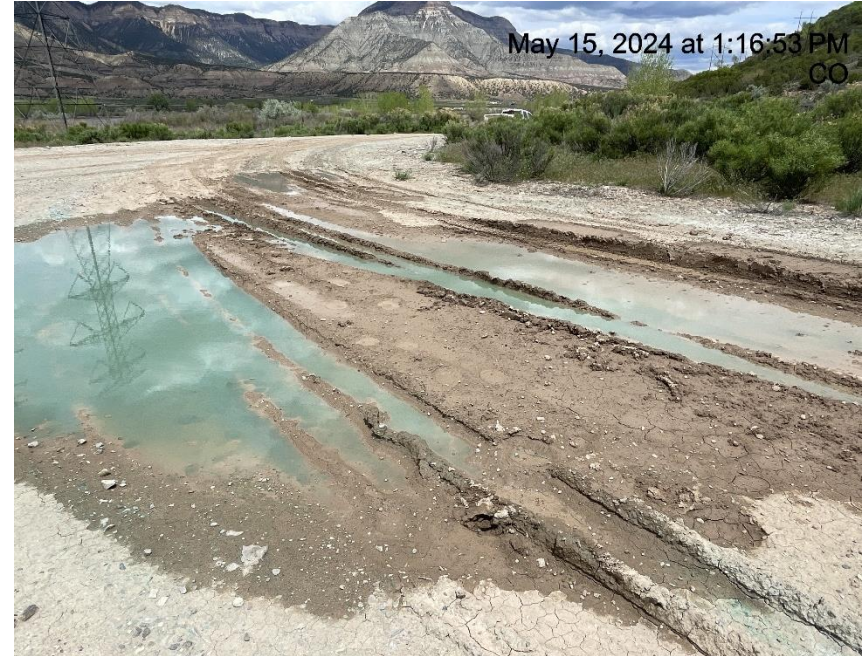
Photo # 7074 Location surface lacks stabilization/compaction with insufficient vehicle tracking BMPs in place to minimize transportation of sediment

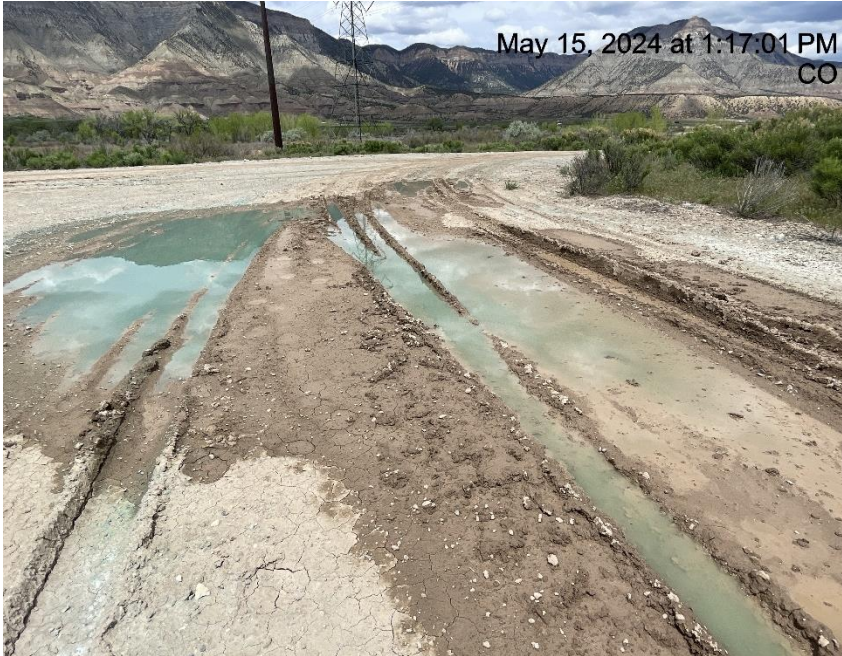
Photo # 7075 Location surface lacks stabilization/compaction with insufficient vehicle tracking BMPs in place to minimize transportation of sediment

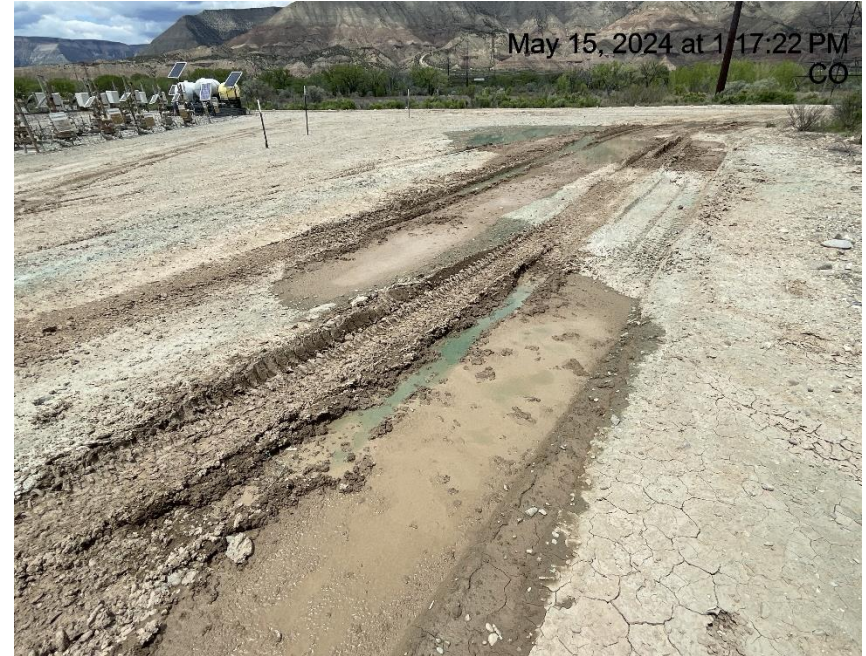
Photo # 7076 Lack of stabilization/compaction/insufficient BMP's

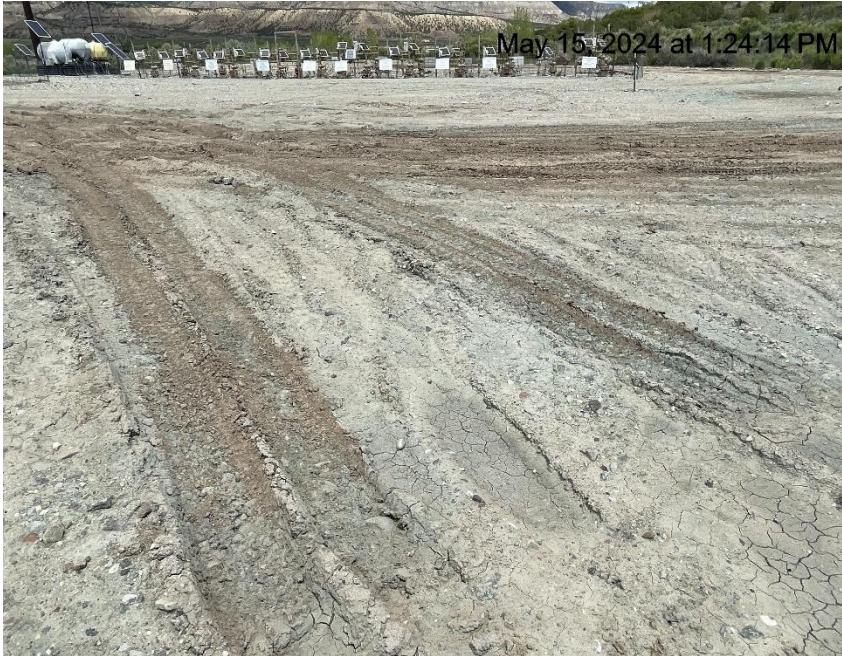
Photo # 7077 Lack of stabilization/compaction/insufficient BMP's

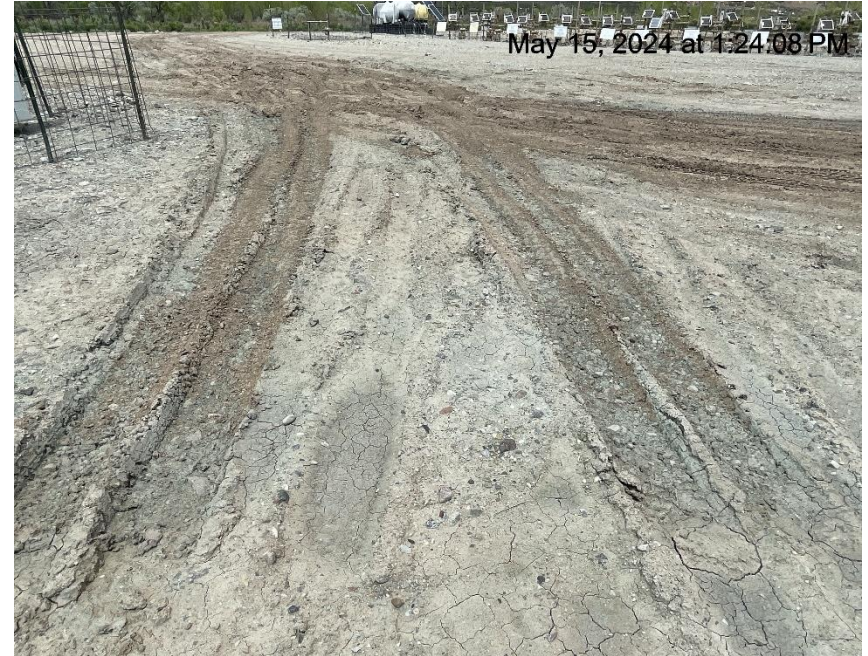
Photo # 7078 Lack of stabilization/compaction/insufficient BMP's

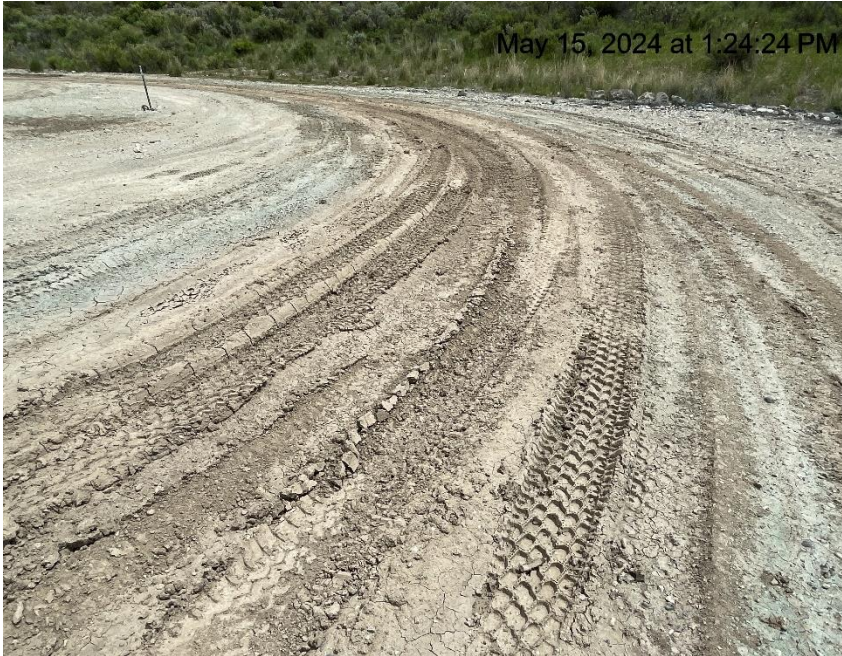
Photo # 7079 Lack of stabilization/compaction/insufficient BMP's

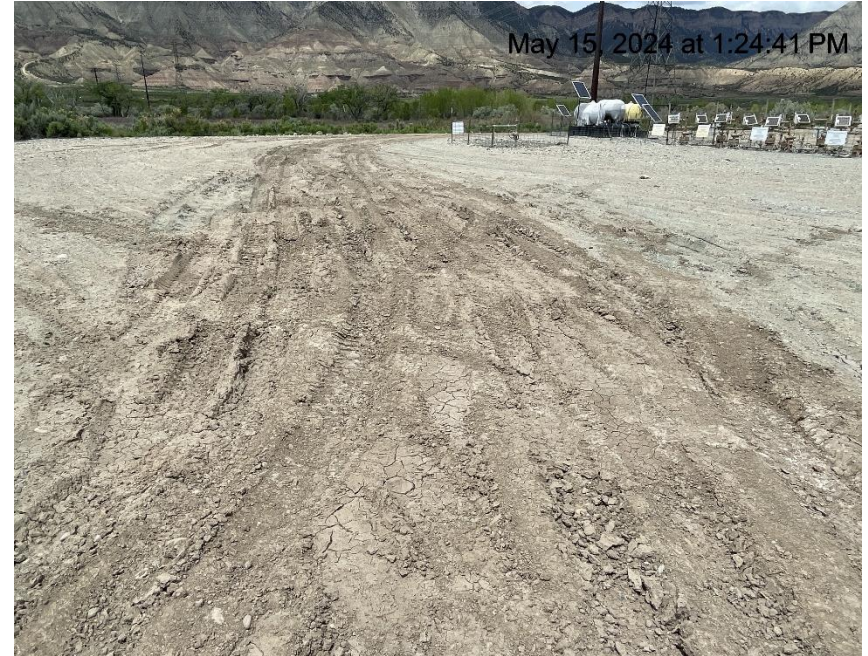
Photo # 7080 Lack of stabilization/compaction/insufficient BMP's

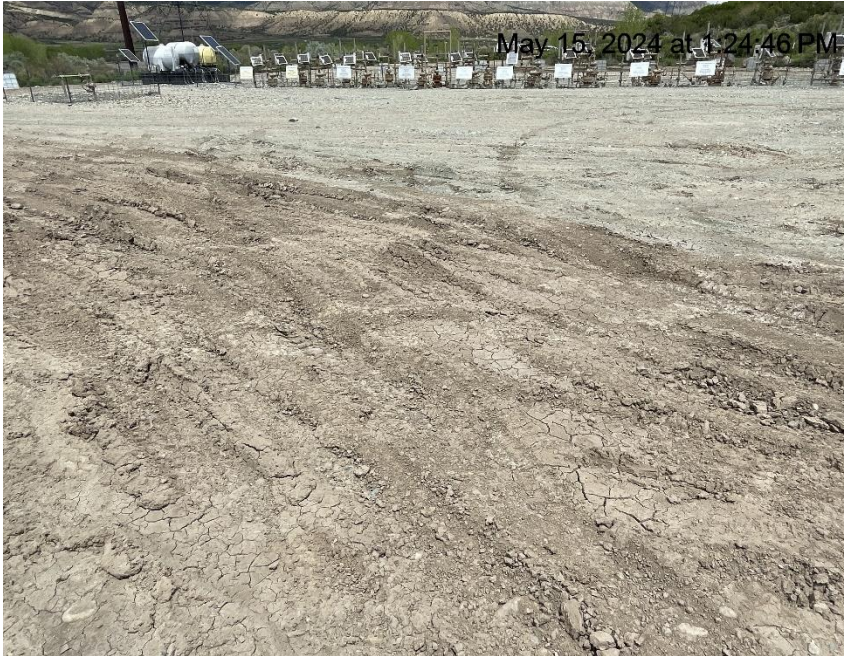
Photo # 7081 Lack of stabilization/compaction/insufficient BMP's

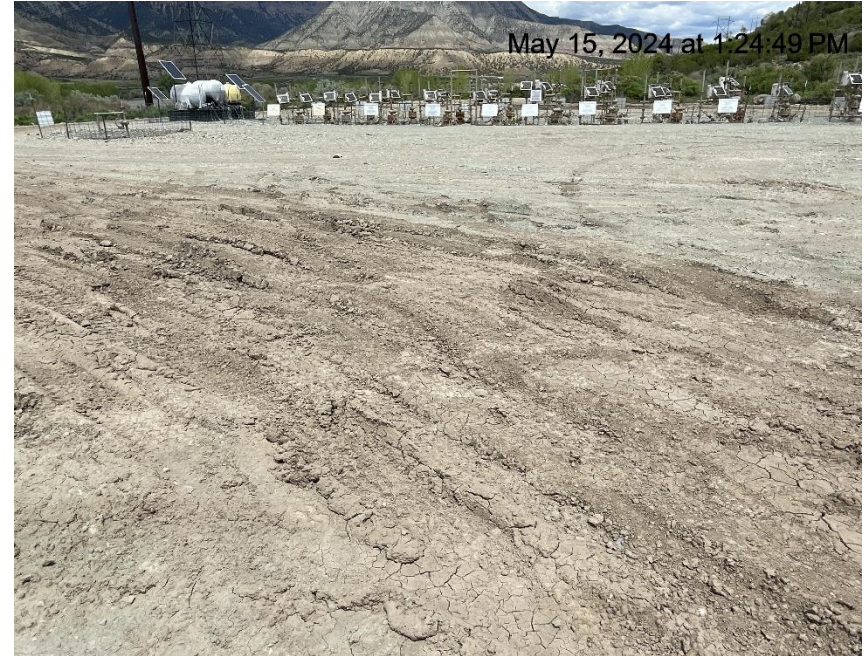
Photo # 7082 Lack of stabilization/compaction/insufficient BMP's

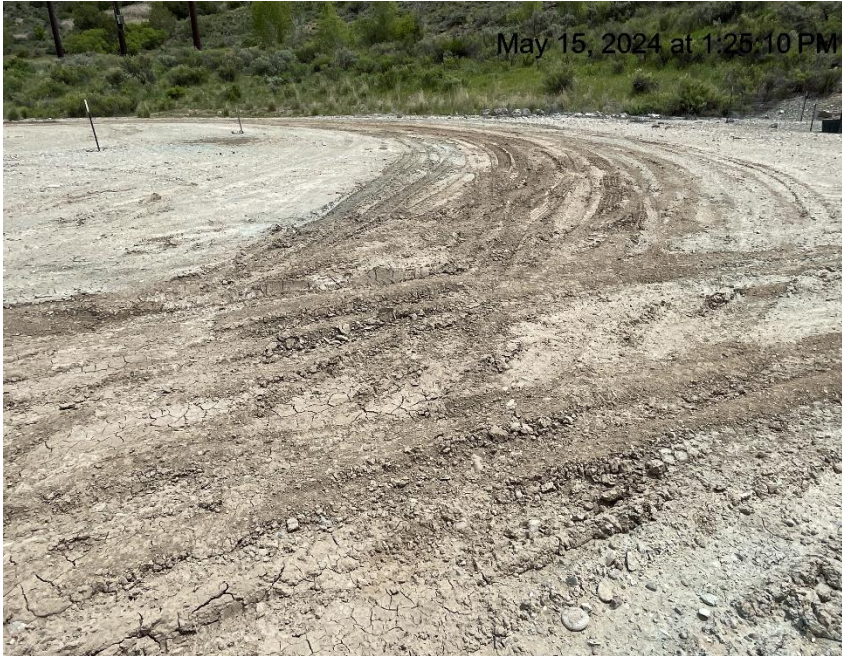
Photo # 7083 Lack of stabilization/compaction/insufficient BMP's

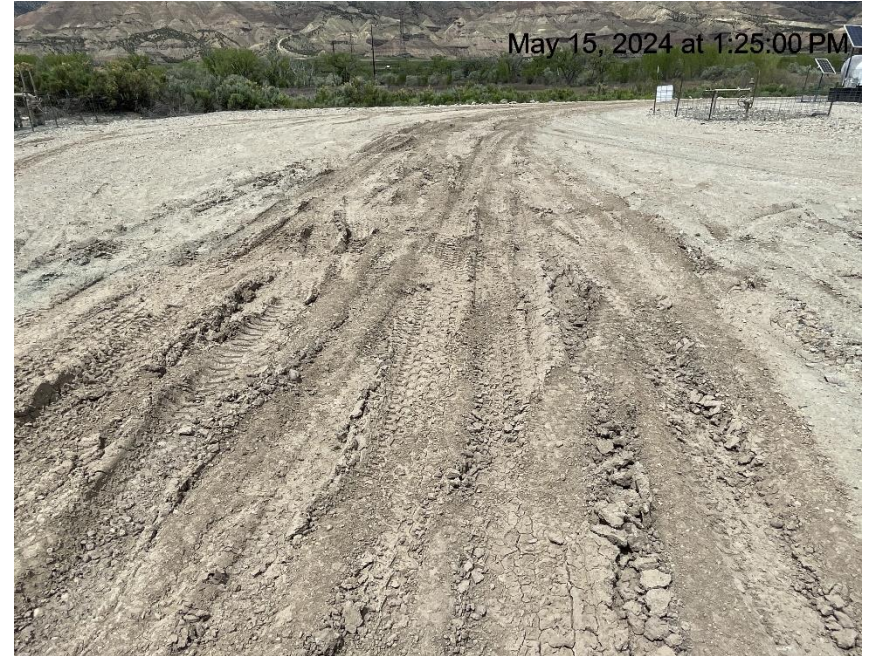
Photo # 7084 Lack of stabilization/compaction/insufficient BMP's

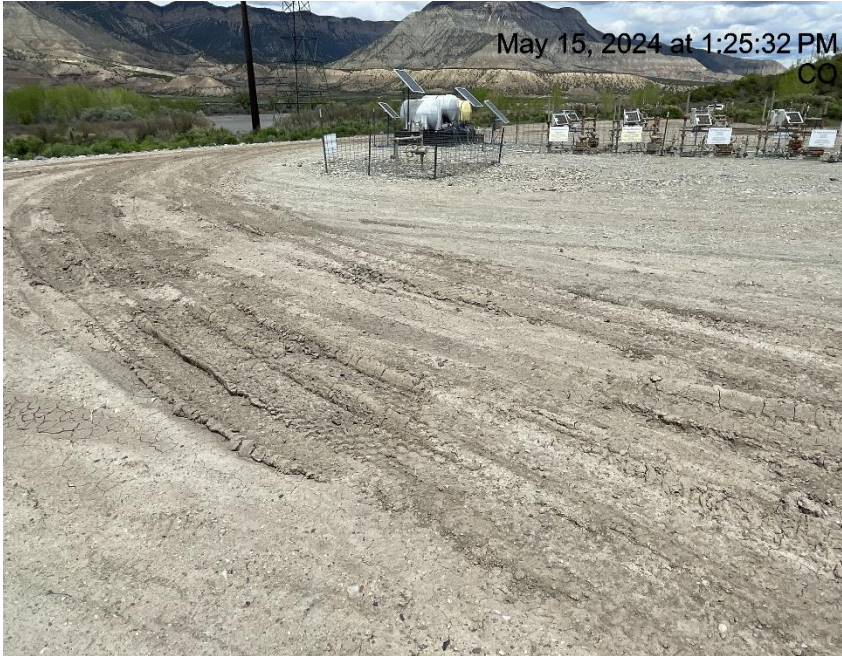
Photo # 7085 Lack of stabilization/compaction/insufficient BMP's

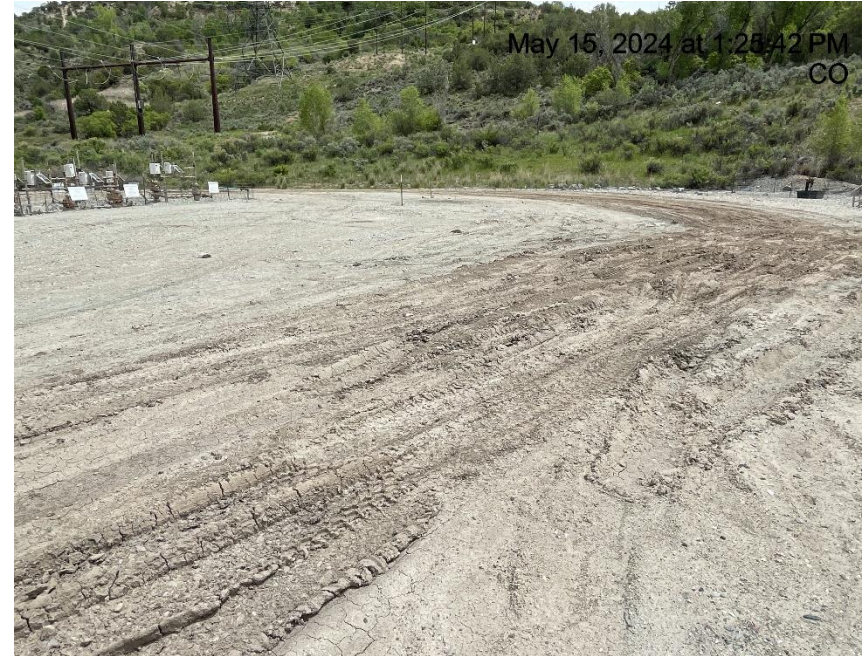
Photo # 7086 Lack of stabilization/compaction/insufficient BMP's

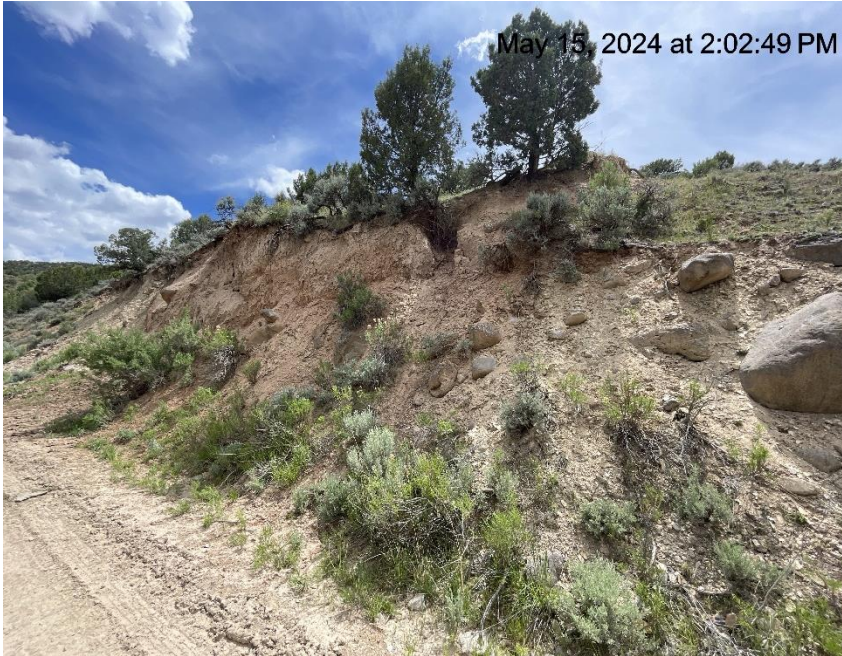
**Photo # 7087 Lack of stabilization & erosion on cut slope
/insufficient BMP's**

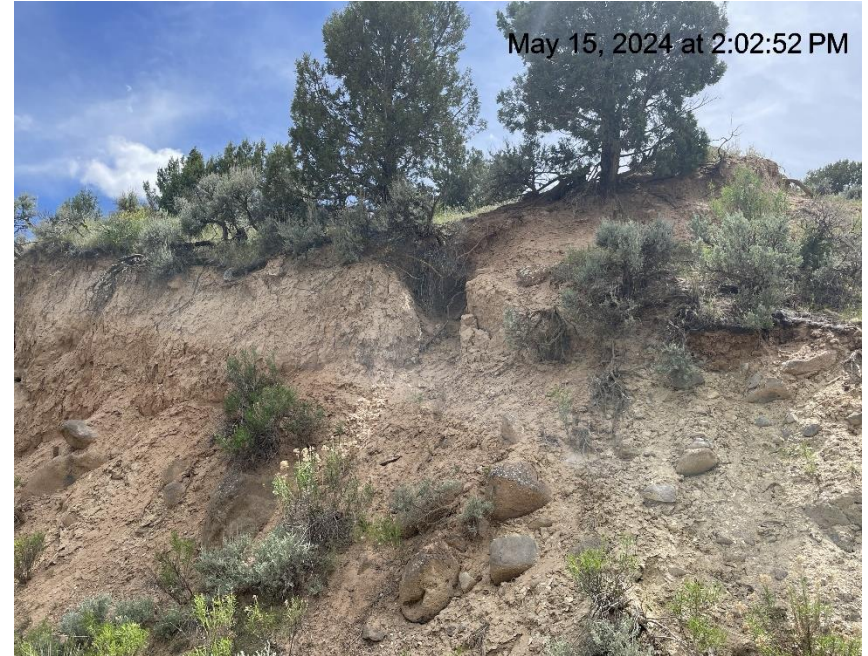
**Photo # 7088 Lack of stabilization & erosion on cut slope
/insufficient BMP's**

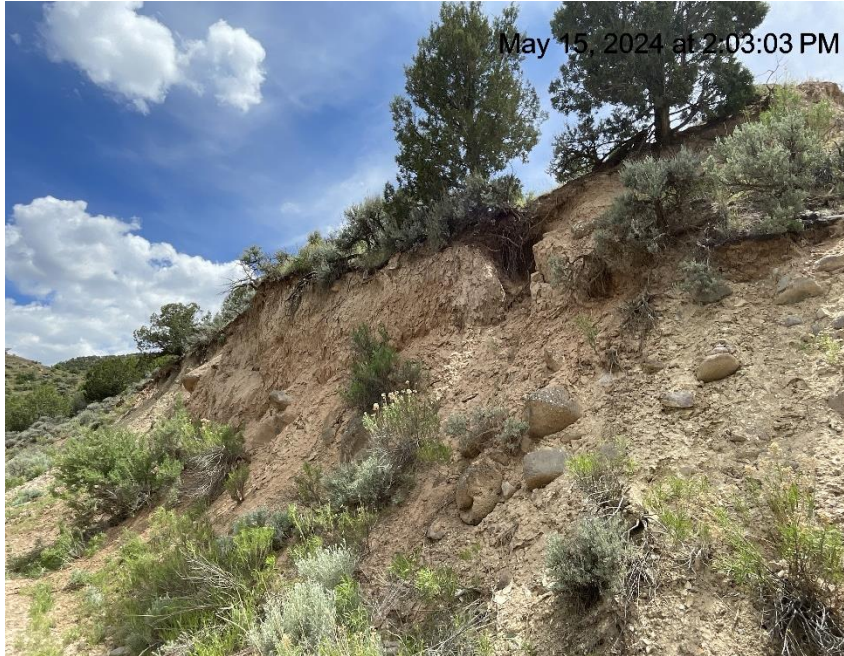
**Photo # 7089 Lack of stabilization & erosion on cut slope
/insufficient BMP's**

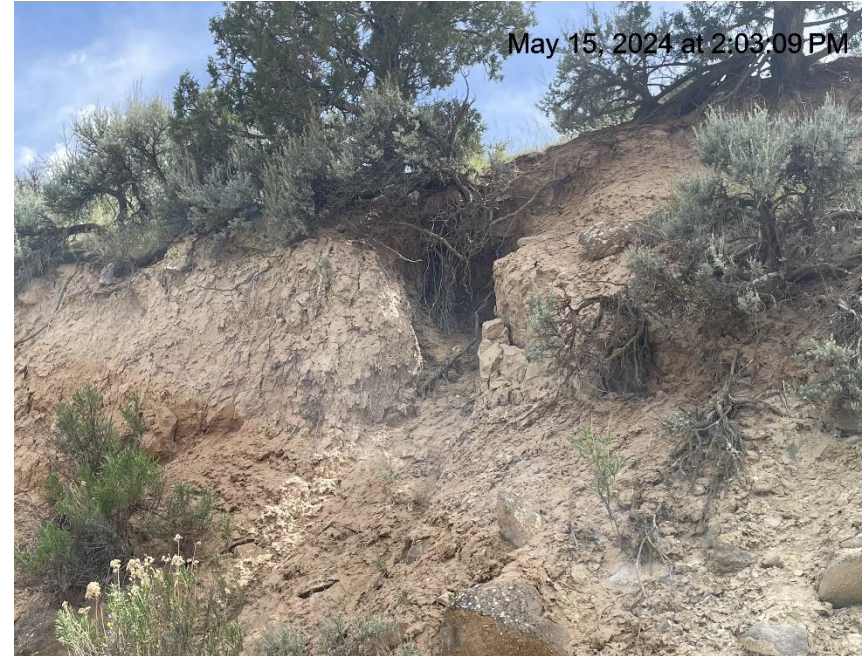
**Photo # 7090 Lack of stabilization & erosion on cut slope
/insufficient BMP's**

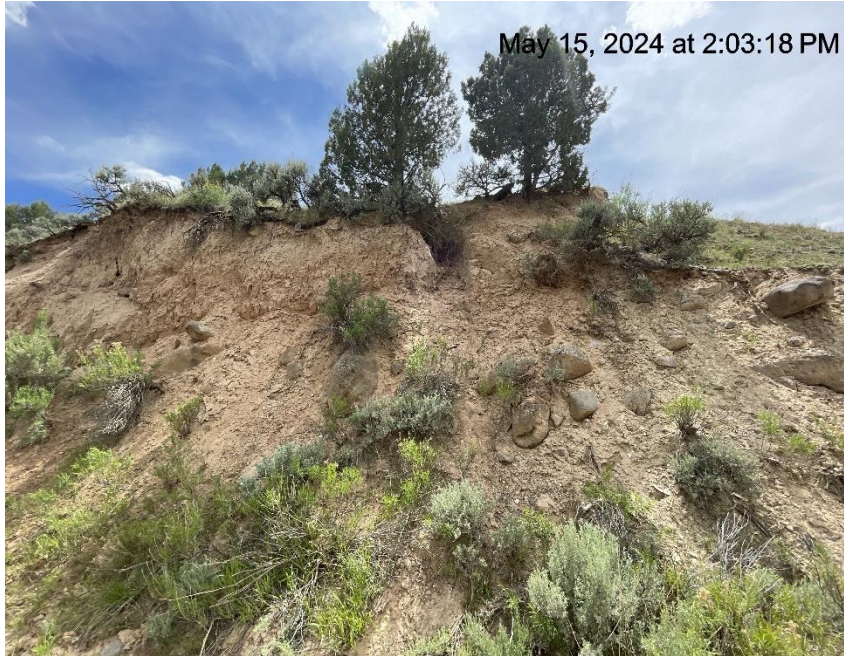
**Photo # 7091 Lack of stabilization & erosion on cut slope
/insufficient BMP's**

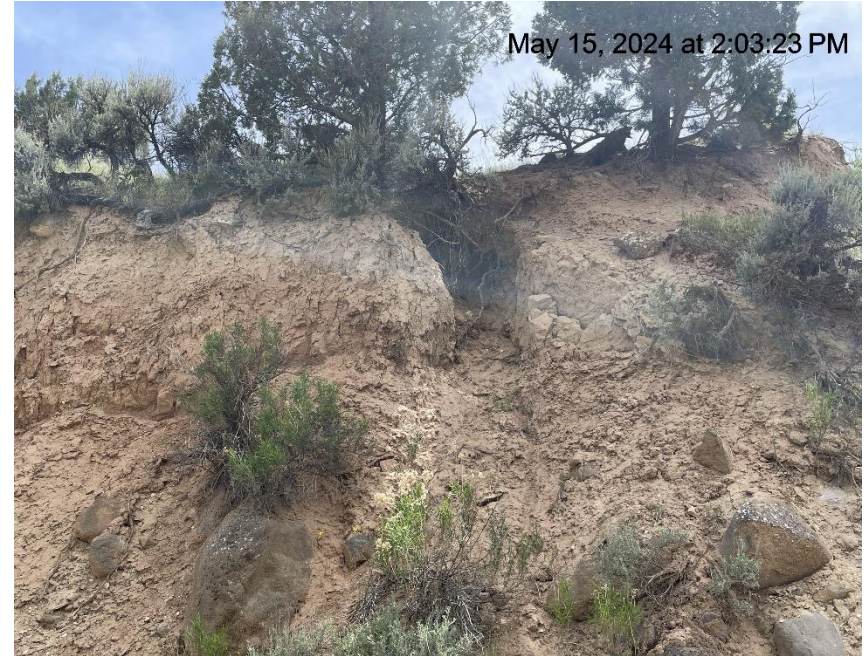
**Photo # 7092 Lack of stabilization & erosion on cut slope
/insufficient BMP's**

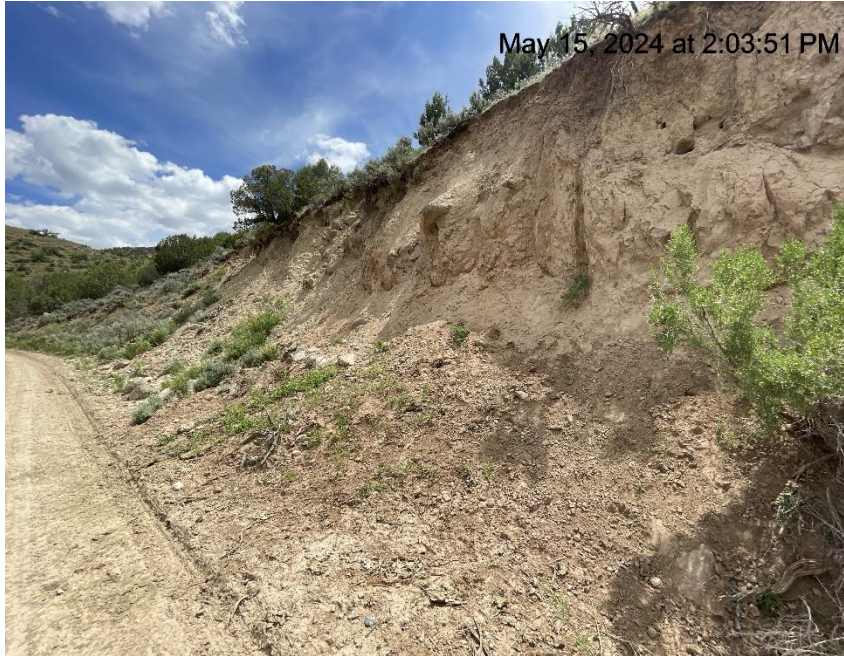
**Photo # 7093 Lack of stabilization & erosion on cut slope
/insufficient BMP's**

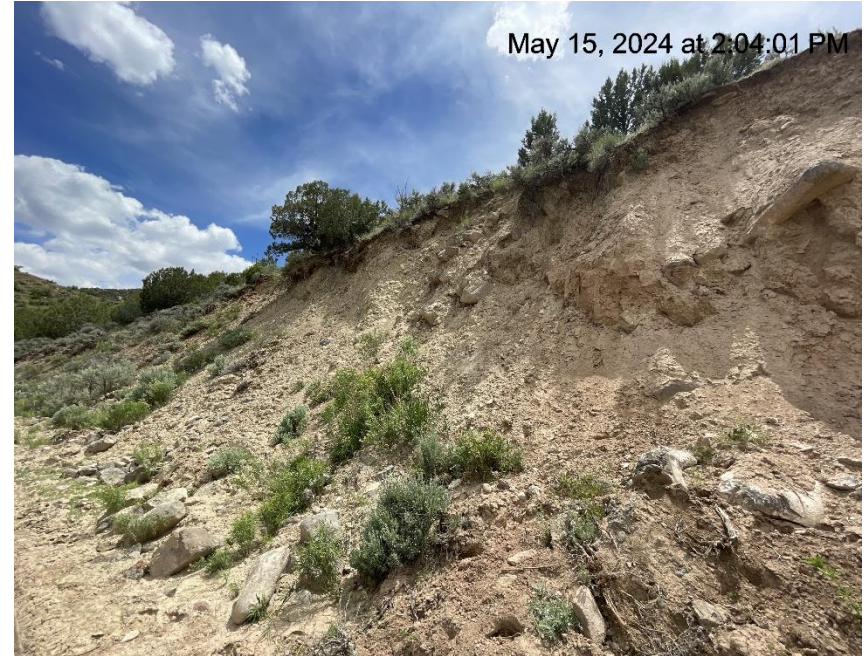
**Photo # 7094 Lack of stabilization & erosion on cut slope
/insufficient BMP's**

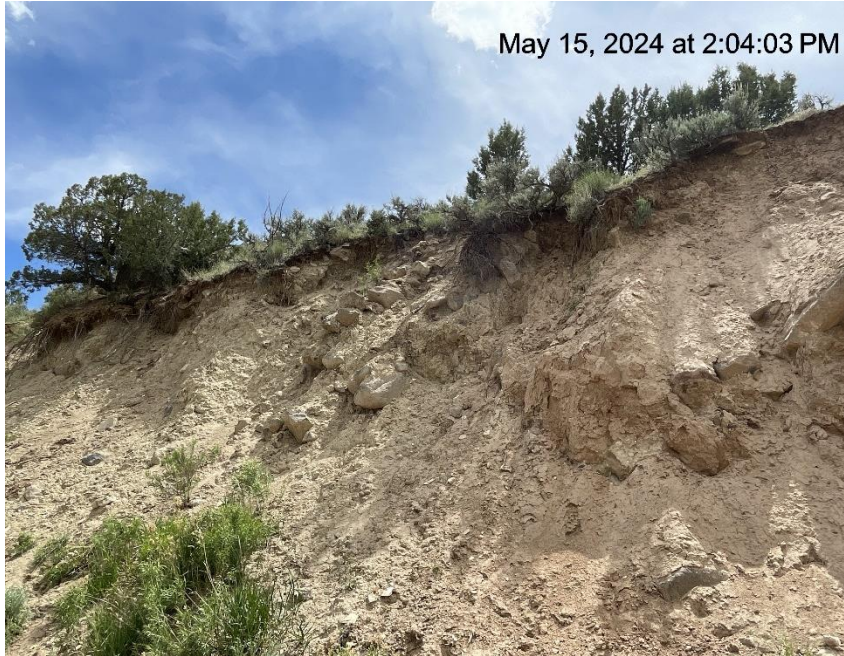
**Photo # 7095 Lack of stabilization & erosion on cut slope
/insufficient BMP's**

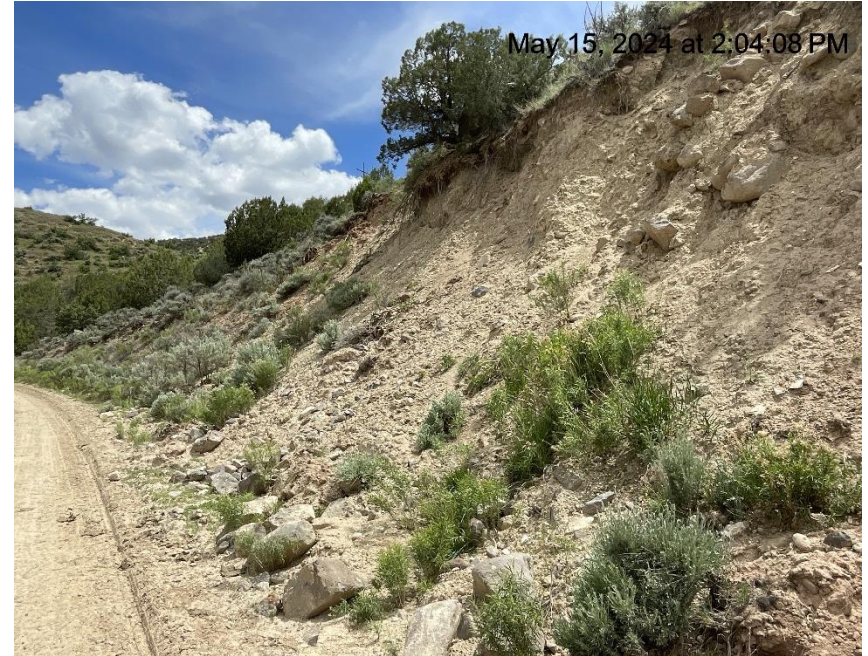
**Photo # 7096 Lack of stabilization & erosion on cut slope
/insufficient BMP's**

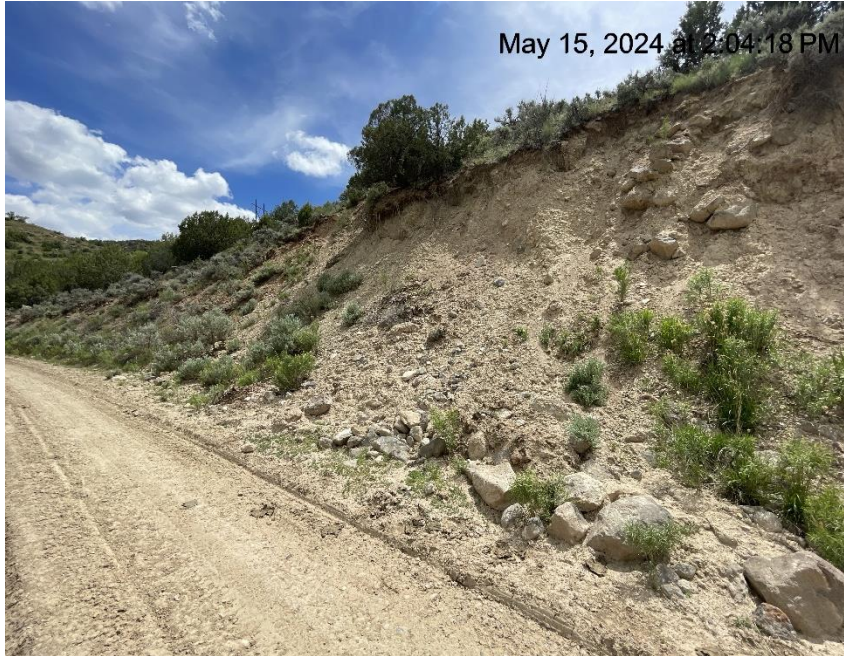
**Photo # 7097 Lack of stabilization & erosion on cut slope
/insufficient BMP's**

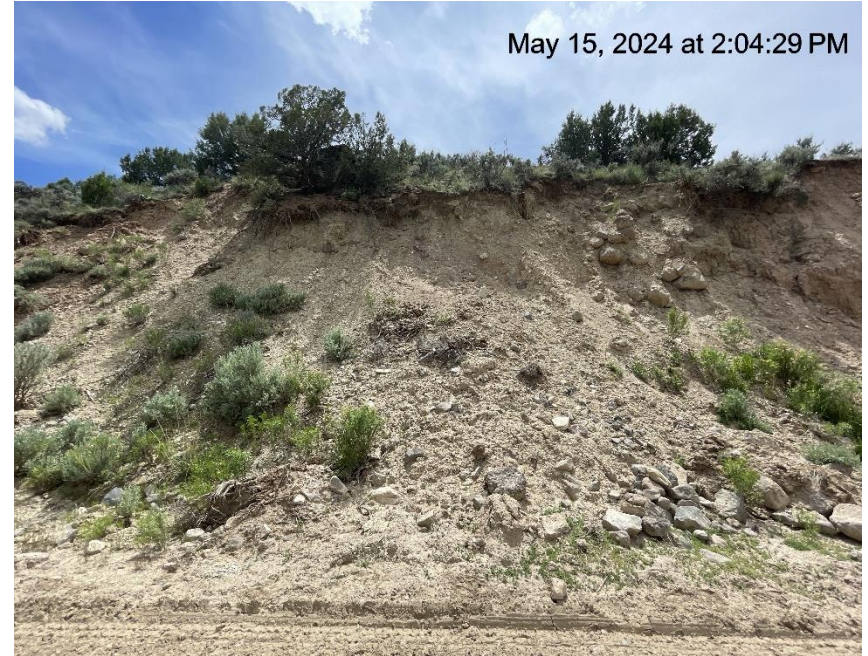
**Photo # 7098 Lack of stabilization & erosion on cut slope
/insufficient BMP's**

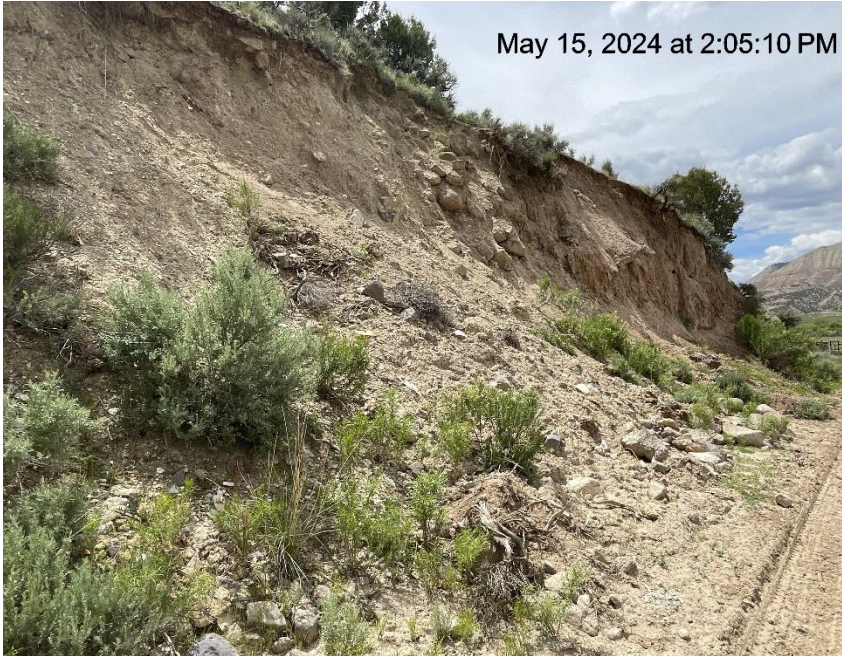
**Photo # 7099 Lack of stabilization & erosion on cut slope
/insufficient BMP's**

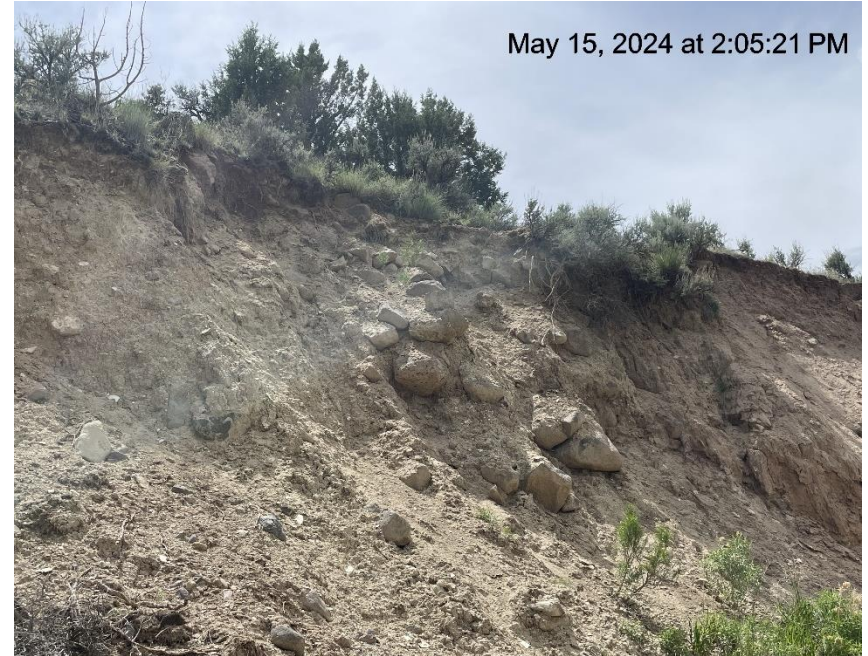
**Photo # 7100 Lack of stabilization & erosion on cut slope
/insufficient BMP's**

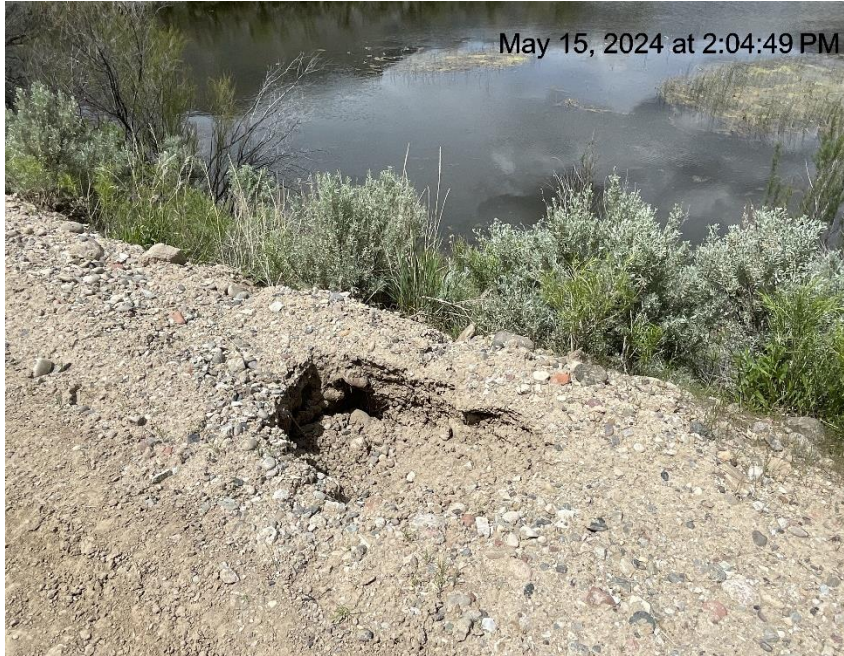
Photo # 7101 Tunnel erosion on lease road (approximately 6/10th of a mile from location)

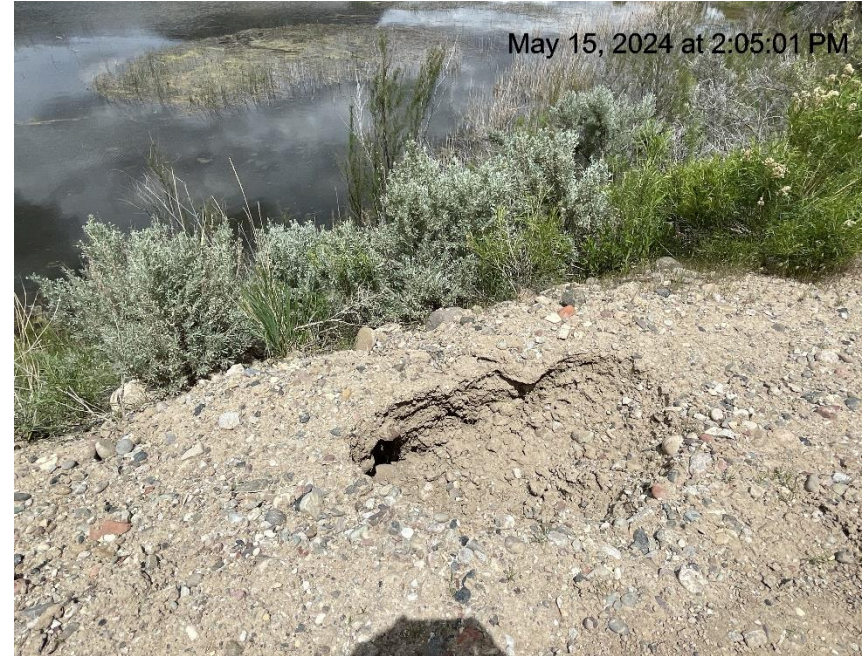
Photo # 7102 Tunnel erosion on lease road (approximately 6/10th of a mile from location)
