Inspection Photos

Location Name: TEP ROCKY MOUNTAIN LLC BATTLEMENT MESA PARTNERS GV 82-5 Pad

Location ID: 334825

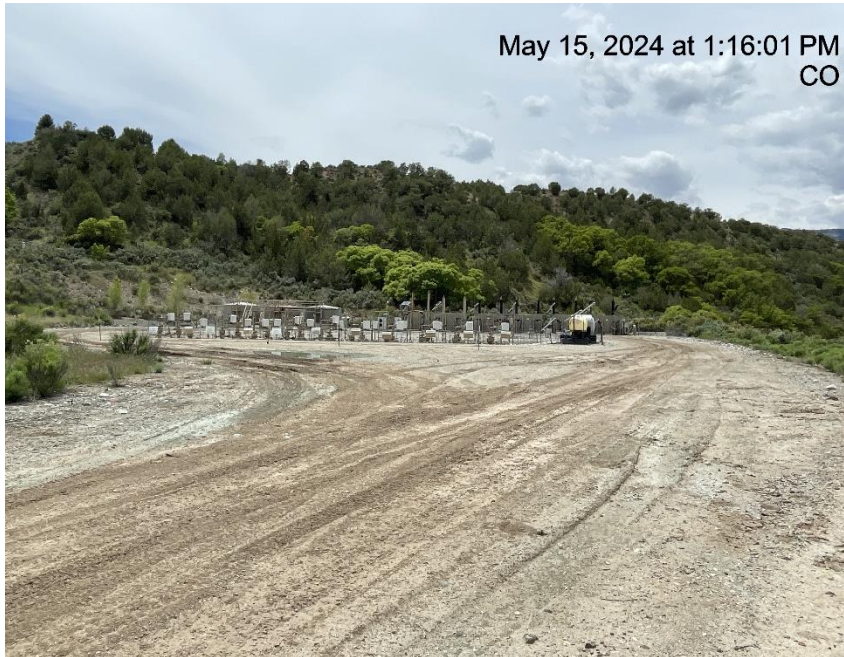
Photo # 7051 From entrance to location

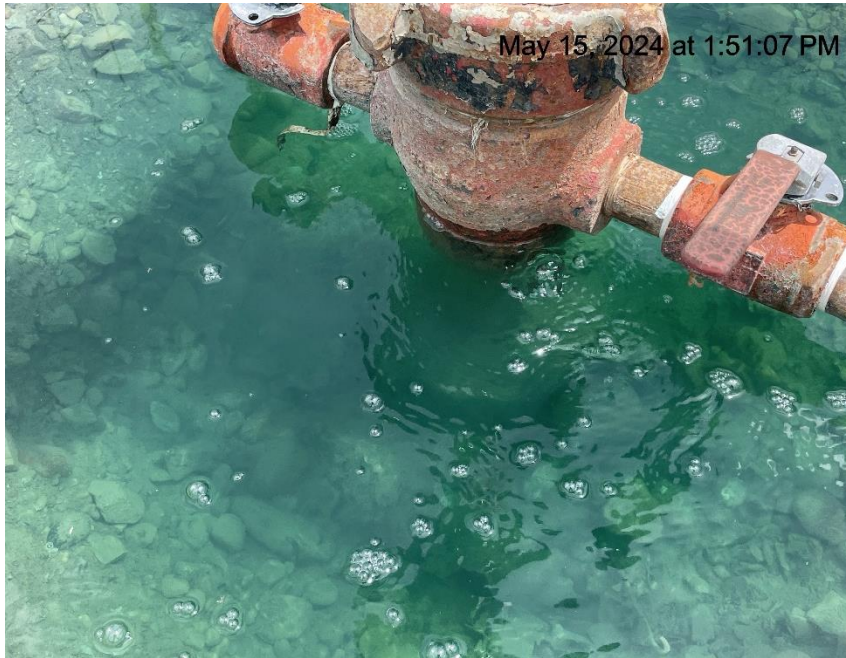
Photo # 7061 Possible wellhead leak on W 15-5 well

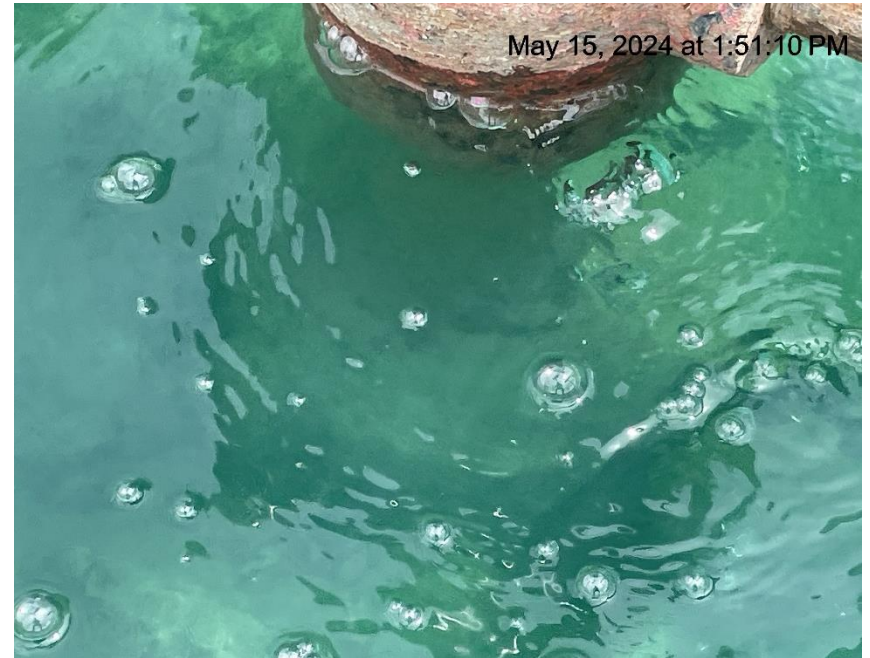
Photo # 7062 Possible wellhead leak on W 15-5 well

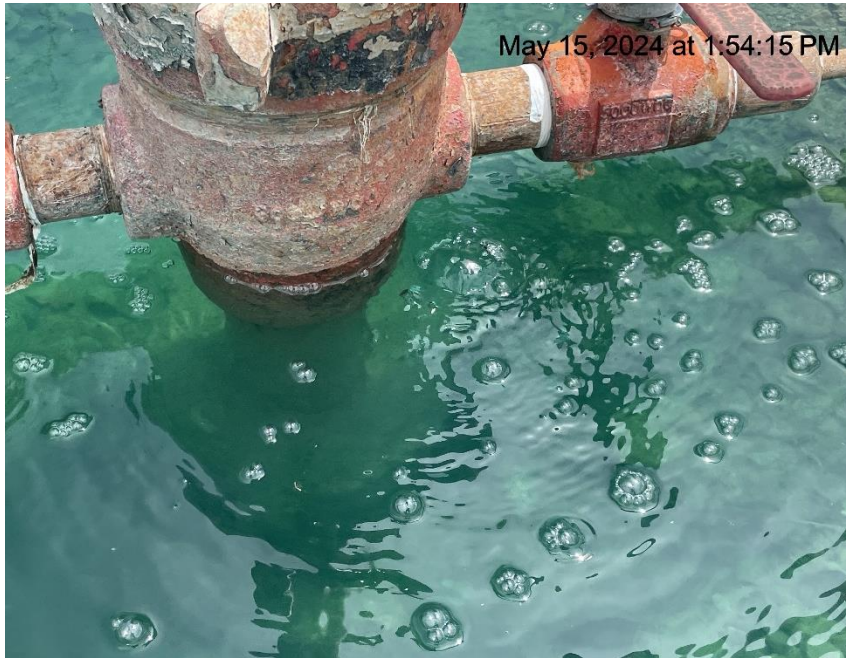
Photo # 7063 Possible wellhead leak on W 15-5 well

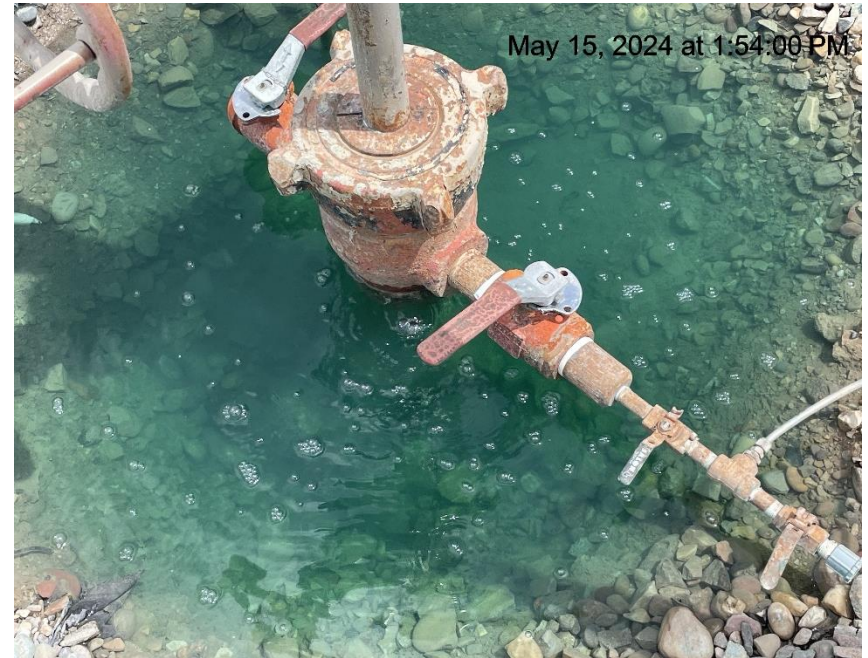
Photo # 7064 Possible wellhead leak on W 15-5 well

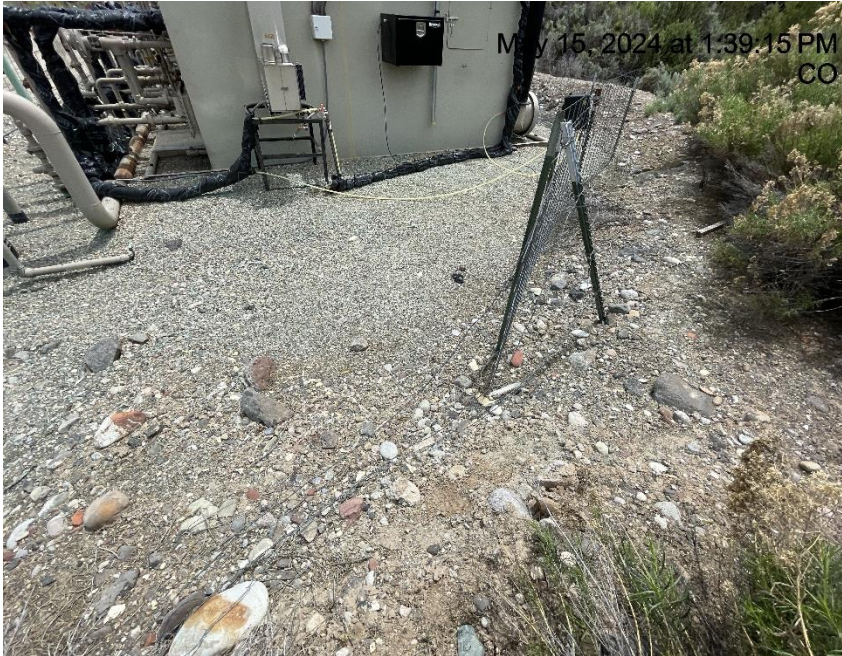
**Photo # 7065 Barbed wire laying on ground/wildlife hazard
(NW corner of location near separator units)**

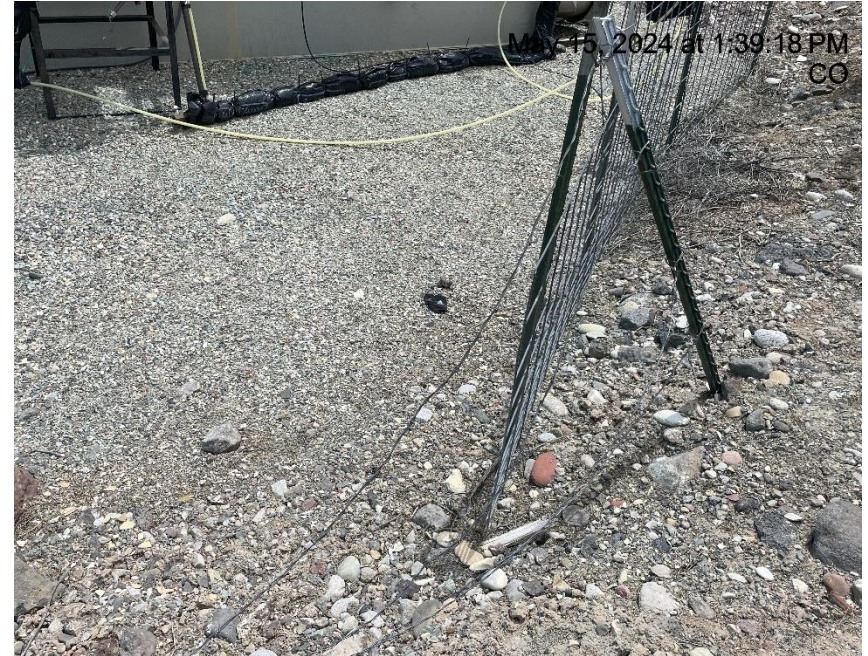
**Photo # 7066 Barbed wire laying on ground/wildlife hazard
(NW corner of location near separator units)**

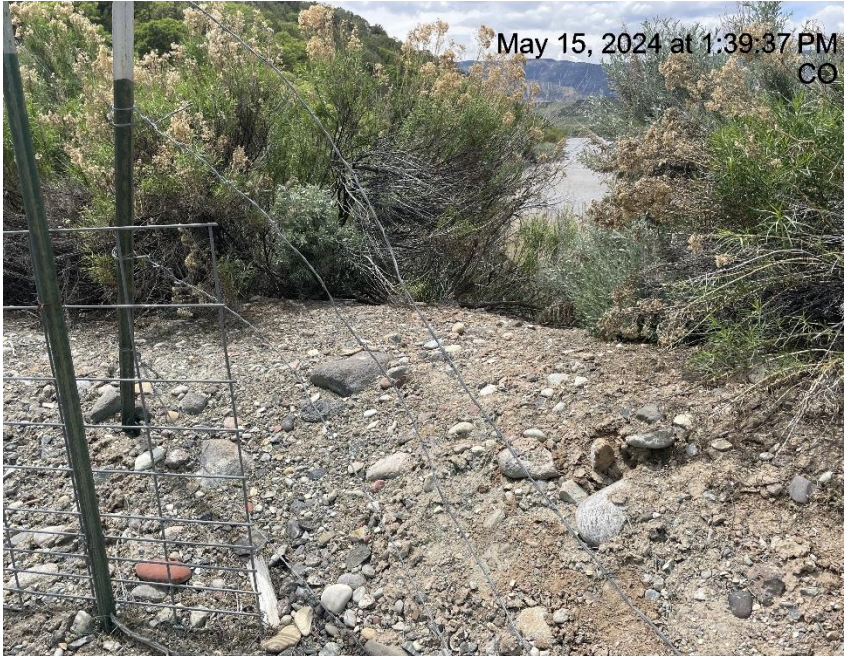
**Photo # 7067 Barbed wire laying on ground/wildlife hazard
(NW corner of location near separator units)**

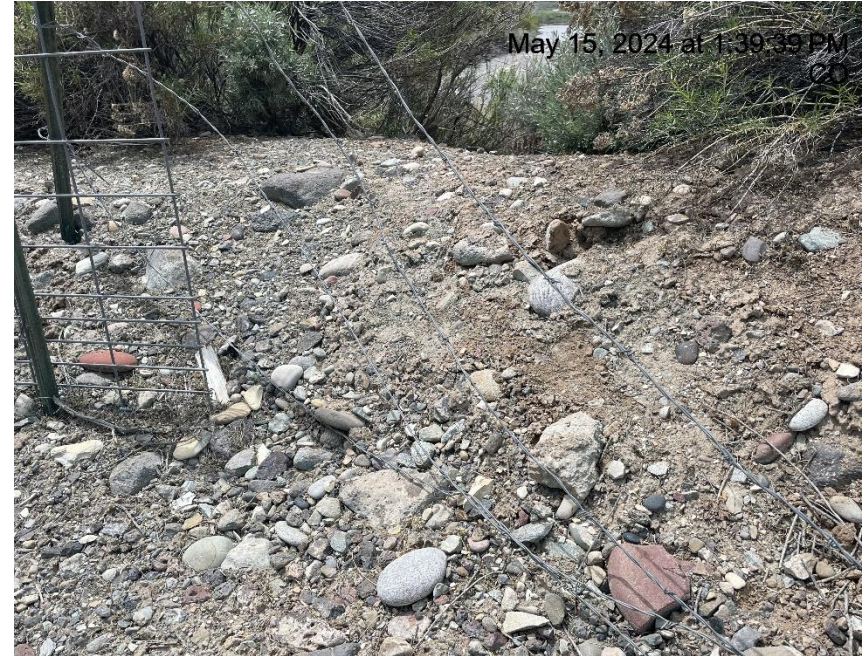
**Photo # 7068 Barbed wire laying on ground/wildlife hazard
(NW corner of location near separator units)**

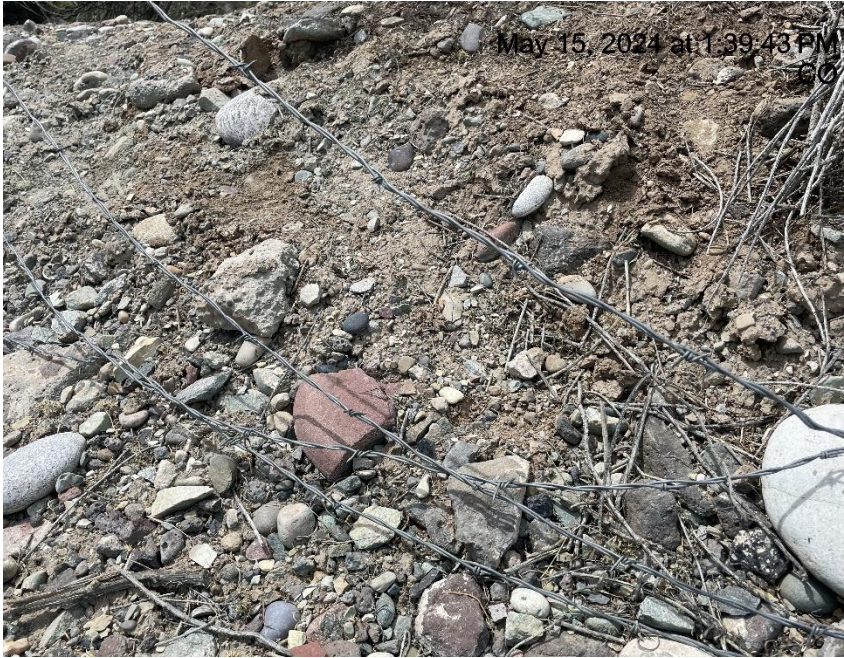
**Photo # 7069 Barbed wire laying on ground/wildlife hazard
(NW corner of location near separator units)**

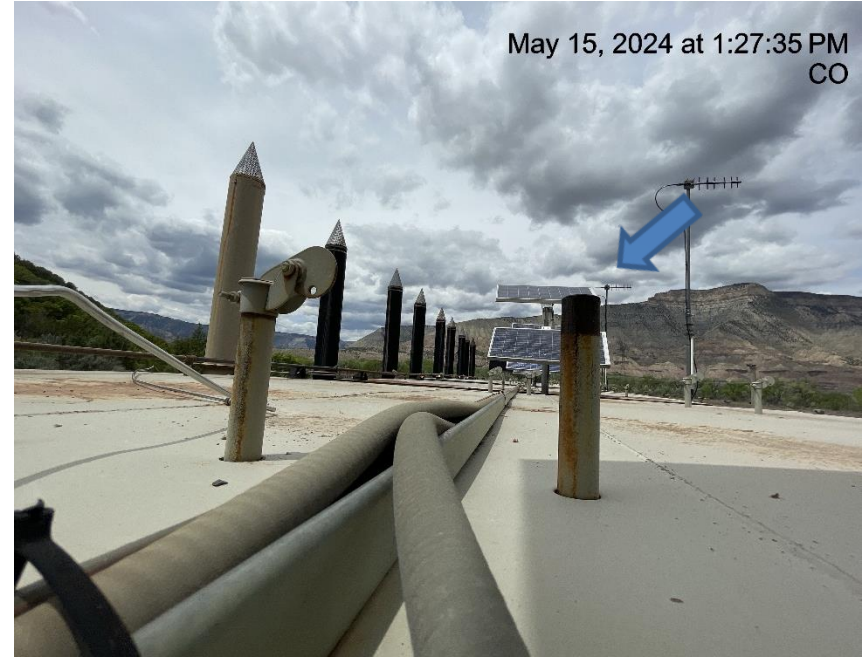
**Photo # 7070 Rupture disc vent line lacks cap/does not
comply with CECMC pressure safety device rules**

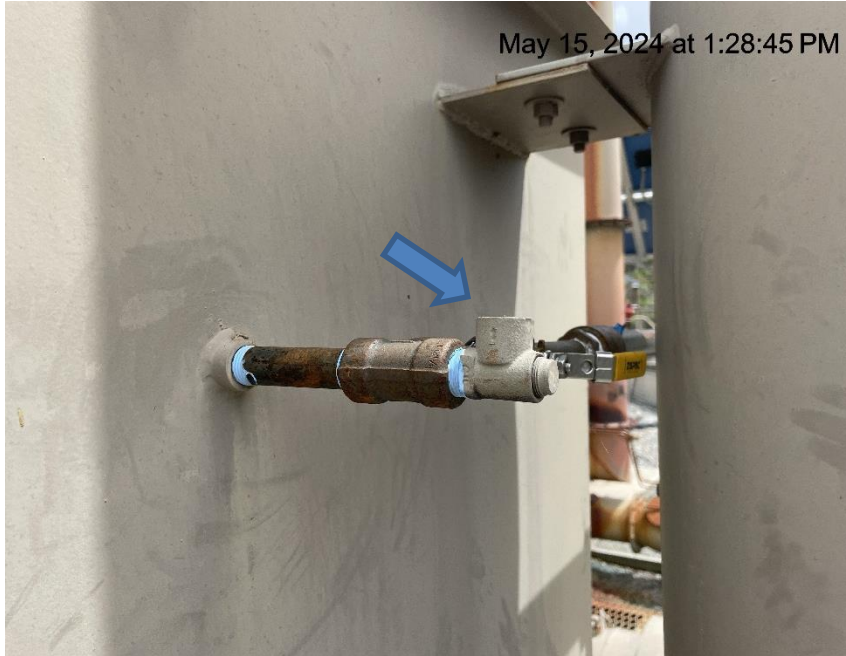
Photo # 7071 PRV does not comply with CECMC pressure safety device rules

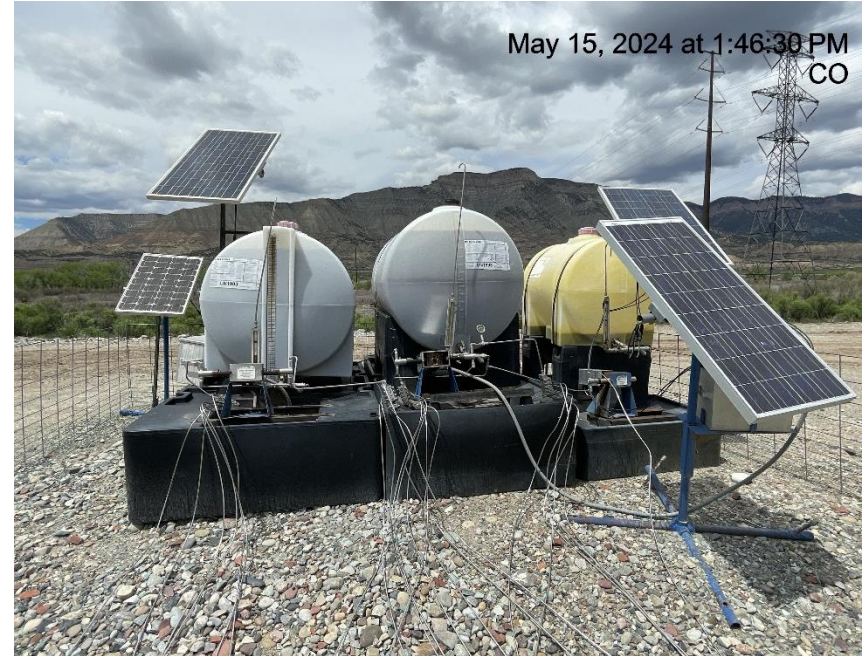
Photo # 7072 Some fluid in 2 of 3 chemical tank containments, may need maintenance in the near future.
