Inspection Photos

API: 061-06403

Operator: STRACHAN EXPLORATION INC

Inspection Date: 5/8/2024

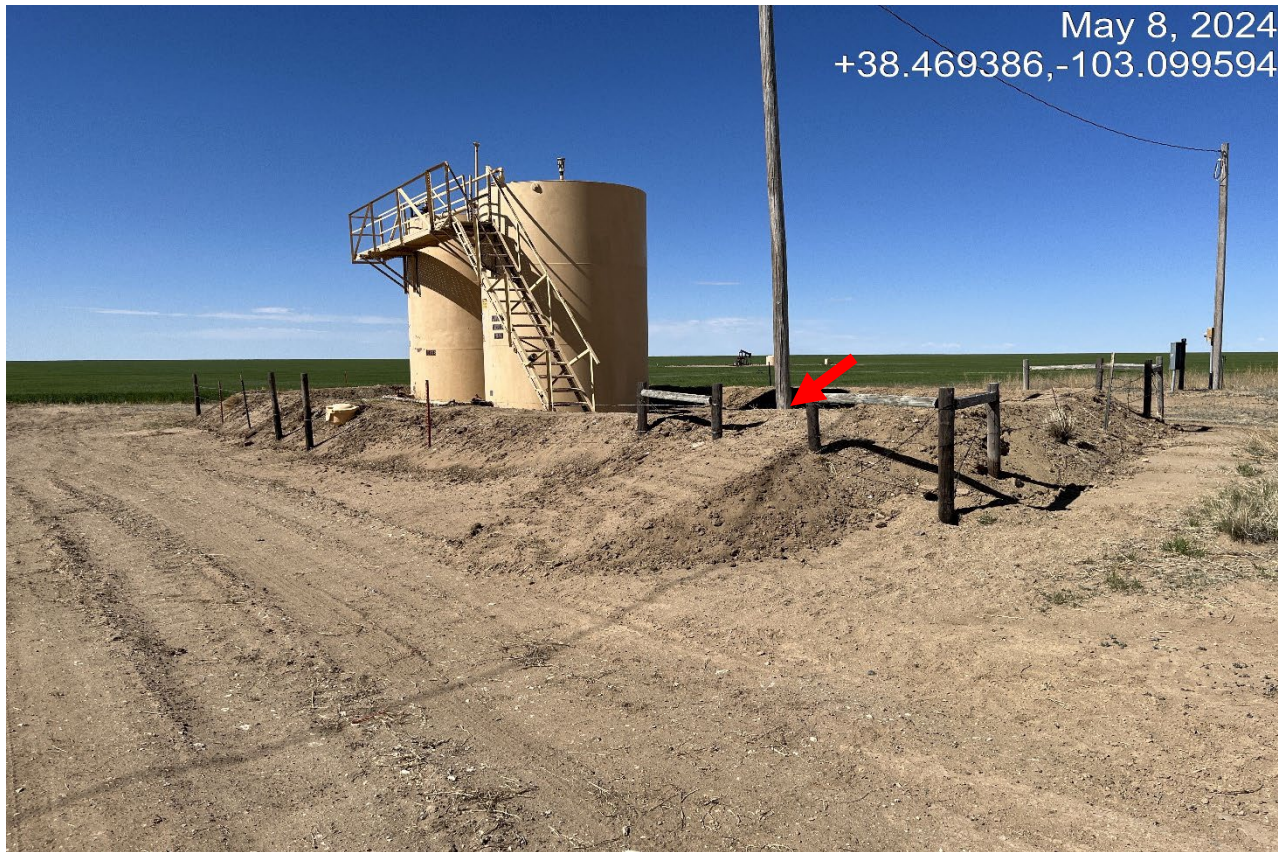
Photo 1. Facing toward the offsite tank battery location. It appears some work has started at the tank battery but is incomplete. No sign has been installed. The fence is not adequate to prevent livestock entry and there is no gate at the red arrow.

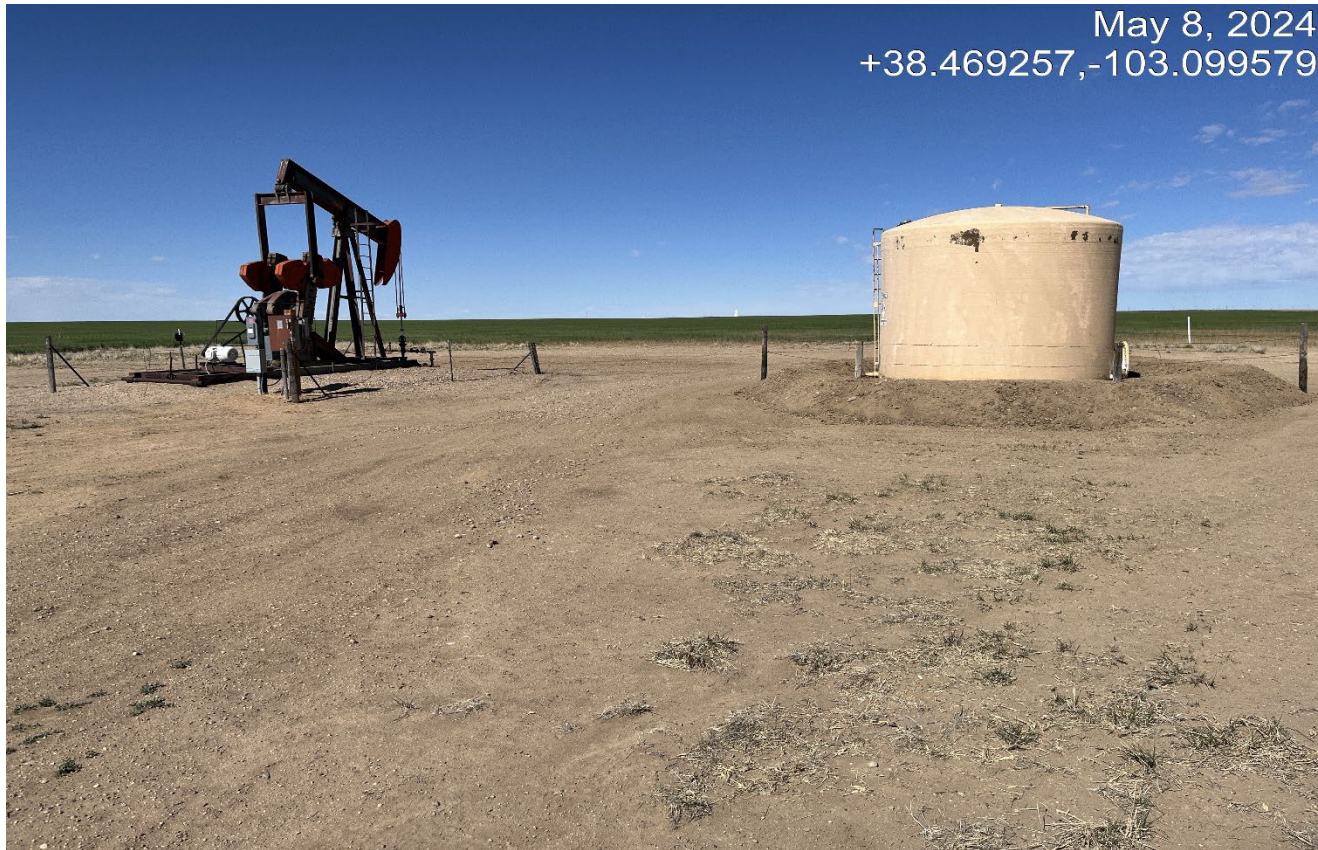
Photo 2. Facing southwest at the wellsite.

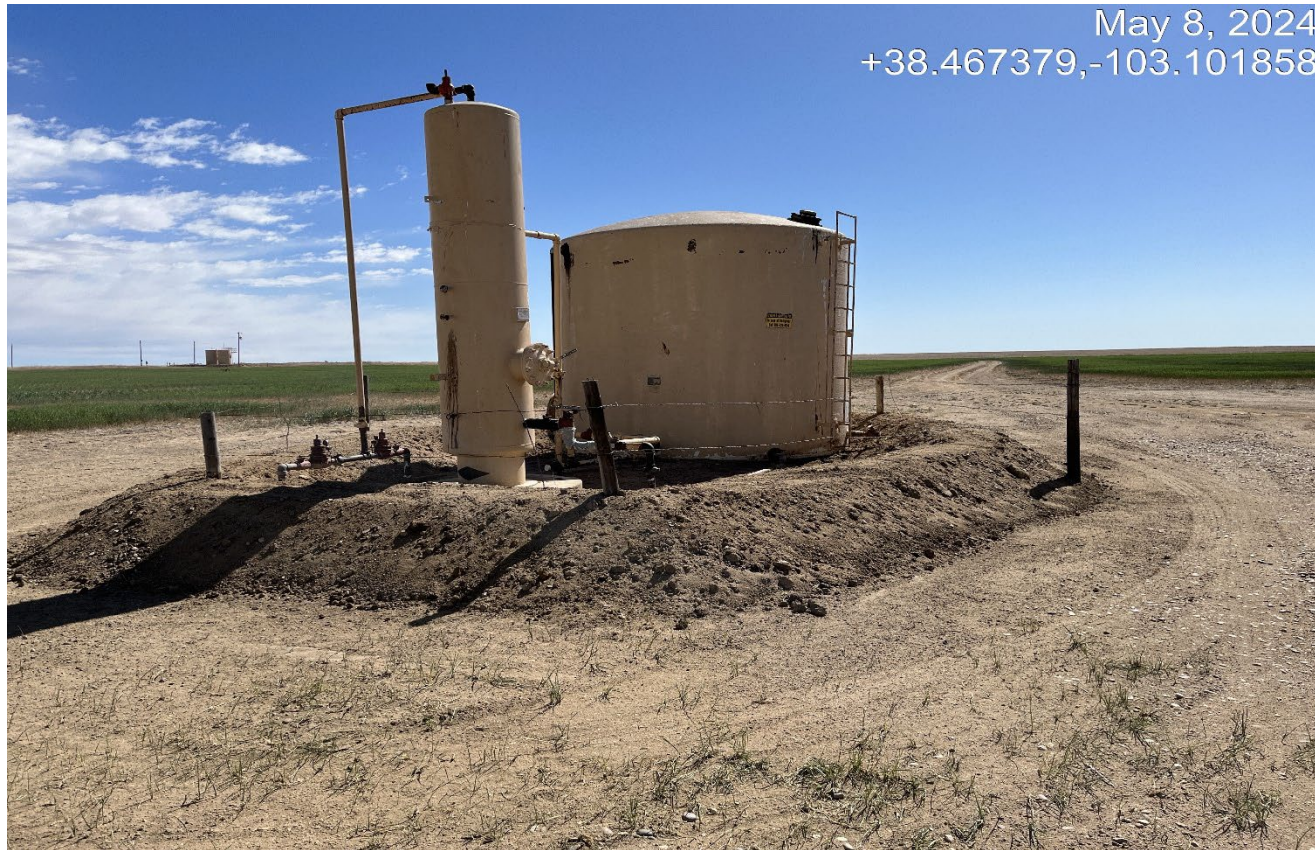
Photo 3. Facing toward the tank. The berm around the tank has been rebuilt. The sides of the berm are not compacted.

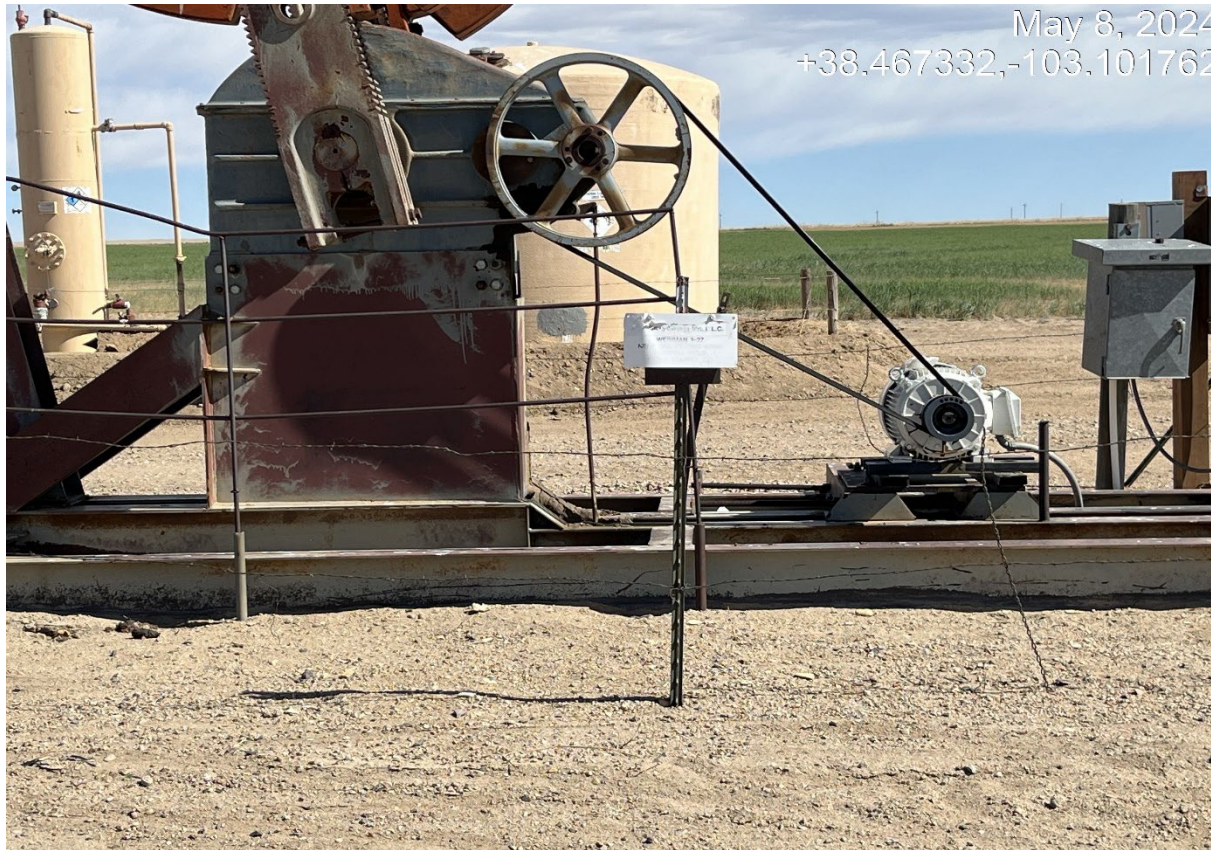
Photo 4. The well sign is faded and does not meet the signage requirements. Previous corrective action was not completed.
