Inspection Photos

API: 061-06394

Operator: STRACHAN EXPLORATION INC

Inspection Date: 5/8/2024

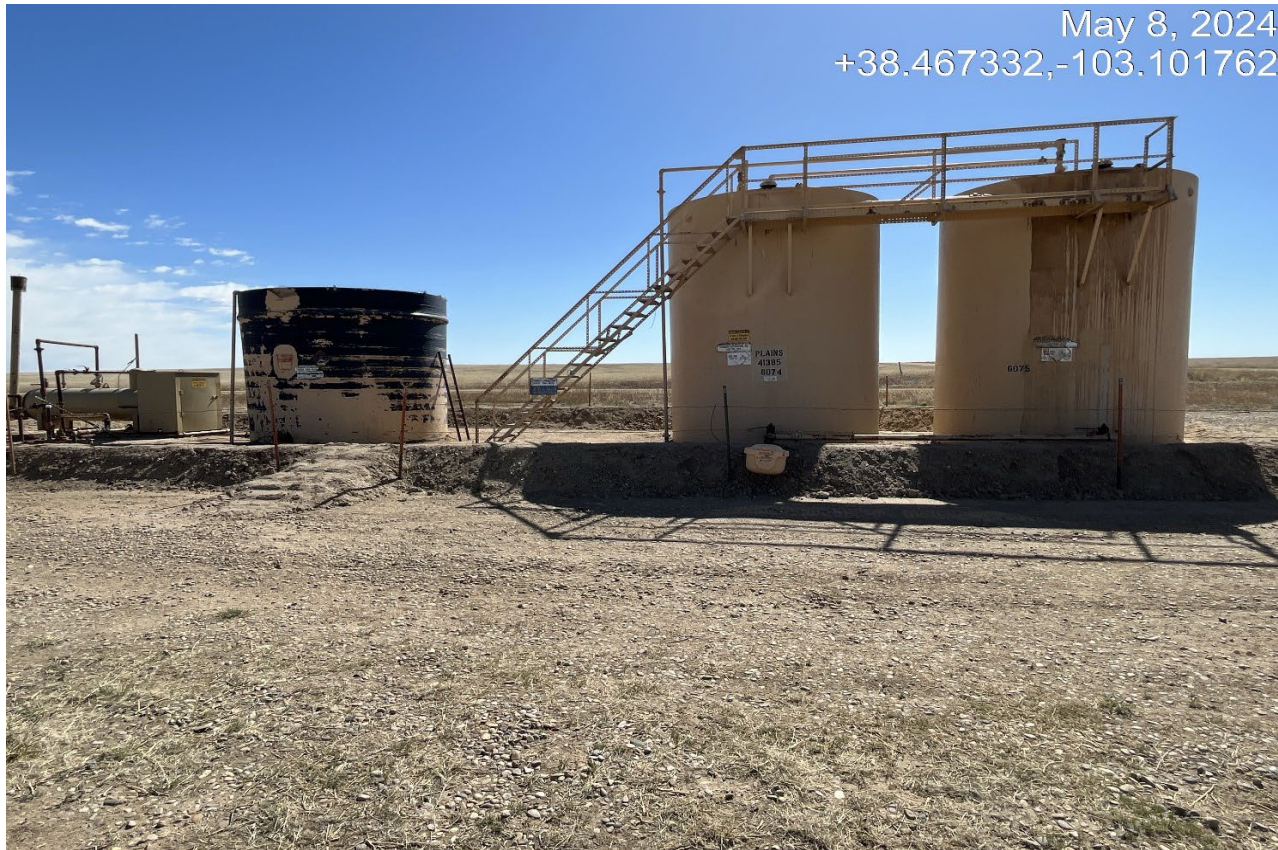
Photo 1. Facing east toward the offsite tank battery location.

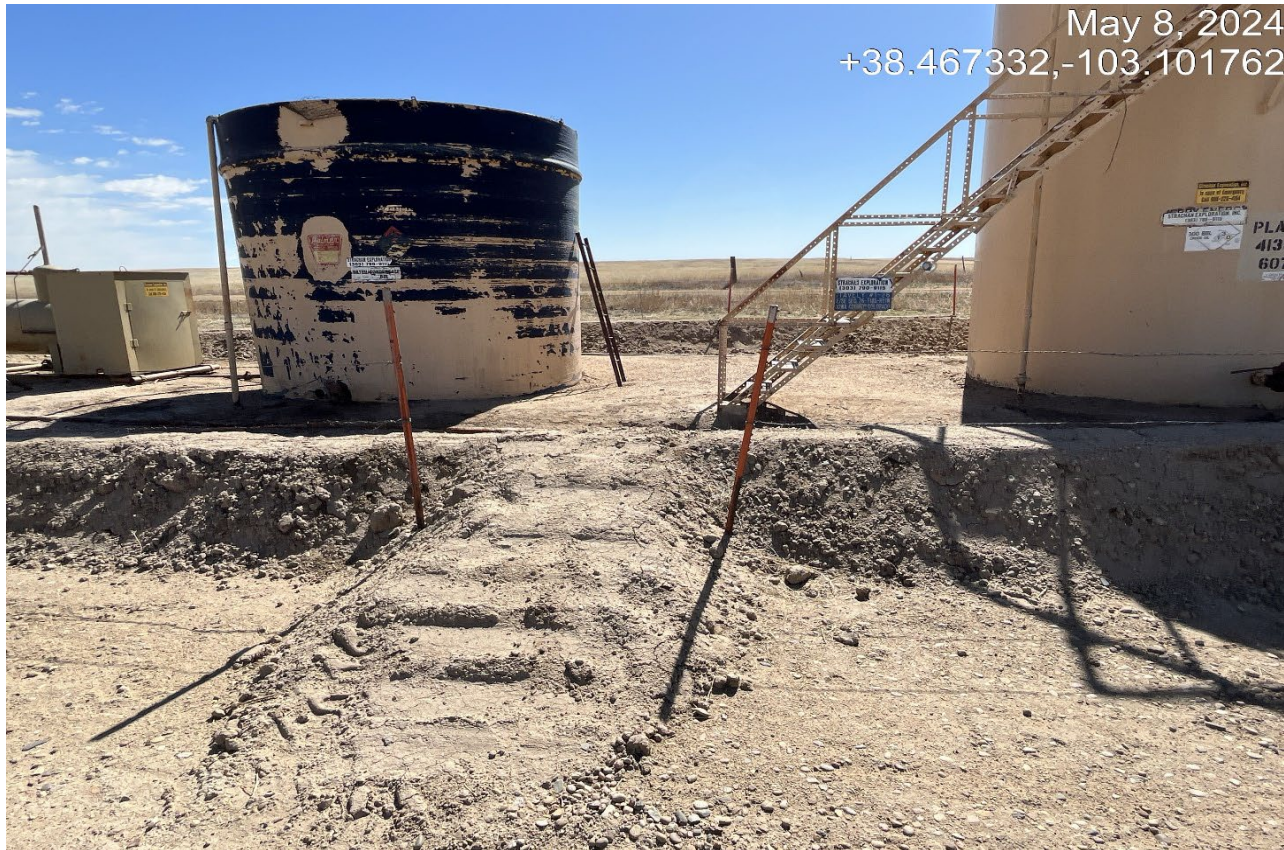
Photo 2. The fence around the tank has been repaired but there is an opening at this area and there are only 2 wires which will not keep livestock out.

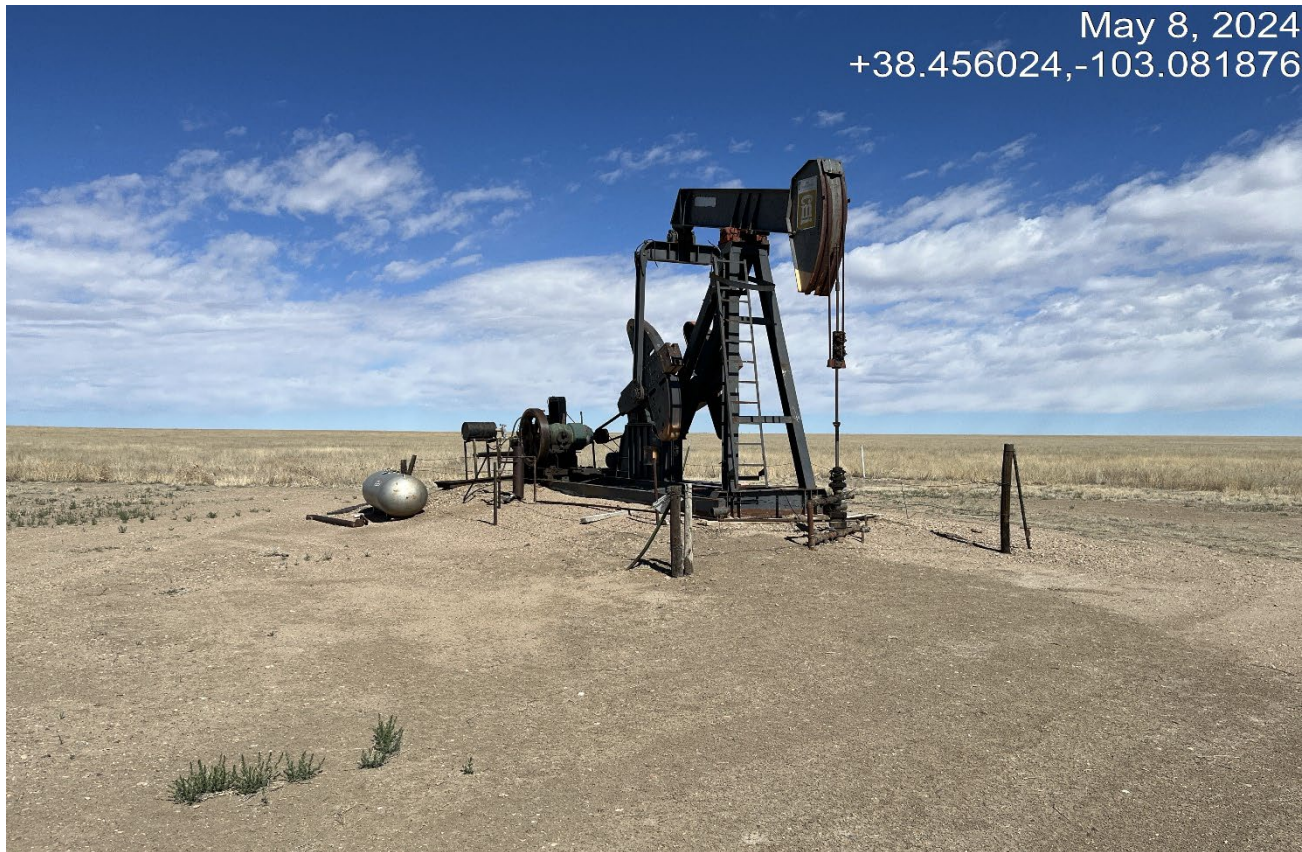
Photo 3. Facing northwest toward the wellsite. The fence around the pumpjack is in disrepair and wont prevent livestock entry.

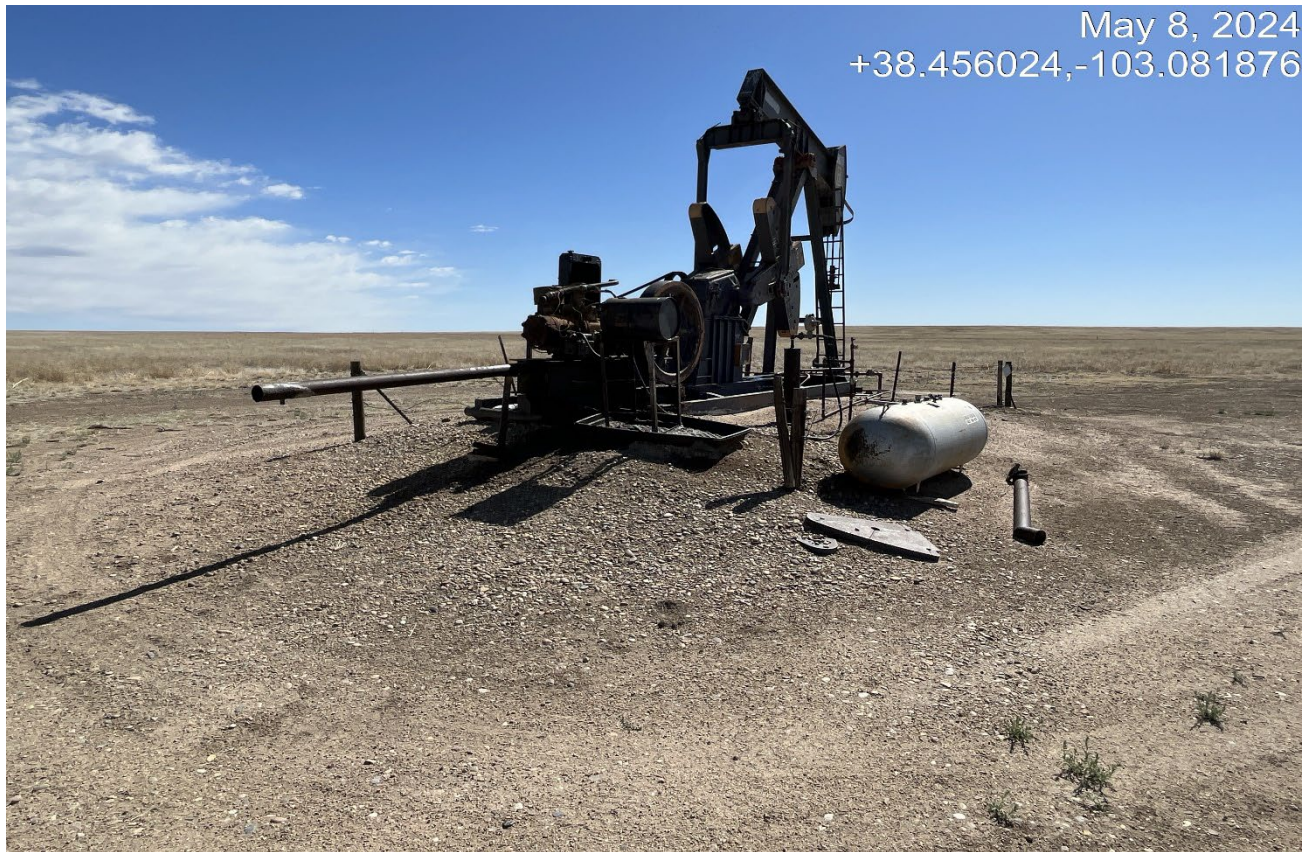
Photo 4. Facing east toward the wellsite. There are parts laying on the ground that should be removed.

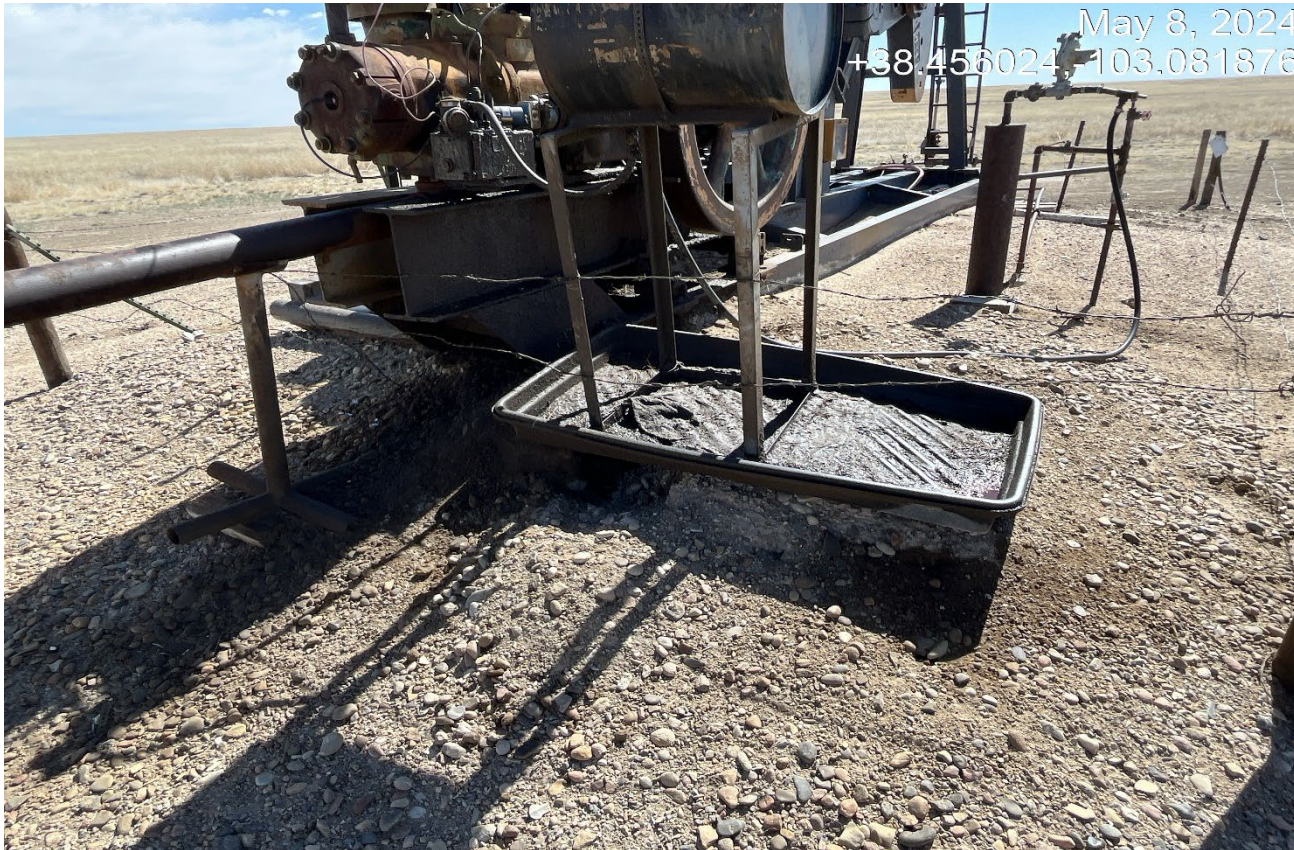
Photo 5. There is oily fluid in the containment next to the pump jack. Oily fluid has spilled onto the ground and needs to be cleaned up. Previous corrective action was not completed. Netting must be installed to prevent wildlife entry.
