Inspection Photos

Location Name: TEP ROCKY MOUNTAIN LLC SPRUCE CREEK PRODUCTION PIT 14-4-794

Location #: 427810

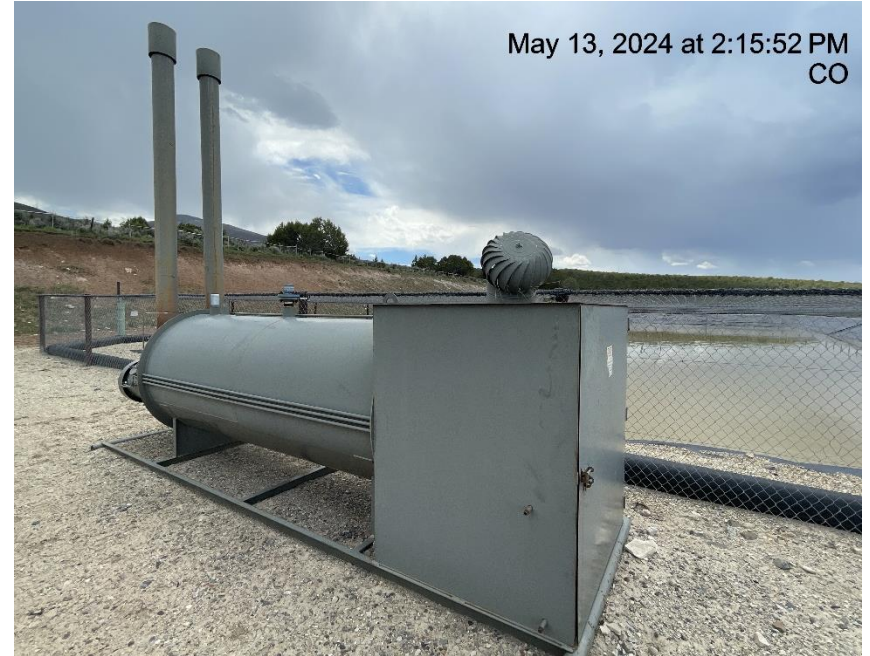
Photo # 6804 Unused equipment

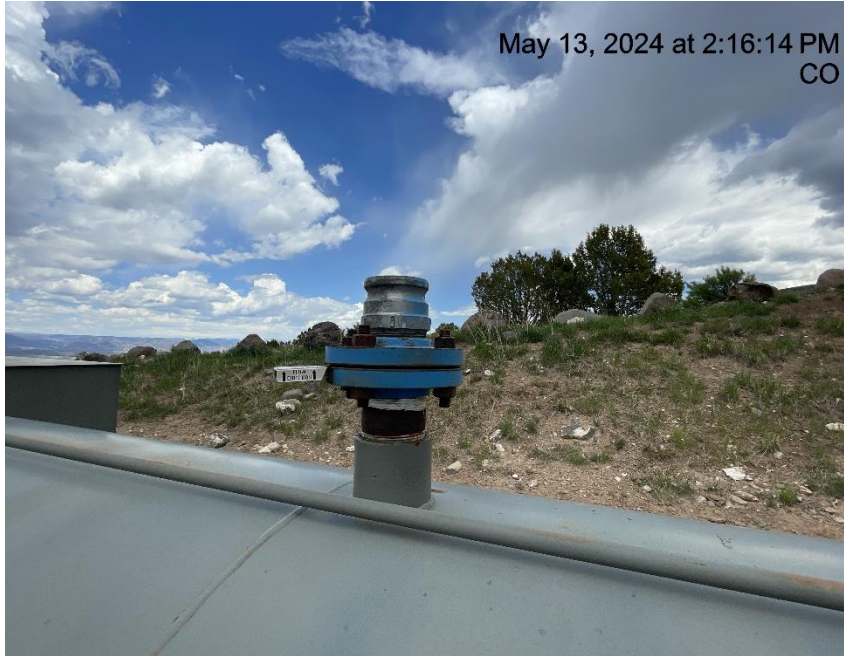
**Photo # 6805 Open ended piping on unused equipment
/wildlife hazard/available for entry by wildlife**

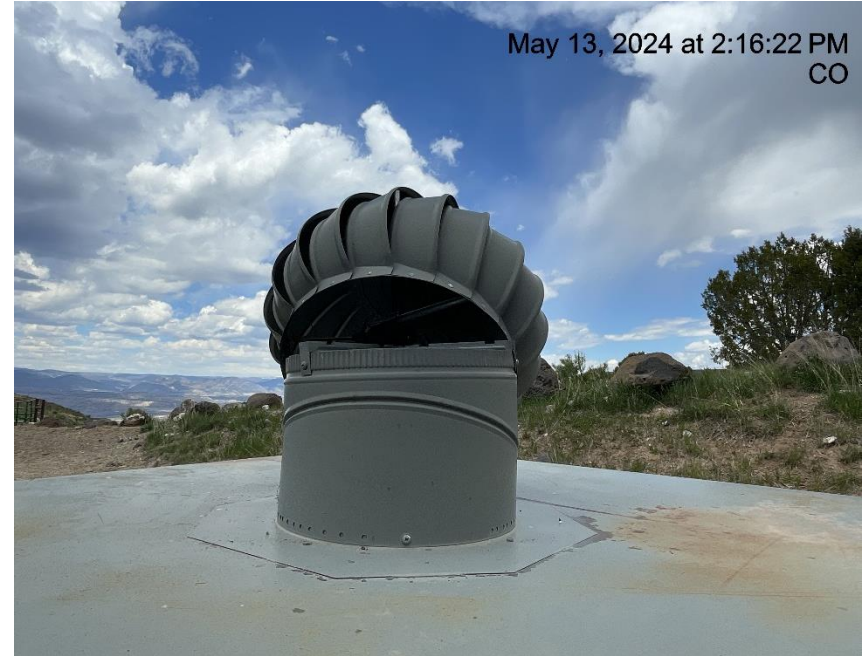
**Photo # 6806 Turbine not properly installed on unused
equipment/wildlife hazard/available for entry by wildlife**

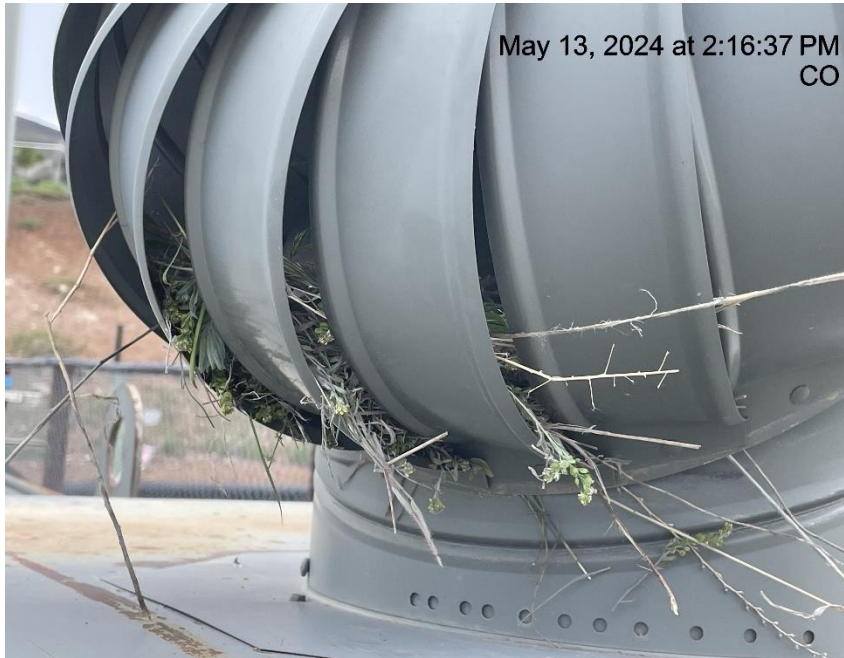
Photo # 6807 Possible nest inside turbine on unused equipment

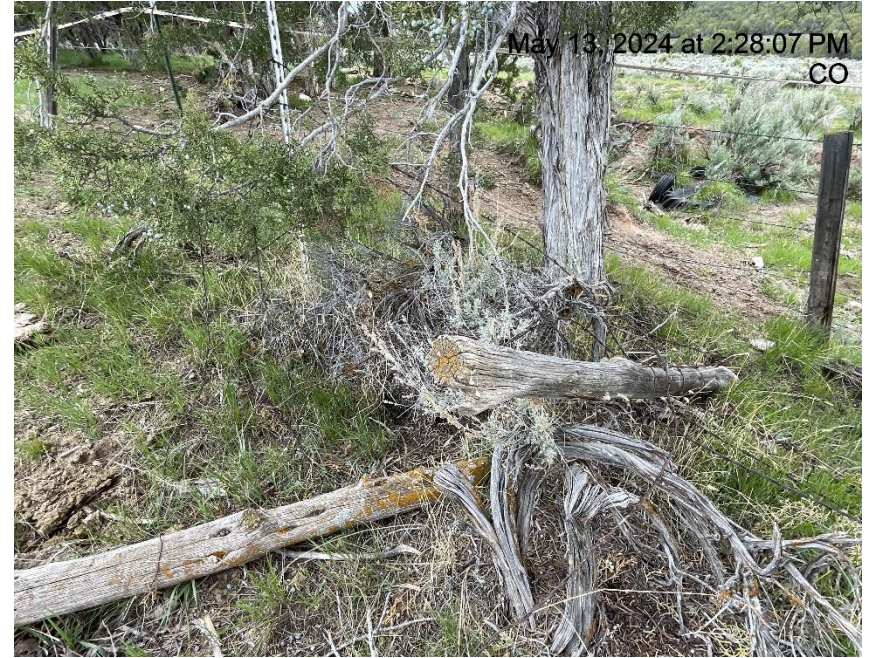
Photo # 6808 Barbed wire laying on ground/wildlife hazard (SW corner of location on top of cut slope)

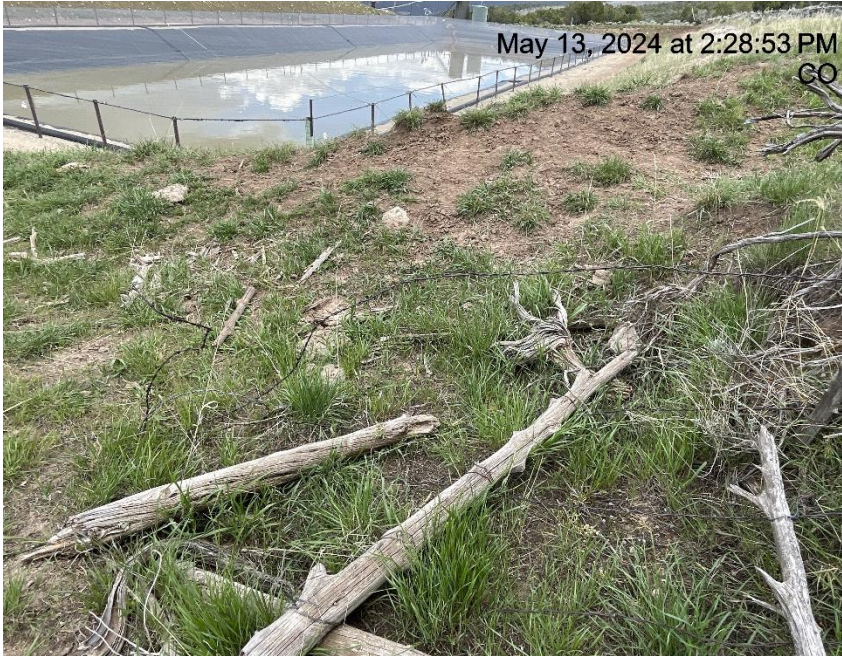
**Photo # 6809 Barbed wire laying on ground/wildlife hazard
(SW corner of location on top of cut slope)**

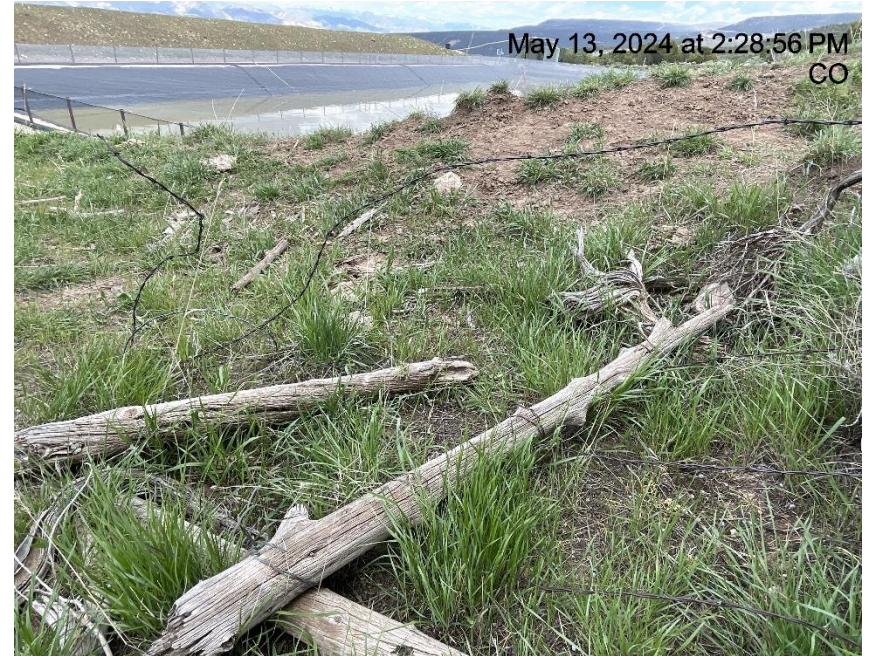
**Photo # 6810 Barbed wire laying on ground/wildlife hazard
(SW corner of location on top of cut slope)**

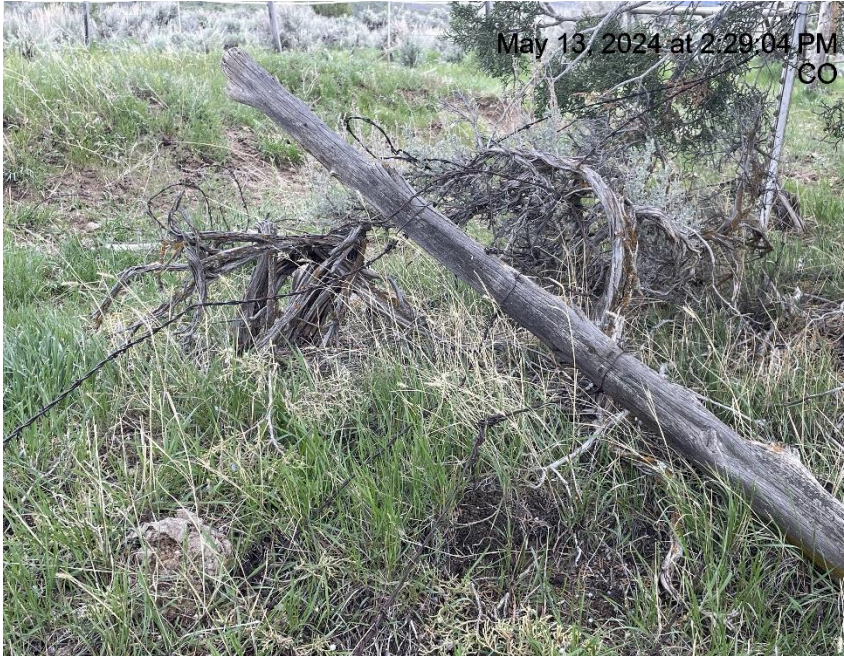
**Photo # 6811 Barbed wire laying on ground/wildlife hazard
(SW corner of location on top of cut slope)**

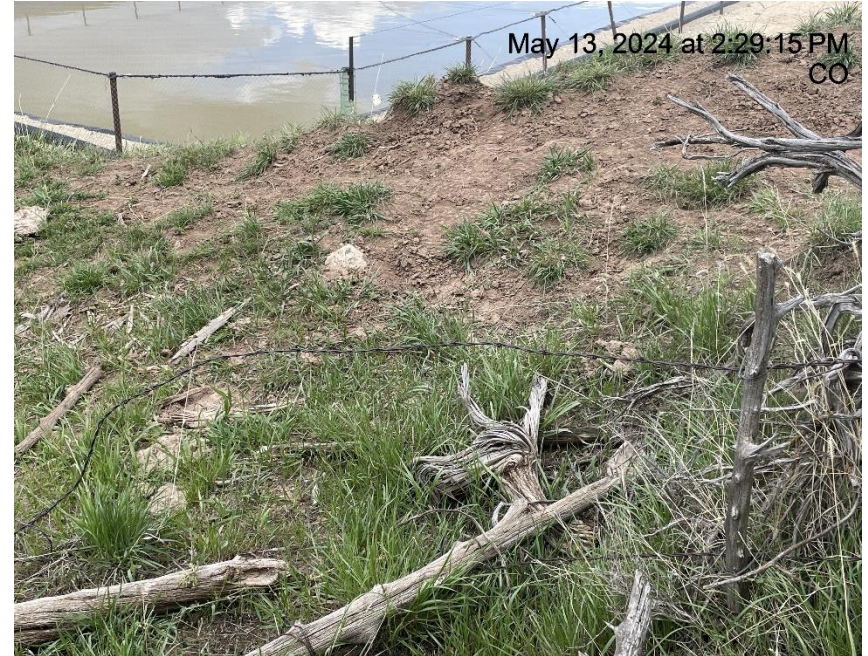
**Photo # 6812 Barbed wire laying on ground/wildlife hazard
(SW corner of location on top of cut slope)**

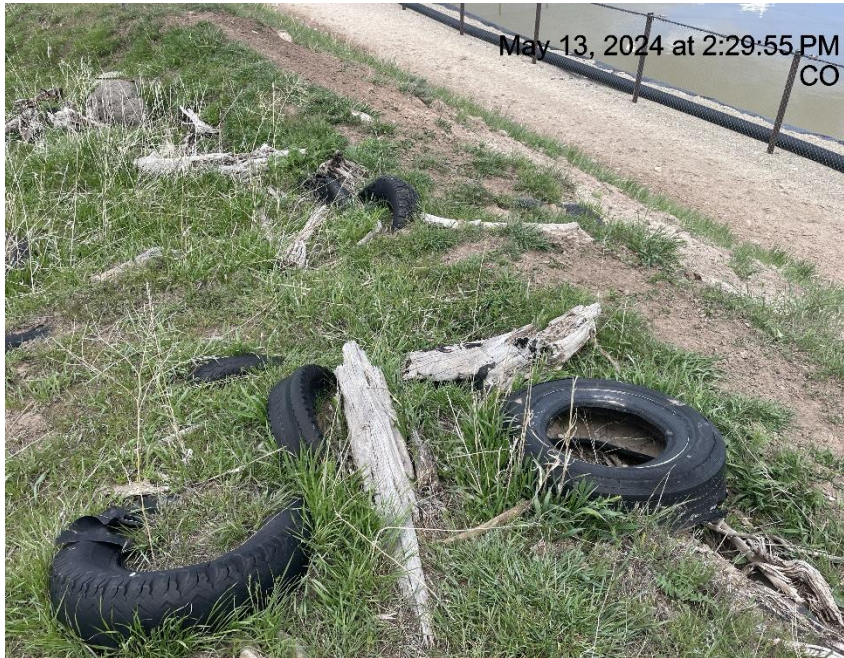
Photo # 6813 Debris

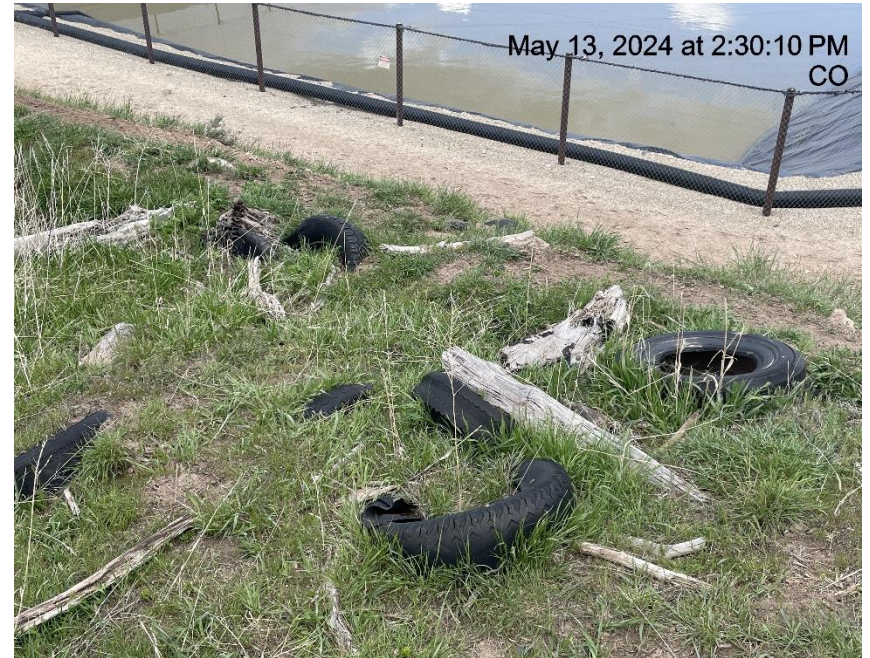
Photo # 6814 Debris

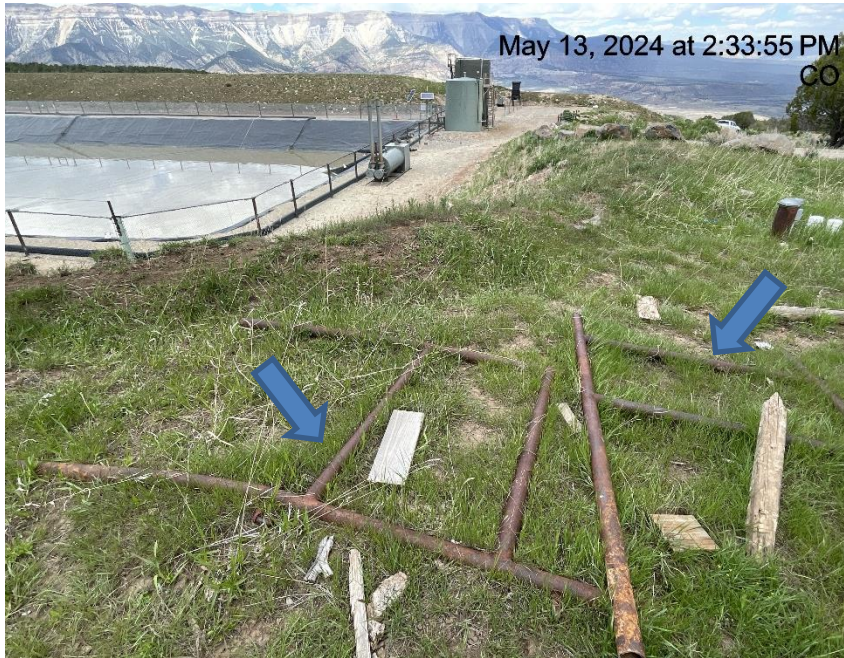
Photo # 6815 Debris

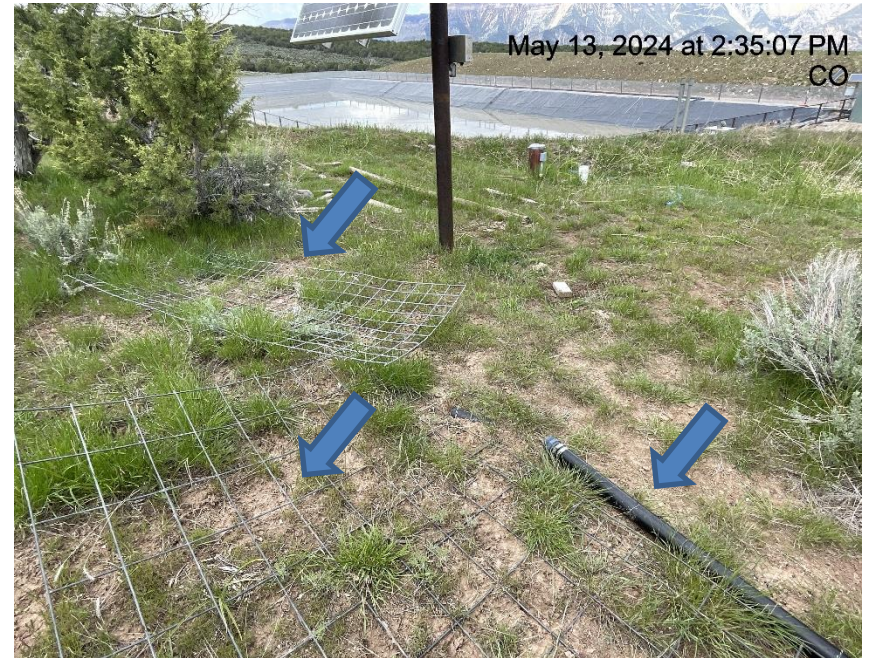
Photo # 6816 Debris
