Inspection Photos

Location Name: TEP ROCKY MOUNTAIN LLC, BORUCH-67S96W/11NESE

Location ID: 334984

Date: 5/16/2024

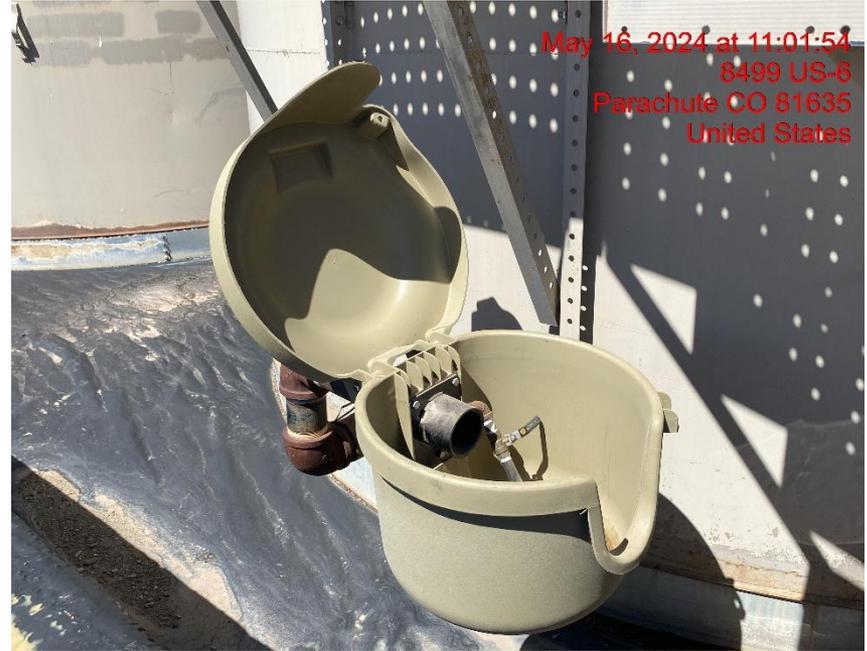
Open-Ended Load Line – Photo #01256

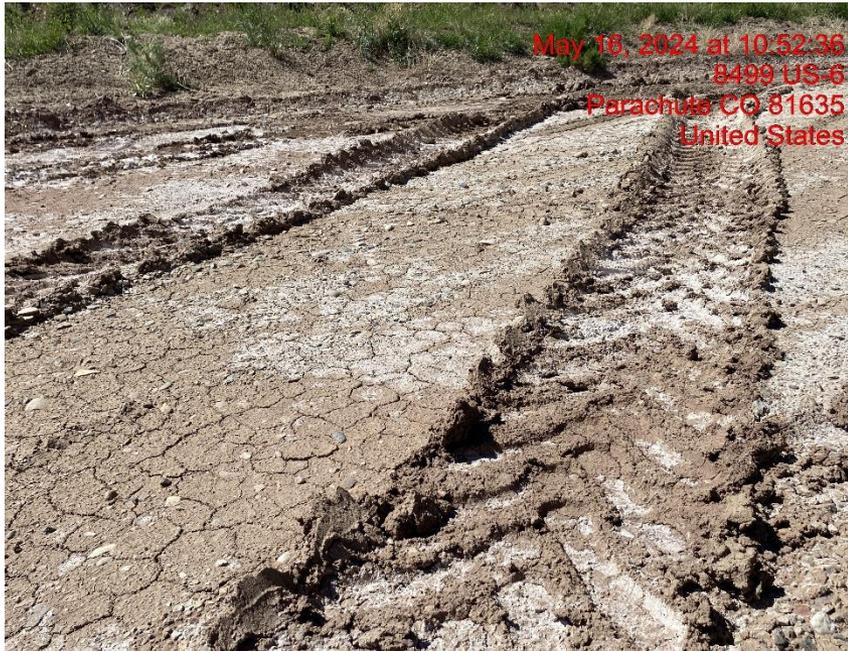
Lack of Stabilization – Photo #01251

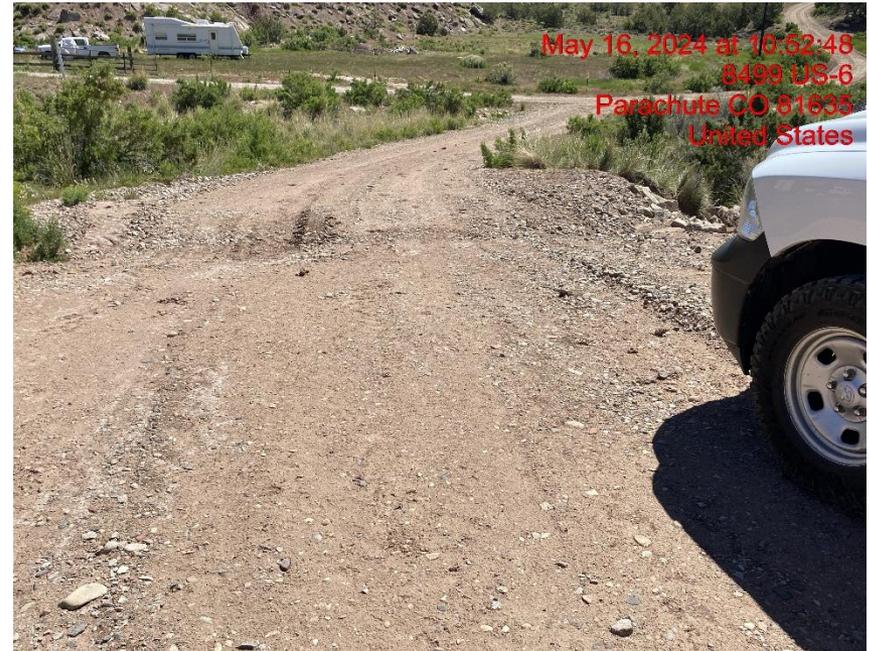
**Insufficient Vehicle Tracking BMPs at Location Entrance/Exit
– Photo #01252**
