# Inspection Photos

Loc: 322234

Operator: **INCREMENTAL OIL & GAS (FLORENCE) LLC**

Inspection Date: 5/20/2024

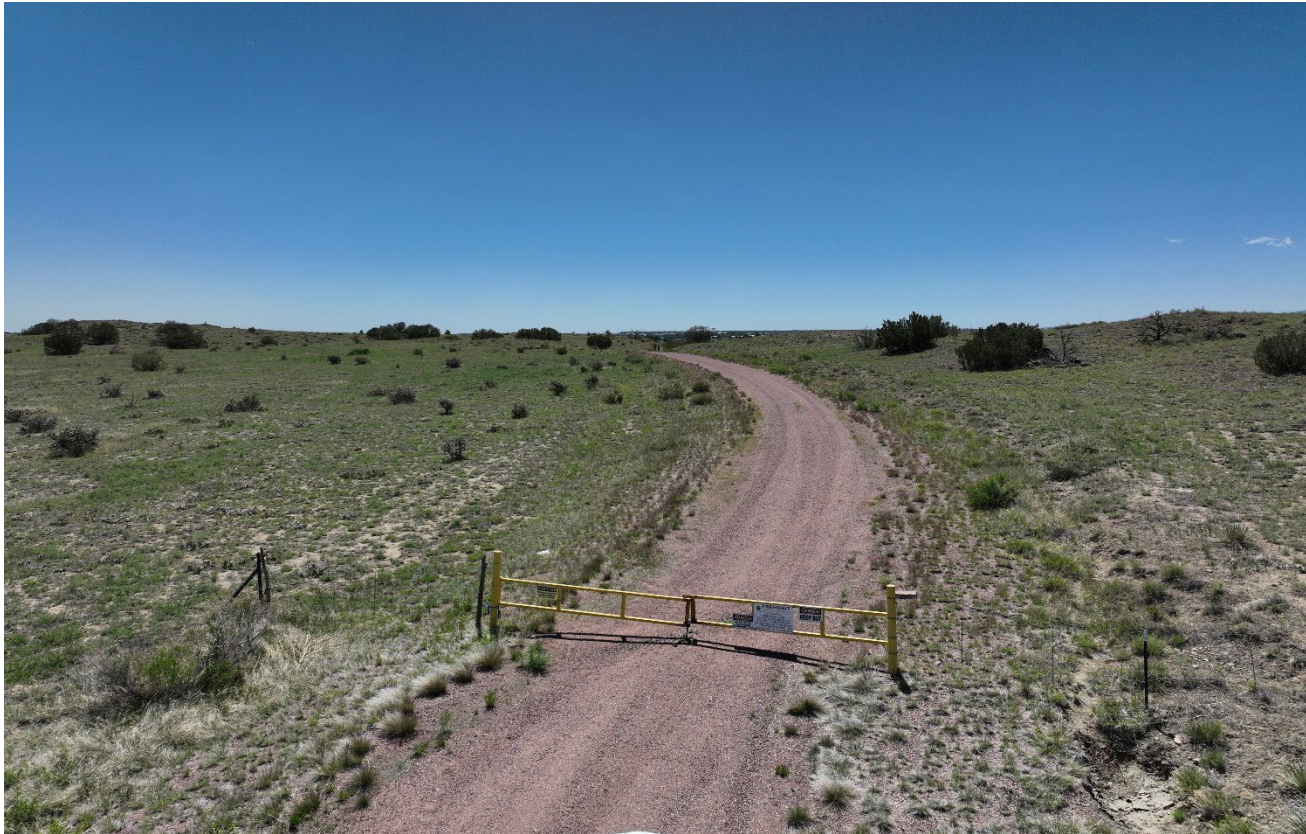
**Photo 1.** Drone photo facing southeast at the beginning of the access road. The access road has not been reclaimed.

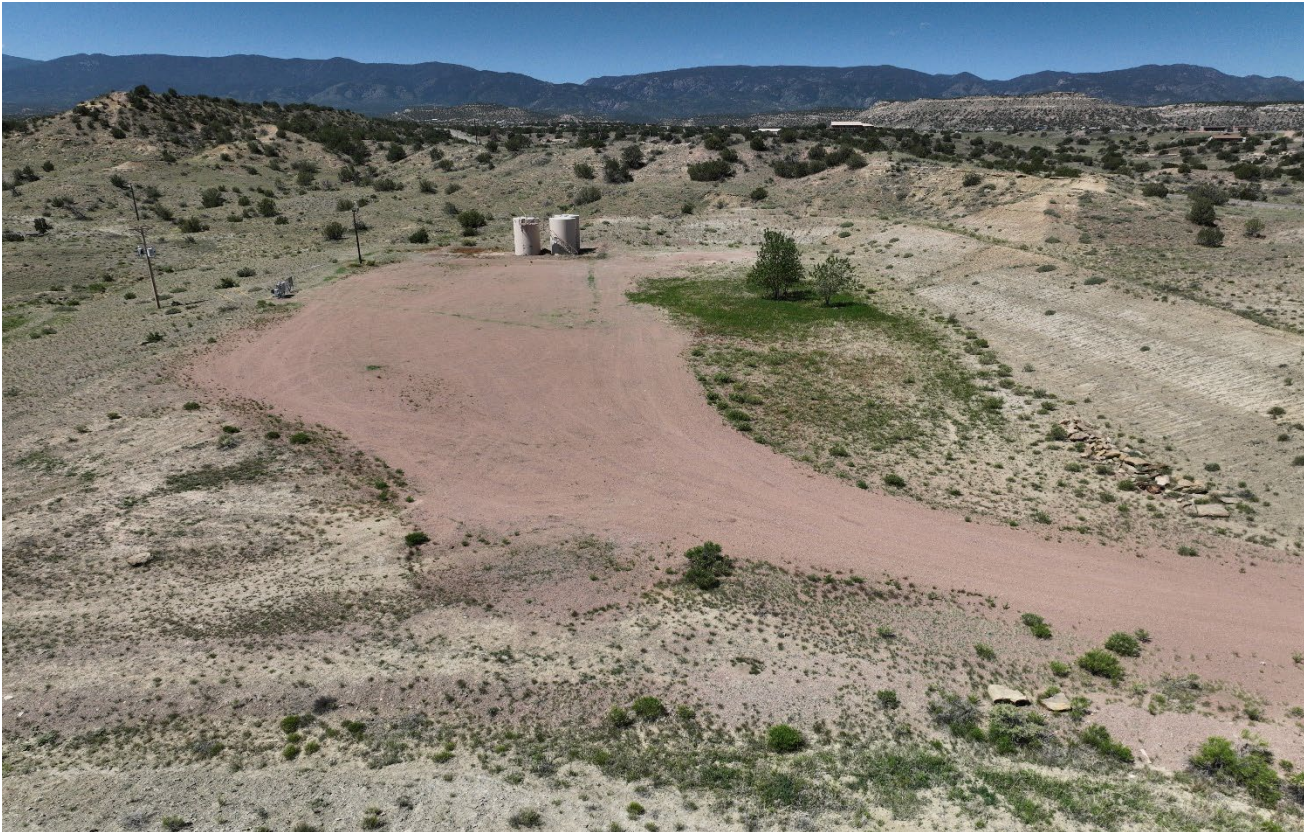
**Photo 2.** Drone photo facing south toward the location. The well has been plugged and abandoned however final reclamation has not yet been completed.

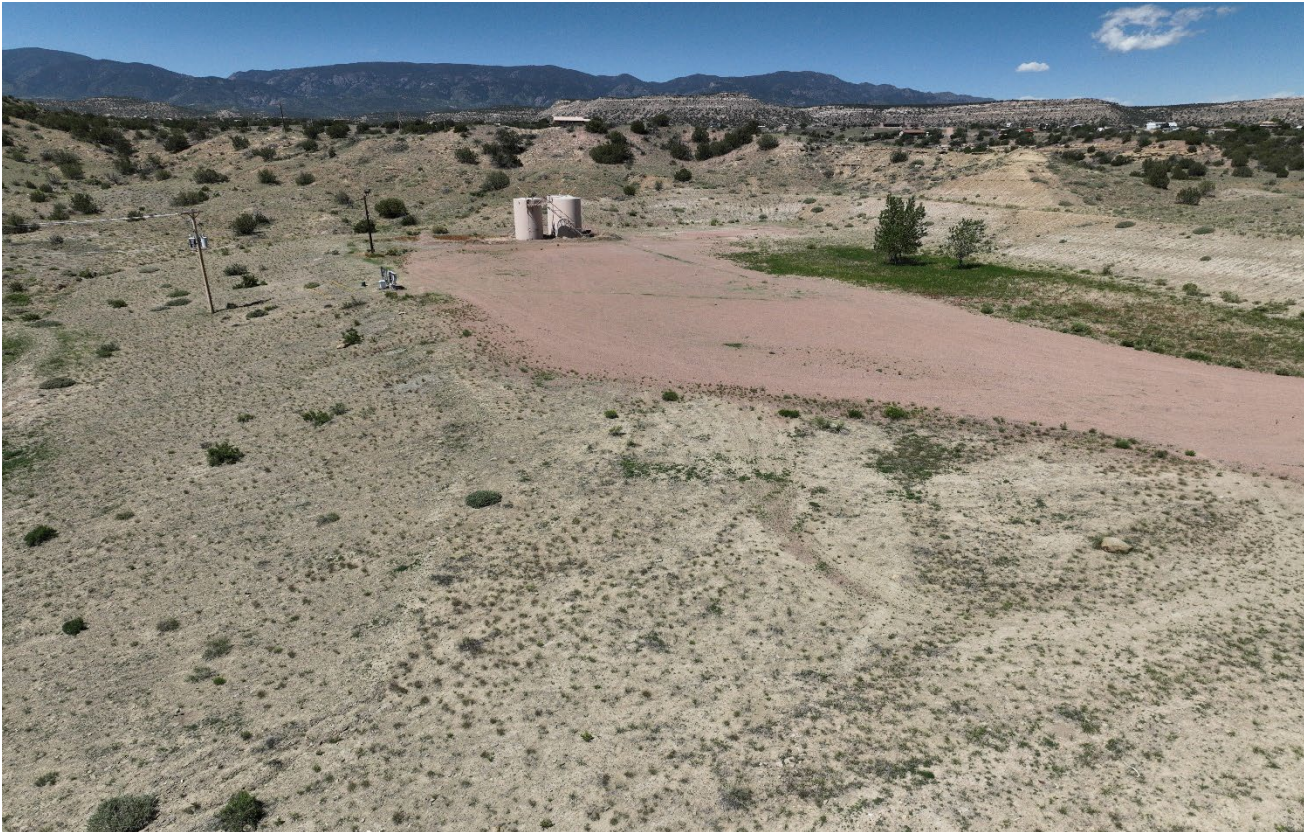
**Photo 3.** Facing southwest along the fill slope. The location will need to be reocntoured back to the original slopes.

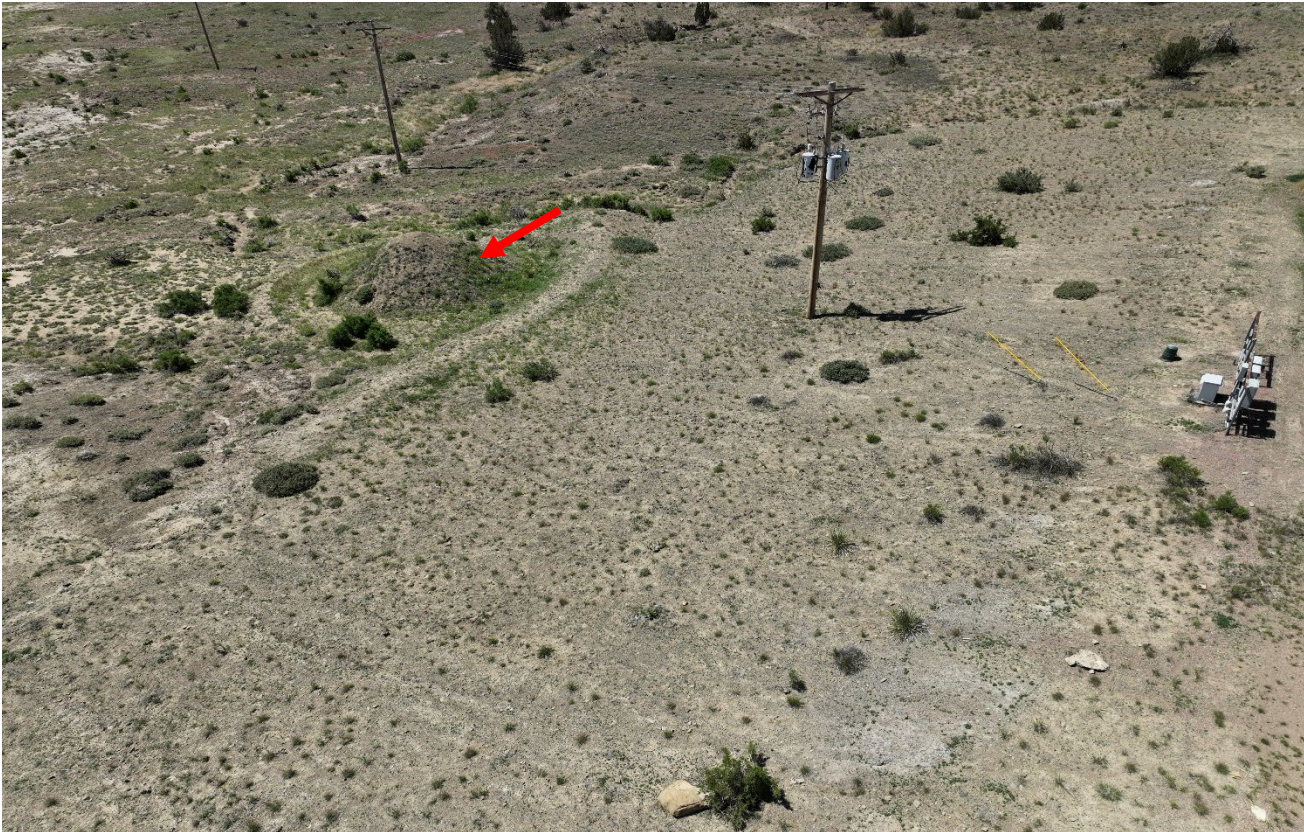
**Photo 4.** The electric utilities remain at the location and should have been removed with 3 months of abandonment. The entire powerline and poles servicing this location must be removed. There is a topsoil pile shown at red arrow.

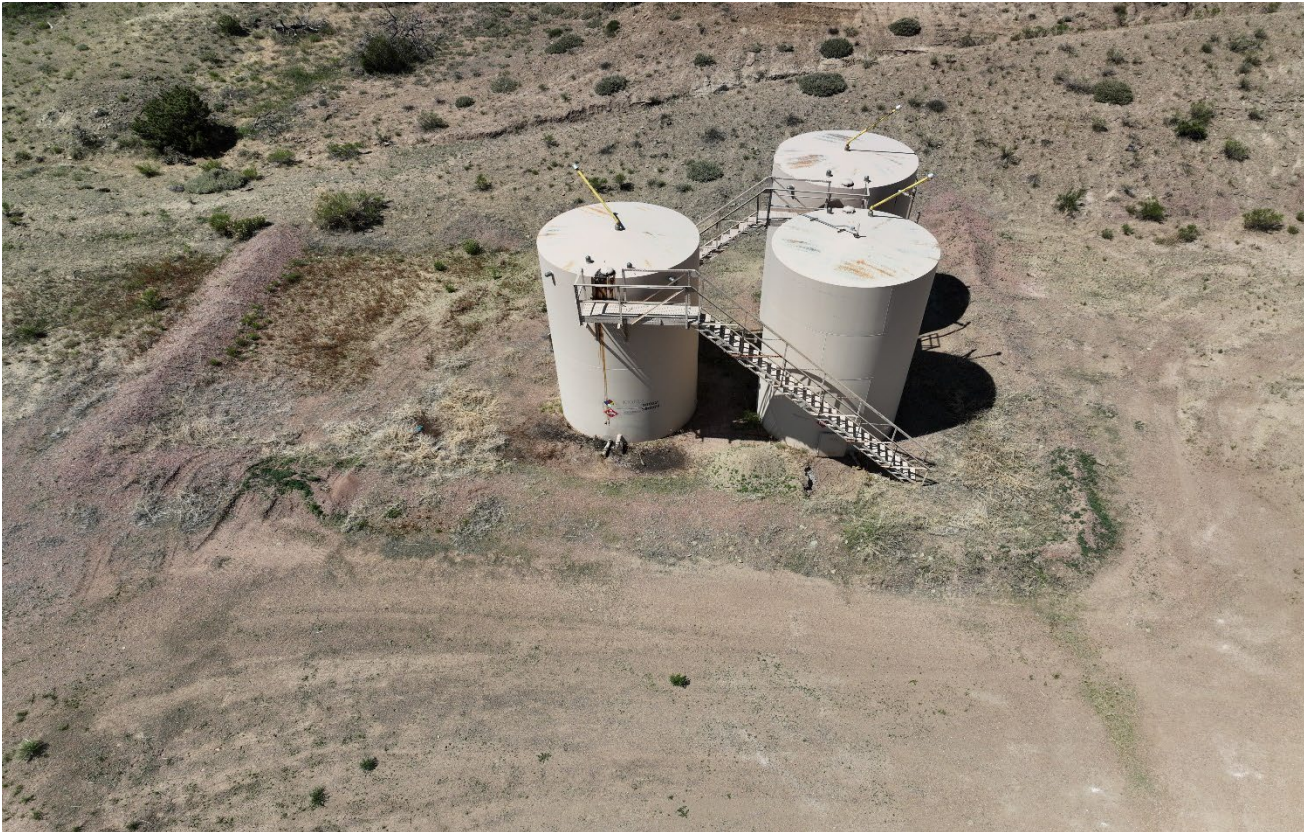
**Photo 5.** Facing toward the south side of the location. There are tanks that have not been removed. All equipment should have been removed within 3 months of abandonment.

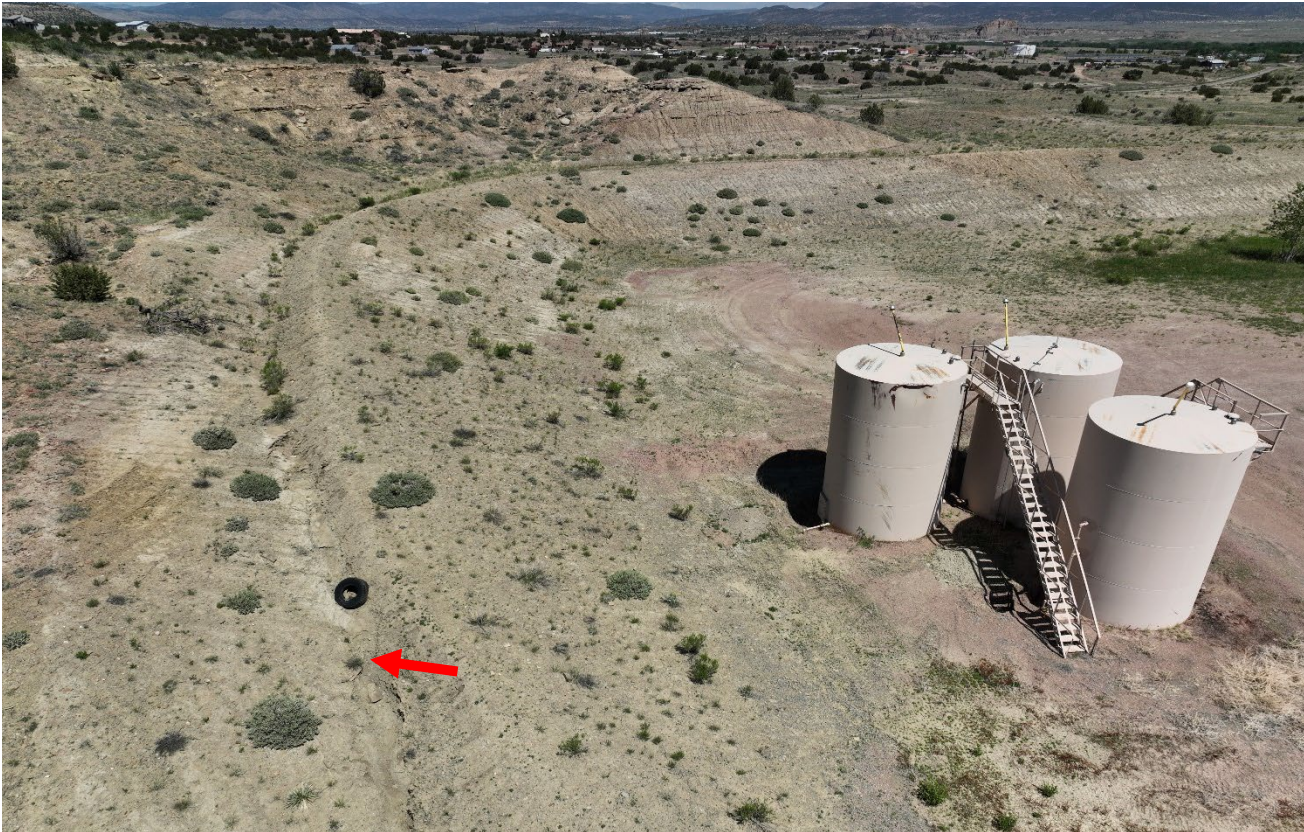
**Photo 6.** Facing west at the south side of the location. There is an erosion channel shown at red arrow which will need to be repaired and stabilized.

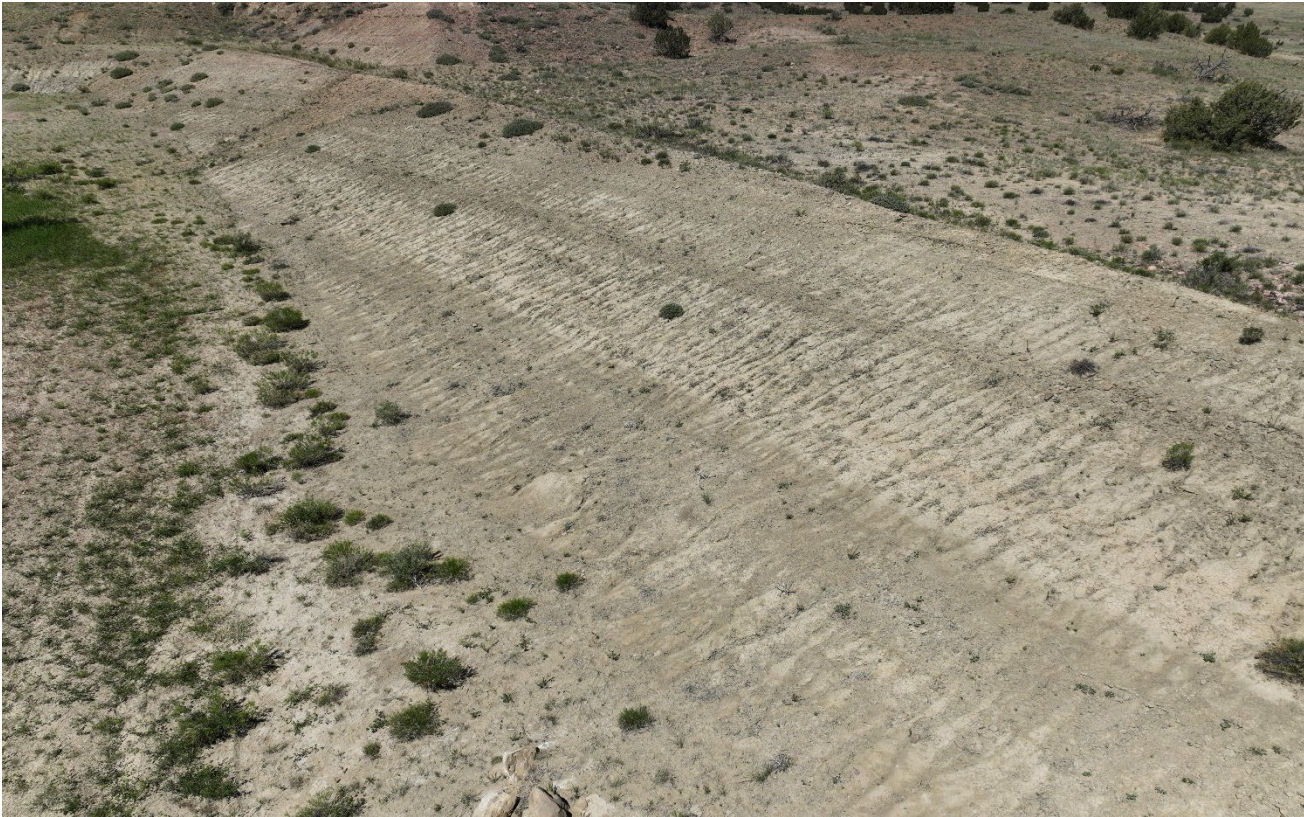
**Photo 7.** Facing southwest along the cut slope. The cut slope is not stabilized and there are signs of rilling erosion.
