Inspection Photos

API: 043-40000

Operator: JAVERNICK OIL

Inspection Date: 5/20/2024

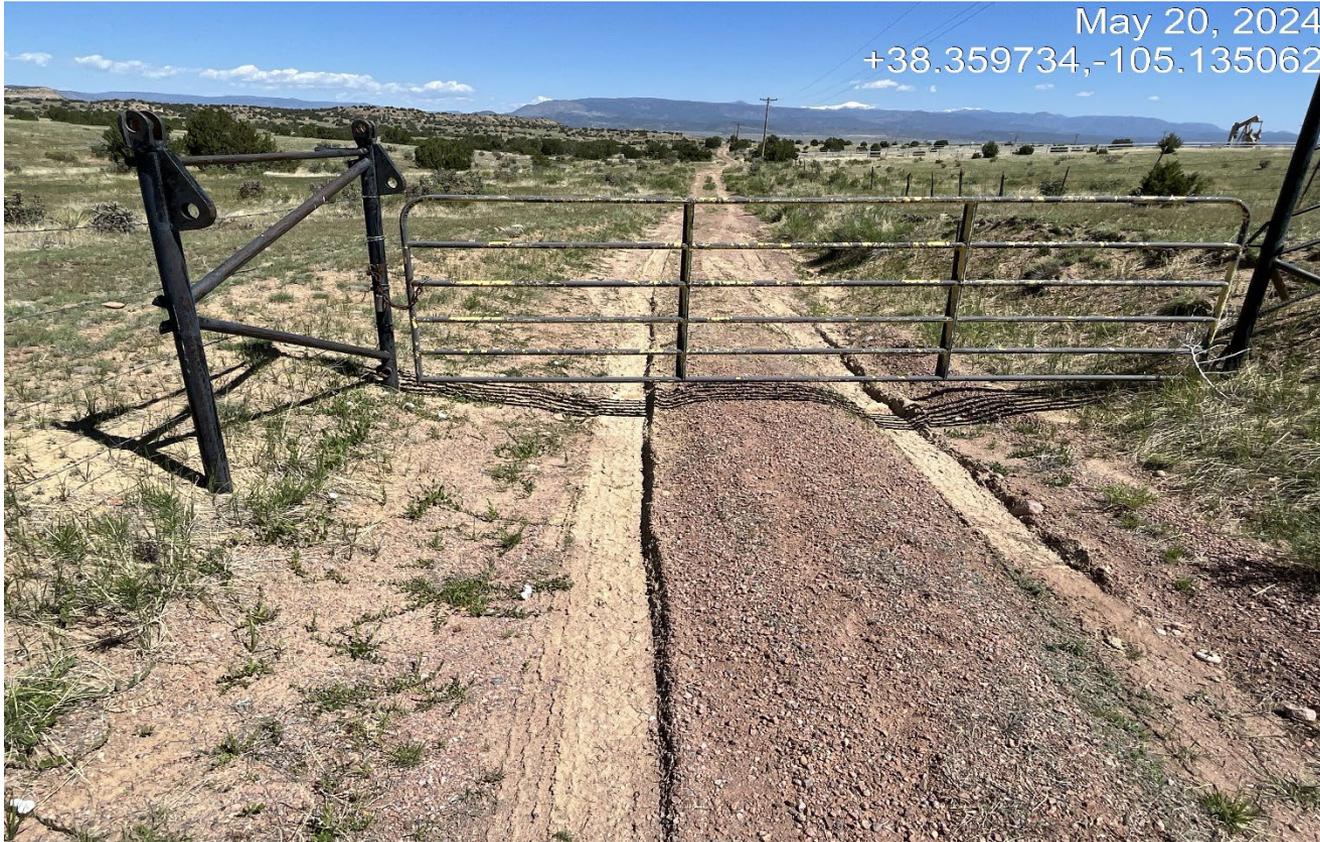
Photo 1. Facing north along the former access road. There is erosion along the road that must be repaired.

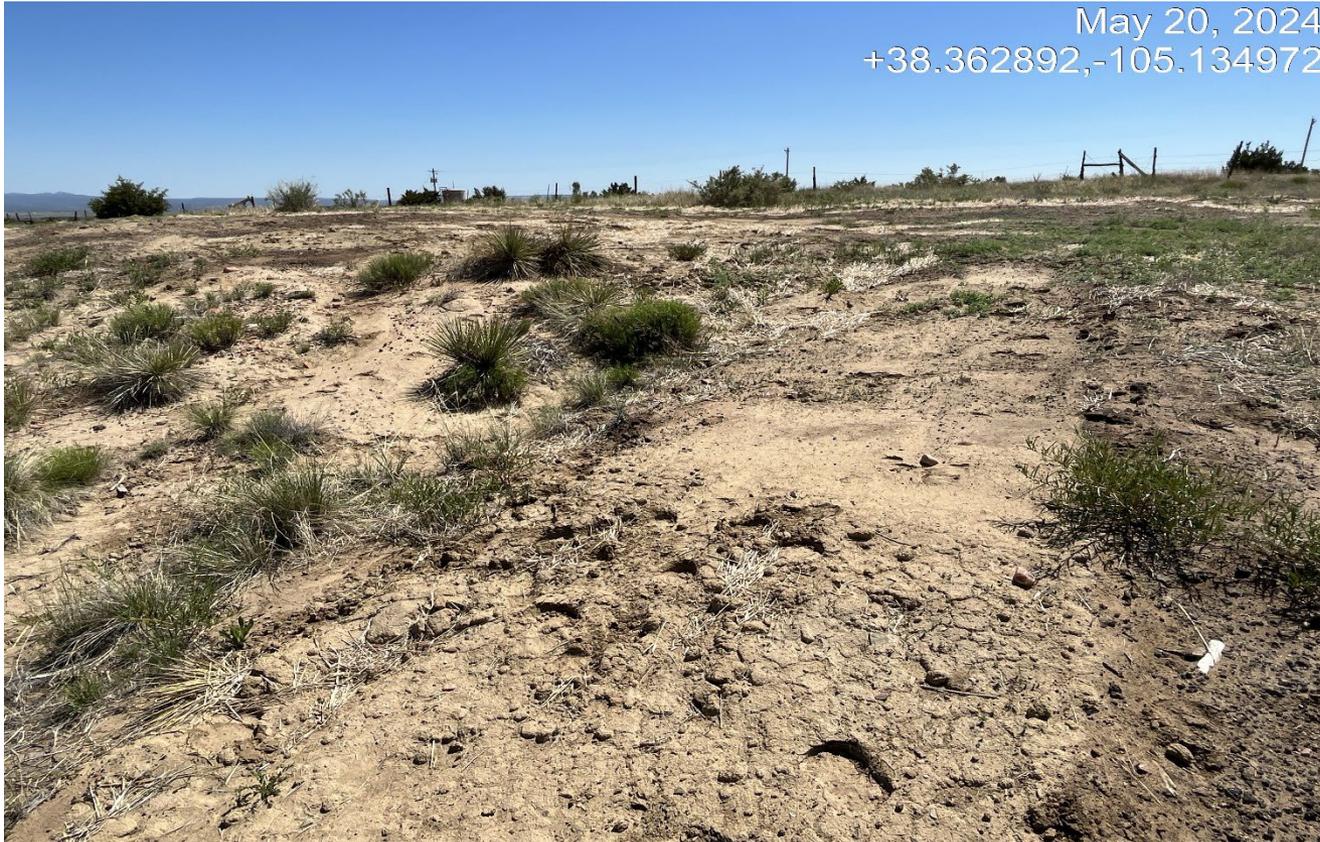
Photo 3. Facing northeast toward the abandoned wellsite. It appears most of the debris has been removed and reclamation was performed since previous inspection.

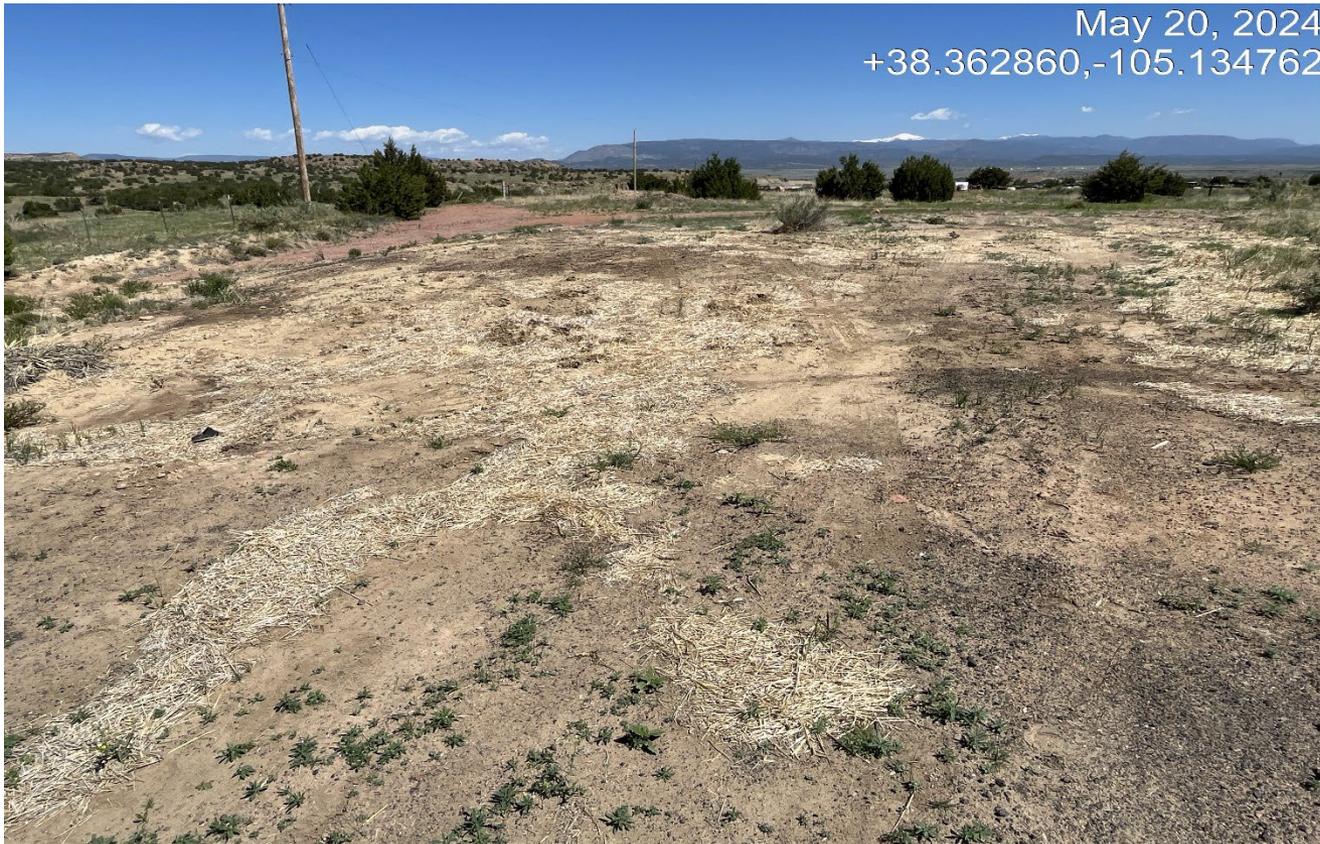
Photo 3. Facing northwest at the location. There was straw applied to soil but has mostly blown off. Did not observe much germination occurring.

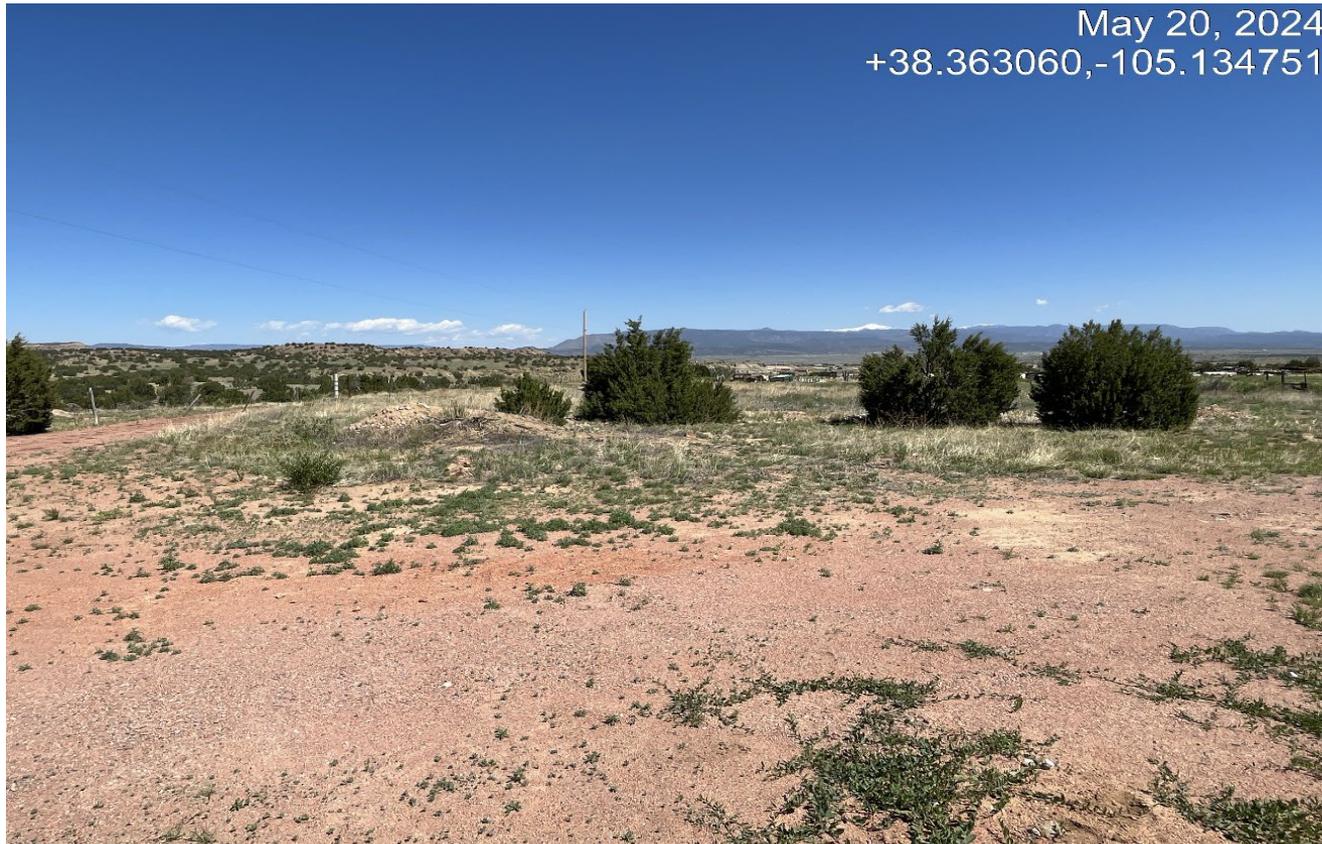
Photo 4. Facing north at the wellsite. The abandoned power pole has been removed and the cement blocks.

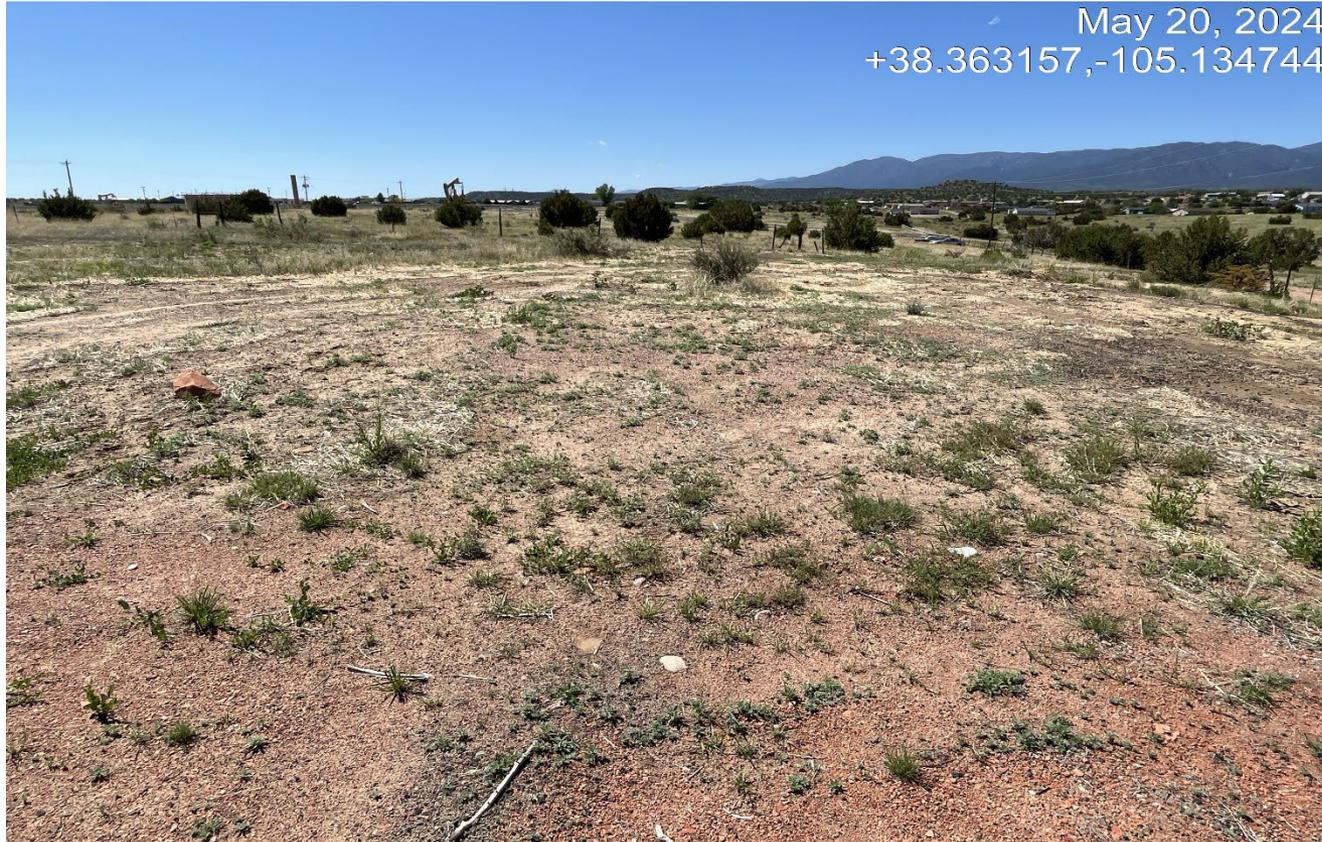
Photo 5. Facing south at the abandoned location.
