# Inspection Photos

API# 043-40014

Operator: **JAVERNICK OIL**

Inspection Date: 3/20/2024

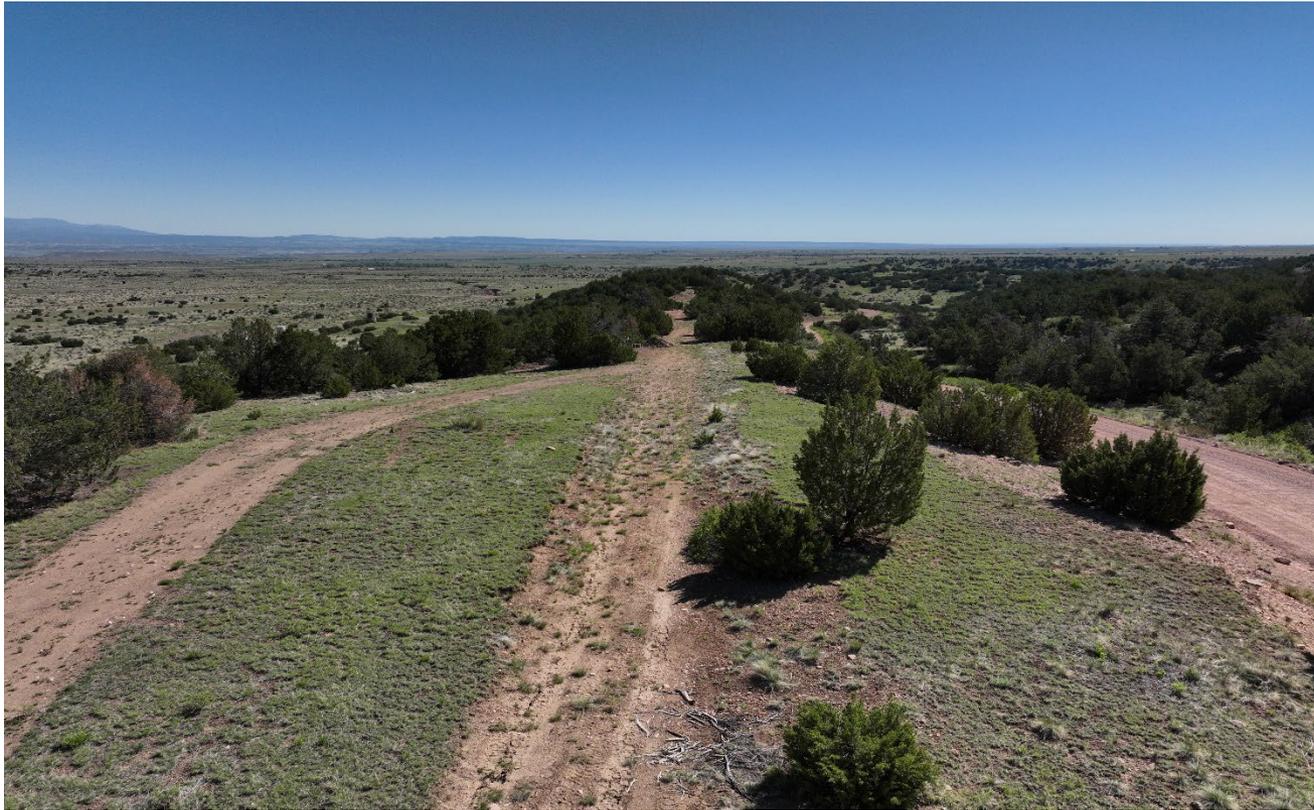
**Photo 1.** Drone aerial photo facing northeast. There is a new road built on the left side however the original access road remain unreclaimed in center of the photo.

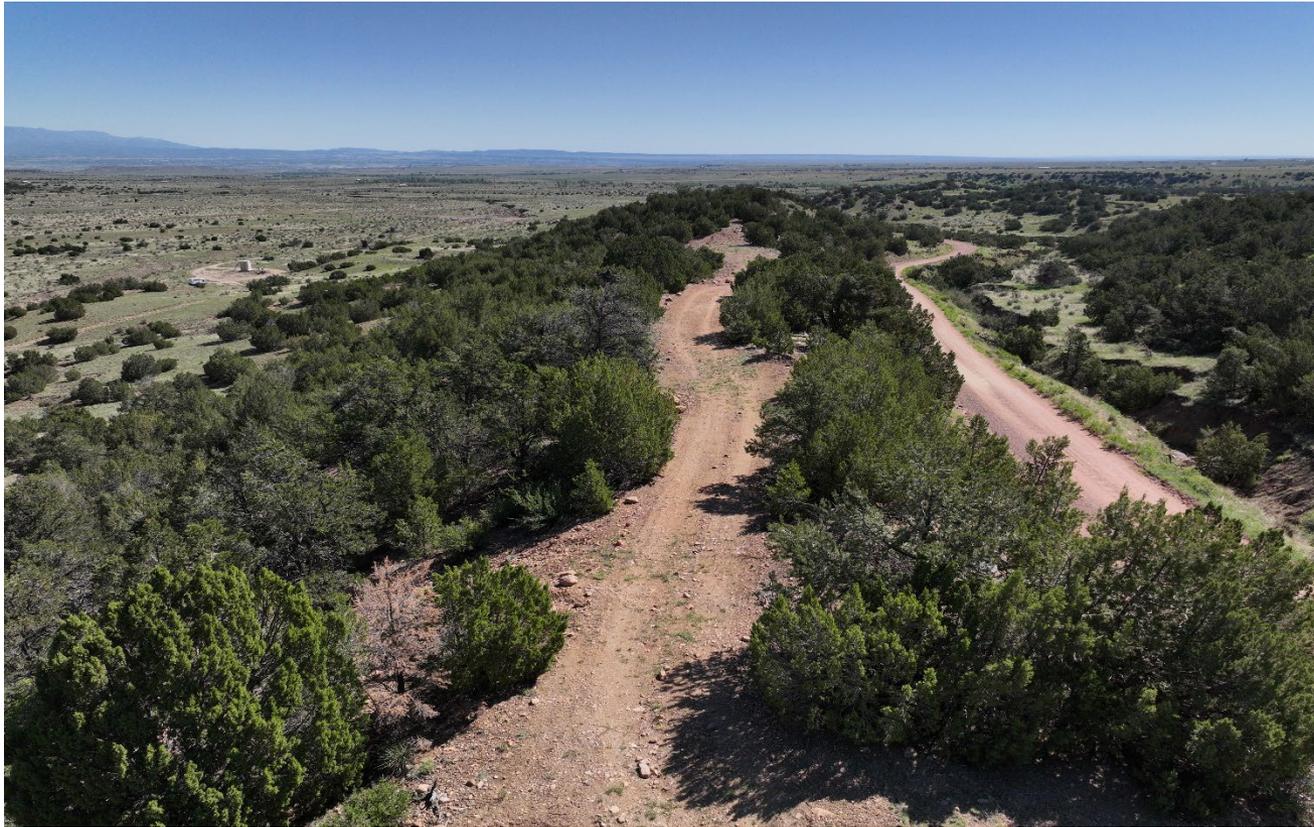
**Photo 2.** Drone aerial photo facing northeast. Access road has not been reclaimed.

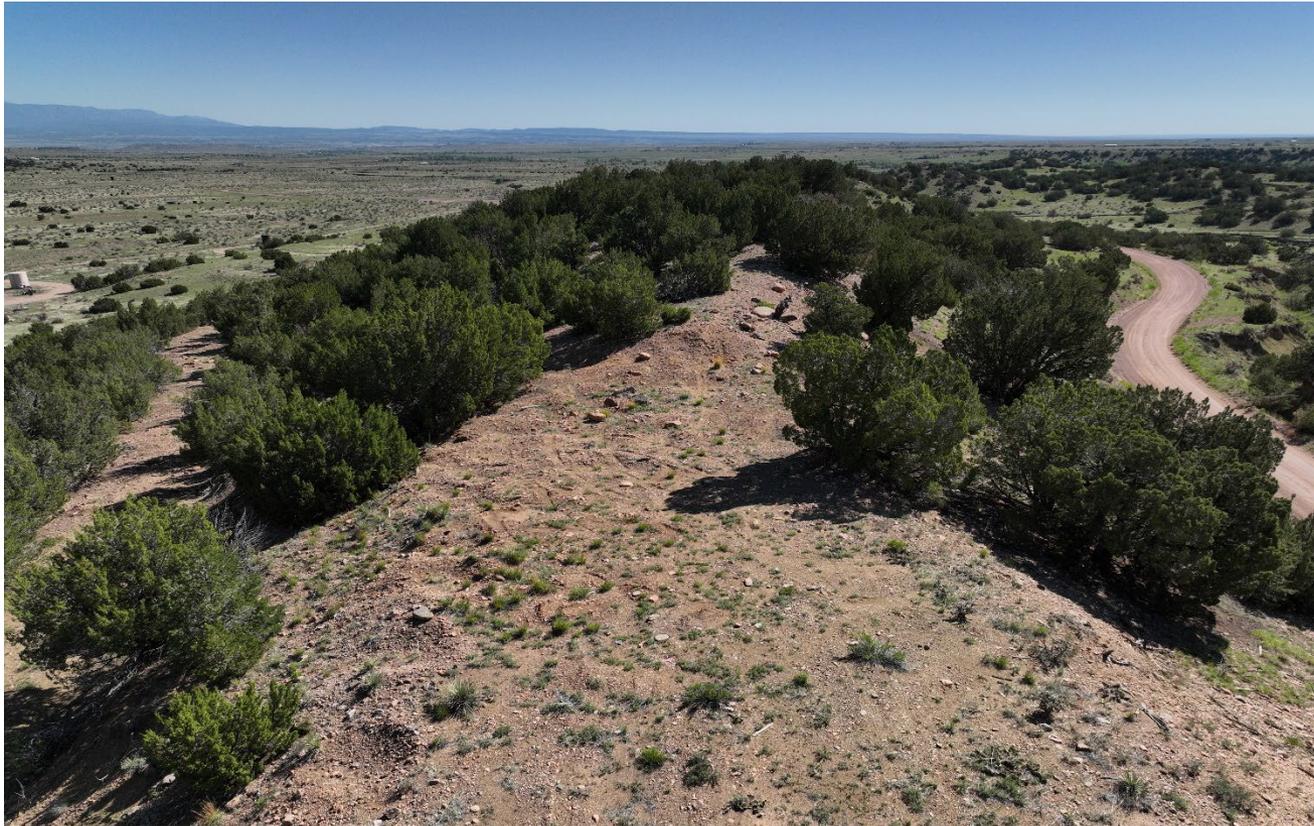
**Photo 3.** Drone aerial photo facing northeast toward the location which has not been recontoured and reclaimed..

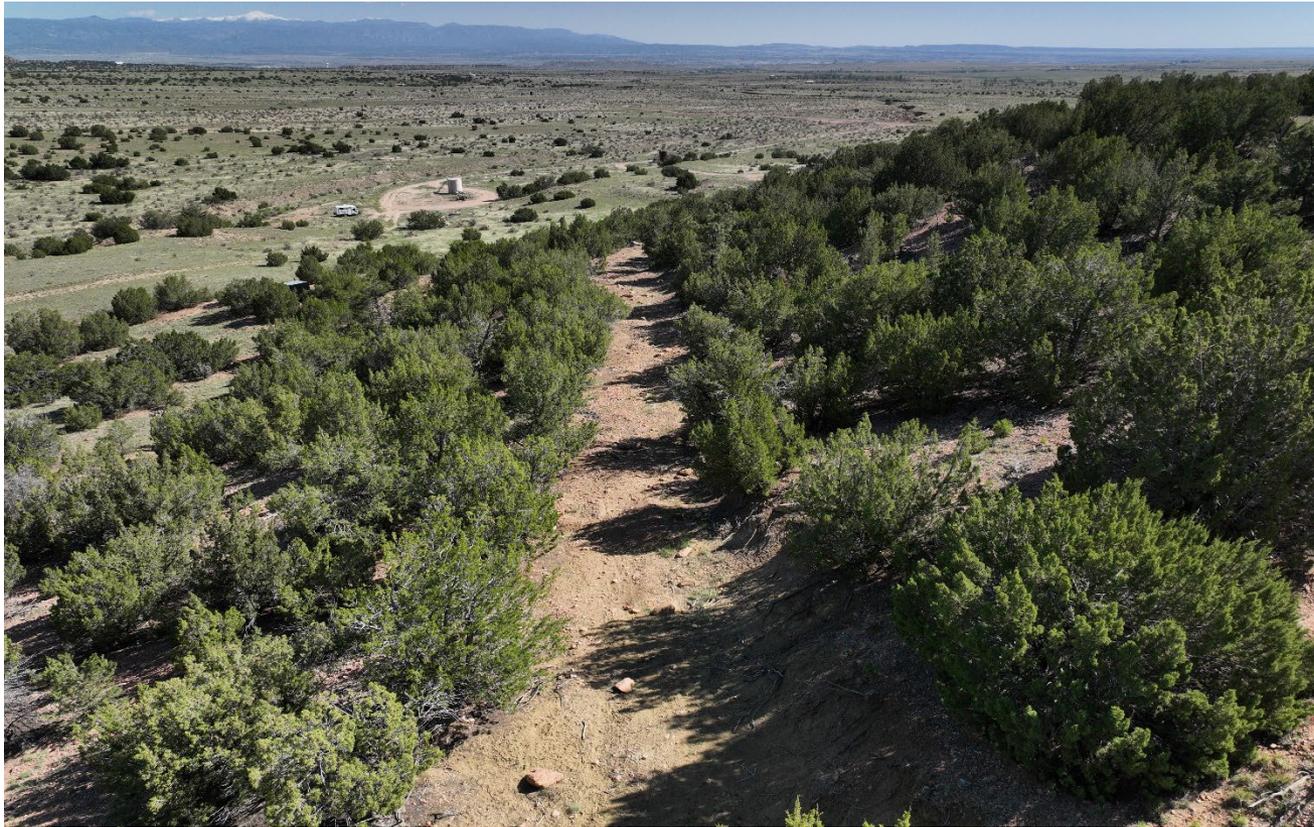
**Photo 3.** Drone aerial photo facing north. There was an additional access road that goes to the Drapper 4 wellsite. This road has not been reclaimed.

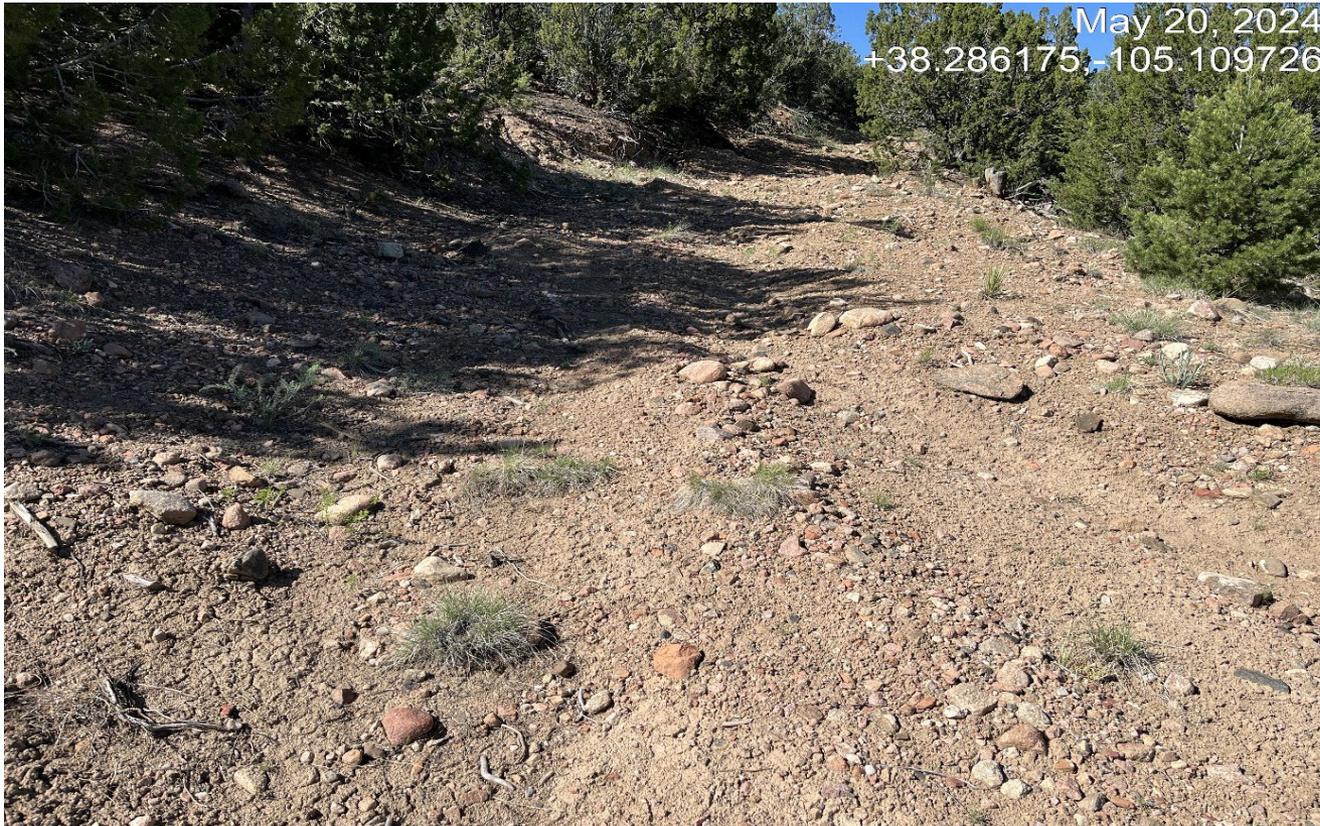
**Photo 5.** Facing south along the access road shown in the previous photo. This road is not reclaimed or stabilized.

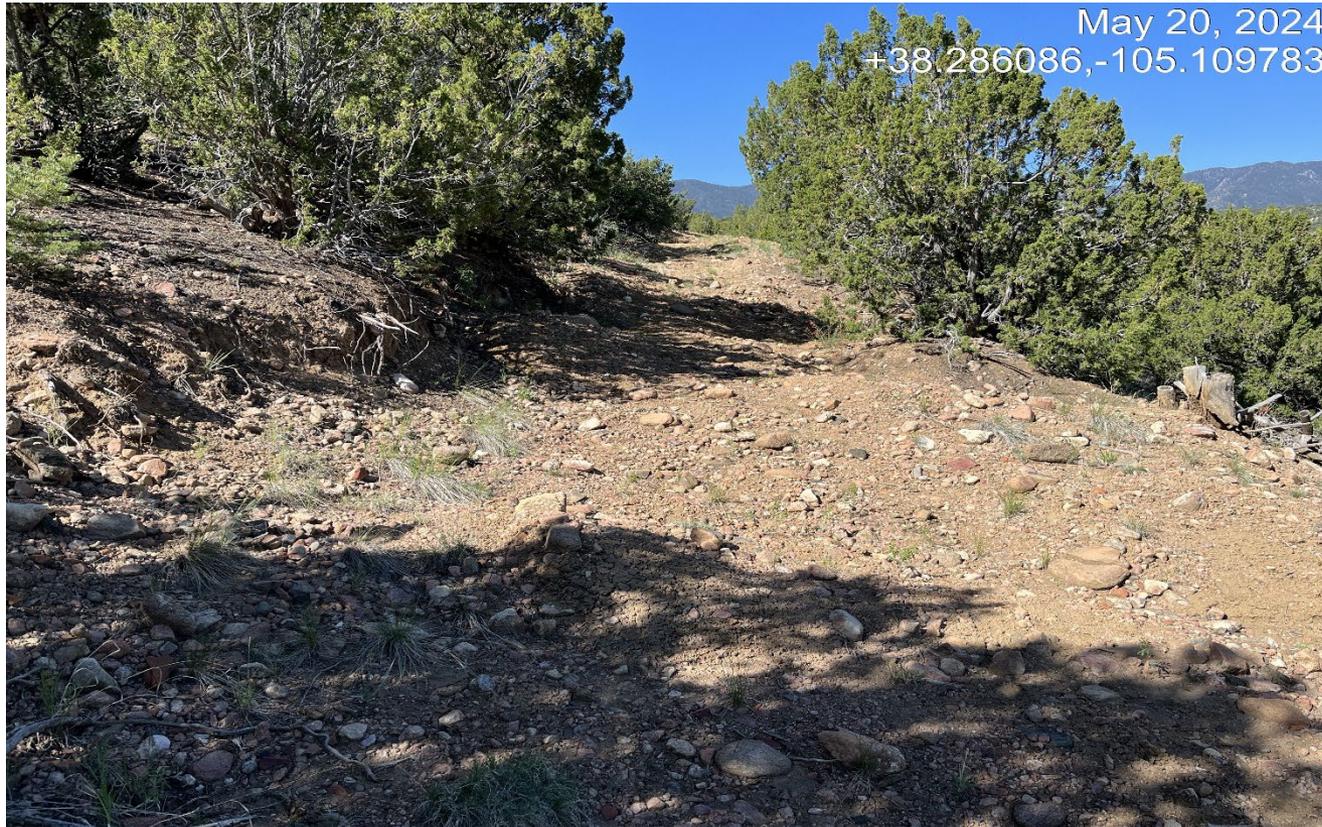
**Photo 6.** Facing south along the access road. This road is not recontoured.
